DESKTOP GEOTECHNICAL REVIEW

340 Cranford Street, Saint Albans

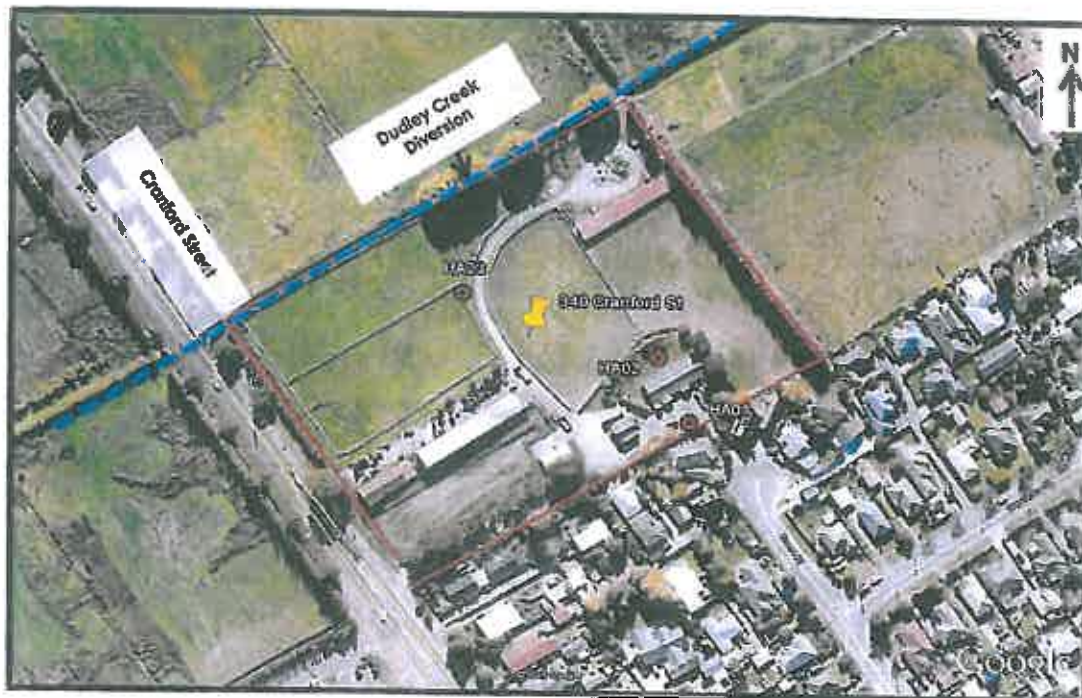
Figure 1: Site location (red outline) and shallow testing location plan.

The site is located 340 Cranford Street, Saint Albans, Christchurch and is legally described as Lot 1 Deposited Plan 471475. The site is located approximately 3.6km north of the Christchurch central city. The site is bounded by Cranford Street to the southwest, residential lots to the east to southeast and farmland. Refer to Figure 1.

The areas covered in this report are largely the agriculture area at the on the western and eastern side of Cranford Street. Within these areas, there are several drains and ditches, including the Dudley Creek Diversion (Refer to Figure 1).

difficult, and another met the target of 4.0m (bgl) (HA03). Refer to Figure 1 for test locations.

The observations made, show evidence of thicker peat layers within the lower elevation levels at northwest area (HA03 location) of the site and becoming thinner towards the southeast area (HA02 to HA01) of the site. The area where the main dwelling is located is at a higher elevation similar to the existing residential areas to the south.

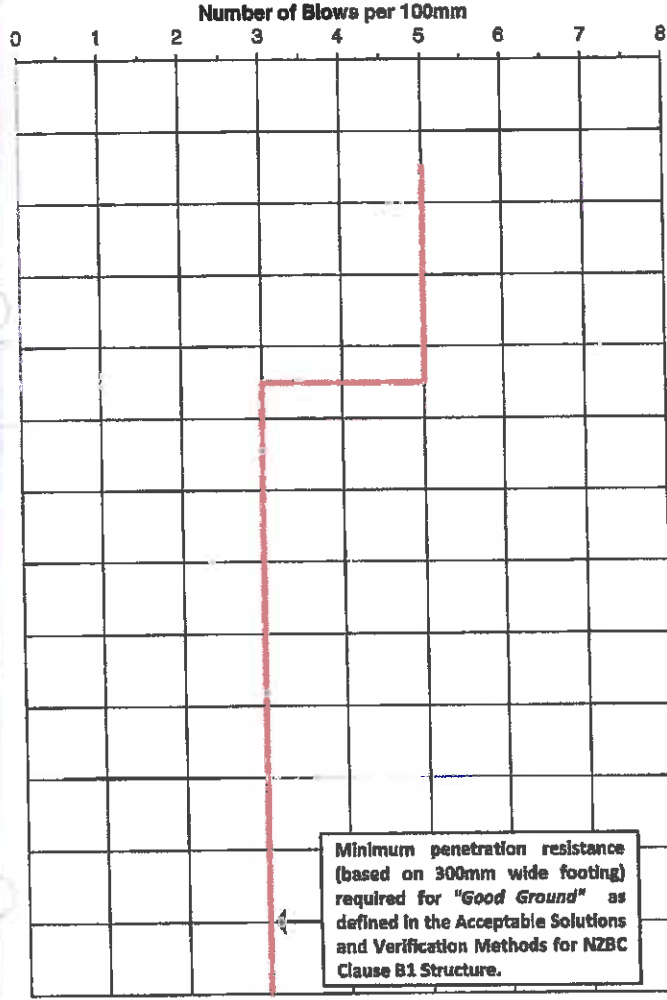
SCALA PENETROMETER TESTS

Minimum penetration resistance (based on 300mm wide footing) required for "Good Ground" as defined in the Acceptable Solutions and Verification Methods for NZBC Clause B1 Structure.
