## ST ASAPH STREET

### POST CONSTRUCTION ROAD SAFETY AUDIT

Prepared for Christchurch City Council

13 March 2017

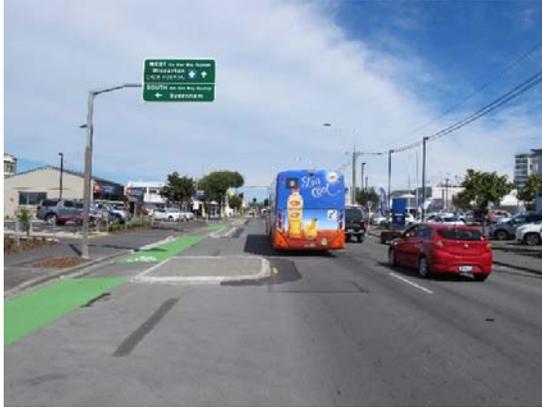
The introduction of the new kerb narrowing's (build outs) associated with the new design has incorporated elements required to correctly position the driver into the lane, minimise the risk of drivers

turning into the new cycle lane, along with the opportunity to provide street side parking facilities that are sheltered from the through lane. The SAT note that during peak travel times, and off peak (day) travel times, the inclusion of kerb side parking creates an element of street narrowing, visually reinforcing a busy street operating environment.

**Photo 1: Example of new constrained road environment. Note low conspicuity of kerb.**

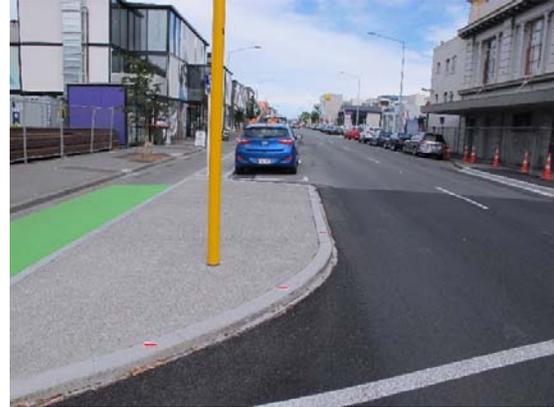
**Photo 2: Example of kerb build outs to achieve protection for parked vehicles, and correct placement of traffic signals.**

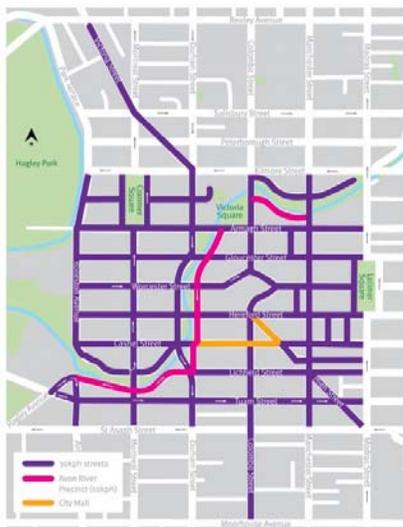
St Asaph Street is on the southern boundary of the central city 30 km/h cordon area (Refer to Figure 2). It is noted that Colombo Street has a 30 km/h speed limit southward to Moorhouse Avenue.

**Figure 2: Current Central City 30 km/h speed limit area.**

Given that the normal day progression speed is around 30 km/h, the SAT recommends that the legal speed limit be lowered to 30 km/h to better reflect the speed environment, and match the actual operating speed.

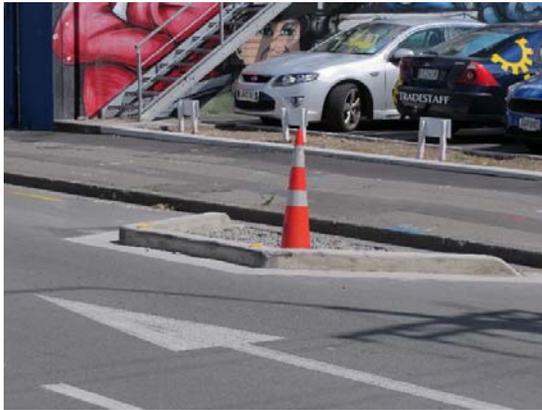
The placement of street planters along the street assist with the definition of the reduced road corridor, and provide a level of speed management. These planters also provide protection from drivers “undertaking” (illegally passing on the right hand side of a vehicle that is in a traffic lane) at speed to advance along the parking shoulder. This situation would mainly occur at off peak times, or low traffic density.

The planters installed generally have a sloped face (in respect to the traffic direction of travel) that assists drivers with entry and exit movements. The provision of perpendicular ends results in an impeded ability to easily enter and exit the parking space.

**Photo 3: Example of new planter – north side. Note lack of plants installed to define vertical element.**

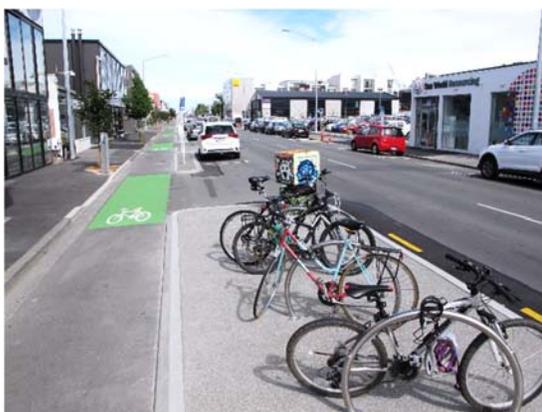
The SAT are of the mind that the kerb build outs are necessary for the correct positioning and orientation of left turn traffic, and to importantly protect the sight line to the right for exiting drivers.

**Photo 5: Example of left turn in protection offered by kerb build out. Note utilisation of this space for cycle parking and street art (installed by local business)**

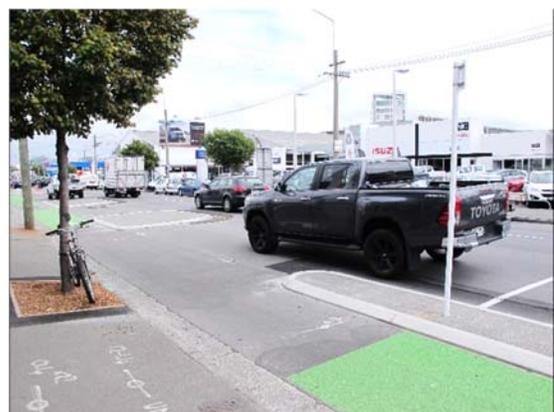
**Photo 6: Example of unprotected left turn in. Driver is positioned such that they cannot see back down cycle facility.**

As discussed, this left turn will be required to be undertaken from the through lane, and the driver will be subject to pressure to depart the traffic lane from traffic formed behind.

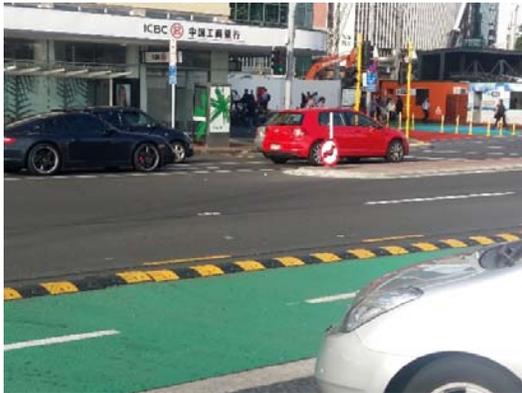
The SAT consider that there may be opportunity to explore a solid barrier line on the traffic side of the cycleway green markings to highlight that the driver is crossing over a separated facility. In some locations throughout NZ, this barrier line is formed through the use of a low profile black and yellow raised separator.

**Photo 7: Example of low profile raised separator at access – Bi-directional facility, Quay Street, Auckland**

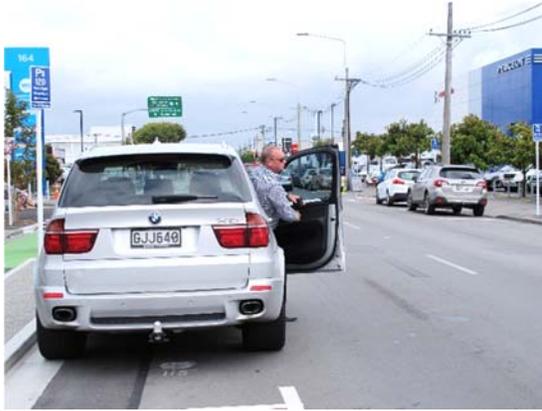
Of note was observations of large vehicles parking in the shoulder parking spaces, with a portion of the vehicle overhanging the through traffic lane. In addition, the SAT observed on numerous occasions where large and small vehicles (typically delivery vehicles) were parked within the through lane, blocking traffic. This action contravenes the traffic regulations (unless for an emergency situation), and causes significant safety risks to users of the street.

Poor lane discipline can result in through vehicles impacting with opening doors, people alighting from their vehicles, and greatly increases the risk of impact with pedestrians emerging from between two parked cars, where their view line along the street will be impacted by parked vehicles, especially HCV and SUV type vehicles.

**Photo 9: Example of larger SUV overhanging parking space. Note door into edge of traffic lane.**

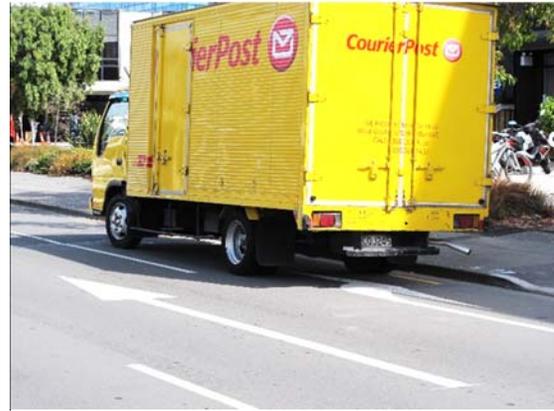
**Photo 10: Example of illegal parking by delivery vehicles**

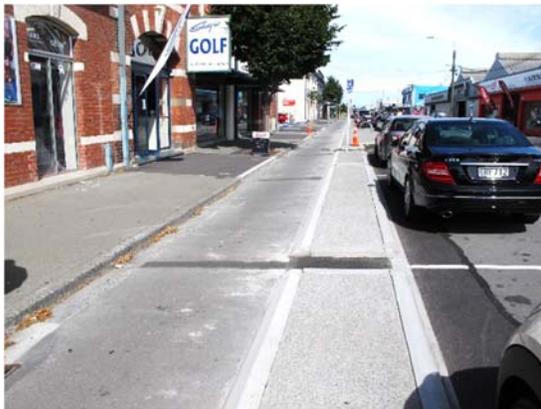
This style of formation presents multiple kerb steps requiring people to step up and down from, especially those alighting from vehicles, or crossing midblock. It is noted that typically these steps would be on the kerb line on each side of the road.

The SAT noted that at a number of locations the new formation offered poor visual contrast to these changes in height. With the new formation, it may be difficult for elderly and visually impaired users to define the edges due to the lack of tonal contrast this instance.

**Photo 11: Example of typical separator formation.**

1. Education of the public of the new facilities, and behaviours expected
2. placement of an appropriate contrast tonal marking in high pedestrian use zones,
3. Better enhancement of the kerb build outs through the use of items such as planters and possible signage.

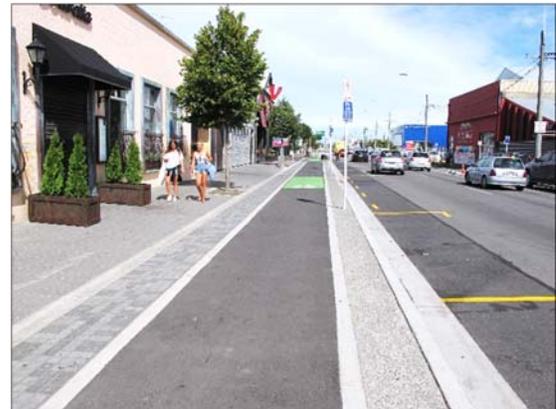
**Photo 12: Example of cycle facility raised to footpath level, with concrete edge treatments to define path.**

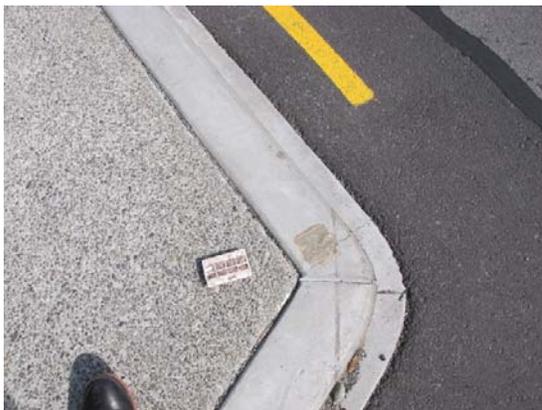
Of concern to the SAT was the high proportion of RRPM's that were absent – evident by the adhesion marks on the kerb top. This would indicate that the attachment adhesive utilised has failed under general use, and the effect of vehicles running over the low profile kerb to access car parks or driving into access ways. This overrun gets worse as more units are knocked off, resulting in a higher level of impacts onto the units, resulting in a greater level of loss.

Photo 13: Example of RRPM loss

2. Undertake immediate remedial repairs of installed red RRPM's

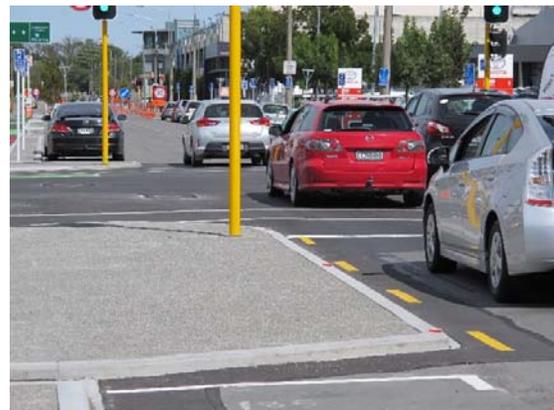
It was noted that the new kerb formation produced a grey on grey tone, offering poor contrast to highlight the kerb units. To counter this, the project has installed red kerb top RRPM markers on the faces that are visible to the approaching driver. This delineation is at approximately 100 mm above the road surface.

Photo 14: Example of Red RRPM installed on kerb top.

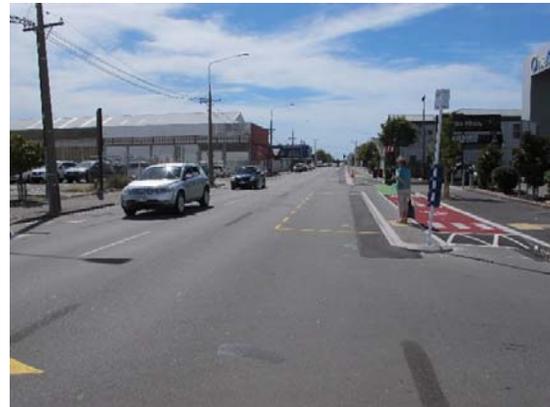
**Photo 16: Example of conflicting markings (including ‘ghost’ markings from old road layout)**

In many instances the new road alignment has required the removal of the old road lane lines. These have been removed by abrasion, and have resulted in ‘ghost’ markings that become more apparent during wet weather. This creates confusion as often two line systems will be visible.

1. That the project length is remarked utilising an appropriate high profiled pavement marking system that performs well in wet and / or dark conditions.
2. That all ghost markings be eliminated as much as possible noting the guidelines outlined by the Road Markers Federation, and that clear specifications be inserted into all future contracts of a similar nature.
3. Consider the use of temporary taped lane markings for future temporary works, or delay placing the final asphalt surfacing to minimise ghost markings.
4. Undertake a review of the specifications for all future major central city projects to ensure that an appropriate level or remark of all pavement markings is incorporated.

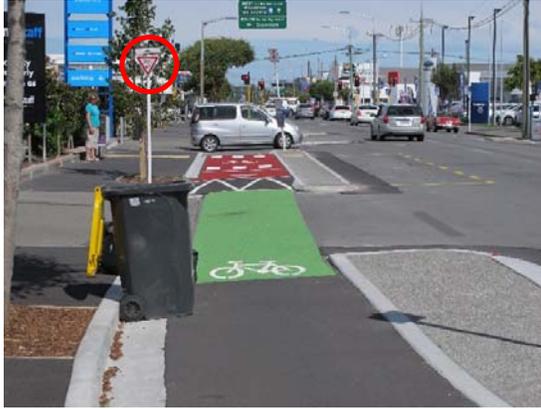
The current design has the bus timetable information installed on the pole immediately adjacent to the traffic lane side of the separator. This requires the pedestrian to cross over the cycle facility, read the information, and then cross back to the seating. This exposes the pedestrian to multiple opportunities for impact with a cyclist. The placement of the bus timetable on the footpath side of the cycle facility would minimise these conflicts.

**Photo 17: Cyclists view on approach to bus stop. Note Give Way sign (circled) is lost in street furniture, and rubbish bin placed in the cycle facility.**

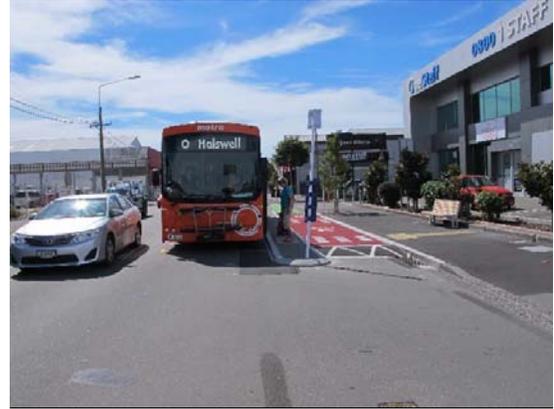
**Photo 18: Bus patron utilising new facility. Note that they are in the shade of the bus and may not be clearly visible to cyclists using the system.**

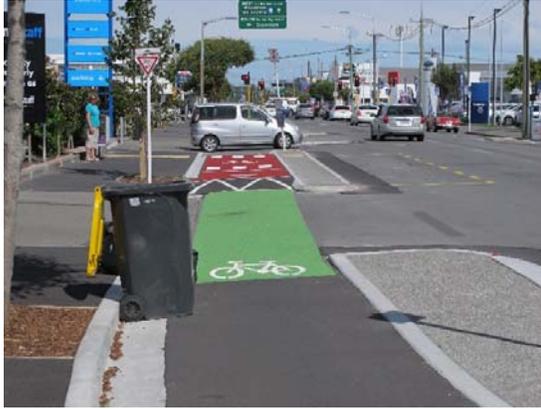
**Photo 19:** Example of rubbish bins placed in the cycle facility.

This will result in cyclist’s travel being compromised, with the risk of impact with a rubbish bin being high on collection day. The presence of vertical kerbs either side of the cycle facility restricts the cyclist’s ability to safely take evasive action.

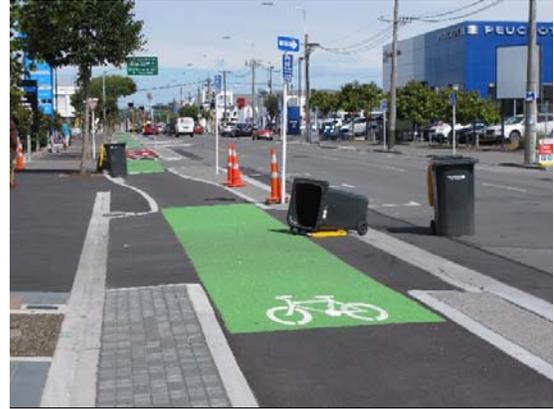
**Photo 20:** Rubbish bins placed in the parking shoulder. Note bins topple into cycle lane and block entrance.

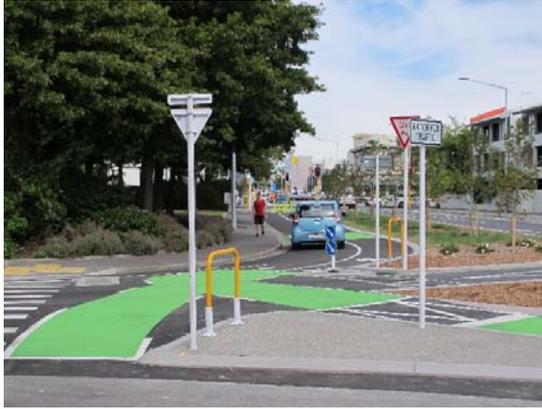
At the time of undertaking the site inspection, the SAT observed 3 vehicles drive down the separated cycleway within 30 minutes during the morning off peak travel time. All three vehicles had to reverse or turn and drive the wrong way out. These vehicles would have been blind to a cyclist entering from the Ferry Road (westbound) lane.

Observations on site indicate that drivers are getting confused as to the westbound lane. This is due to the lack of physical separation, and apparent entry, at the cycle lane crossing. While close scrutiny of the intersection would reveal the cycle lane markings and coloured surface, to the approaching driver, requiring to make an instant decision, the clarity of the correct path is less defined.

**Photo 21:** The blue car “comfortably” driving along the 2 way cycle path. The man in the red top flagged down the car and got the driver to reverse back out of the cycle lane.

Improve the delineation and channelisation of Ferry Road traffic approaching the St Asaph Street intersection. While a wider review of the intersection layout and operation is recommended (discussed below in further detail), in the interim it is strongly recommended the use of bollards to prohibit motorists from accidentally accessing the cycle path.

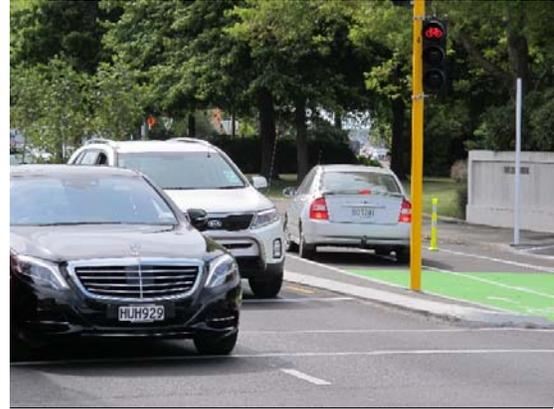
**Photo 22:** The silver car on the right has just completed a 5 point turn at the Cashel Street end of the 2 way cycleway before heading back to Ferry Road.

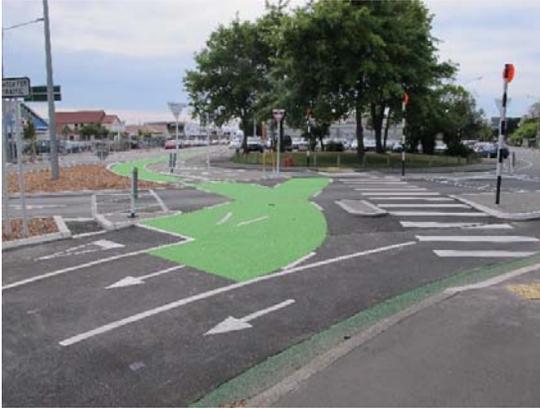
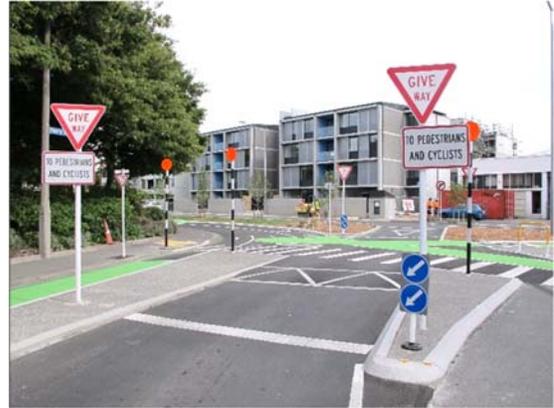
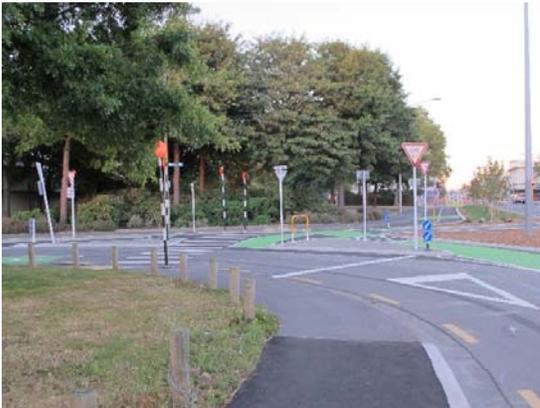
movement over the pedestrian crossing, however the sign also requires the cyclist to give way to left turn vehicles.

- The give way for the left turn movement (into Ferry Road) is positioned in such a location that it legally applies (placed on the left side of the cycle lane) to the westbound cycle movement. This conflicts with the priorities for the other approaches for the cycle lanes.
- Signs have been rotated to an incorrect direction
- Number of signs result in poor readability, blocked signs, conflicting / confusing layout. High number of signs causes confusion

**Photo 23: Confusing markings and signs – Ferry Road / St Asaph Street intersection**

**Photo 24: Confusing markings and signs – Ferry Road / St Asaph Street intersection**

**Photo 25: Confusing markings and signs – Ferry Road / St Asaph Street intersection**

1. That the designers undertake a review of the current design, noting these conflicts and constraints, and undertake a remedial design to address the issues. The signage needs to be intuitive and easy to read – too much signage and the motorist/cyclists cannot absorb all the information in such a short decision time when entering the intersection.
2. It is strongly recommended that the design team observe driver behaviour on site to understand the conflicts and confusion that exist.

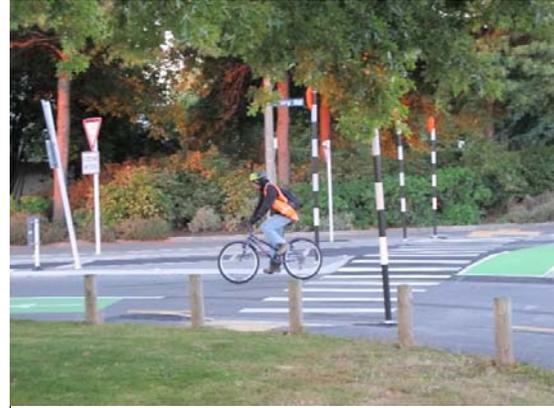
**Photo 26: Example of cycle path exiting (eastbound) from the Ferry Road Intersection. Note pole damage to left.**

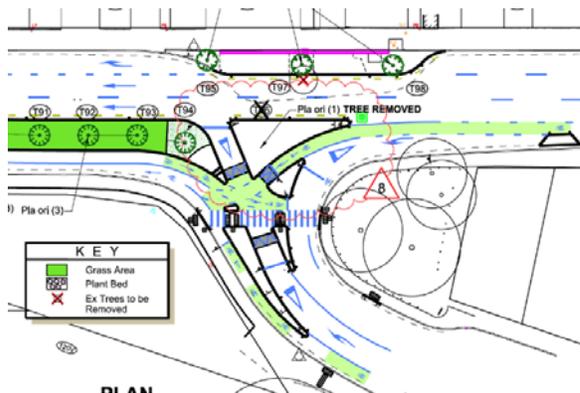
Figure 2-3: Design Drawing of intersection.

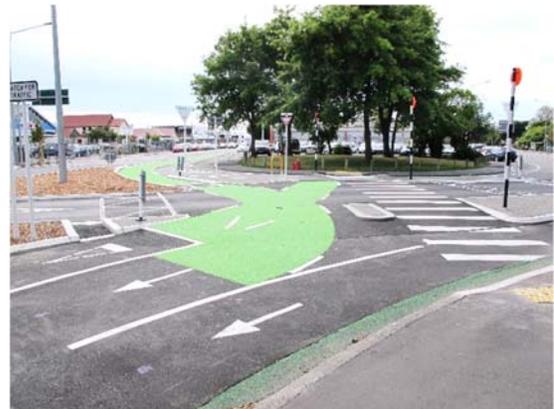
Cyclists are approaching the intersection at generally 20km/h to 30km/h, however the markings (and signage) is reasonably complex and difficult to interpret when travelling at these speeds, especially when changing direction, and potentially giving way to other cyclists, motorists and pedestrians.

Figure 2-4: Actual controls and markings installed.

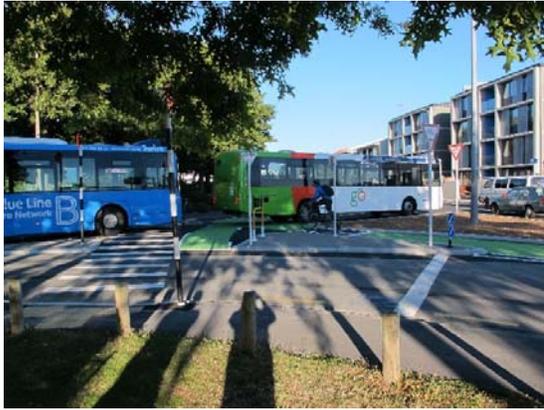
Ferry Road is a dominant bus route. During the site inspections it was observed on numerous occasions that stacked vehicles waiting to turn from Ferry Road into St Asaph Street, be they cars or buses. A summary of issues is presented below:

- Bus's overhang facility – multiple stack of vehicles causing cyclists to veer around and between vehicles, especially buses,
- Stacked buses blocking visibility for cyclist and eliminating cyclists ability to observe cyclists approaching along the system on Ferry Road approach to bi-directional facility,
- Drivers failing to look right upon exiting Ferry Road, driving directly into the path of an approaching cyclist on a permitted through movement,

**Photo 27:** Current design requires an exiting bus to straddle the new facility. Cyclists cannot see merging cyclists on opposite side of the bus

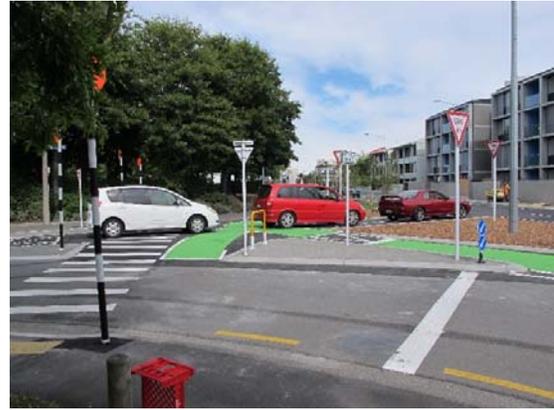
**Photo 28:** Multiple cars parked over the new facility. This was observed at almost every time where vehicles queued for exit.

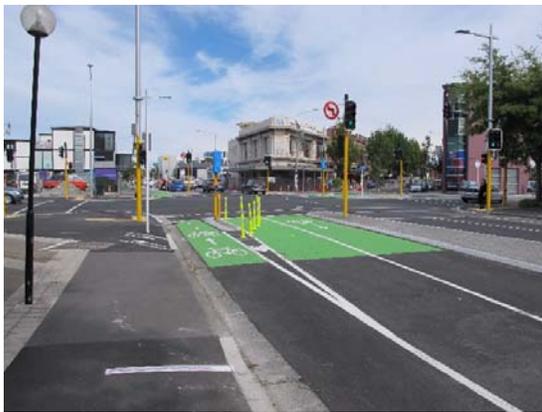
- The markings on Madras Street were incomplete, and resulted in what appeared to be an additional lane where cyclists were required to position for the northbound movement. Colouring of the road surface would be required to clearly define the cycle lanes to avoid motorists positioning themselves in the cycle lanes.

**Photo 29: Madras Street / St Asaph Street. Note footpath markings marked for removal?**

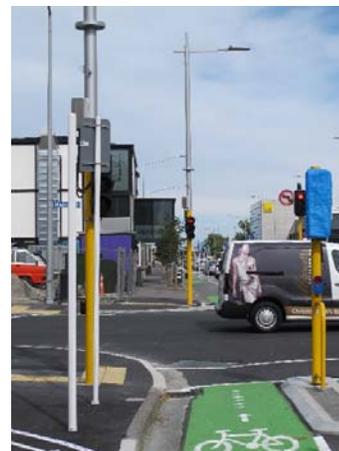
- The left hand traffic signal (westbound) for the cycle facility is partially masked by a preceding sign.
- The current dashed leader line between the St Asaph Street bi-directional facility, and the partially completed High Street facility. The current road markings do not give good guidance to the cyclists. The current line leads from the left hand side of the High street facility, onto the centre of the bi-directional facility. The use of a white line could miss-lead a driver. A change of colour to (say) green dashed would better represent the cycle path.

**Photo 30: Sign masks primary traffic signal for cyclists.**

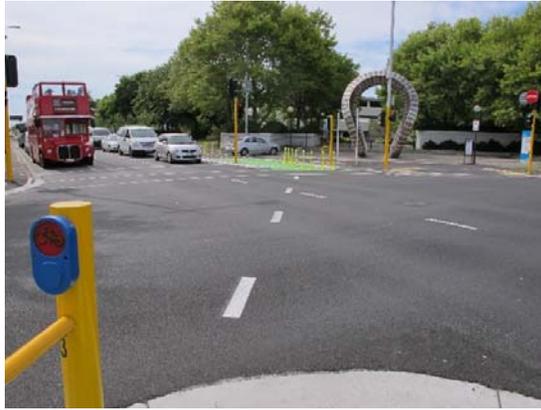
**Photo 31: Miss-aligned pavement markings for cyclists. Note – this could be confused for conventional lane leader lines for drivers.**

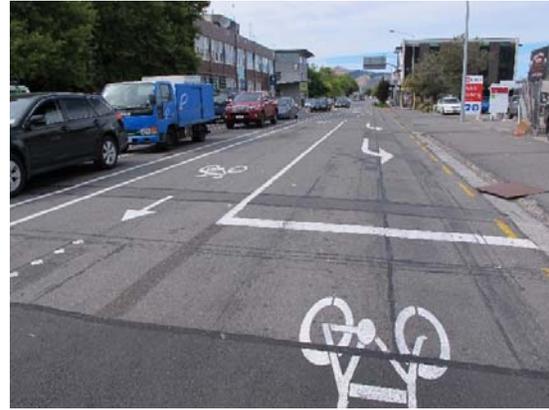
**Photo 32: Lack of green markings – Madras Street.**
