CHRISTCHURCH MUNICIPAL CHAMBERS

A CONSERVATION PLAN

MUNICIPAL CHAMBERS
159 OXFORD TERRACE
CHRISTCHURCH

October 2000

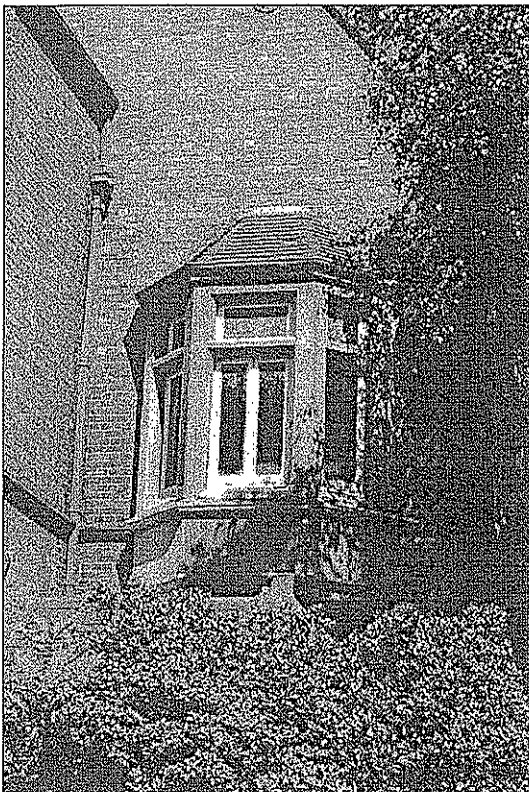
Figure 17: Oriel window on north elevation

The north elevation is not as prominent as the others and was probably not intended to be viewed with the same critical eye as the street frontages. As a consequence, it is less formal, more casual and somewhat reminiscent of Philip Webb's Red House (see fig. 9) at Bexley Heath, Kent. The main features include the tiled roof, a large chimney near the north corner, a stair tower with a pyramidal roof and the gable end of the Council Chamber. From the Council Chamber, an oriel window looks out over the Avon River and across, before the trees grew, to the buildings of Mountfort's Provincial Council buildings. It has been surmised that this was Seager's way of paying tribute to Mountfort.

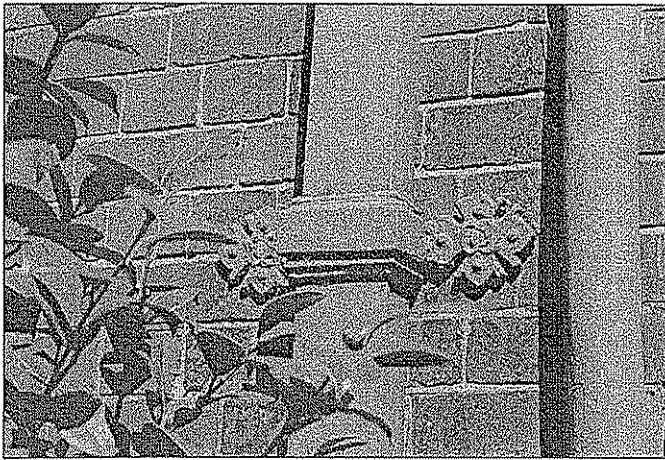
Figure 18: Cast iron downpipes and brackets

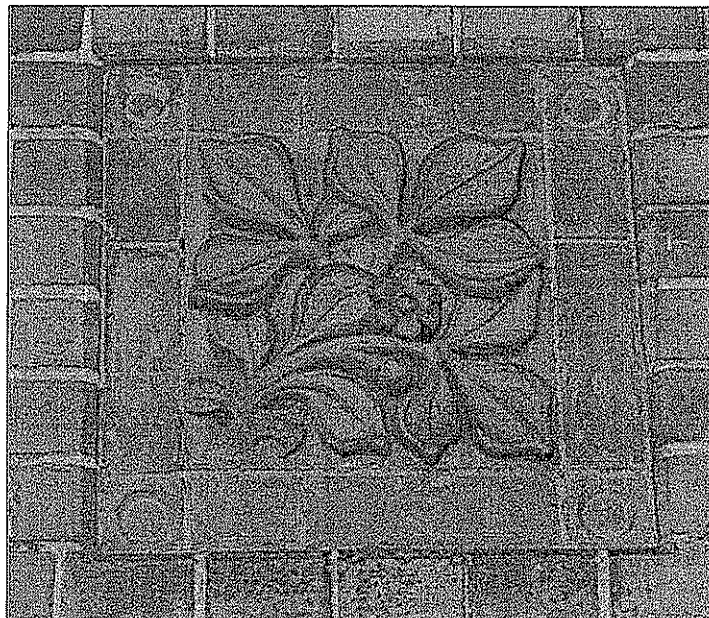
Figure 19: Moulded terracotta tile.

Of special interest is the terracotta work on the building which is believed to have been designed by Seager and known to be made by Glentunnel Pottery Works, near Christchurch. This includes the panels notably below the tower but also in other locations, featuring stylised sunflower and leaf patterns, and possibly the Frampton-designed terracotta figures flanking the window to the Council Chamber¹⁸.

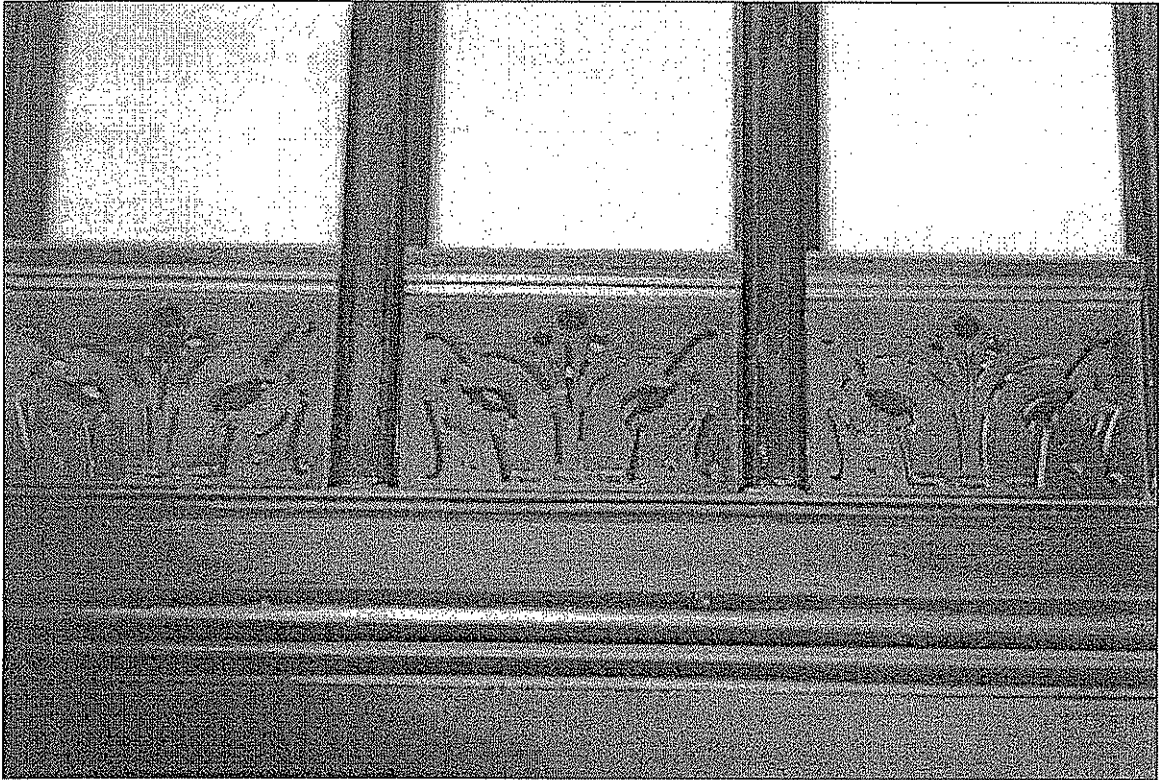
Figure 20: Carved panels in staircase

The decorative qualities of the building extend through to the interior. Although much of the interior detailing has unfortunately been lost through successive remodellings, aspects remain. These include the fine balustrading to the main stair with its Arts and Crafts flavour, the timber work with its incrusta panels in the Council Chamber, the fireplaces in the Council Chamber and Library and the various cornices.

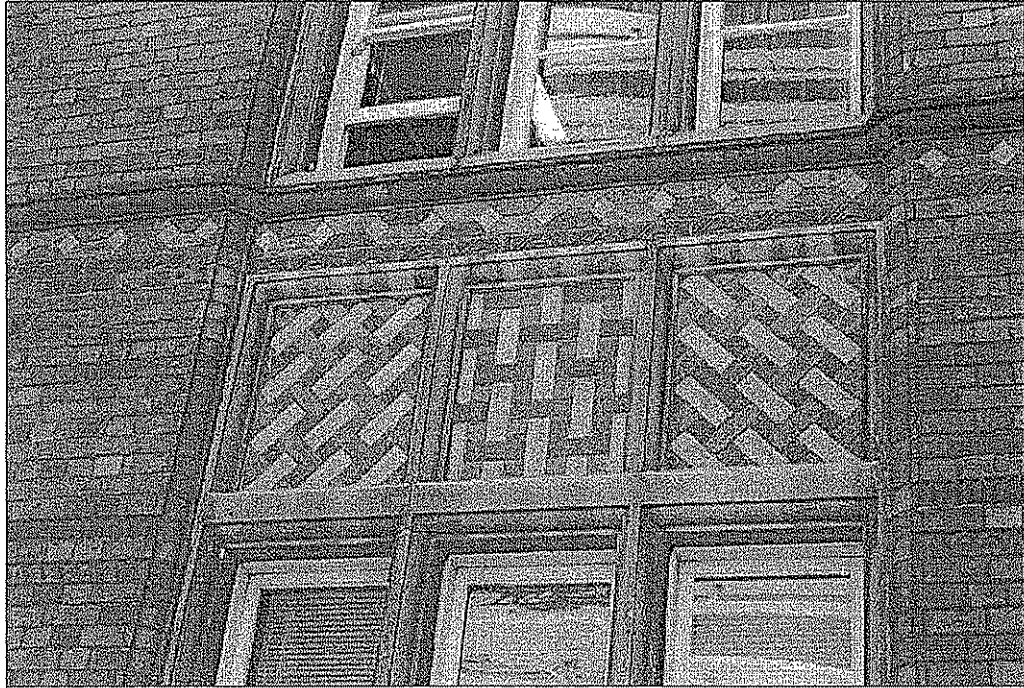
Figure 21: Decorative brick work and stone window surrounds

The exterior walls are constructed of red brick decorated with courses of cut and shaped brick in a variety of colours. Small terracotta panels have been used for decorative purposes. Stone has been used for window surrounds, sills, and balusters.

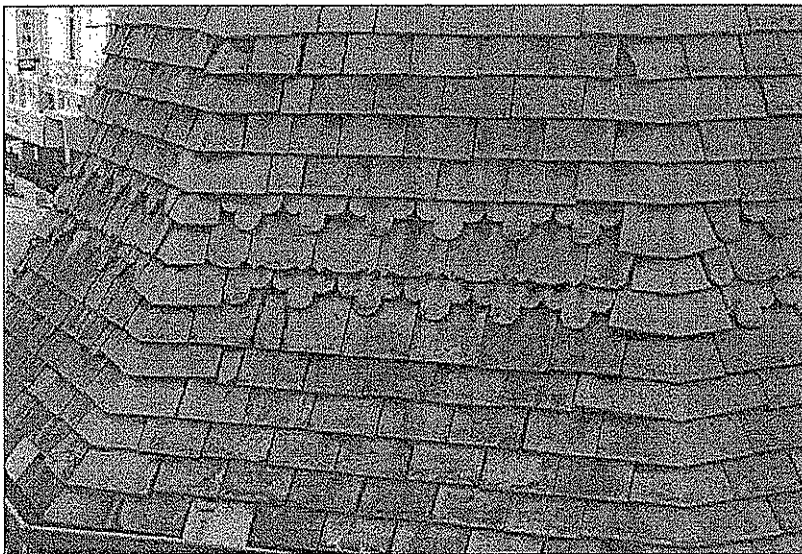
Figure 22: Decorative clay tiles visible on tower roof

The roof is clad in two different materials: the internal section is roofed with corrugated galvanised steel, while the visible part of the roof is covered with clay tiles. The roof structure is in two separate forms: a series of large trusses span the ten metre width which support the clay tiles. The rest of the roof structure consists of normal light timber rafters and purlins, supporting the internal steel roofing on one side and the clay tiles on the external faces.
