PART TWO

CONSERVATION POLICIES

FACTORS AFFECTING THE CONSERVATION OF THE ROBERT MCDUGALL GALLERY

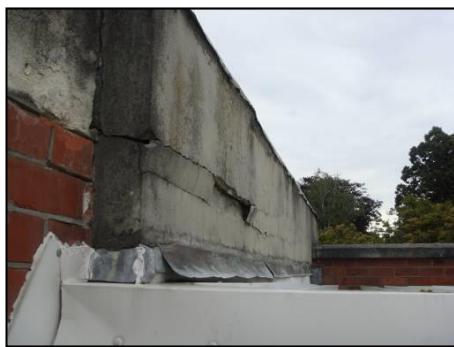
The roof is flat area with pyramidal and angled roof lights. An inspection of the roof area revealed sheets of corrugated steel roofing laid over roof lights. A fibreglass membrane laid over the flat roof shows signs of bubbling, buckling and in some areas this has been patched particularly on the eastern side. In some areas water pooling is evident.

Damage to parapet with erosion evident (DPAL)
membrane (DPAL)

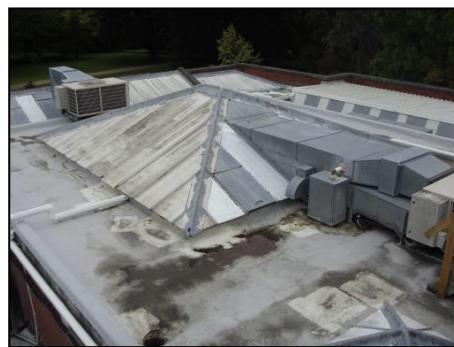
Evidence of water pooling and patched surface

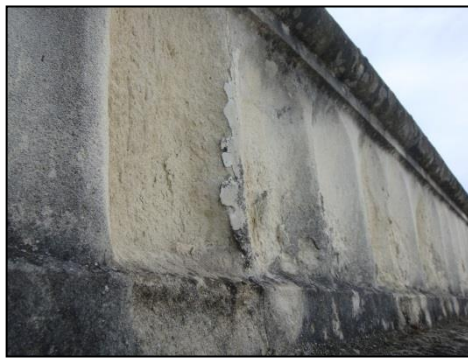
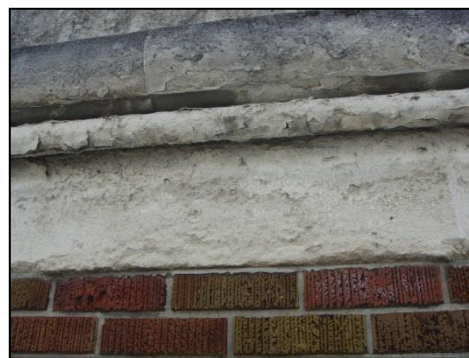
At the Robert McDougall Gallery, Oamaru limestone has been used at parapet level and for some of the detailing elsewhere on the south and west walls. Although much of the limestone remains in good condition, some has weathered, particularly on the parapets and upper sections of the walls. Cracks are also evident in some sections of the parapet and mortar pointing has been lost. The limestone is also eroding and spalling in areas where it is apparently in contact with hard cement mortar.

Christchurch has had high levels of atmospheric pollution and this is possibly the main agent of deterioration of the stone. In polluted areas, sulphur dioxide gas in the atmosphere can react with water and oxygen to produce sulphuric acid. This then attacks limestone producing calcium sulphate and water. The calcium sulphate crystallises as the mineral gypsum which is deposited in the pores of the stone. This can block the pores in the stone and reduce its ability to “breathe”. Dirt deposited on the surface can also block the pores of the stone. The dirt is therefore more than likely to have been a major factor in the deterioration of the stone over the years.

Erosion of stonework. Dirt in the pores reduces the ability of the stone to breathe while the deterioration continues below the outer surface (DPAL).

The limestone was previously cleaned in 1996 and it is recommended that the limestone be again cleaned to remove soiling and plant growth. One option is the use of a passive washing system. There is, however, some anecdotal evidence that, because New Zealand limestone is relatively soft, excessive moisture may weaken the matrix from which the stone is comprised, leaving it susceptible to more rapid deterioration. Chemical cleaning which involves less water may be the preferred option. [Prior to cleaning the stone, a long acting biocide should be applied.](#)

After cleaning, a comprehensive survey of all the limestone should be carried out. A stone conservation report should be prepared including a map of each face of the building, noting each stone and its condition. A schedule should then be prepared outlining maintenance regimes, along with an estimate of when deteriorating stones may need to be replaced.

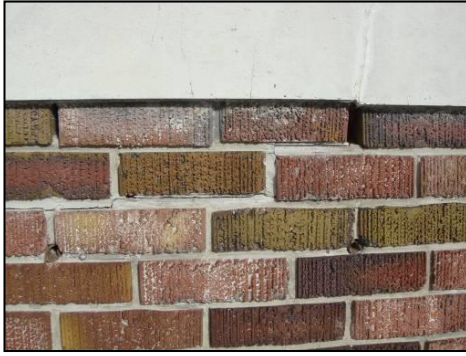
Cracking is evident to the brick facades and plaster string course at the rear of the building (east elevation). On the string course the skim plaster coat is eroding and there is evidence of failure. Settlement cracks through the string course extend down through the brickwork. Loss of mortar is evident in the tapestry brickwork. The chimney to the former boiler room has efflorescence on the surface.

Crack in stringcourse with evidence of loss of mortar in brickwork. (DPAL)

Various cracks should be repaired as soon as possible to exclude moisture.

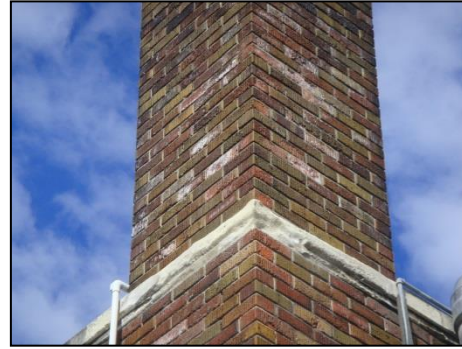
Efflorescence in chimney. Note also erosion of limestone string course (DPAL).

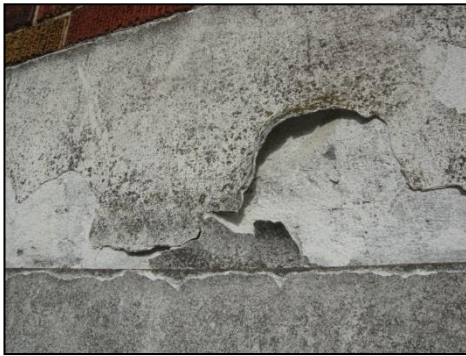
Plaster failure, east elevation (above left) and the movement between capping stones (above right) (DPAL).

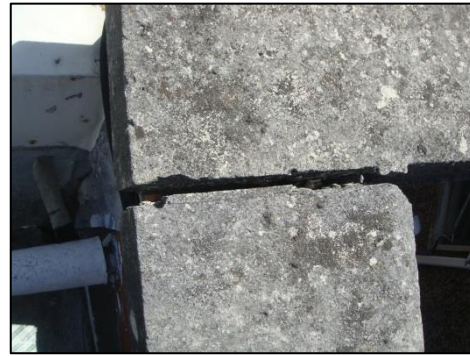
Damage as a result of the Canterbury earthquakes includes the opening up of the joints between the parapet stones and the loosening of some stones.

In the brickwork vertical and horizontal cracks along mortar joints, particularly at corners, are evident as a result of the earthquakes.

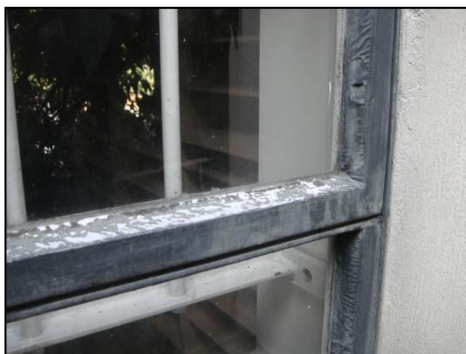
There does not appear to be any damage to the window joinery as a result of the earthquakes. The window joinery is generally in good condition. Prior to the earthquakes it was noted that paint was blistering on some of the sash frames and muntins. The putty is also sagging.

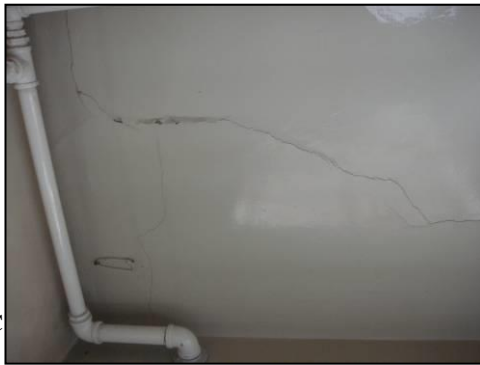
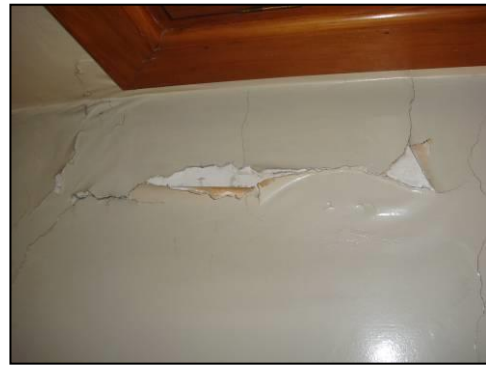
On the walls of the servery at first floor level above the main entrance, moisture ingress is evident with a crack in the wall and paint lifting. Minor cracking is evident to the concrete basement walls as a result of the earthquake.

Crack and paint lifting in the wall of the upstairs servery.
