**Canterbury Earthquakes 2010/11 Port Hills Slope
Stability: Risk assessment for Quarry Road**

**GNS Science Consultancy Report 2014/75
August 2014 FINAL**

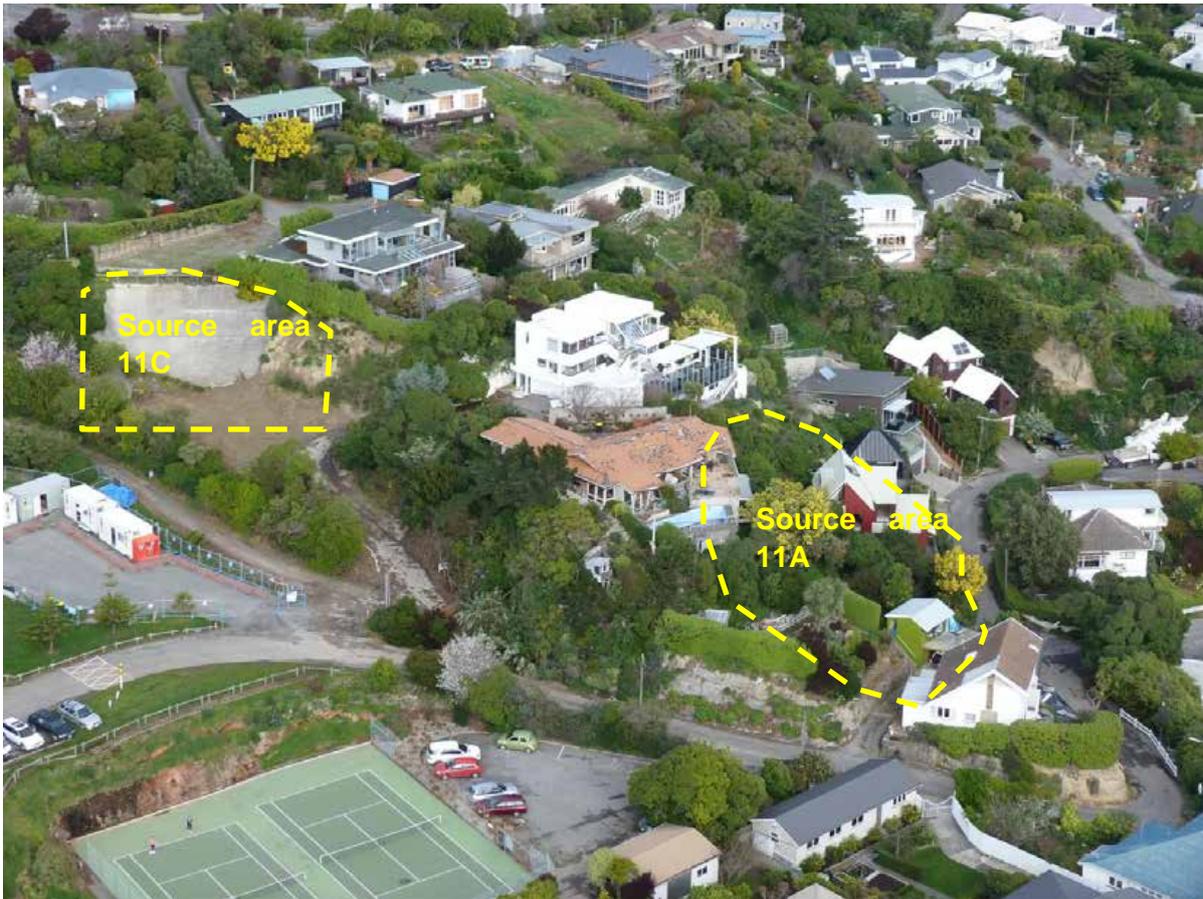
Figure 3 Aerial view of the Quarry Road source areas 11A and 11C (within the yellow dashed lines). Photograph taken by M. Yetton (2012).

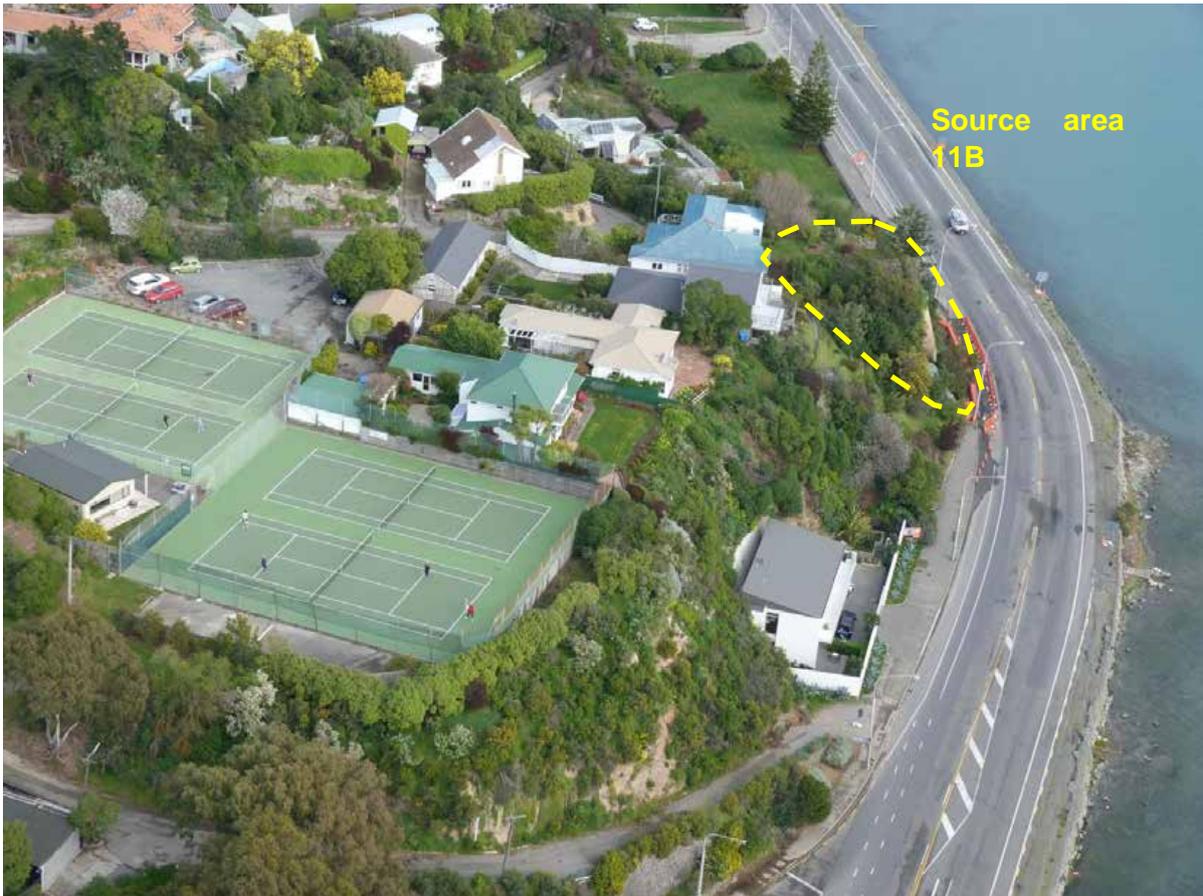
Figure 4 Aerial view of the Quarry Road source area 11B (within the yellow dashed line). Photograph taken by M. Yetton (2012).

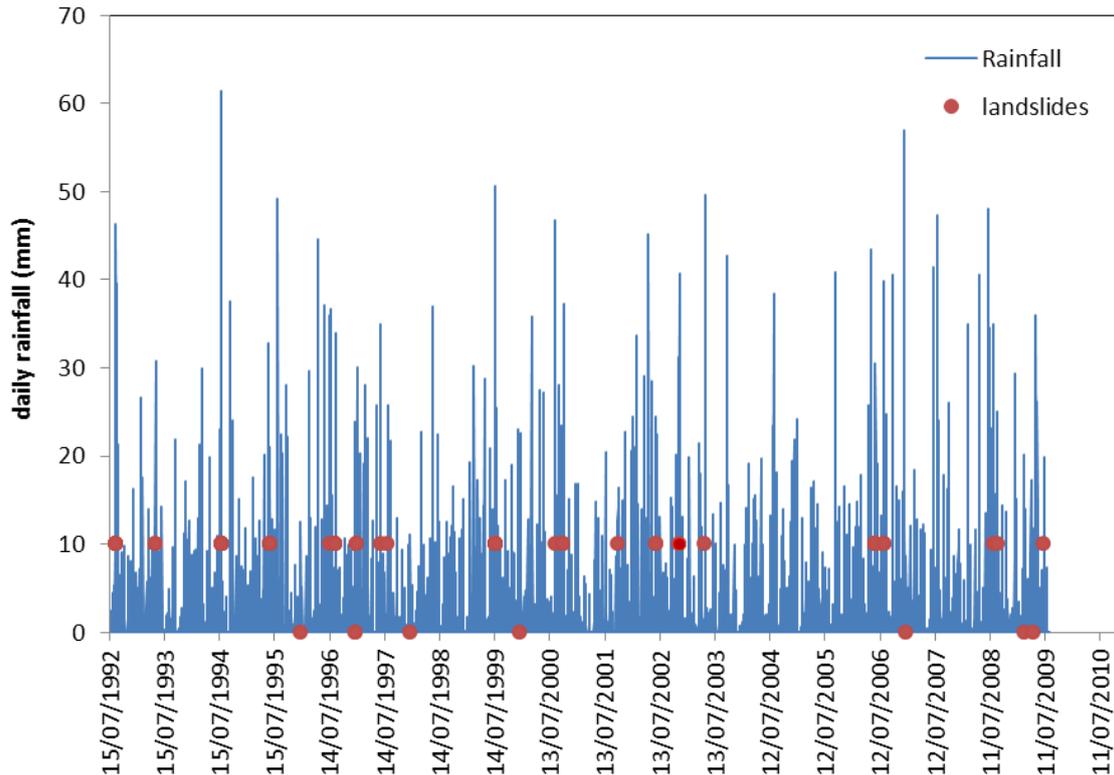
Figure 9 Daily rainfalls at Christchurch Botanic Gardens and landslides in the Port Hills. Daily rainfalls at Christchurch Botanic Gardens and landslides in the Port Hills investigated by Geotechnical Consulting Ltd, or listed by the Earthquake Commission as causing damage to homes. Landslides without rain are plotted at 0 mm, all others are plotted at 10 mm of rain (the minimum rainfall for triggered landslides).

McSaveney et al. (2014) examined a list of Earthquake Commission claims for landslide damage for the period 1997–2010, and a Geotechnical Consulting Ltd. landslide investigations list, which covers much of the period 1992–2009. Any duplicate records for the period 1997–2009 contained in the data sets were removed. These records, though incomplete with respect to all of the landslides that occurred over those intervals, may be approximately complete with respect to the episodes of rain associated with landslide occurrences that damaged homes and urban properties (Figure 9).

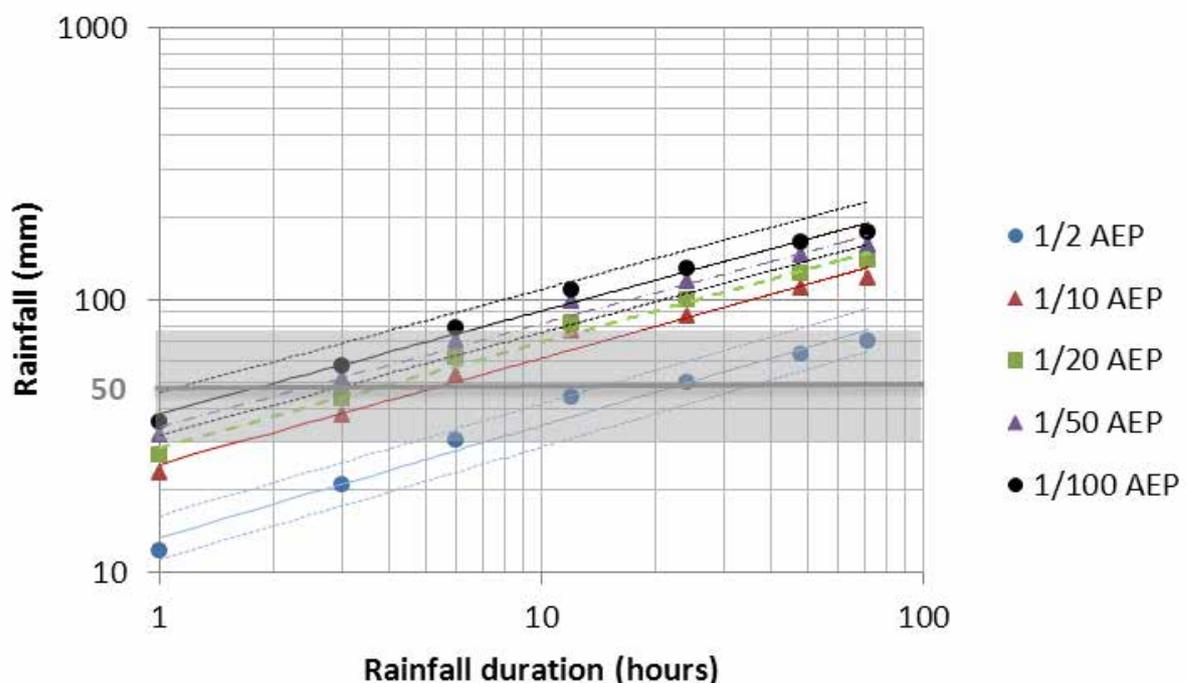
Figure 10 Rainfall depth-duration-return period relations estimated by Griffiths et al. (2009) using recorded rainfall data. Error limits of 20% are shown by dotted lines for the 1/2 and 1/100 AEP curves. Shaded area covers the range of 30–75 mm of rainfall over which the expected number of soil landslides in the Port Hills rises from very few to many. Rockfalls can occur without rain, but the probability of rockfalls occurring increases with increasing intensity of rainfall.

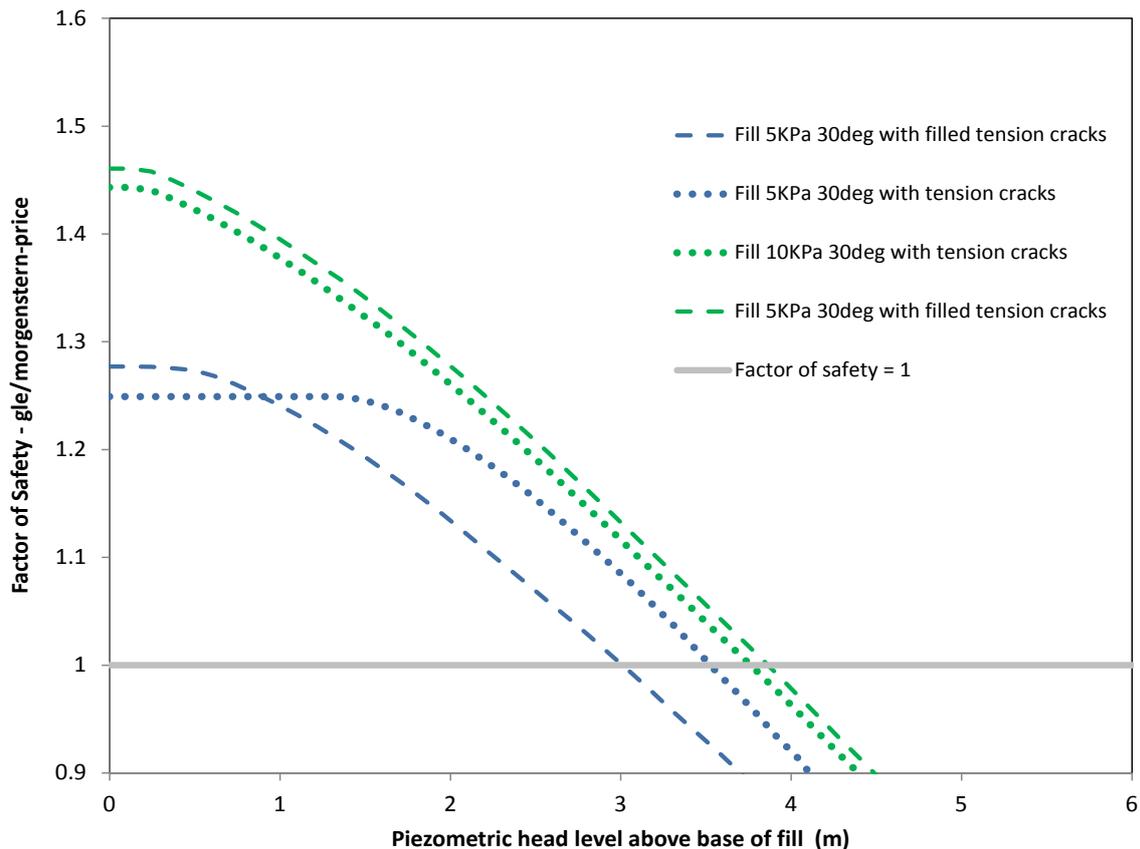
Figure 11 Sensitivity assessment of the slope factor of safety (source area 11A) in response to changing piezometric head levels and tension crack conditions. Variable tension crack depths have been used.

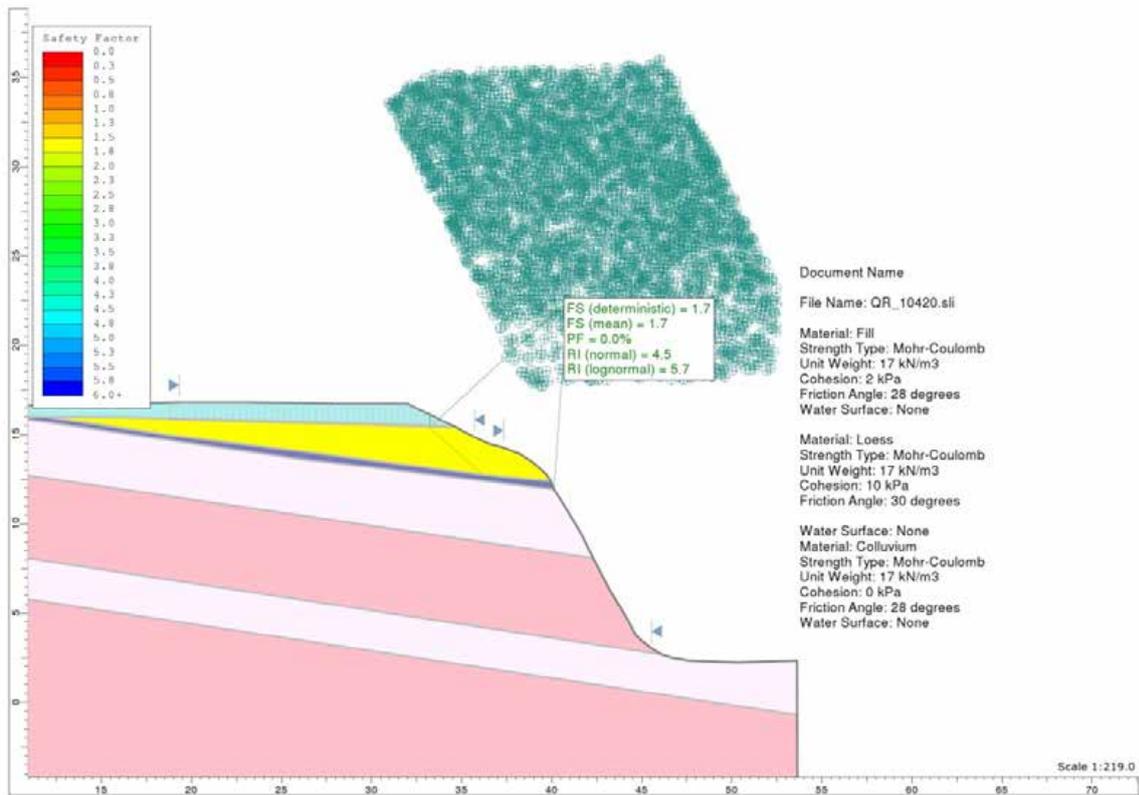
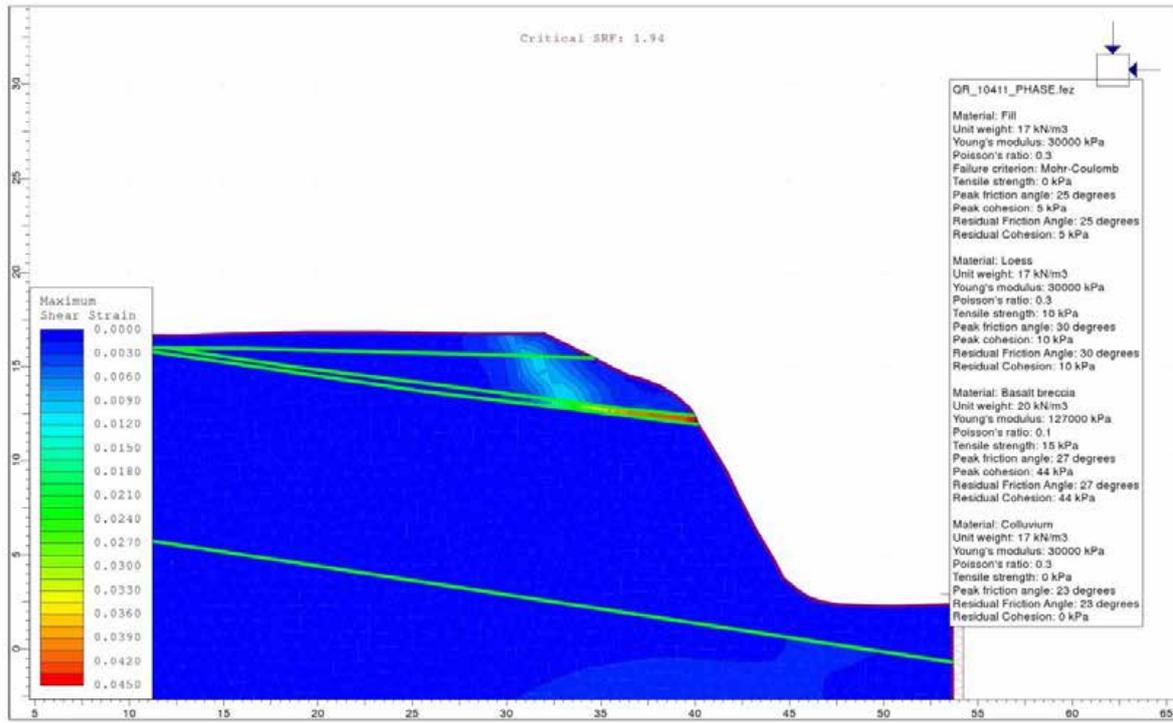
Figure 14 Example of limit equilibrium and finite element modelling results for cross-section 1, representing source area 11B, for failure mechanism 1 through the loess.

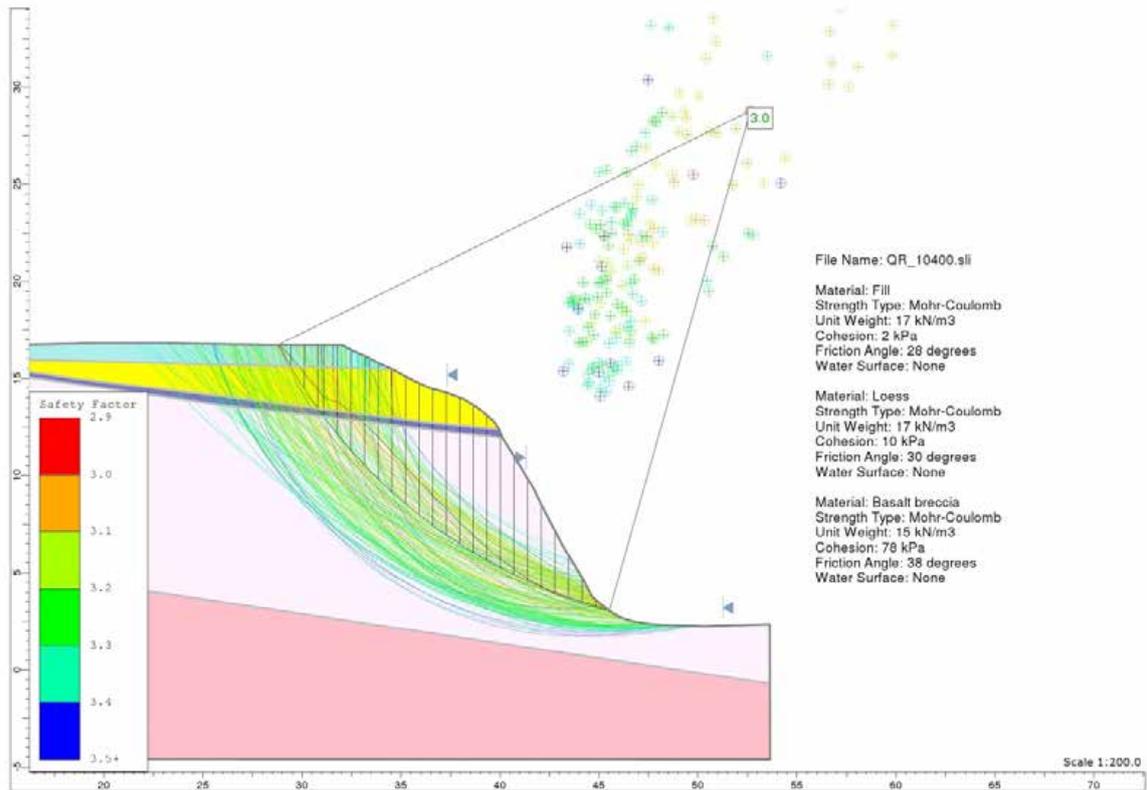
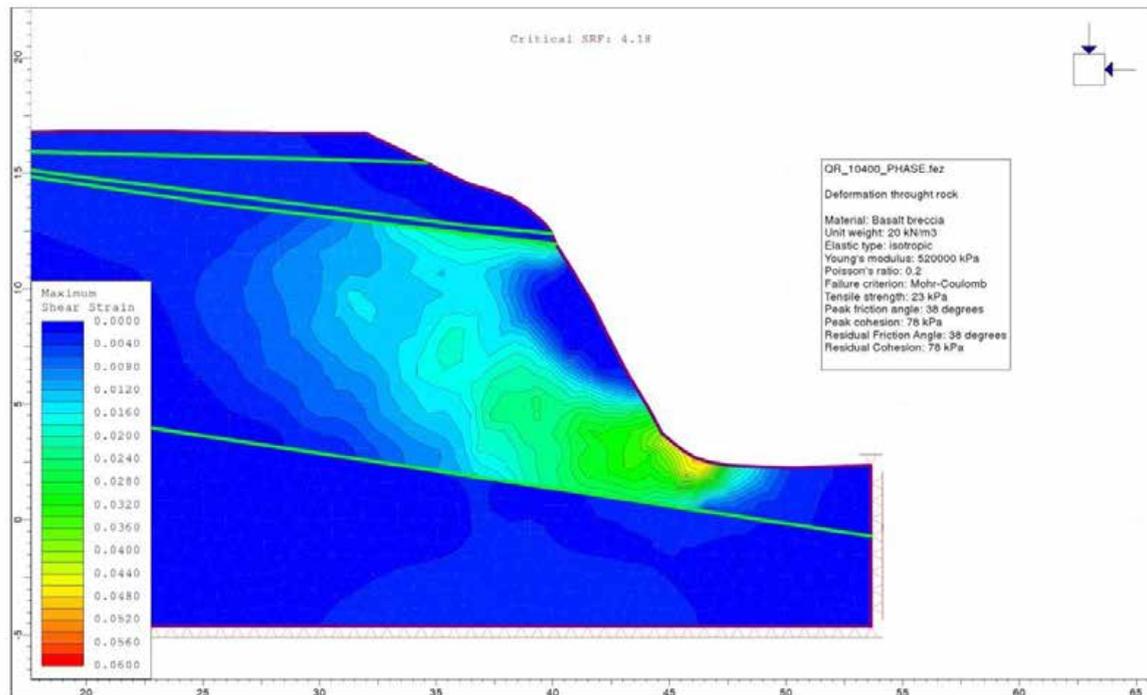
Figure 15 Example of limit equilibrium and finite element modelling results for cross-section 1, representing source area 11B, for failure mechanism 2 through the rock.

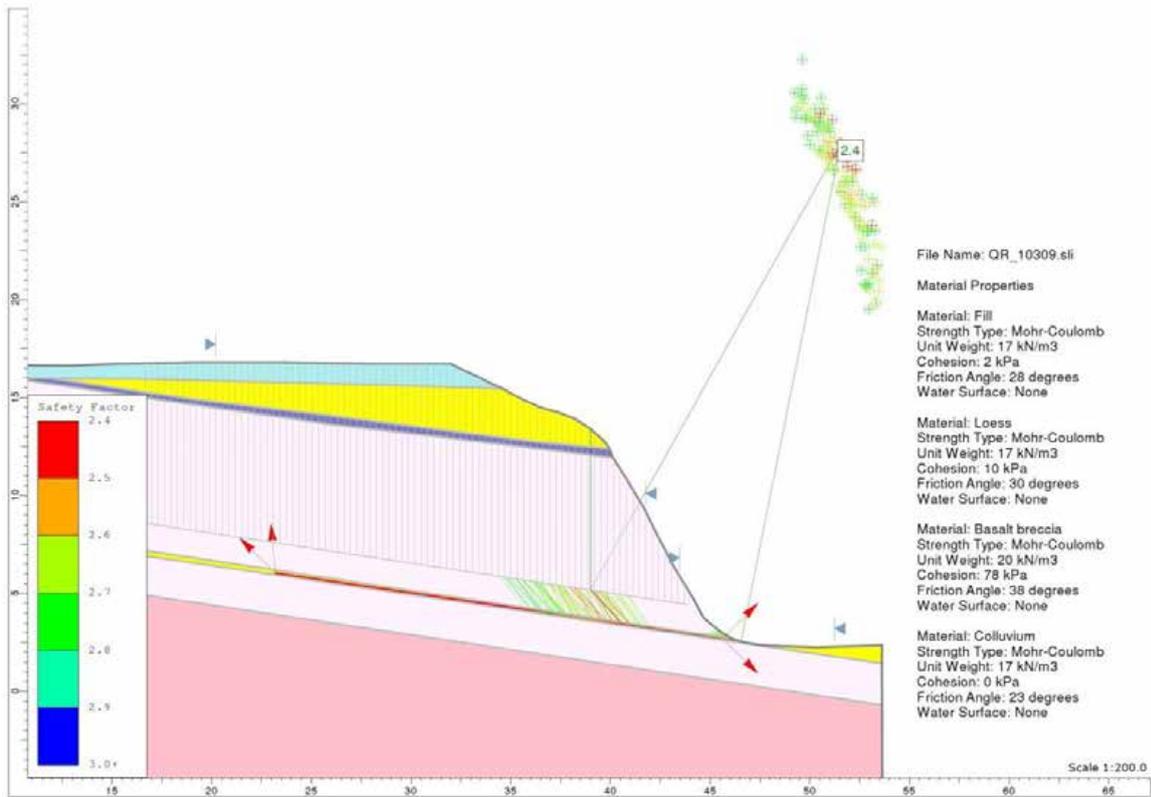
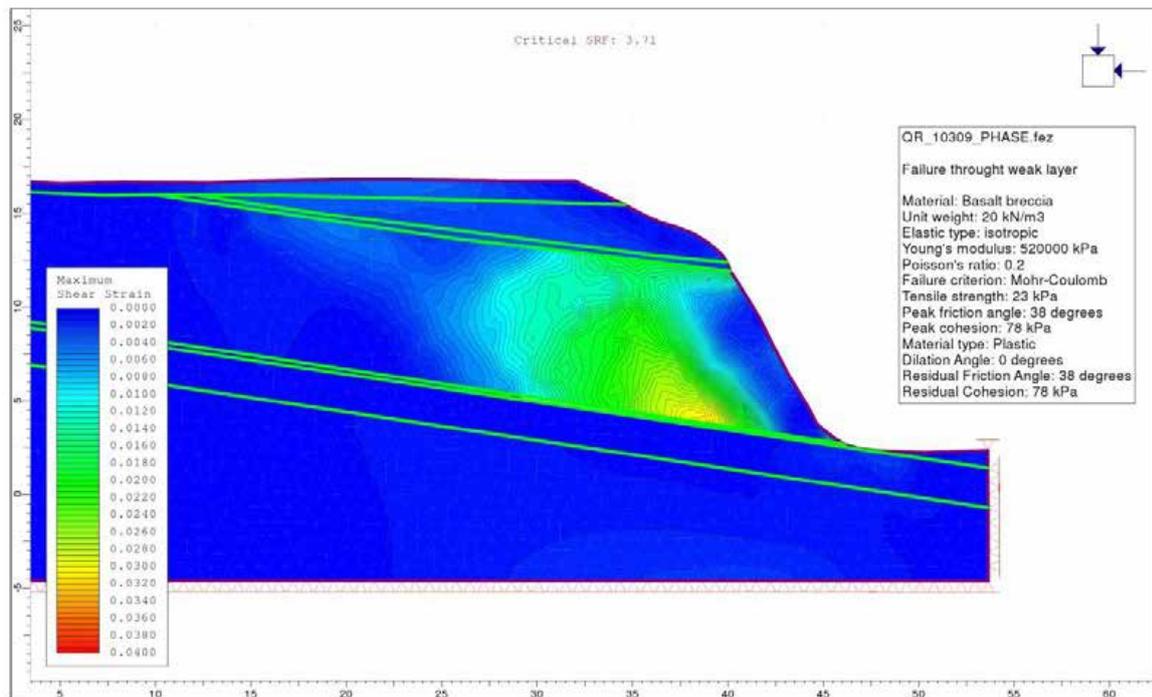
Figure 16 Example of limit equilibrium and finite element modelling results for cross-section 1, representing source area 11B, for failure mechanism 3 through the weak layer.

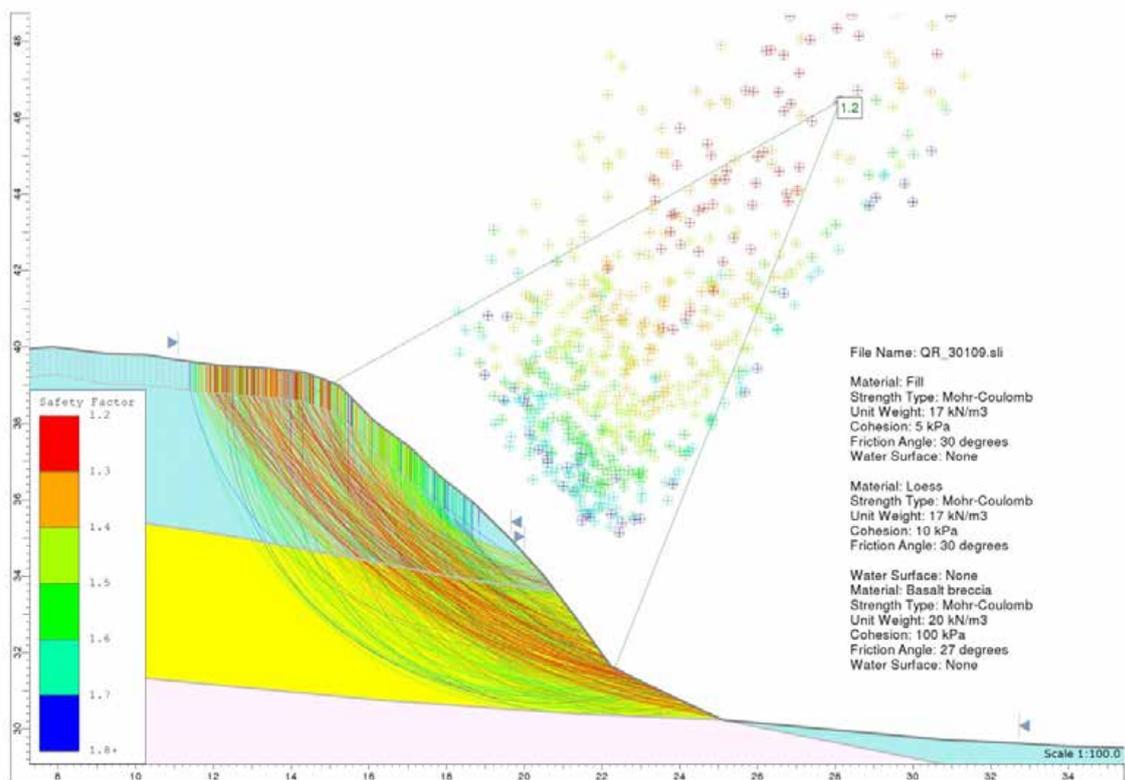
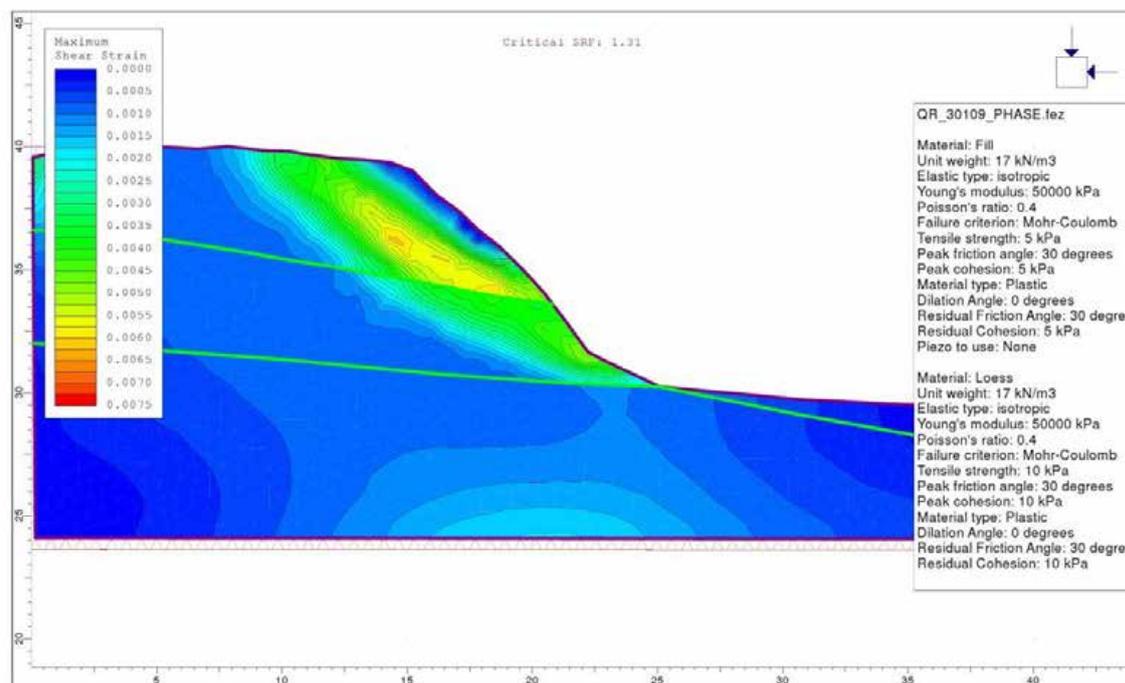
Figure 17 Example of limit equilibrium and finite element modelling results for cross-section 3, representing source area 11C, for a failure mechanism through the fill and loess.

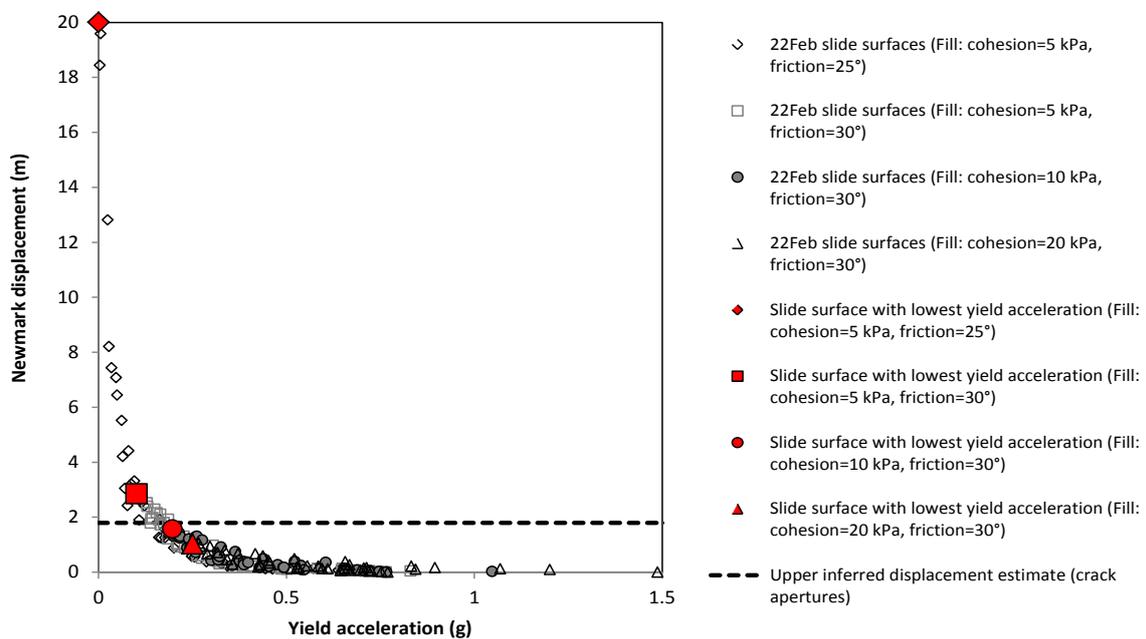
Figure 18 22 February 2011 earthquake, modelled Slope/W decoupled displacements for source area 11A (cross-section 2), adopting variable estimates of the material strength of the fill. Each data point represents a modelled slide surface and the corresponding estimate of its displacement as a result of the 22 February 2011 earthquake – adopting the synthetic free-field rock outcrop earthquake acceleration time histories. Data points are for slide surfaces mainly in fill. The dashed lines represent the total inferred coseismic permanent displacement for the cross-section during the given earthquake.

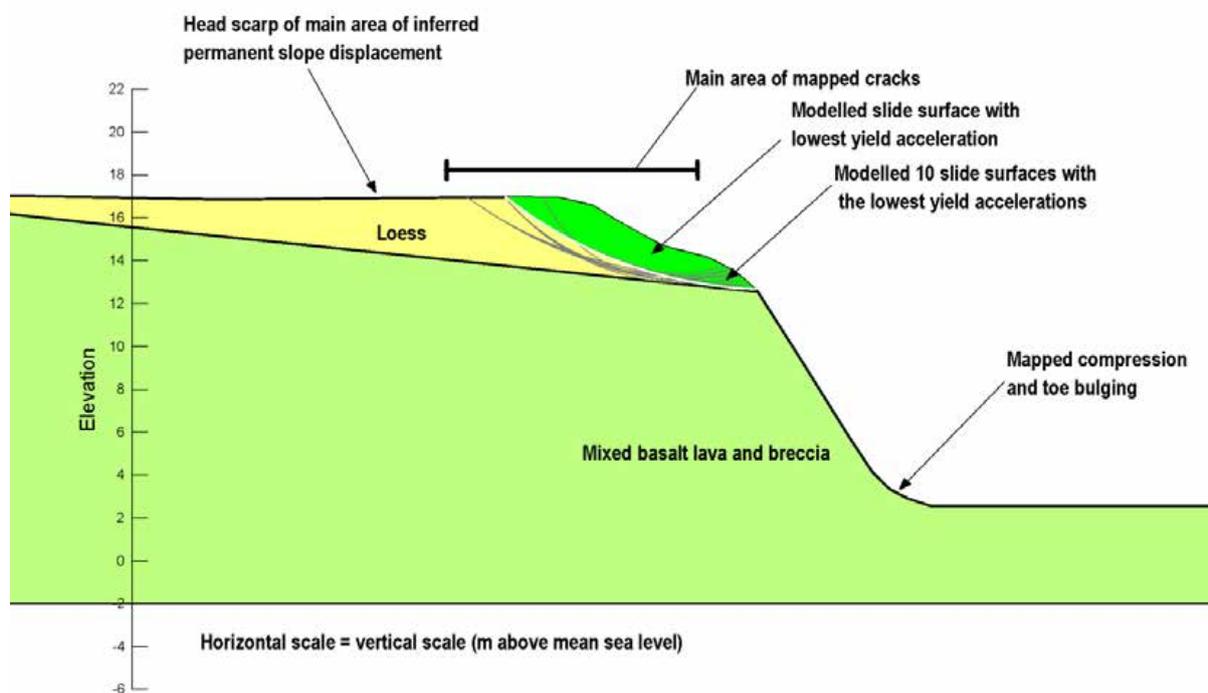
Figure 21 Source area 11B (cross-section 1) seismic slope stability assessment for the 22 February 2011 earthquake. Failure mechanism 1, failure through the loess only. The slide surface, and associated slide mass, with the lowest yield acceleration is shown bright green in colour.

Figure 21, Figure 22 and Figure 23 show the modelled slide surfaces for the different assessed failure mechanisms. Figure 24 and Figure 25 show the estimated displacements for each assessed failure mechanism.

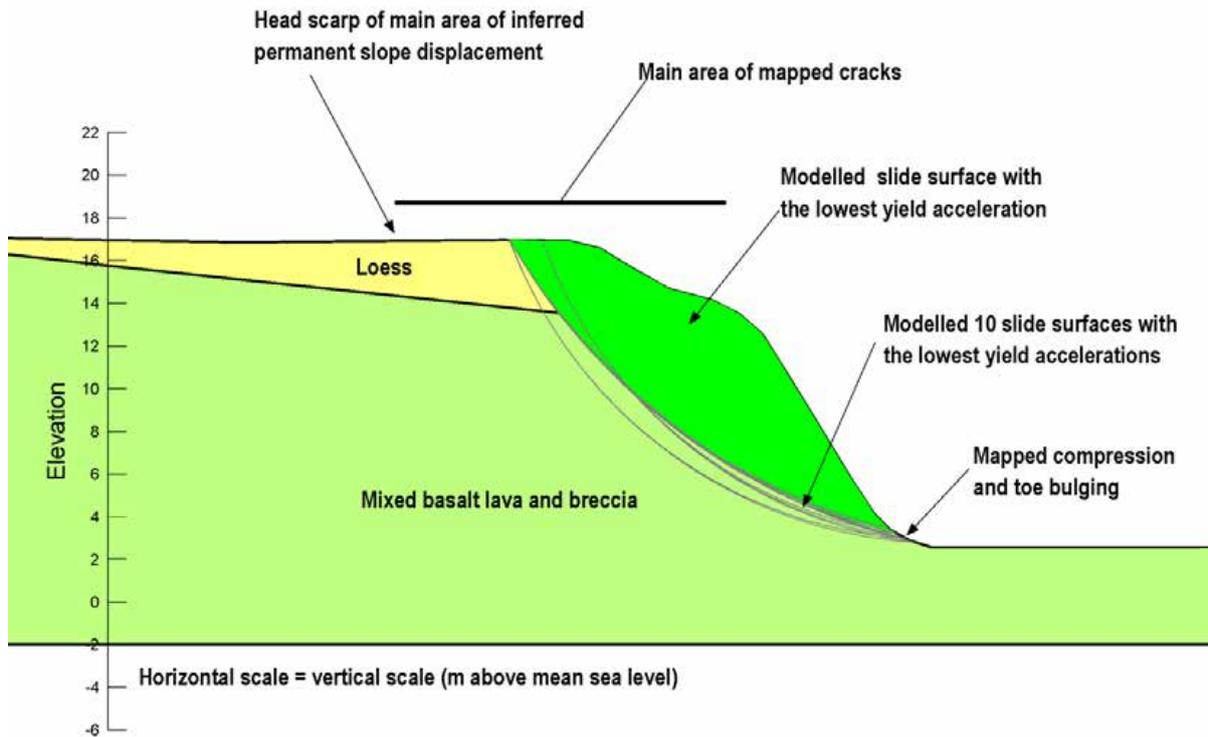
Figure 22 Source area 11B (cross-section 1) seismic slope stability assessment for the 22 February 2011 earthquake. Failure mechanism 2, relatively shallow failure through the rock. The slide surface, and associated slide mass, with the lowest yield acceleration is shown bright green in colour.

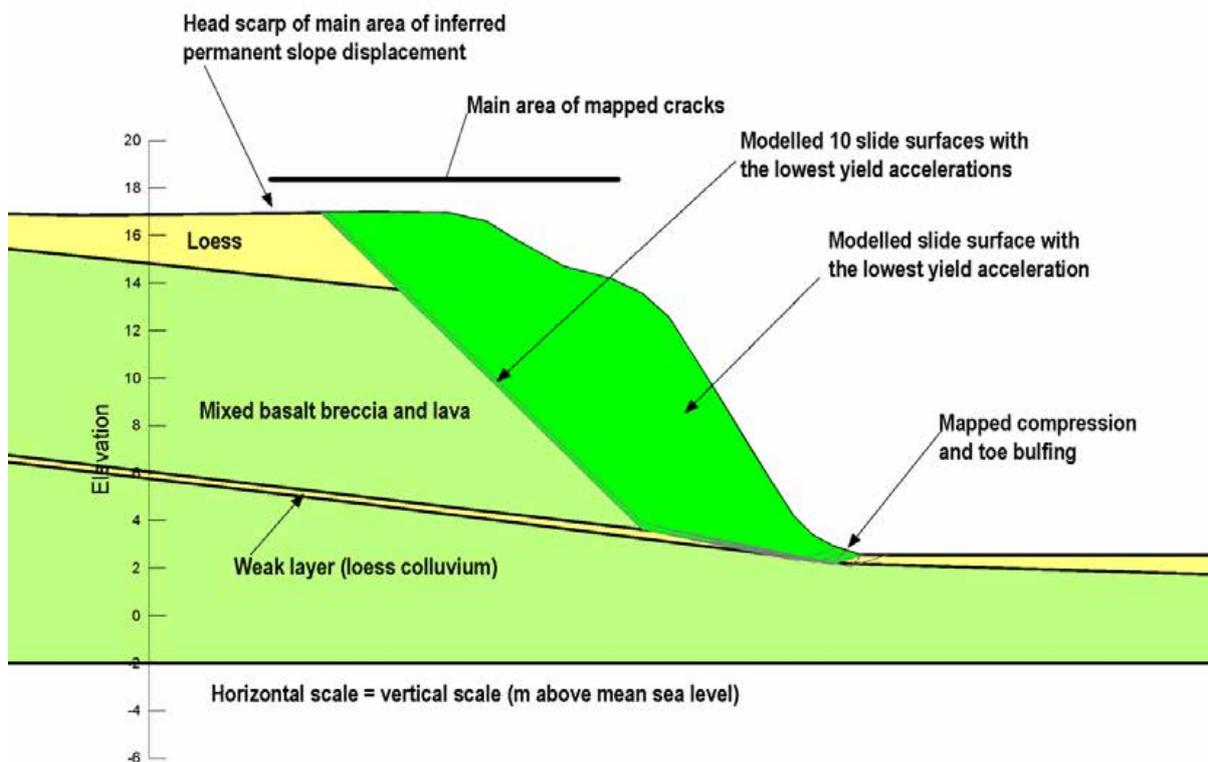
Figure 23 Source area 11B (cross-section 1) seismic slope stability assessment for the 22 February 2011 earthquake. Failure mechanism 3, failure of rock through the weak layer within the rock mass. The slide surface, and associated slide mass, with the lowest yield acceleration is shown bright green in colour.

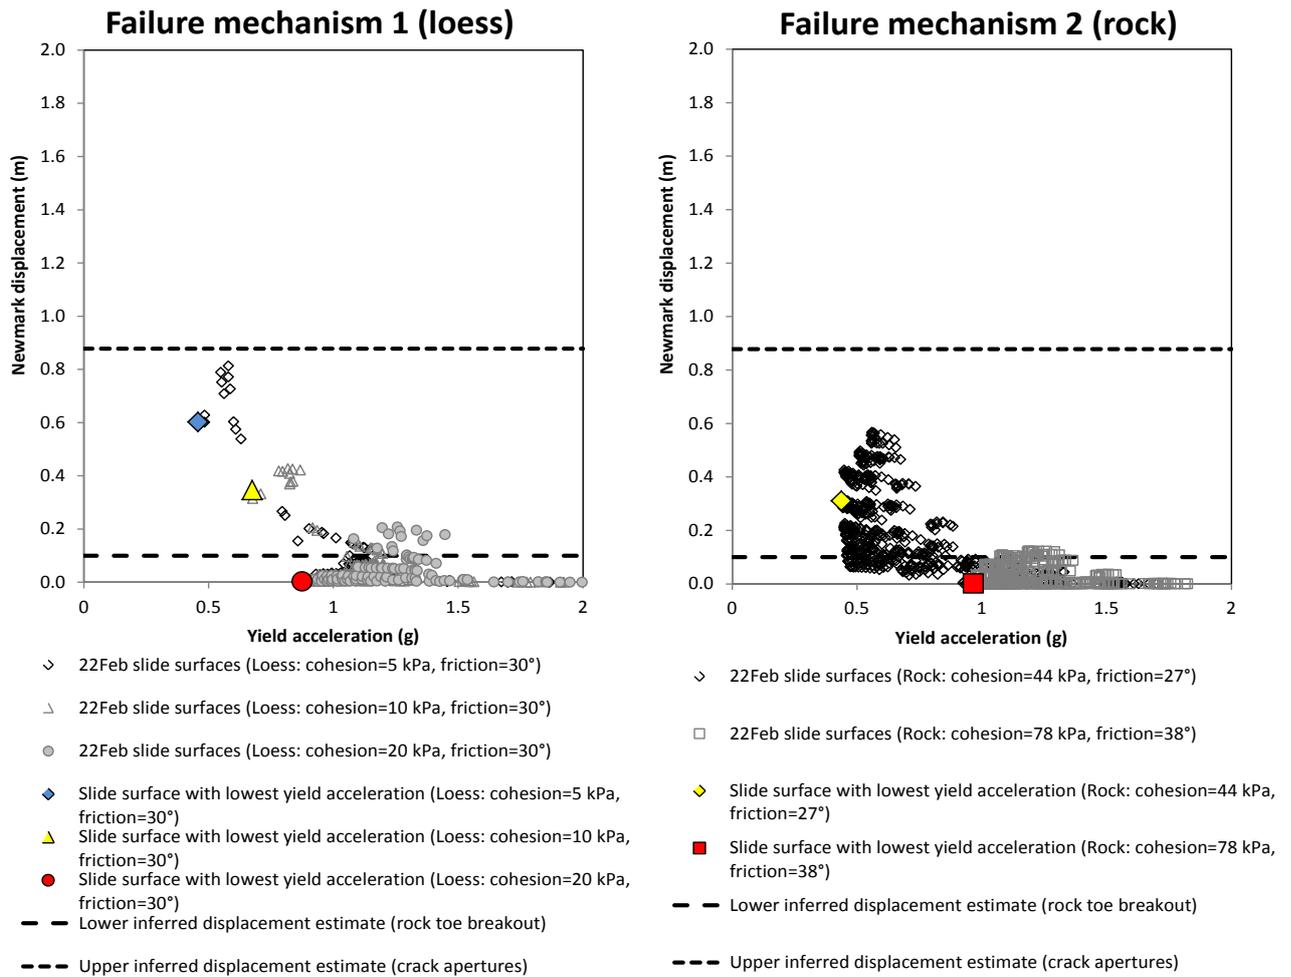
Figure 24 22 February 2011 earthquake, modelled Slope/W decoupled displacements for source area 11B (cross-section 1), adopting variable estimates of the material strength of the loess and rock. Each datapoint represents a modelled slide surface and the corresponding estimate of its displacement as a result of the 22 February 2011 earthquake – adopting the synthetic free-field rock outcrop earthquake acceleration time histories. Data points are for failure mechanisms 1 and 2. The dashed lines represent the total inferred coseismic permanent displacement for the cross-section during the given earthquake.

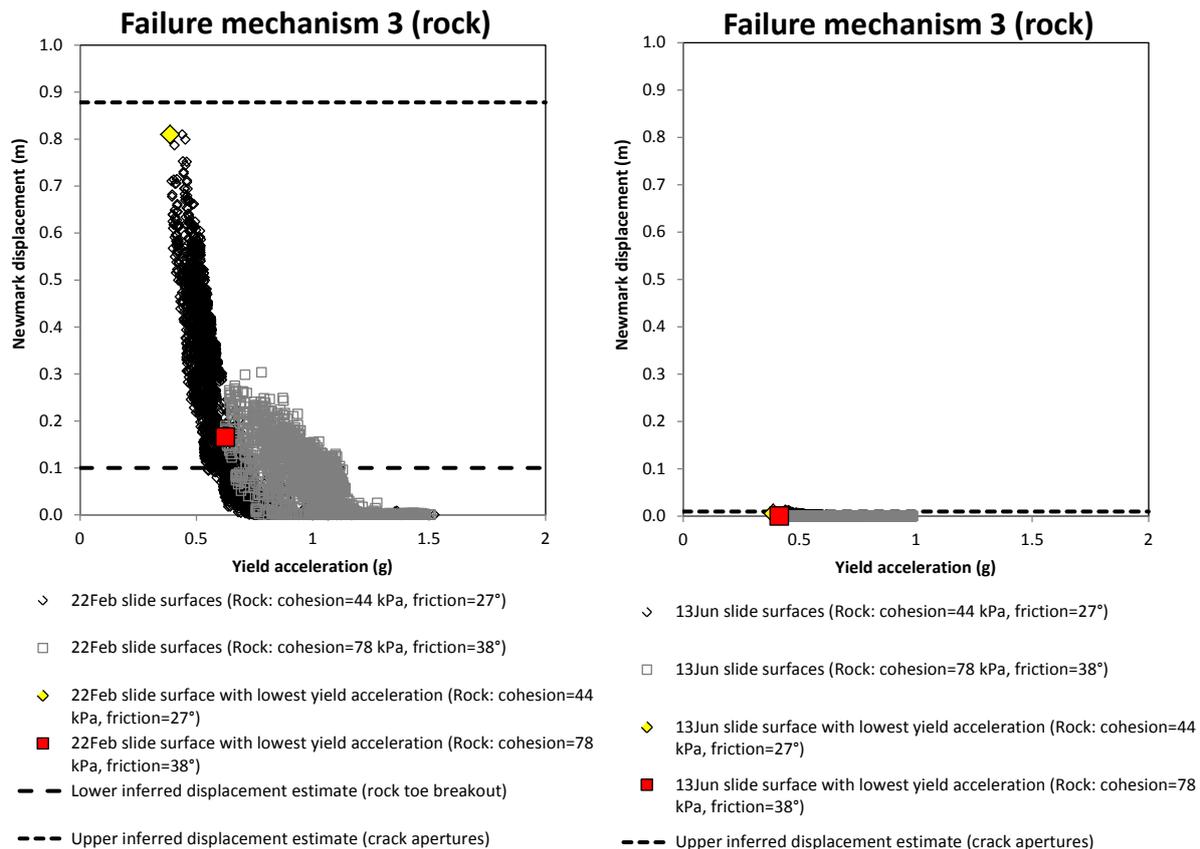
Figure 25 22 February and 13 June 2011 earthquakes, modelled Slope/W decoupled displacements for source area 11B (cross-section 1), adopting variable estimates of the material strength of the rock. Each datapoint represents a modelled slide surface and the corresponding estimate of its displacement as a result of the 22 February and 13 June 2011 earthquakes – adopting the synthetic free-field rock outcrop earthquake acceleration time histories. Data points are for slide surfaces through the weak layer within the rock (mechanism 3). The dashed lines represent the total inferred coseismic permanent displacement for the cross-section during the given earthquake.

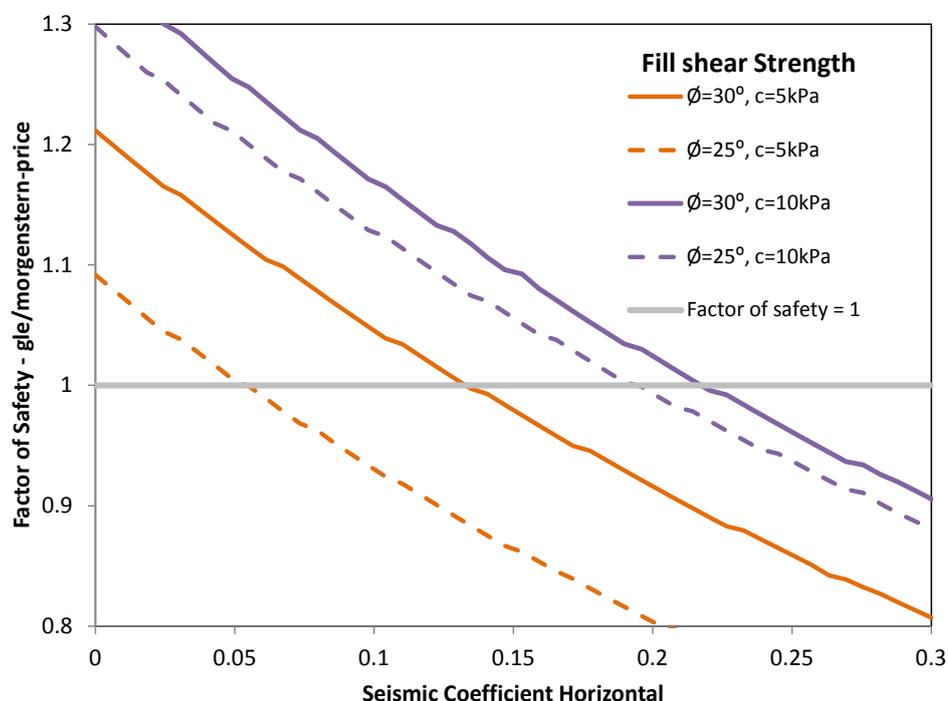
Figure 26 Yield acceleration of the slope based on variable fill parameters and loess parameters shown in Table 11. Yield acceleration calculated adopting the pseudostatic method (Kramer, 1996).

The results are shown in Figure 26, for various fill (including topsoil) shear strength parameters. The critical yield acceleration of the slope varies between about 0.05 and 0.2 for the range of parameters assessed.

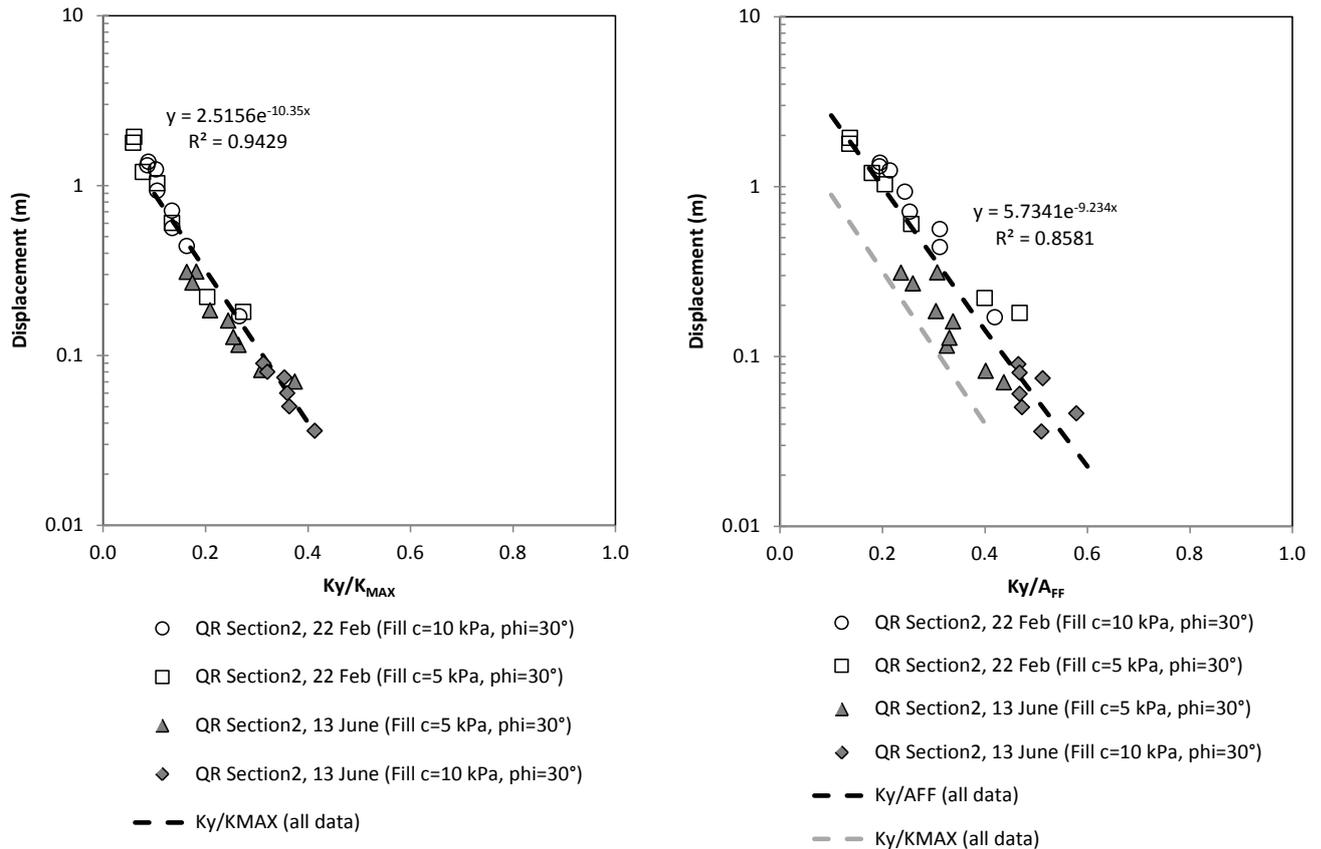
Figure 27 Source area 11A (cross-section 2), decoupled Slope/W displacements calculated for different ratios of yield acceleration to maximum average acceleration of the mass (Ky/K_{MAX}), and maximum acceleration of the mass (Ky/A_{FF}), for selected slide-surface geometries, and given material shear strength parameters. A_{FF} is the peak acceleration of the input earthquake time acceleration history. Synthetic rock outcrop time acceleration histories for the 22 February and 13 June 2011 earthquakes were used as inputs for the assessment. ($N = 31$). The dashed lines are exponential trend lines fitted to the semi-log data. The formula and the coefficient of determination (R^2) for the trend lines are shown.

For ratios of K_y/K_{MAX} in Figure 27, the estimated magnitudes of displacement are consistent with those reported by Jibson (2007), where the data plot between the ranges of data for earthquakes of M6.5–7.5 reported by Makdisi and Seed (1978) and plotted by Jibson (2007).

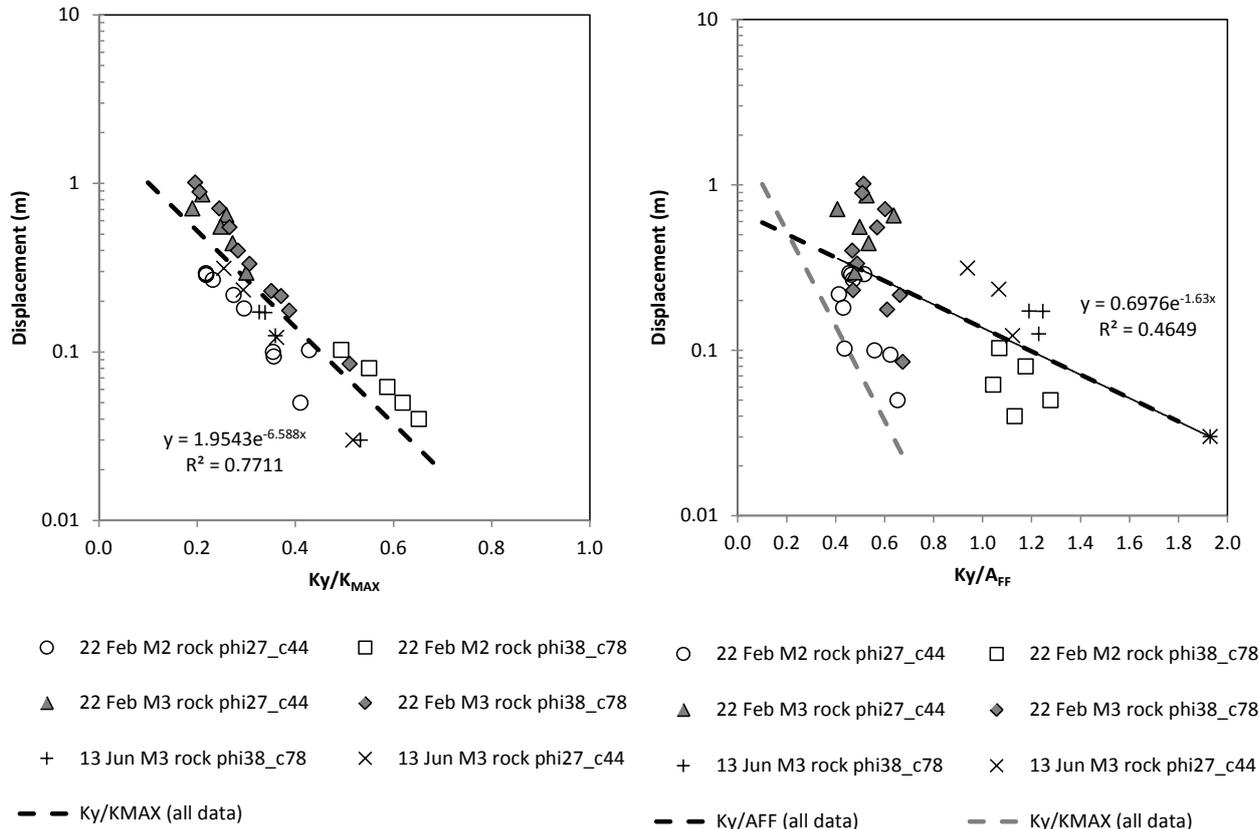
Figure 28 Source area 11B (cross-section 1), decoupled Slope/W displacements calculated for different ratios of yield acceleration to maximum average acceleration of the mass (K_y/K_{MAX}), and maximum acceleration of the mass (K_y/A_{FF}), for selected slide-surface geometries, and given material shear strength parameters. M2 represents slide surfaces associated with failure mechanisms 2 and M3 with failure mechanism 3. A_{FF} is the peak acceleration of the input earthquake time acceleration history. Synthetic rock outcrop time acceleration histories for the 22 February and 13 June 2011 earthquakes were used as inputs for the assessment. ($N = 40$). The dashed lines are exponential trend lines fitted to the semi-log data. The formula and the coefficient of determination (R^2) for the trend lines are shown.

For ratios of K_y/A_{FF} in Figure 28, the estimated magnitudes of displacement are consistent with those reported by Jibson (2007), where the data plot between the ranges of data for earthquakes of M6.5–7.5 reported by Makdisi and Seed (1978) and plotted by Jibson (2007).

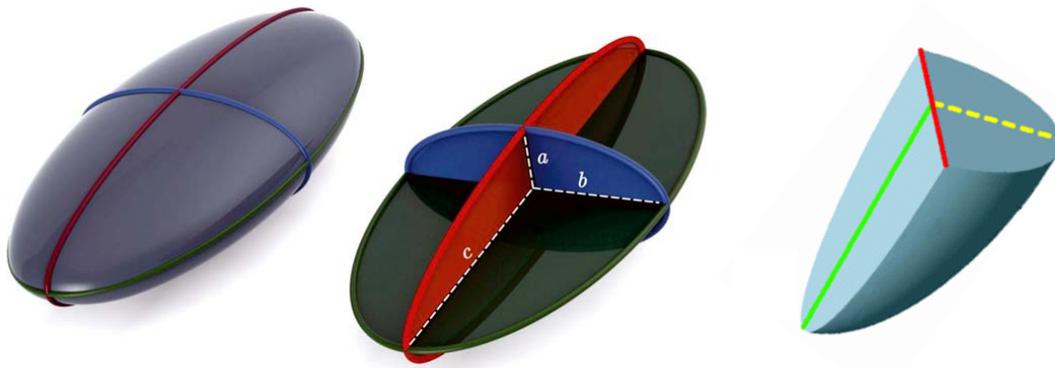
Figure 29 Estimation of landslide volume assuming a quarter-ellipsoid shape.

Volumes were calculated by estimating the shape of any future failures as quarter-ellipsoids (half-spoon shaped) (following the method of Cruden and Varnes, 1996) (Figure 29) and estimated volumes are shown in Table 12.
