**Canterbury Earthquakes 2010/11 Port Hills Slope
Stability: Risk assessment for Quarry Road**

**GNS Science Consultancy Report 2014/75
August 2014 FINAL**

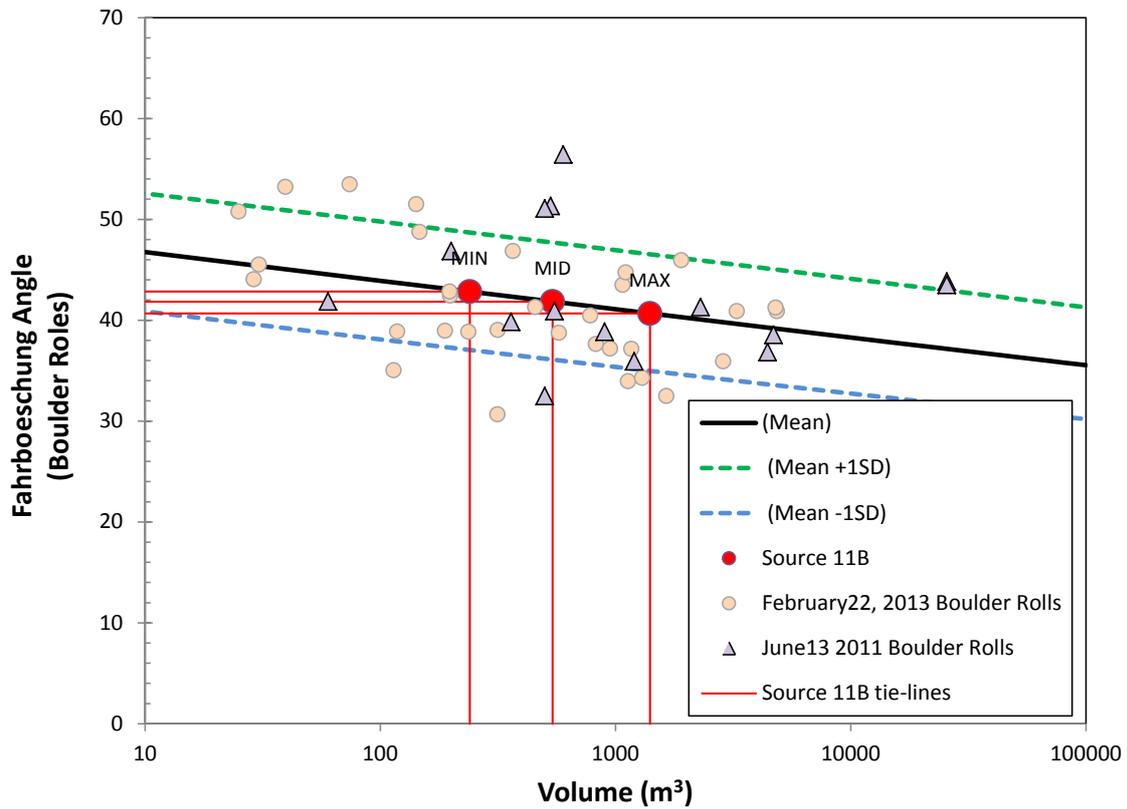
Figure 33 Estimation of boulder roll and talus fahrboeschung angles based on empirical runout data.

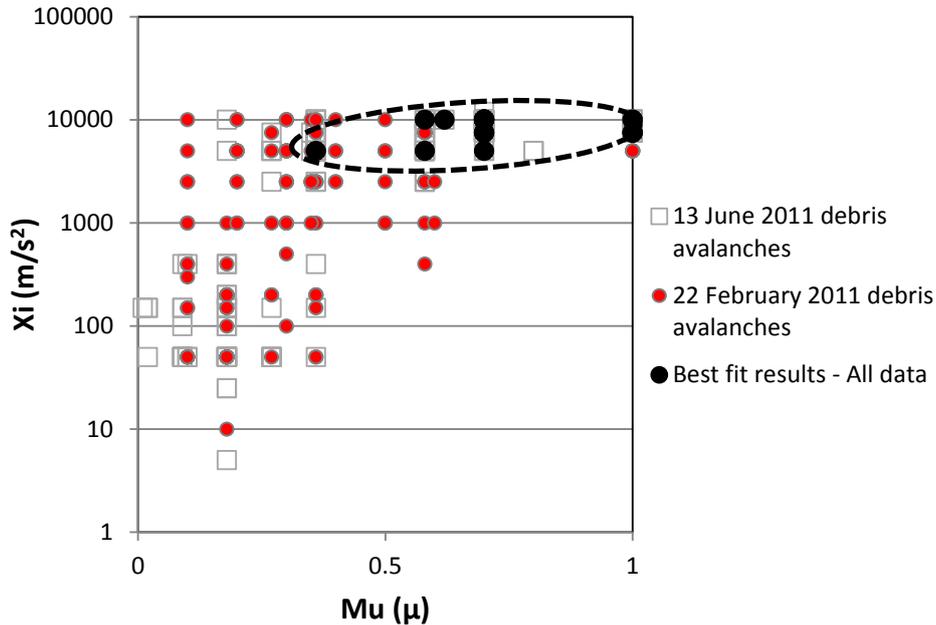
Figure 35 Range of parameters used to back-analyse the runout of debris avalanches in the Port Hills triggered by the recent earthquakes using the RAMMS software (RAMMS, 2011).

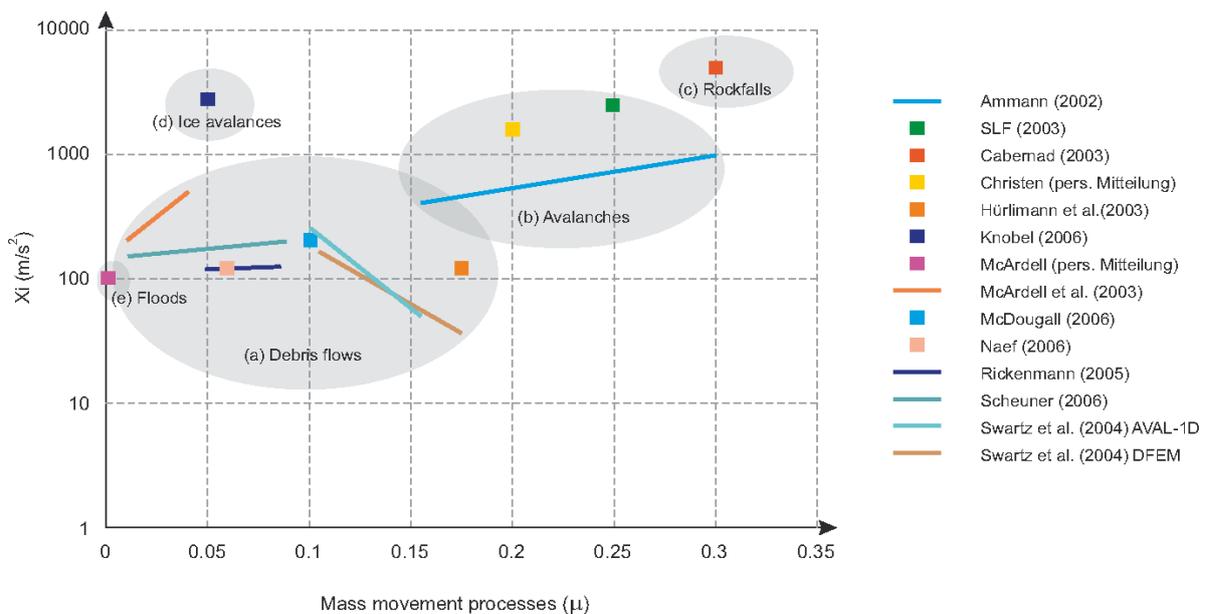
Figure 36 Range of parameters for different mass movement processes: a) debris flows, b) snow avalanches, c) snow avalanches, d) ice avalanches, e) debris floods. Modified from Andres (2010).

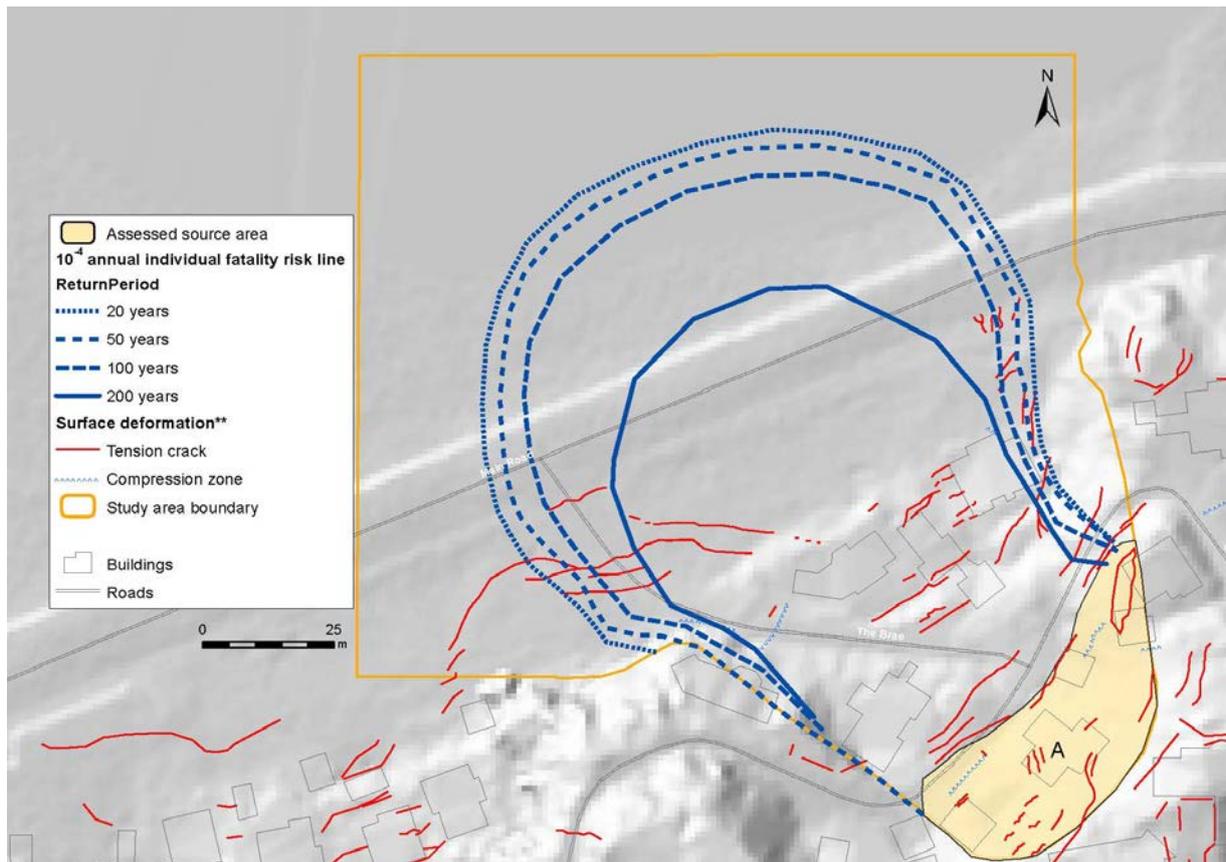
Figure 41 Sensitivity of the risk estimates for source area 11A, upper volume estimates, for triggering event return periods of 20, 50, 100 and 200 years.

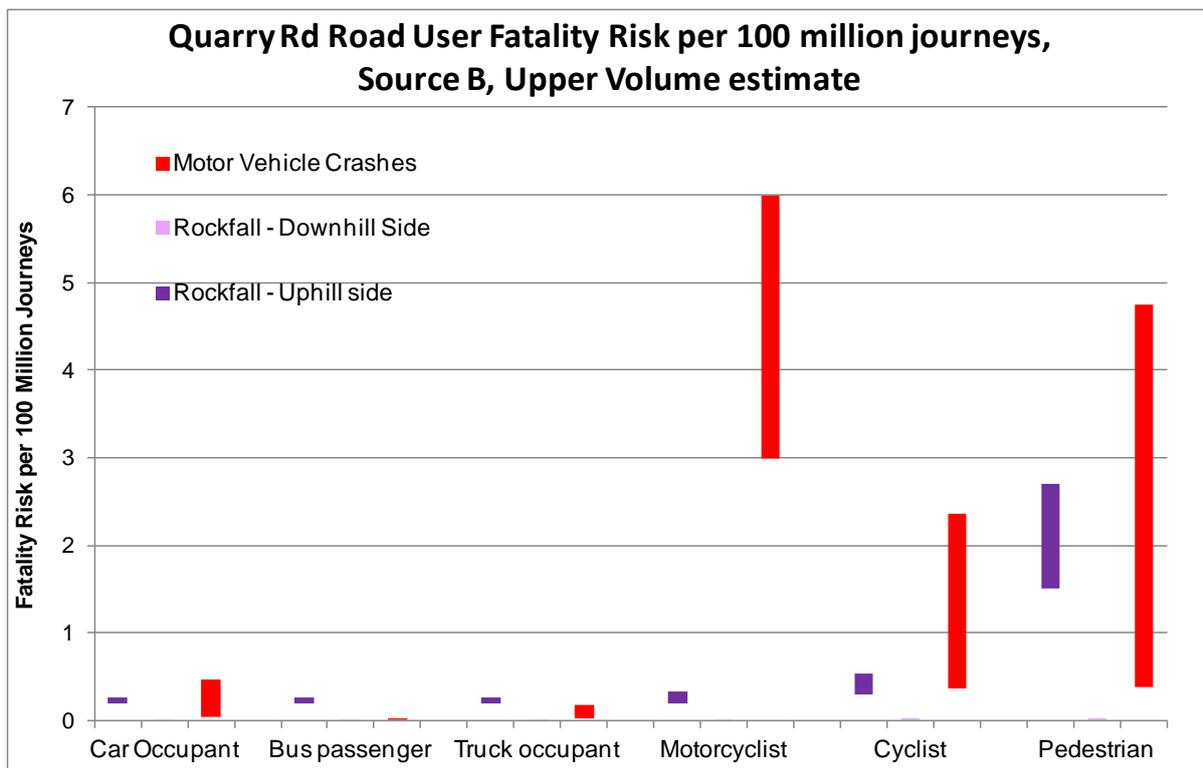
Figure 44 Maximum calculated road user risk per journey, source area 11B.

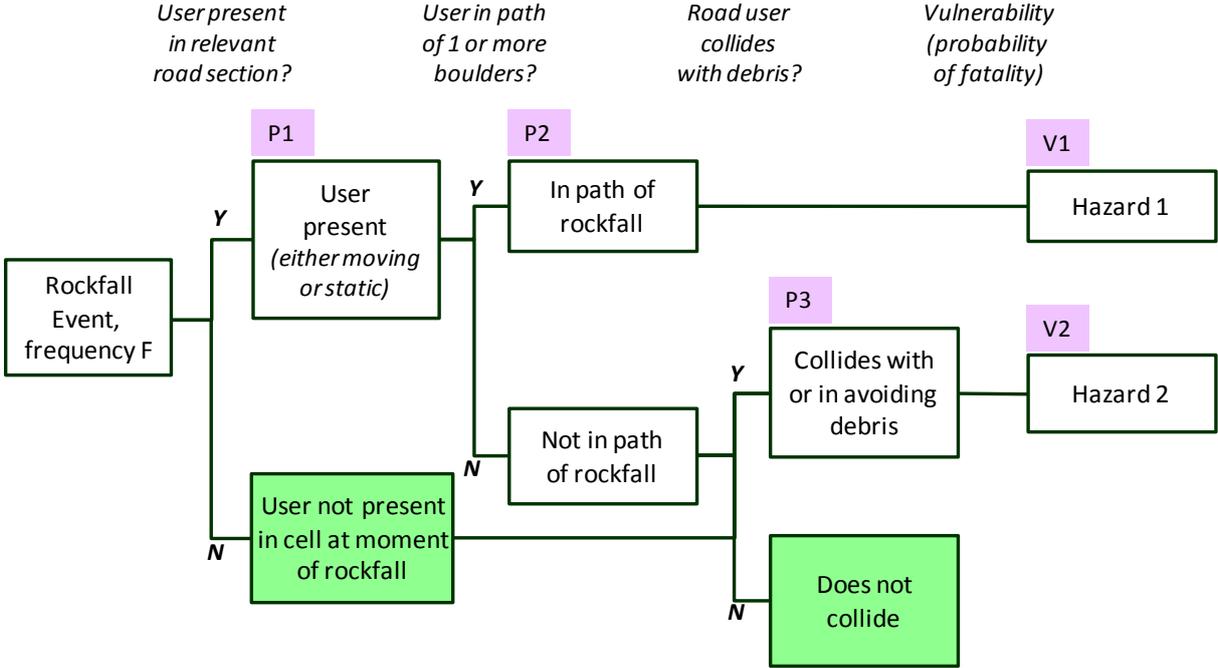
Figure A1.1 Event tree model for road user risk assessment.

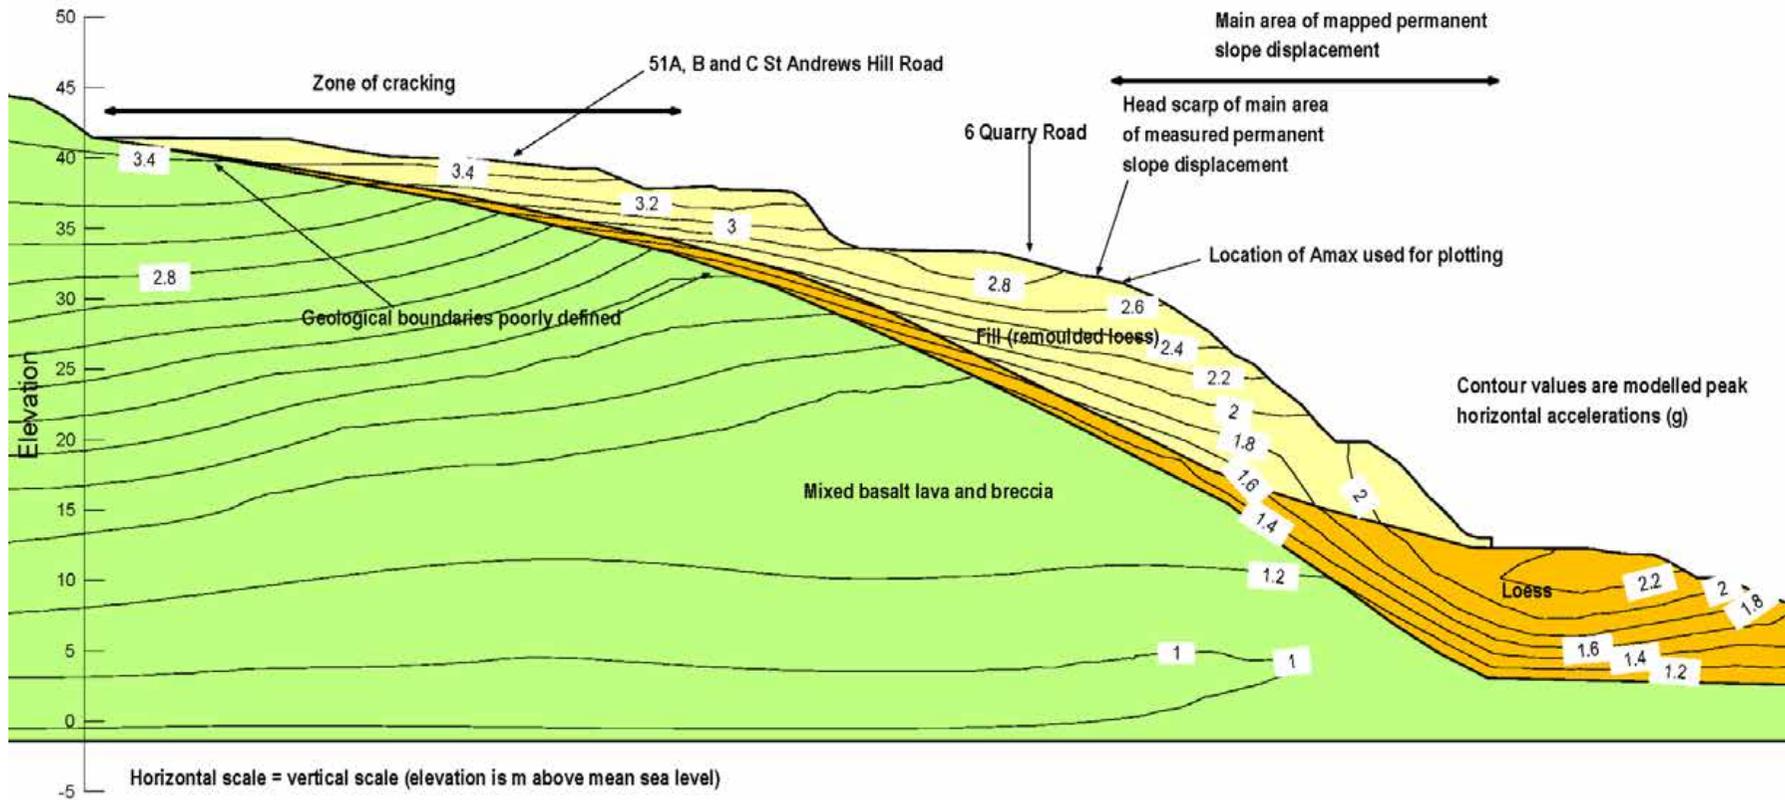
Figure A3.2 Modelled peak horizontal ground acceleration contours for the 22 February 2011 earthquake at Quarry Road, source area 11A (cross-section 2). Note: the high peak horizontal ground accelerations shown at the left of the drawing are not thought realistic as the geological boundary conditions in this area are unknown and have been inferred.
