## AMI Stadium - East Stand Development Construction

### Introduction to the Project

This waste reduction case study demonstrates that with careful on-site and off-site waste sorting, 77% of construction waste can be recovered for reuse and recycling.

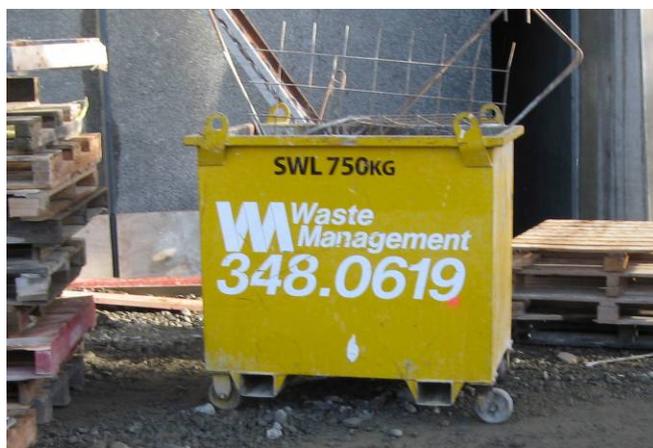
Bucket skips used to transport waste to the central sorting area © Copyright

- Separate skips and bins were clearly labelled.
- Initially sorted materials into small (bucket) skips and then removed these to the central construction waste sorting area. Fletchers allocated one full-time staff member to sort the waste in the smaller bins into the separate recycling and waste skips.

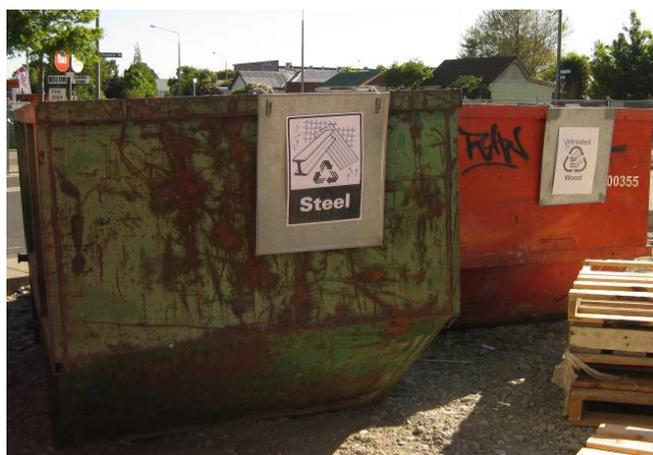
Clearly labeled skips for on-site waste sorting © Copyright

The use of skips and further off-site waste sorting was undertaken to ensure maximum recovery of materials for reuse and recycling. Waste Management provided separate skips and wheelie bins for the separation of different waste streams on-site.

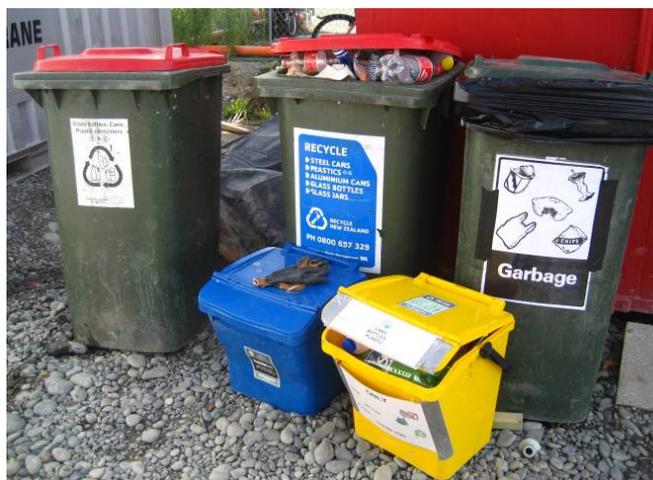
Central waste station for non-construction waste © Copyright

- Had separate waste, paper and recycling wheelie bins for staff and sub-contractors lunch and office waste.
- Sent pallets back to suppliers for reuse or sent to Pallet Improvements for reuse/recycling.
