## Christchurch Civic Building

### Introduction to the Project

This Christchurch Civic Building waste reduction case study demonstrates that with careful on-site and off-site waste sorting; at least 86.9% of construction and demolition waste can be recovered for reuse and recycling.

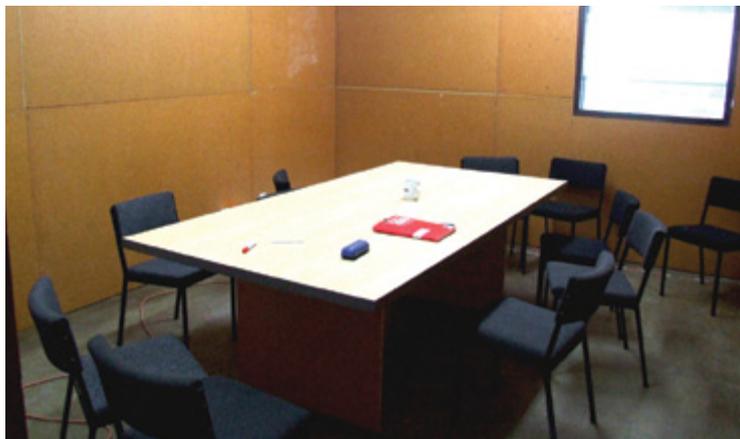
Temporary site office meeting room made from re-used timber and particle board © Copyright

- Reused parts of the original building. Concrete panels saved from demolition have been reused on the building facade. Timber and particle board was reused in the temporary site offices.

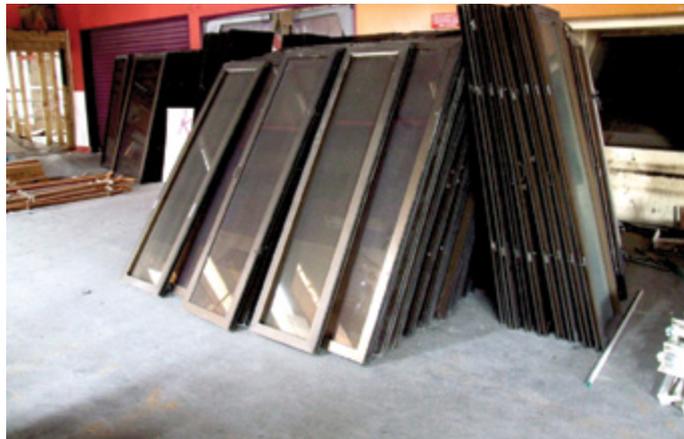
Aluminium windows for re-sale © Copyright

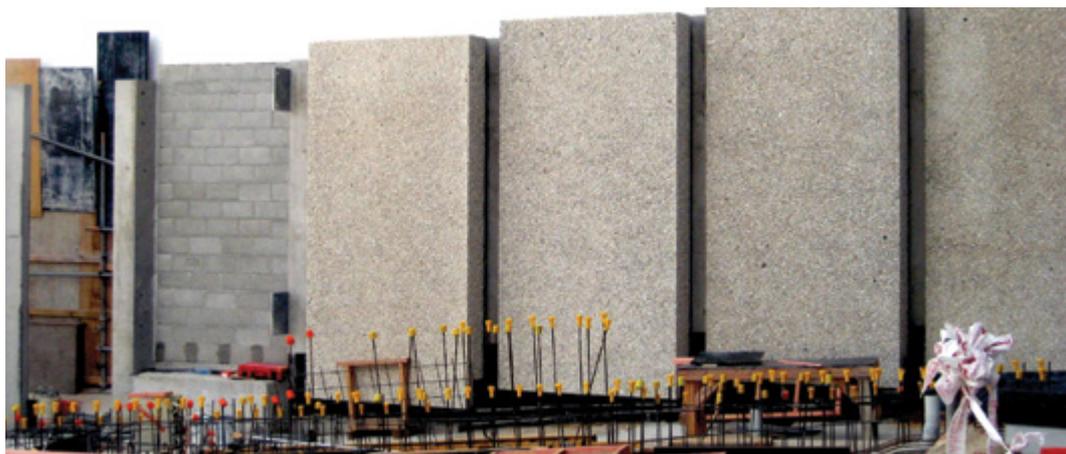
Panels from the original building reused in the refurbished building © Copyright

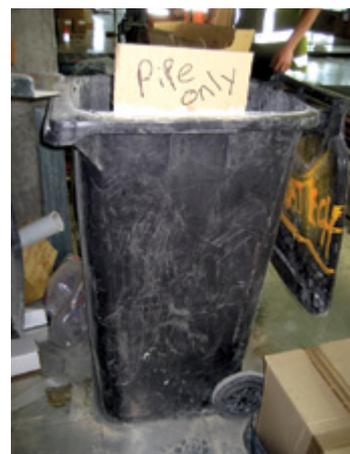
Wheelie bins used to transport waste to the central sorting area © Copyright

- Sub-contractors sorted materials into wheelie bins and wool sacks and then removed these to the central waste sorting area and sorted waste into the appropriate skips. The bins were clearly labelled with the sub-contractor's name and were the responsibility of the sub-contractors. This method was chosen as central waste areas could not be located on each floor due to access limitations, and was considered to be the most effective way to manage waste over a number of floors.

- In every project meeting, waste management was included as an item on the agenda and included in the minutes.
- Provided wheelie bins to enable easy movement of material around the site.

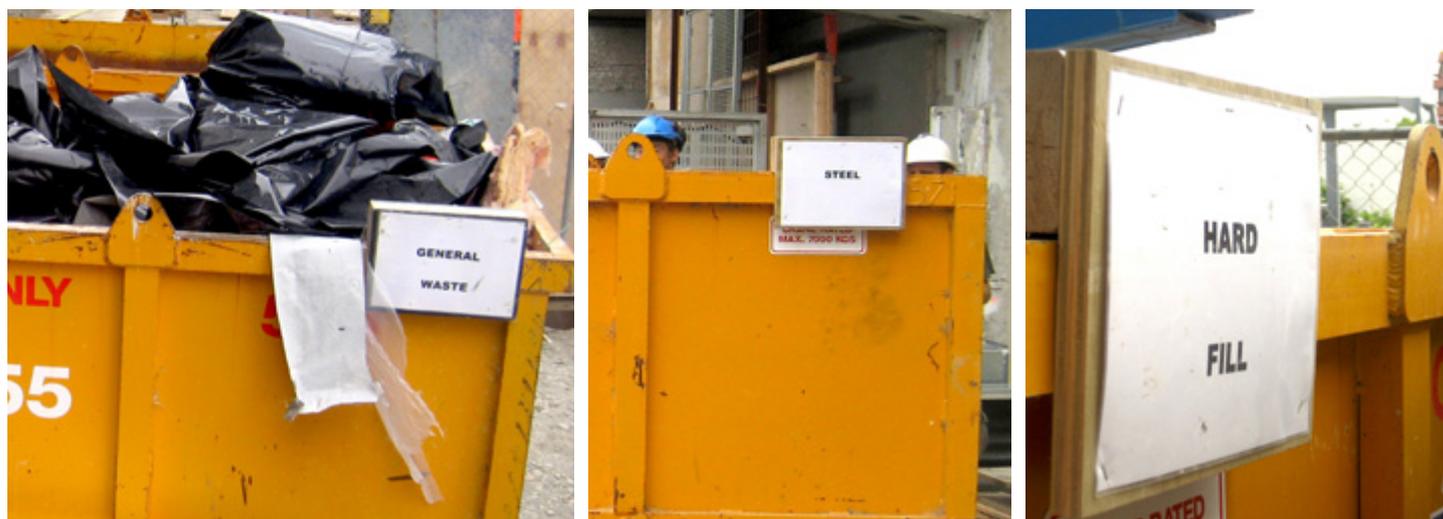
Signage in the central waste sorting area © Copyright

- Had a central waste area with separate collection units for metal, untreated timber, hardfill (mainly concrete), paper, cardboard, soft plastics, plasterboard and general waste.

- Clearly labelled the separate collection units.
  - Rewarded staff and sub-contractors for good waste sorting e.g. a workplace shout.
  - Sub-contractors were also contracted to recycle at least 75% of their waste. If contamination was found in the central waste sorting area, the sub-contractor was identified by the nature of the waste and given a written warning. If the contractor caused contamination again they were charged for the cost of sorting the waste (approximately \$200). This approach was implemented several times during the project and was found to be a useful deterrent to causing contamination.
