Avon River Catchment Aquatic Ecology 2019

August 2019

Prepared for:
Christchurch City Council

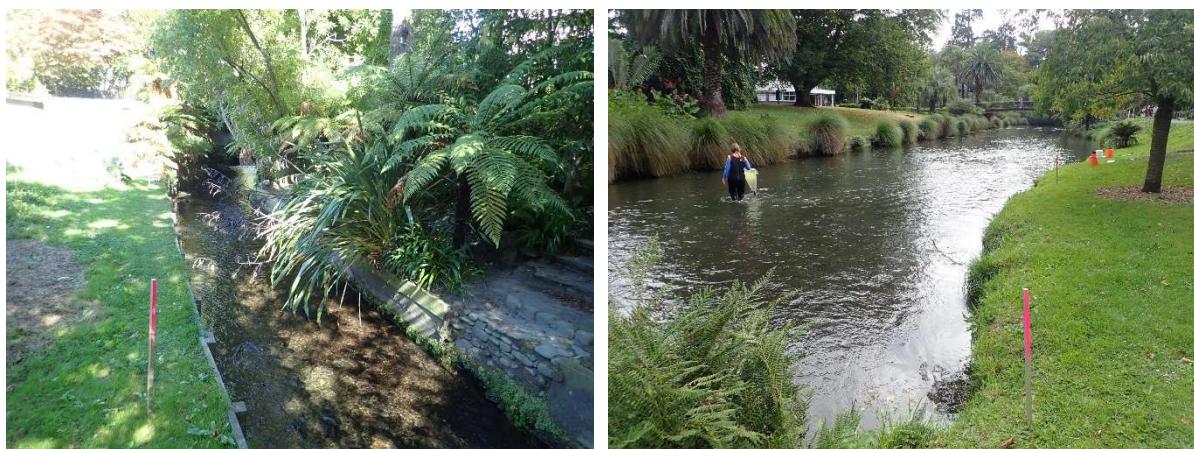
Figure 2: Sites in the mid to upper reaches of the Avon catchment often have timber or stone banks, such as Site 7 at Clyde Road (left) and the riparian zone has a manicured appearance with minimal native plants, such as Site 26 at Botanical Garden North Car Park (right).

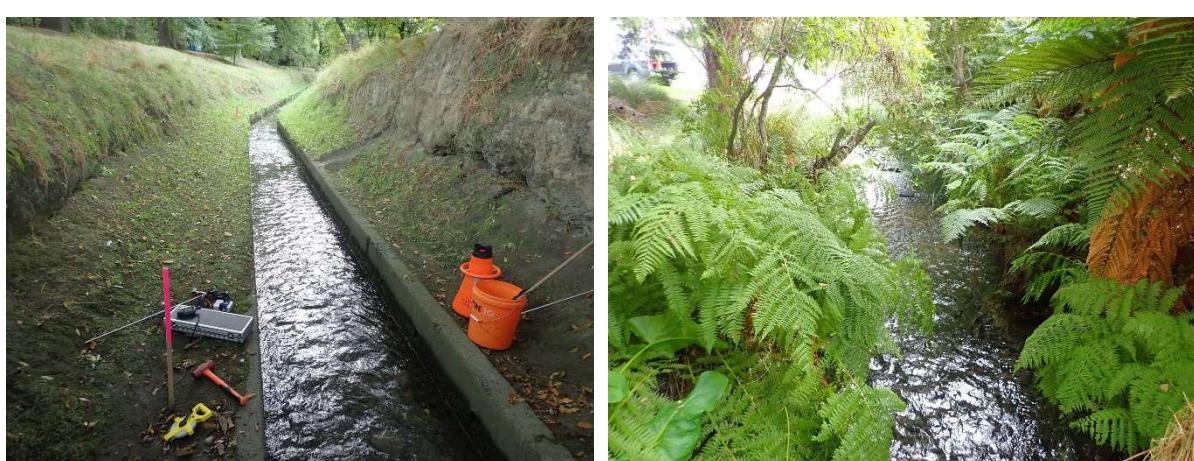
Figure 3: Contrasting riparian and bank habitat conditions in tributary waterways, with Riccarton Main Drain (Site 13) on the left and Okeover Stream (Site 6) on the right.

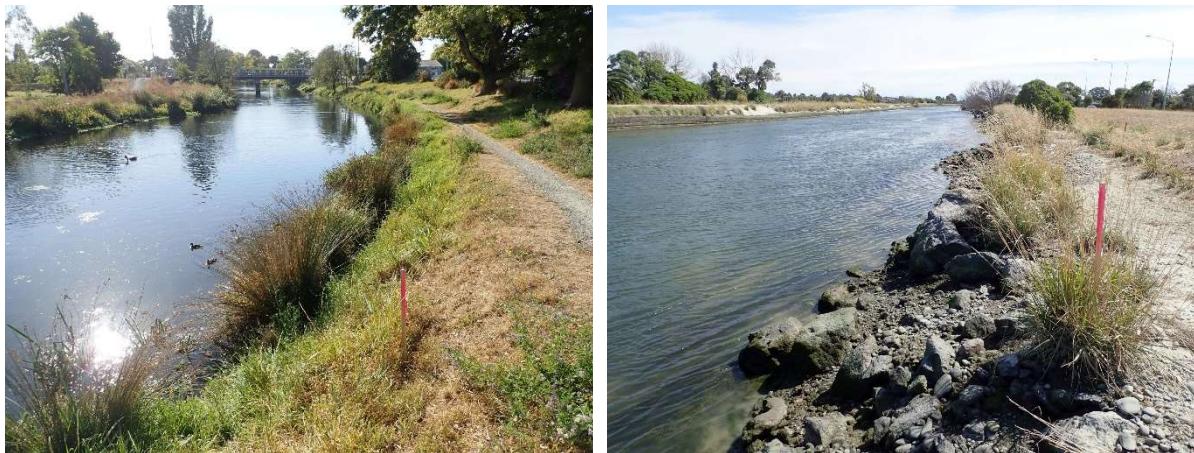
Figure 4: Images from Site 30 at Gayhurst Road (left) and Site 32 at Pages Road (right) illustrate how the lower Avon River is lined by stopbanks, which prevent development of a natural floodplain and associated ecosystems.

The Avon River changes character from Site 30 (Gayhurst Road) downstream, with the lower river becoming deeper and broader, and with increasing tidal influence on water levels and vegetation (Figure 4). The lower river is also constrained by stopbanks, resulting in artificially-steep banks that greatly limit the development of native riparian vegetation. This is particularly acute at Site 32 (Pages Road), where the steep stopbanks are composed of rock and only sparse grasses occur (Figure 4). See Appendix 1 for photographs of all the sites in 2019.

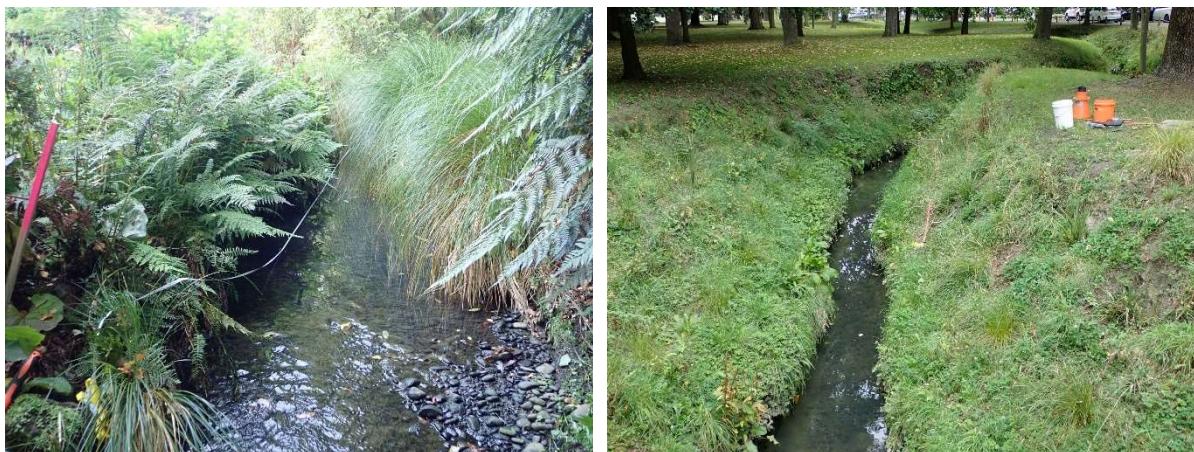
Figure 5: Addington Stream at the 2013 monitoring site in the Botanical Gardens (left) and less than 200 m upstream at the 2019 monitoring site in Hagley Park (right), showing major habitat differences.

The only site with a marked habitat difference in riparian and instream habitat between 2013 and 2019 was Site 12 on Addington Brook. That is because sampling in 2013 occurred in Christchurch Botanical Gardens, immediately upstream of the Avon River, whereas in 2019 sampling was further upstream in Hagley Park. While the two sites were less than 200 m apart, they have markedly different habitat conditions; the old downstream site has a stony bed and extensive native planting in the riparian zone, whereas the new upstream site has grass banks and silt-dominated bed sediments (Figure 5). This illustrates how quickly riparian and habitat conditions can change over short distances along urban waterways, due to different land ownership and maintenance regimes.

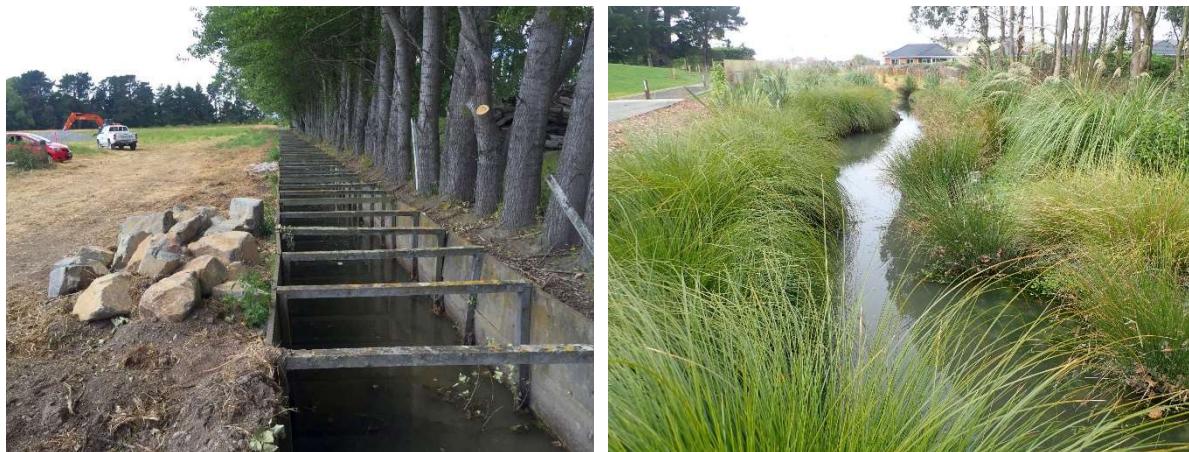
Figure 30: Buller Stream on January 2017 (left) and on May 2019, after waterway restoration (right).

- **Buller Stream.** Replacement of a straight, timber-lined channel with natural banks, logs, and undercutts reinforced with tree stumps, along 400 m of stream adjacent to a new stormwater wetland (Figure 30). No follow-up monitoring is currently planned.
- **No. 1 Drain.** Replacement of a shallow, concrete-lined channel with a combination of narrow stream sections and broad stormwater wetland basins, with wetland and riparian planting, over a length of 400 m through Shirley Golf Course (Figure 31). The stormwater basins include a floating wetland for stormwater treatment, one of the first of its kind in Christchurch. Follow-up ecological monitoring is proposed within the next two years.

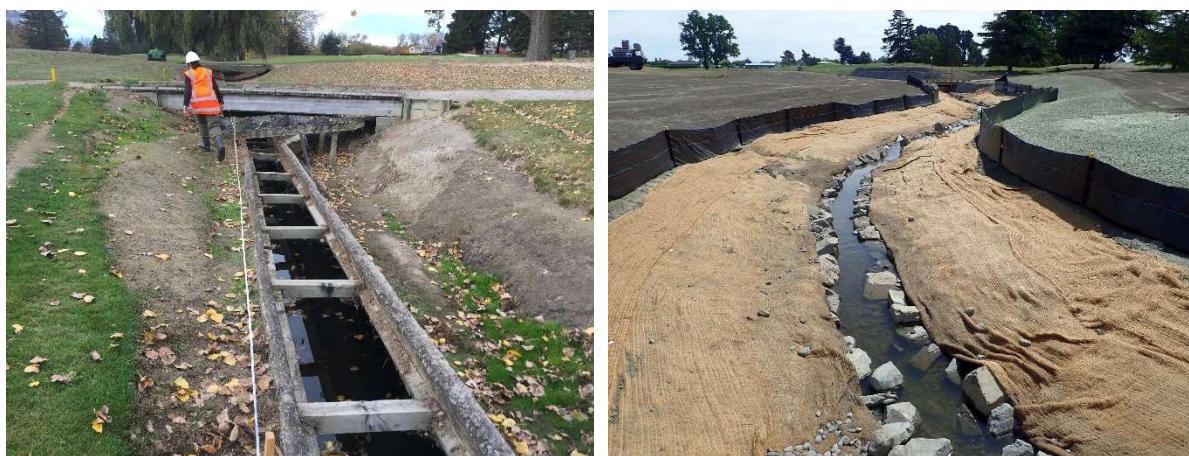
Figure 31: No. 1 Drain in Shirley Golf Course, on May 2017 (left) and nearing completion of restoration work on November 2018 (right).
