Annual Aquatic Ecology Monitoring

Styx River, Cashmere Stream and Balguerie Stream

Prepared for
Christchurch City Council

Prepared by
Tonkin & Taylor Ltd

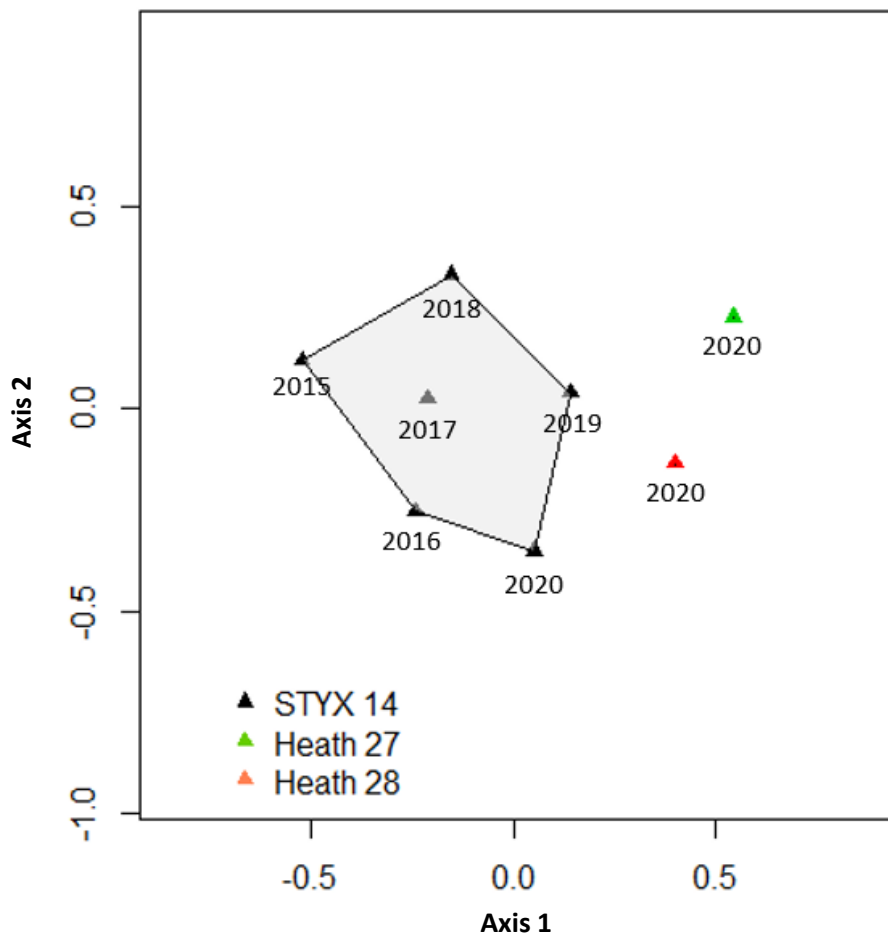
Of interest is whether there is a shift in invertebrate composition over time that may suggest a change in the environmental conditions within the stream. Results showed that the macroinvertebrate community at STYX 14 between 2015 to 2020 remained consistent and was represented by a macroinvertebrate community dominated by a mix of pollution sensitive and tolerant species *Potamopyrgus antipodium*, *Pycnocentroides aureolis*, *Deleatidium_sp*, *Oligocheata*, *Pycnocentria evecta*, *Ferrissia*, *Ostracoda*, *Paracalliope sp*. However, in 2019 and 2020 there was a slight shift which was associated with a decrease in the relative dominance of *P. antipodarum*.

The Heathcote River sites (Heath 27 and Heath 28) macroinvertebrate community were dominated by pollution tolerant taxa including *P. antipodarum*, *Paracalliope sp*, and *Sphaeridae sp*; and the cased caddisfly *Hudsonema sp*.

Figure 3-7: NMDS plot of macroinvertebrate communities for all sites. Sampling years are displayed below each site sample. Plot stress is 0.09.

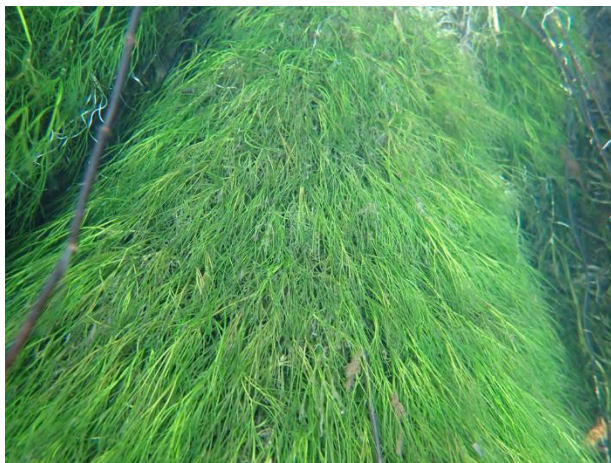
Photograph C3: Styx Mill Reserve, instream habitat images, showing macrophyte abundance.

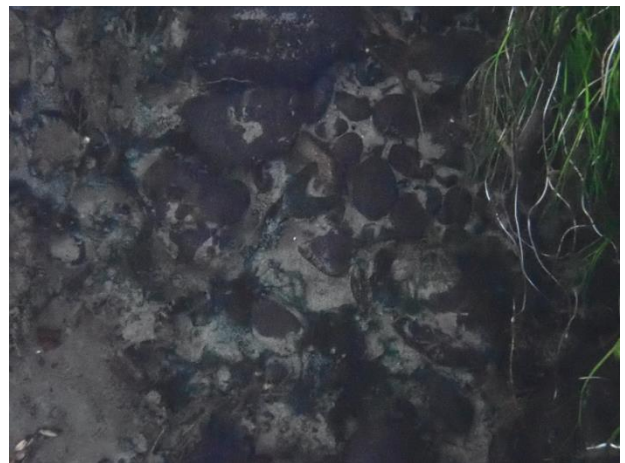
Photograph C4: Styx Mill Reserve, instream habitat images, showing streambed sediment, cobble and debris cover.

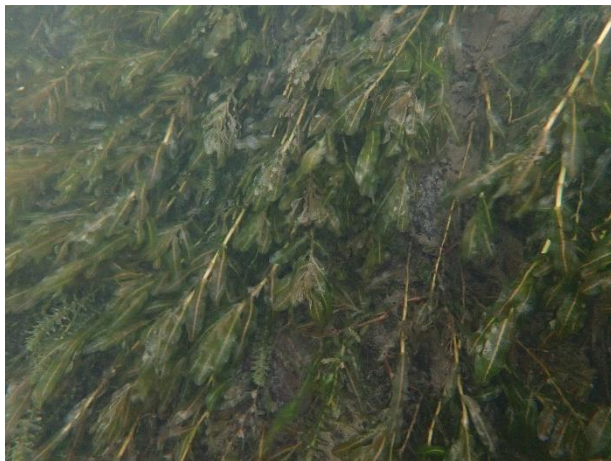
Photograph C7: Cashmere Stream - Heath 27. Instream habitat images, showing macrophyte abundance.

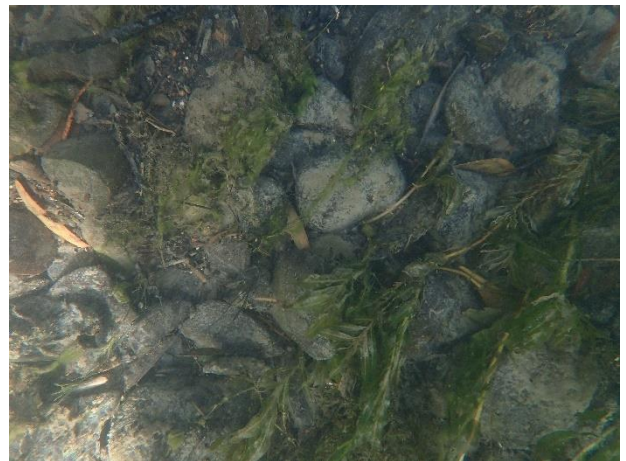
Photograph C8: Cashmere Stream - Heath 27. Instream habitat images, showing streambed sediment, cobble, debris and scattered macrophyte cover.

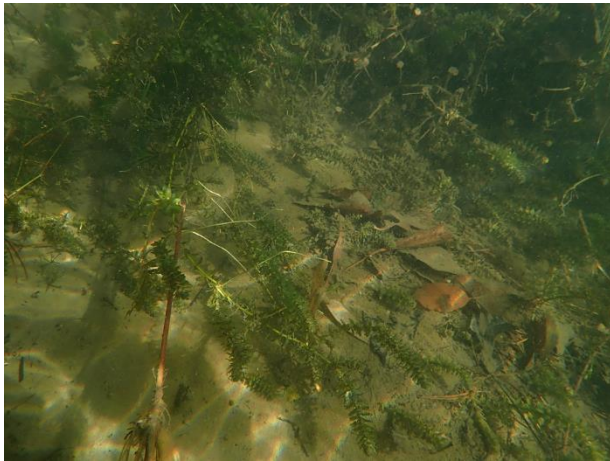
Photograph C11: Cashmere Stream – Heath 28. Instream habitat images, showing macrophyte abundance.
