# Ballintines, Stilwells, and Sherrings Waterways

Freshwater Ecology Assessment  
Prepared for Christchurch City Council

1 July 2025

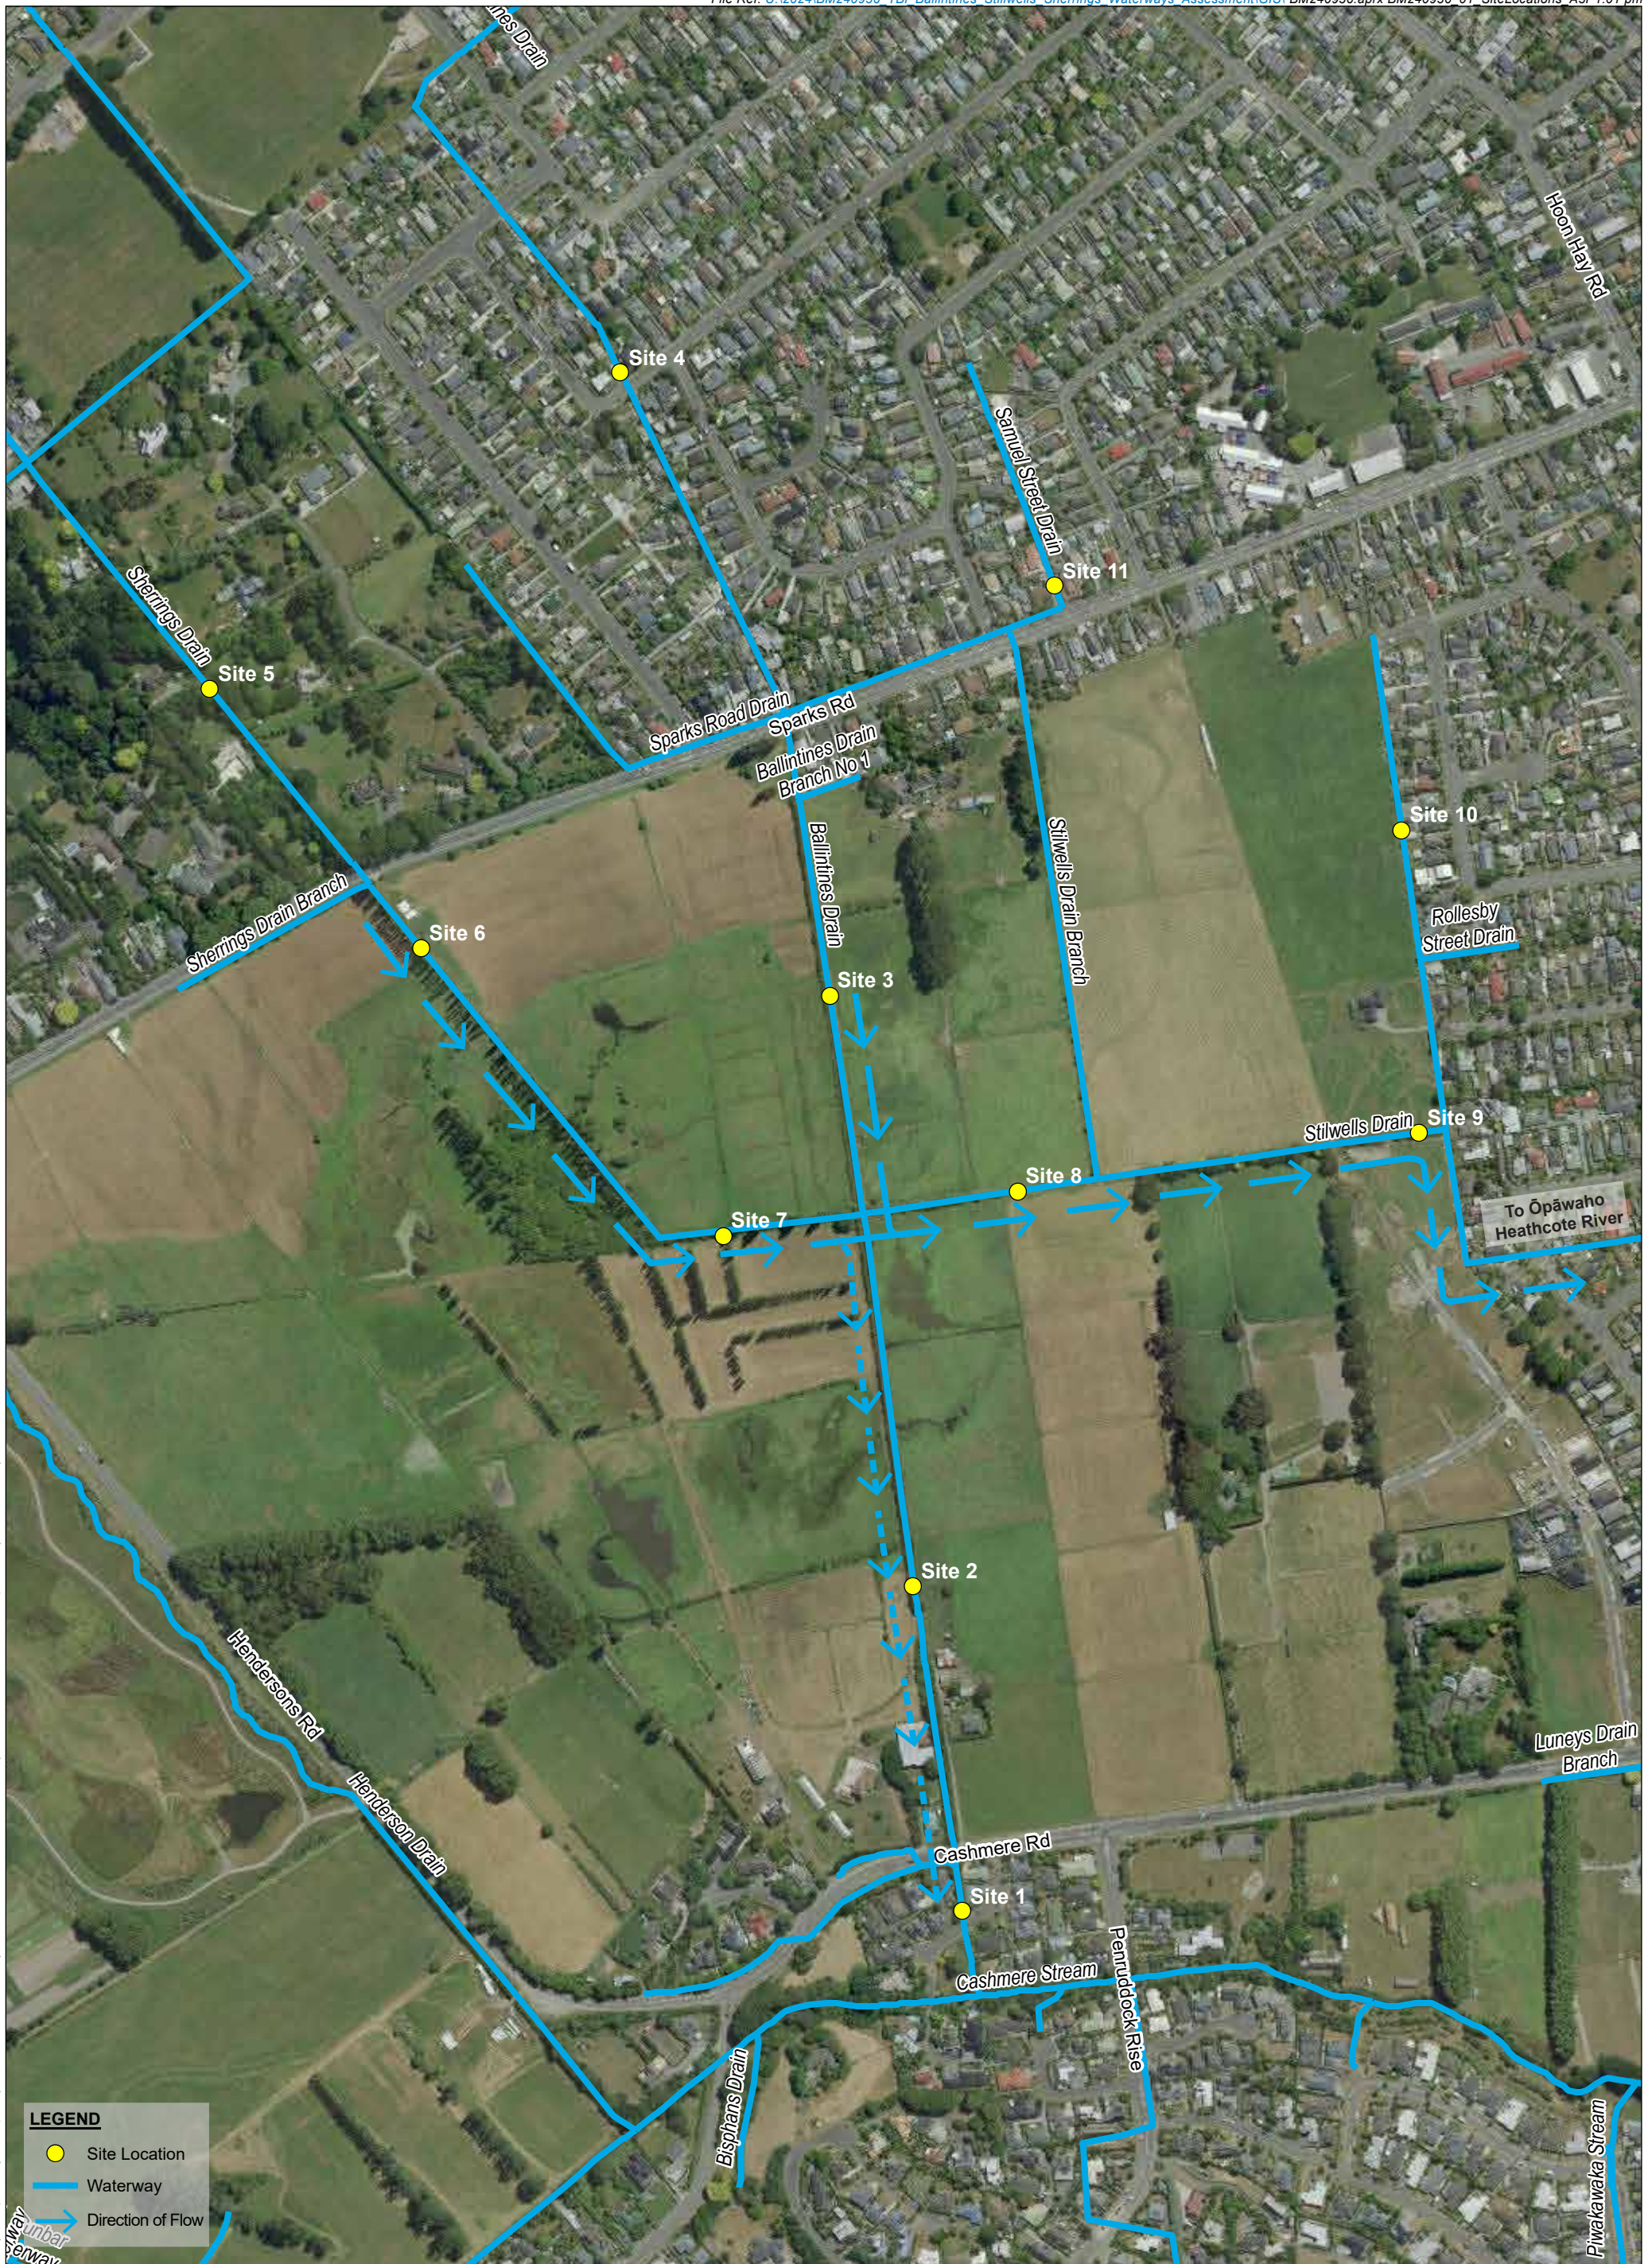
**Figure 1: Survey site locations, April 2025.**  
 Direction and proportion of flow is shown by arrows and line weighting.

Following the initial stream walk, we (in conjunction with Katie Kerr, CCC’s Principal Waterways Ecologist) selected ten sites across Ballintines, Stilwells, Sherrings waterways, and Samuel Street Drain (Table 1, Figure 1). Sparks Road Drain was dry in March 2025, so no sites were located here.

At each of the ten sites listed above and shown in Figure 1, assessments of riparian and in-stream habitat (including periphyton and macrophyte) conditions, and the macroinvertebrate and fish communities, were completed during base-flow conditions (i.e., no sooner than 7 days of a heavy rainfall event, and no less than 3 weeks after a bed-moving flood event) between 7 and 28 April 2025.

When Ballintines Waterway converges with Stilwells and Sherrings waterways, the flow directions are somewhat complex (Figure 1). Based on our site observations, the majority of surface water from Ballintines Waterway flows east into Stilwells Waterway and to Ōpāwaho Heathcote River (via a short, piped section of Blakiston Drain).

Sherrings Waterway flows for 530 m until it converges with Ballintines and Stilwells waterways. At the confluence, the majority of flow from Sherrings Waterway appears to head south into Ballintines Waterway, but some flow continues east with the majority of flow from Ballintines Waterway into Stilwells Waterway (Figure 1).

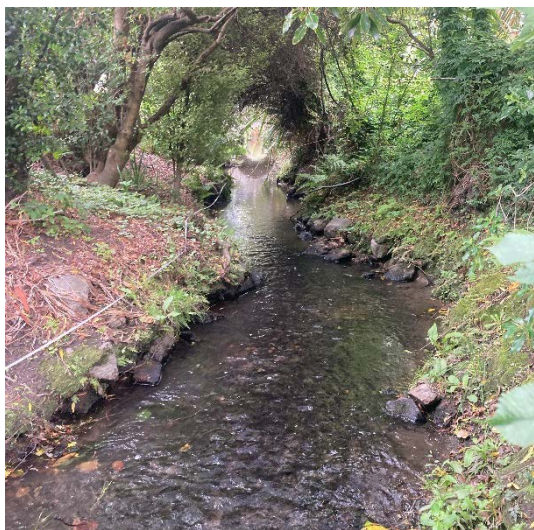
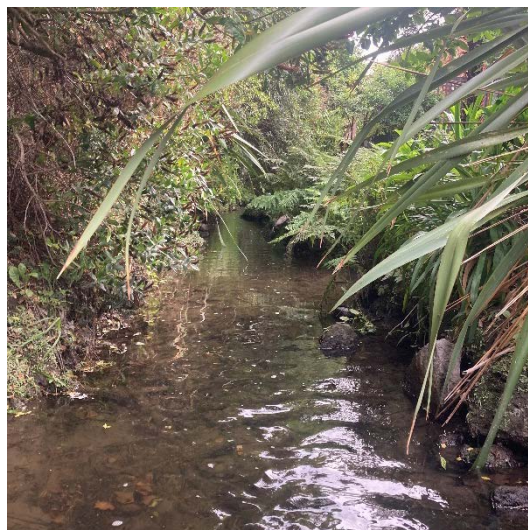
Photo 1: Site 1 - Ballintines Waterway downstream of Cashmere Road, looking downstream (left) and upstream (right).

The waterway at Site 1 was 1.8 m wide and 11.7 cm deep with an average velocity of 0.57 m / s. The stream bed substrates were dominated by fine silt (43%) and gravels (20%). Larger substrates (e.g., cobbles, boulders) were present, but covered by fine sediments. Embeddedness at Site 1 was 46%. Sediment depth at this site was relatively low, averaging 7.6 cm deep. Organic matter (sticks, leaf litter) was moderate at this site (14.1%). Macrophyte cover was low (6.1%), dominated by *Nitella hookeri*, with *Elodea canadensis* (Canadian pondweed), *Potamogeton crispus* (curly-leaf pondweed), and *Lemna minor* (floating duckweed) also present.

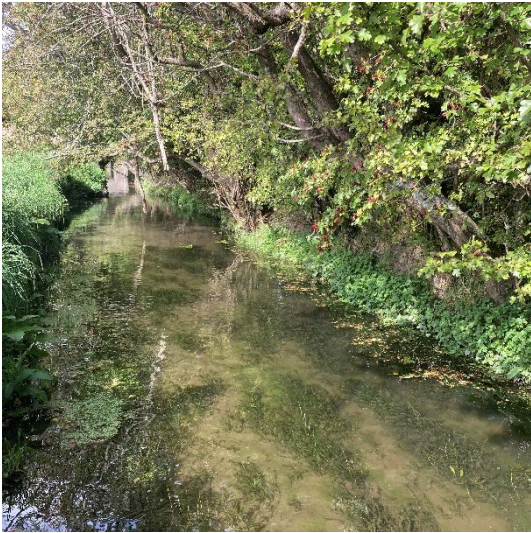
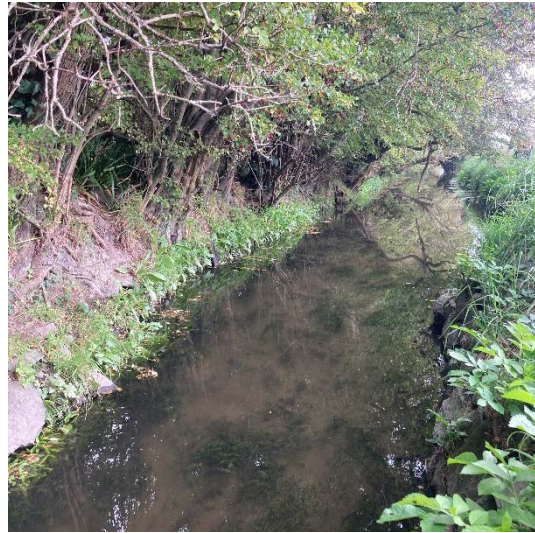
Photo 2: Site 2 – Ballintines Waterway upstream of Cashmere Road, looking downstream (left) and upstream (right)

The stream bed substrates were dominated by fines silt (100%), with an average substrate index (SI) of 3. Sediment depth at this site was moderate, averaging 42.0 cm deep. Organic matter was present at this site and dominated by leaf litter (10.7%). Macrophyte cover was moderate (44%), dominated by *Nitella*, Canadian pondweed, and curly-leaf pondweed.

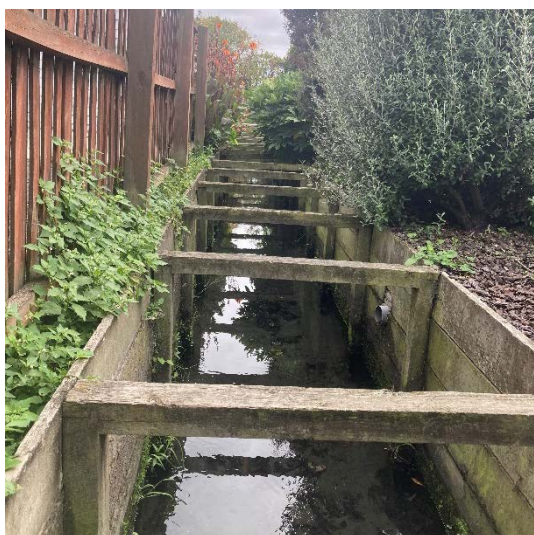
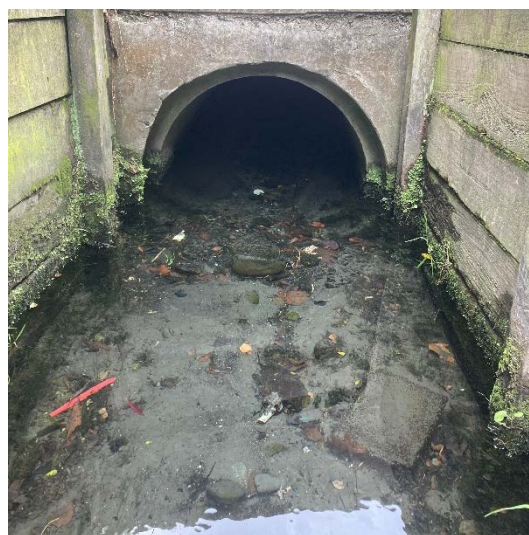
Photo 4: Site 4 – Ballintines Waterway upstream of Sparks Road, looking downstream (left) and upstream (right).

RHA assessments undertaken by Instream (2024) in the waterway section that included this site showed a moderate habitat score (RHA score of 31.5-40.5). Habitat was limited by low hydraulic heterogeneity, low shading, narrow riparian widths, low habitat abundance and high fine sediment cover. However, the site did have highly stable banks (timber-lined), and some in-stream habitat diversity (e.g., larger substrates).

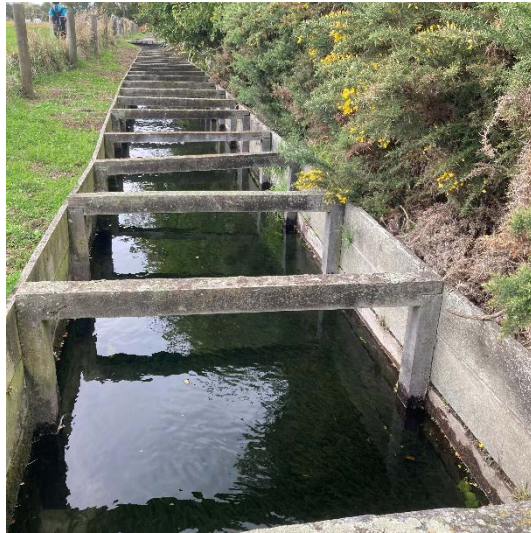
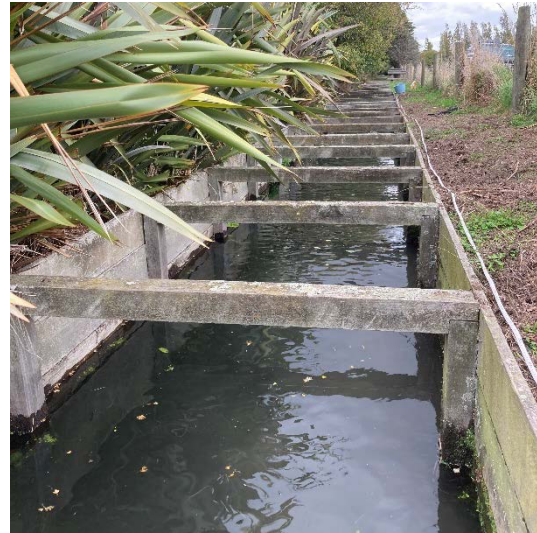
Photo 5: Site 8 – Stilwells Waterway downstream of Ballintines Waterway, looking downstream (left) and upstream (right).

The channel at Site 8 was 1.5 m wide with an average water depth of 48.6 cm, the deepest of all sites. The stream bed substrate was dominated by fine silt (100%). Sediment depth at this site was moderate, averaging 43.5 cm deep. Leaf litter was very low at this site (0.3%). Macrophyte cover was very high (97.3%), dominated by Canadian pondweed.

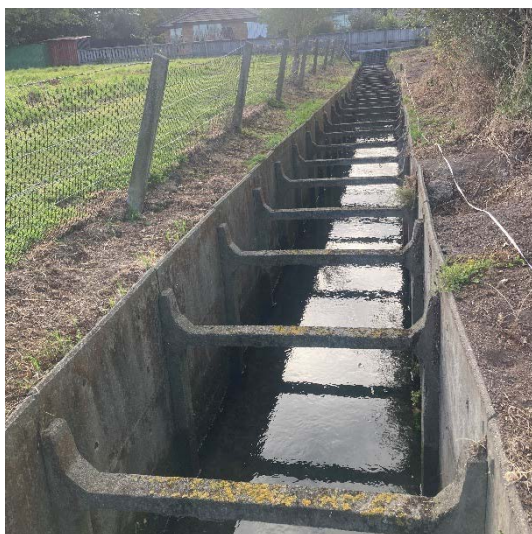
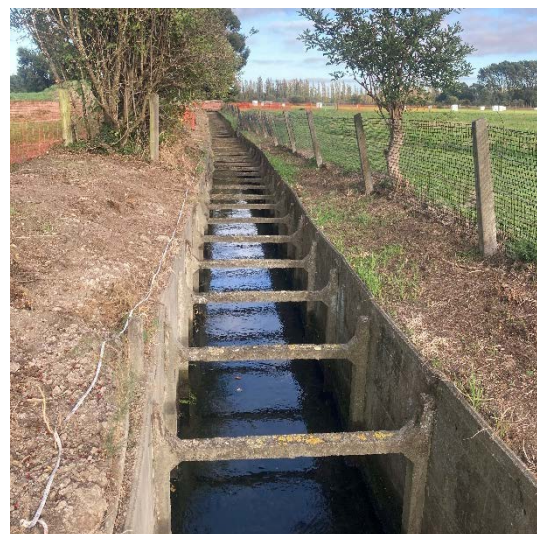
Photo 6: Site 9 – Stilwells Waterway upstream of Blakiston Drain, looking downstream (left) and upstream (right).

The channel at Site 9 bound by concrete lining, averaging 1.5 m wide and 23.5 cm deep. The stream bed substrates were dominated by fine silt (60%) and pebbles (20%). Larger substrates (e.g., cobbles) were present, but covered by a thin layer of fine sediments (i.e., silt / sand). Embeddedness at Site 9 was 55%, but sediment depth at this site was low, averaging 3.8 cm deep. Leaf litter was very low this this site (1.8%). Macrophyte cover was moderate (35%), dominated by *Nitella* and Canadian pondweed.

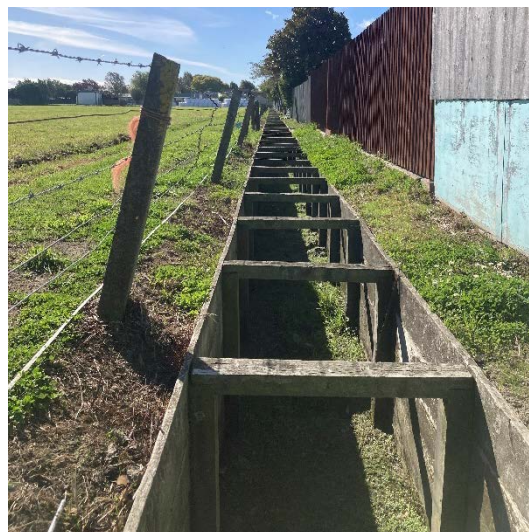
Photo 7: Site 10 – Stilwells Waterway downstream of Northaw Street, looking downstream (left) and upstream (right)

The riparian margin was very narrow on both banks (i.e., <0.5m), bound by tall residential fencing on the true left and fenced paddock on the true right. This narrow margin was dominated by bare earth, grass, and low stature weeds. Canopy cover and overhanging vegetation was absent from this site (Photo 7).

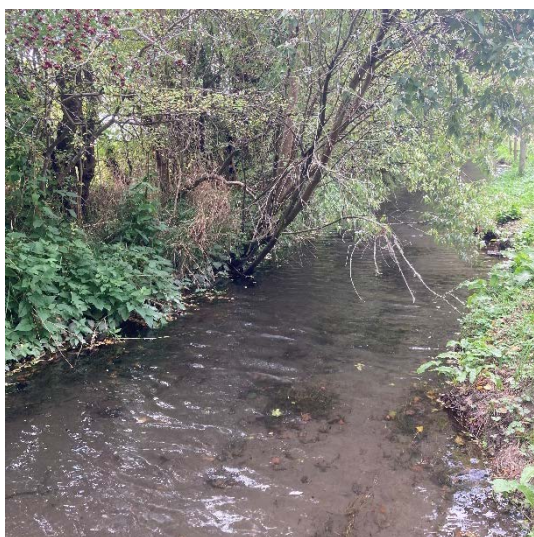
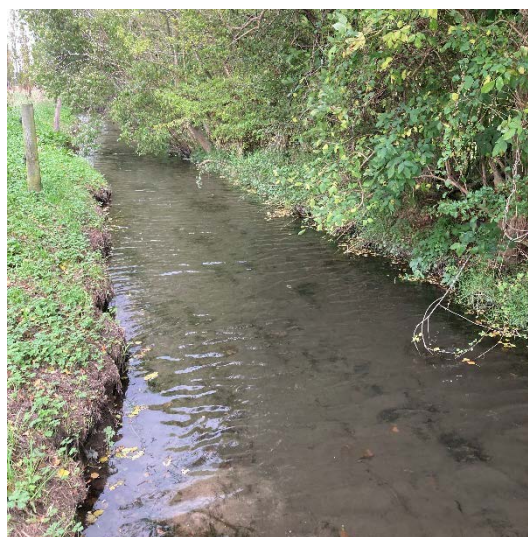
*Photo 8: Site 7 – Sherrings Waterway upstream of Ballintines, looking downstream (left) and upstream (right).*

The riparian margin was bound by paddocks, which appeared to be retired from livestock. Vegetation was dominated entirely by long grass on the true right bank, and deciduous exotic trees on the true left bank (i.e., poplar, hawthorn, willow). These exotic trees provided 73% canopy cover to the TLB, and 6% to the TRB. Bank height was relatively low at this site (>70 cm), and banks on both sides were unstable with >80% erosion. Overhanging vegetation and undercut banks were absent from this site (Photo 8).

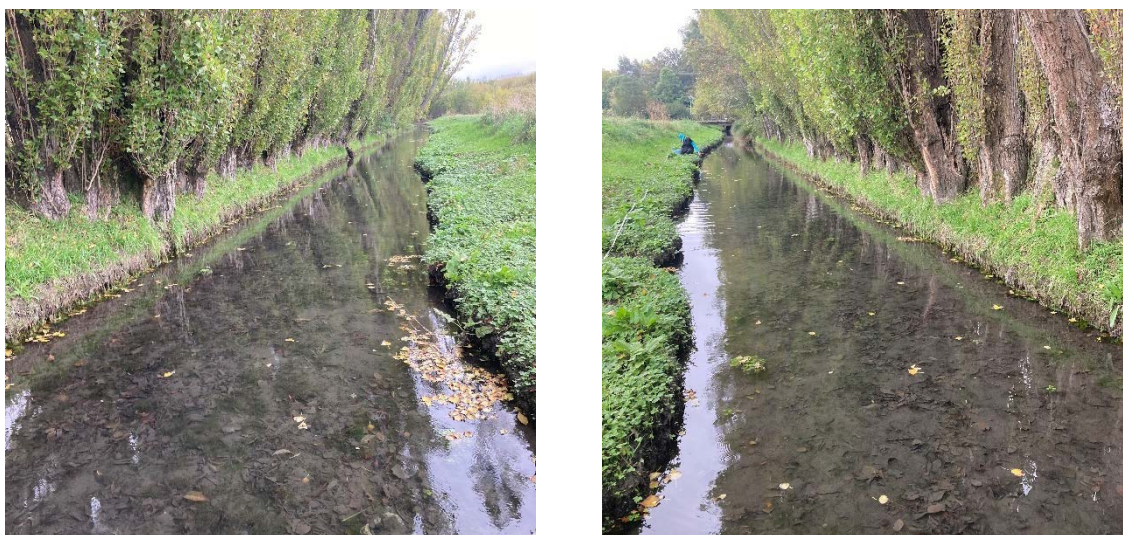
Photo 9: Site 6 – Sherrings Waterway downstream of Sparks Road, looking downstream (left) and upstream (right).

The riparian margin was bound by paddocks, which appeared to be retired from livestock. Bank height was relatively low at this site (>80 cm), and banks on both sides were unstable with >60% erosion. Vegetation was dominated entirely by long grass on the true right bank (providing just 6% shade), and grass and deciduous poplar trees on the true left bank, providing 50% shade to the waterway. Overhanging vegetation and undercut banks were absent from this site (Photo 9).

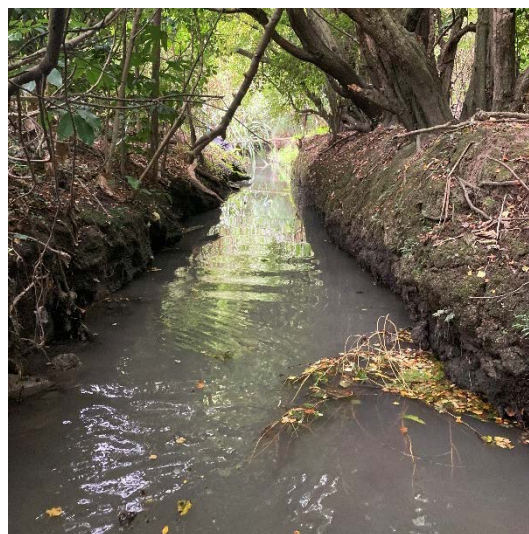
Photo 10: Site 5 – Sherrings Waterway upstream of Sparks Road, looking downstream (left) and upstream (right)

The stream bed substrate was dominated by fine silt (100%), with an average SI of 3. Sediment depth at this site was moderate, averaging 75.6 cm deep. Organic matter was present at this site and dominated by leaf litter and larger woody debris (54.7%). Macrophyte cover was relatively low (14%), dominated by *Nitella*.

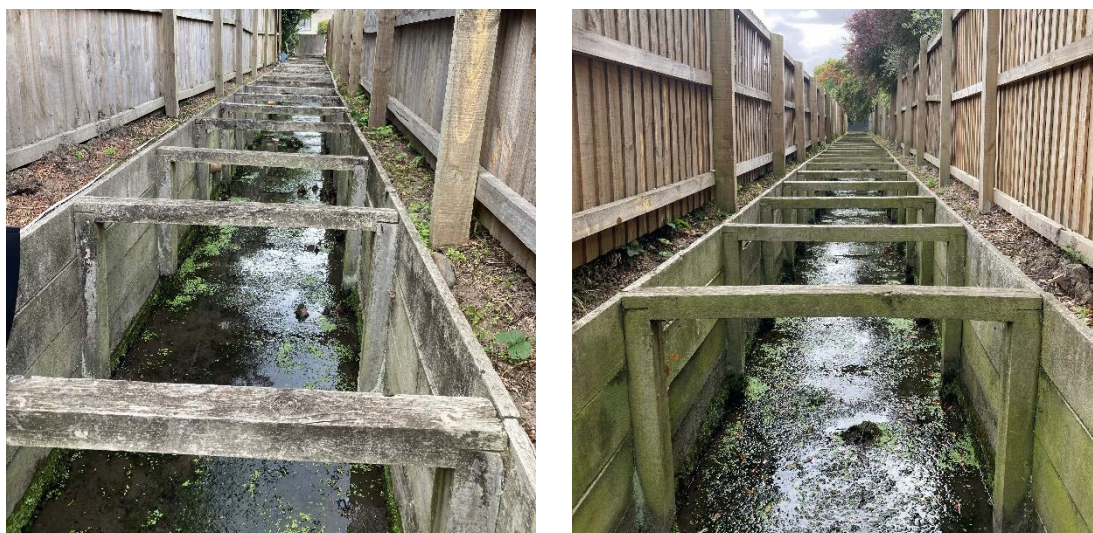
Photo 11: Site 11 – Samuel Street Drain upstream of Sparks Road, looking downstream (left) and upstream (right).

Leaf litter was marginal this this site (6.9%), and woody debris were absent. Macrophyte cover was high (62%), dominated by *Nitella* and starwort. Macrophyte depth averaged 4.4 cm, meaning there was very little free water. Accordingly, we could not measure velocity at this site. The stream bed substrates were dominated by fine silt, with an average SI of 3. Sediment depth at this site was high, averaging 108.2 cm deep.

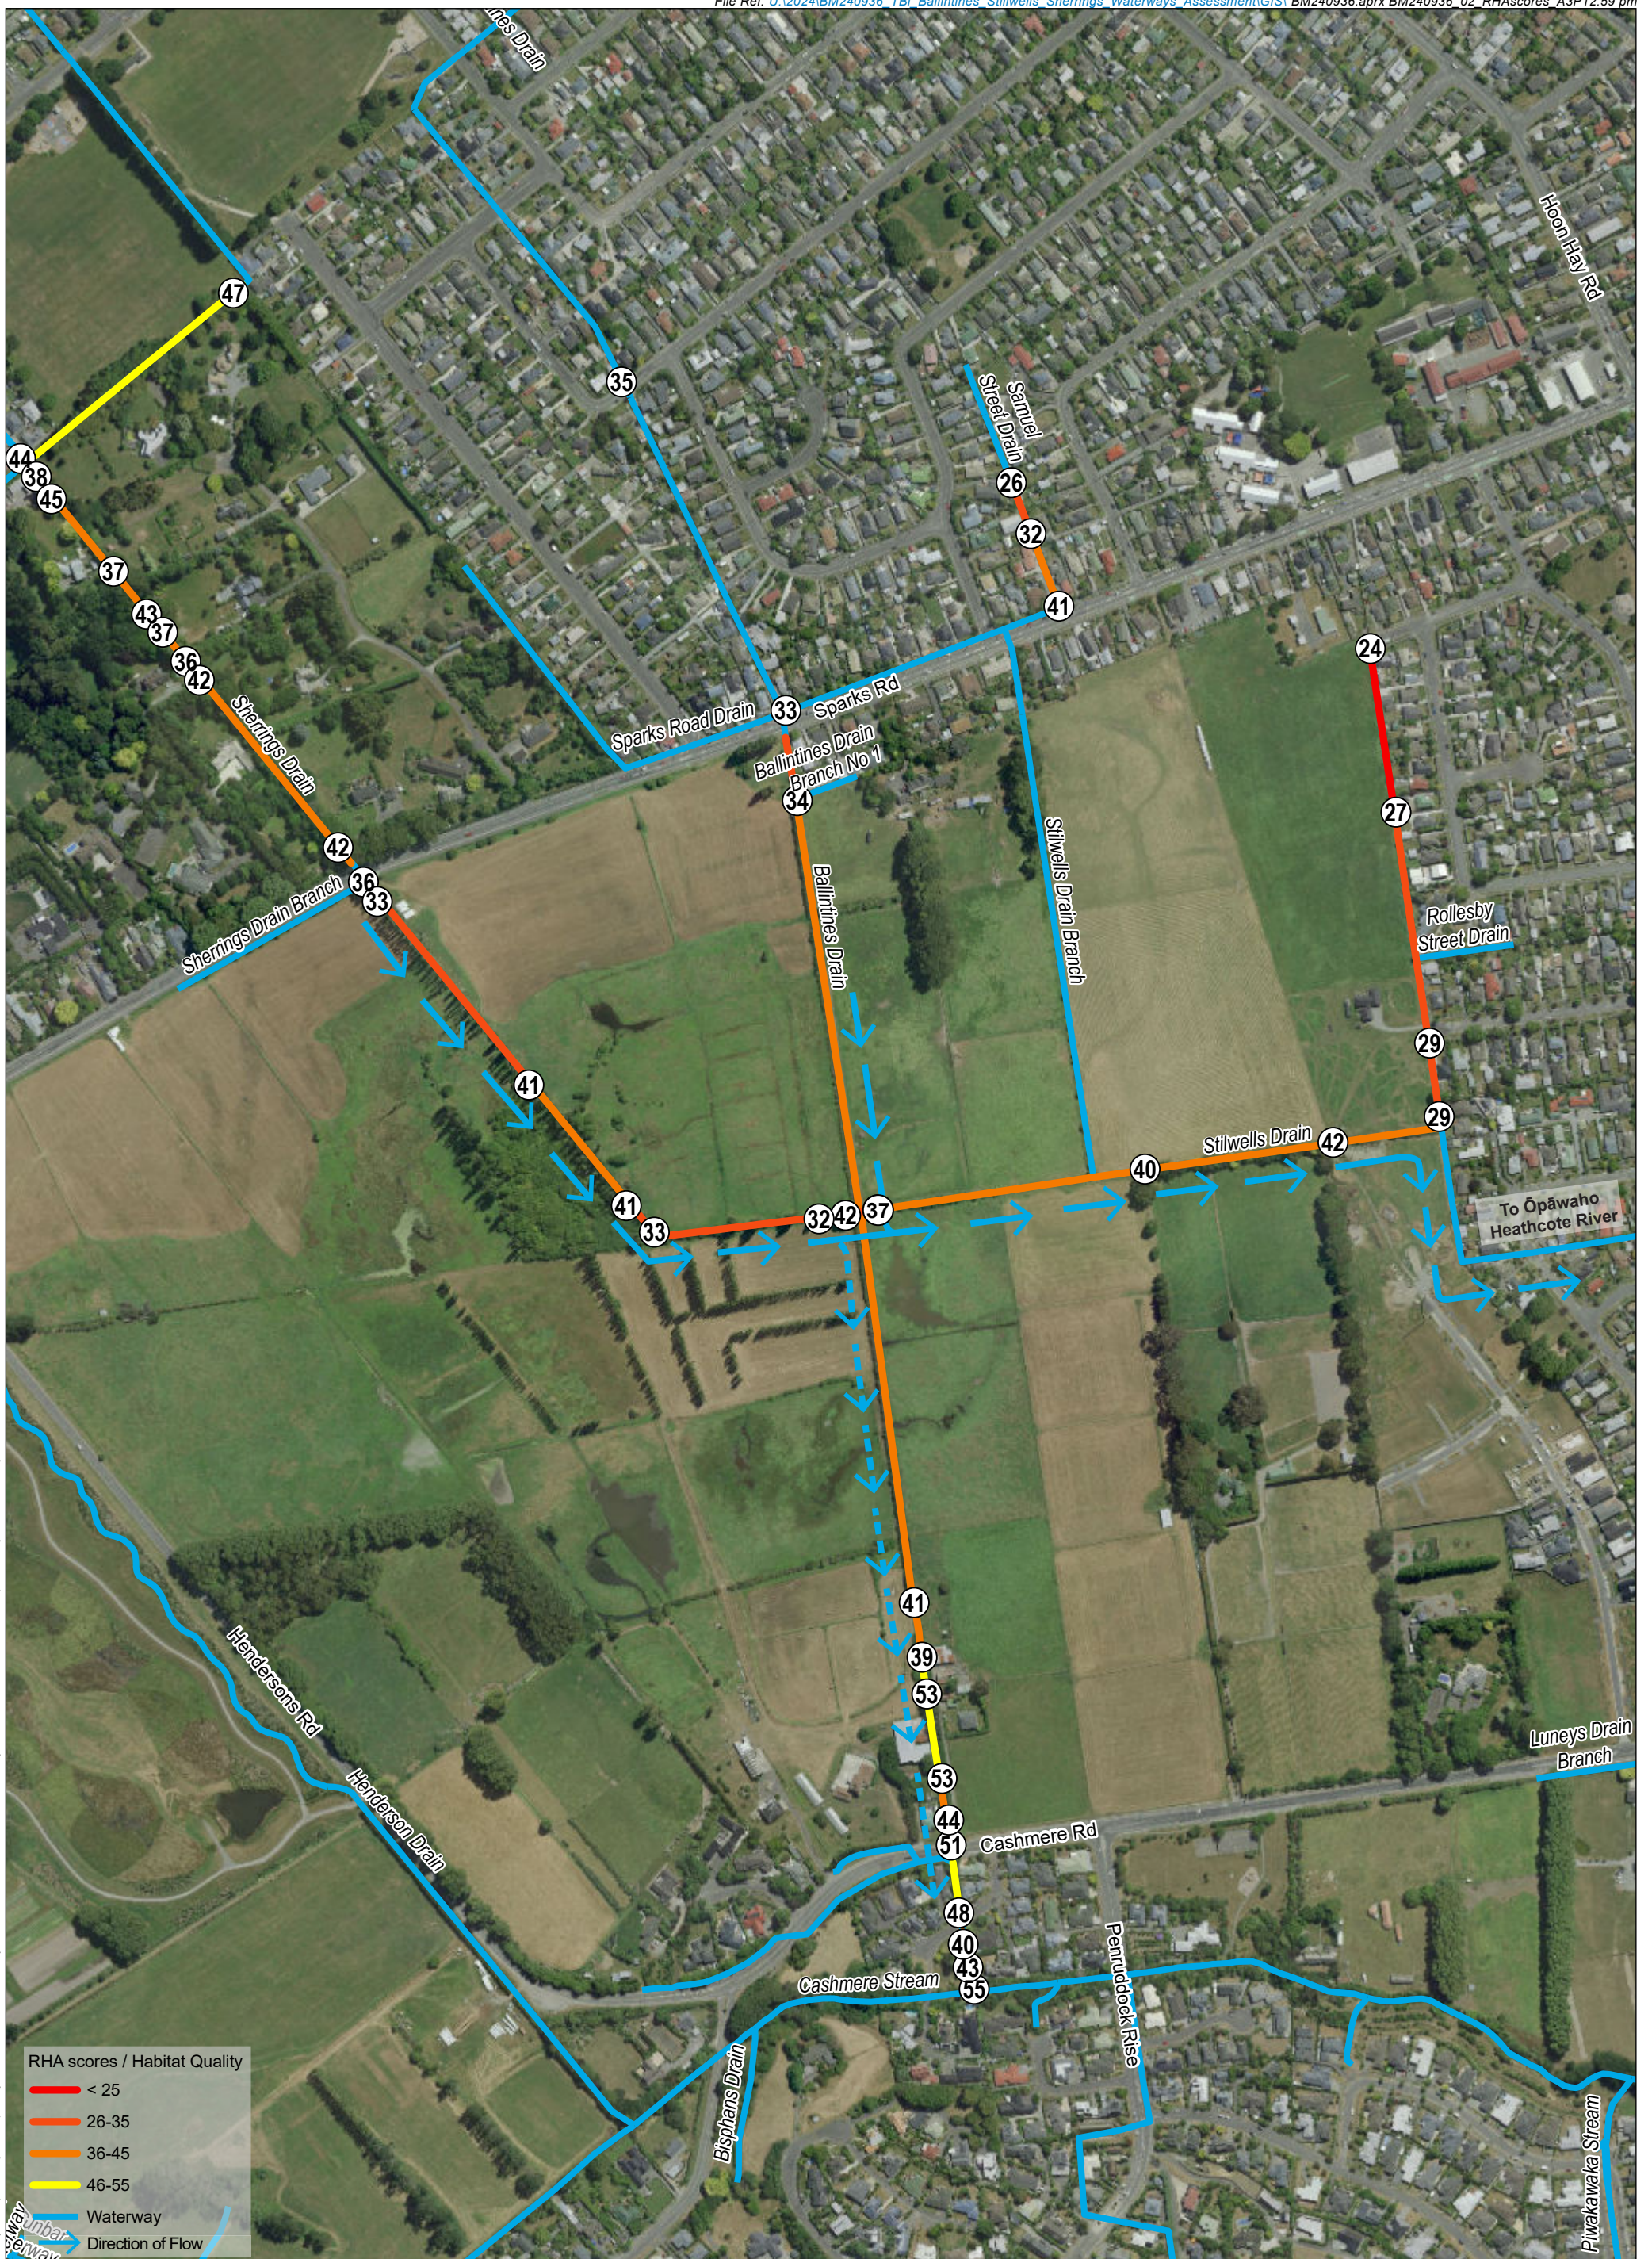
Site 11 was located 17 m upstream of Sparks Road. Here, the waterway was 1.5 m wide and 5.7 cm deep (Photo 11). Undercut banks were absent from this site, with the waterway confined to the timber-lined channel. However, gaps between the lower slats of the timber walls may provide some habitat for freshwater fishes, particularly for smaller eels. There was a very narrow (<0.5 m) riparian margin, bound by residential fences. Vegetated cover in this margin was minimal, with c.8% cover of grass and weeds, with sparse large exotic trees overhanging the fences at the upper extent of the site.

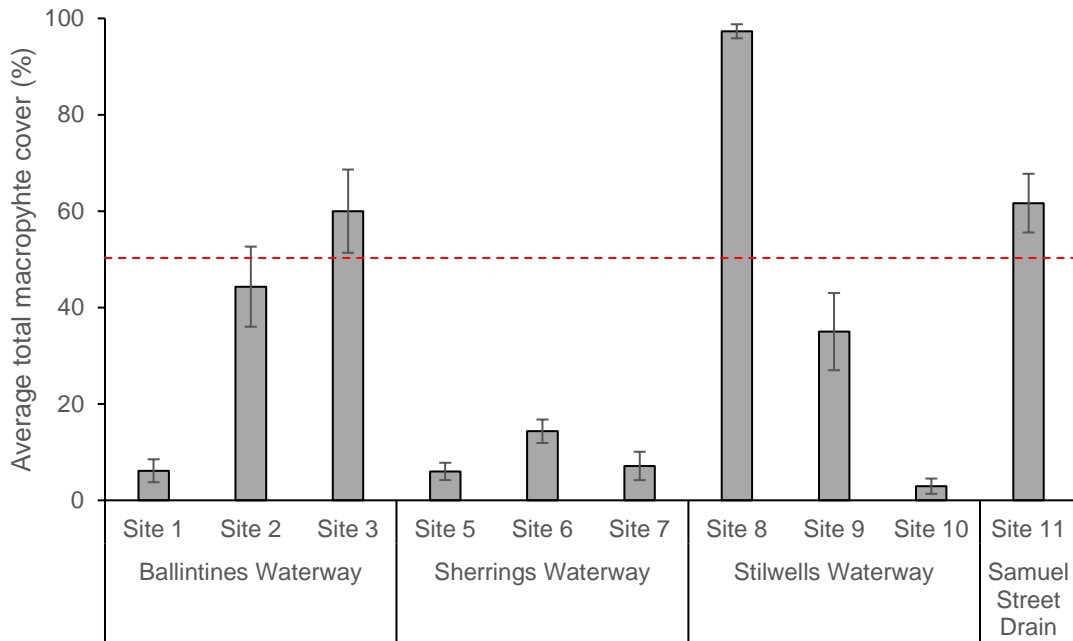
4). Dominant species were Canadian pondweed, curly-leaf pondweed, floating duckweed, starwort, *Nitella*, and *Veronica* spp. Very little algal cover was recorded at any site, the exception to this was short filamentous algae at Site 10: Stilwells d/s Northaw Street, with 32.6% average cover. Leaf litter was variable across sites, ranging from 0.3% at Site 8: Stilwells d/s Ballintines Waterway, to 68% at Site 6: Sherrings d/s Sparks Road. Notably, larger woody debris were present at Site 5: Sherrings u/s Sparks Road and 7 Sherrings u/s Ballintines Waterway.

Figure 5. Average ( $\pm 1SE$ ) total macrophyte cover at sites in 20253. The dashed red line indicates the CSNDC guideline for total macrophyte cover of <50%.

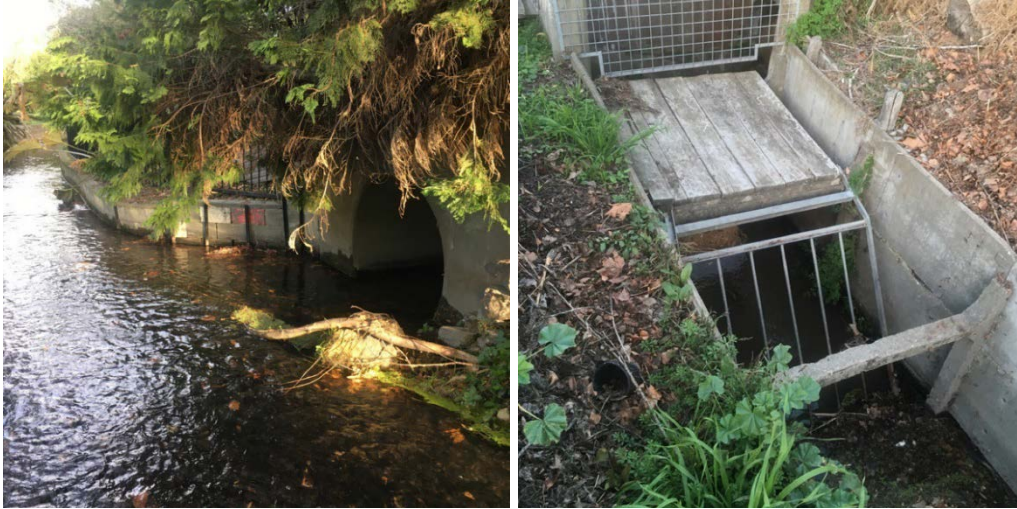
Many of the freshwater fish species present are migratory, requiring access to the sea to complete their lifecycles. There were no high-risk in-stream structures, such as culverts, observed between Cashmere Stream and Ballintines Waterway. However, Stilwells Waterway flows through an c.590 m piped section (through Blakiston Drain) to Ōpāwaho Heathcote River. A debris grate over the drain inlet was unlikely to pose a barrier fish, as grate spacings were c. 20 cm (Photo 12). However, if this becomes blocked by debris between maintenance periods, it could create a partial barrier. From CREAS data, the drain outlet does not appear to be perched, but the piped section itself may be a partial barrier to the upstream migration of some species.

Photo 12: Downstream (left) and upstream (right) structures in Blakiston Drain. Photos were taken during the 2020 CREAS survey, rather than April 2025 when these ecology assessments were completed.

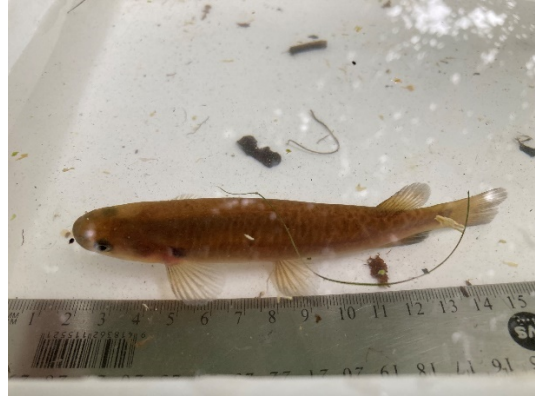
Banded kōkopu at Site 5: Sherrings u/s Sparks Road
