Christchurch February Earthquake

EFFECT ON AQUATIC INVERTEBRATES

EOS Ecology Report No: 11010-CIV01-01 | June 2011
Prepared for: Environment Canterbury and Christchurch City Council
Prepared by: EOS Ecology; Alex James and Shelley McMurtrie

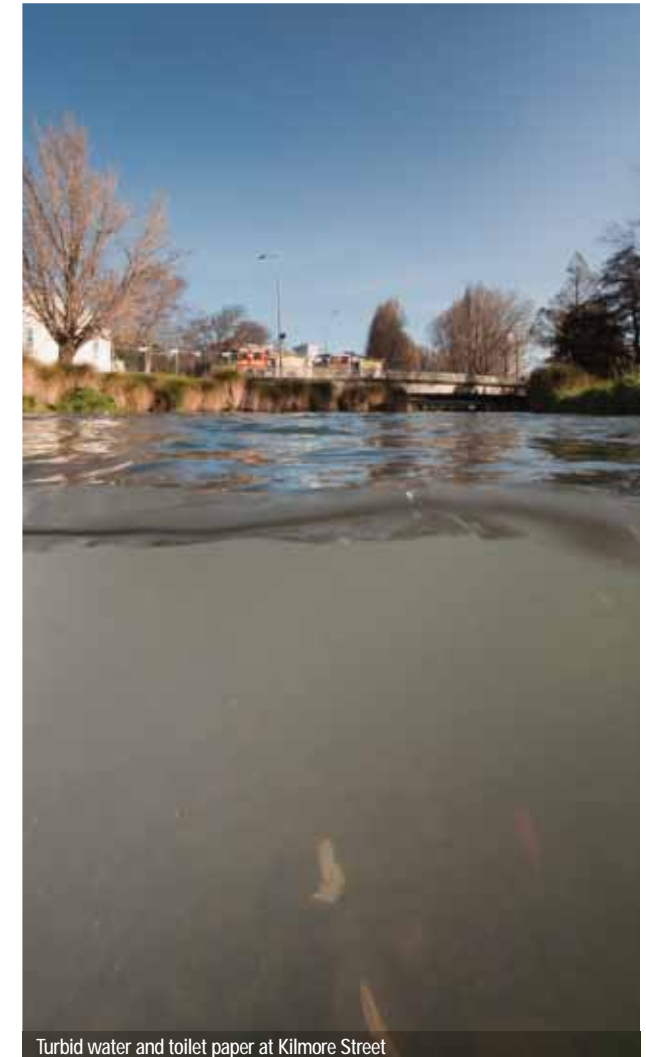
Turbid water and toilet paper at Kilmore Street

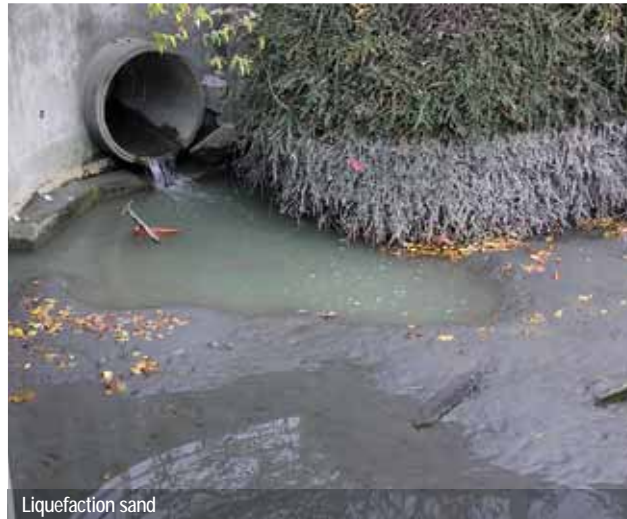
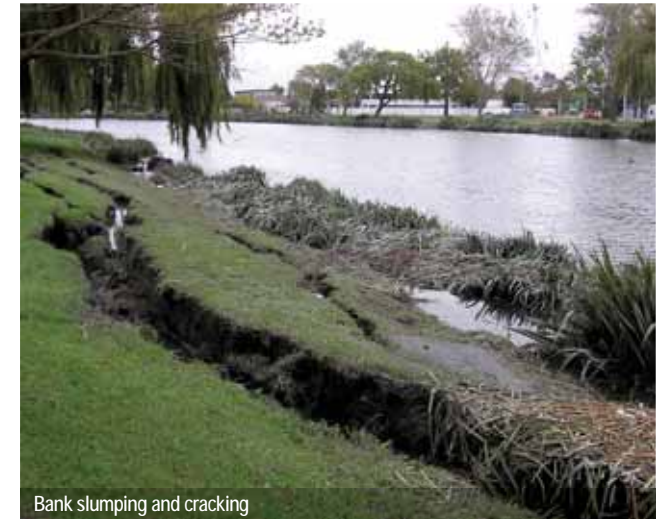
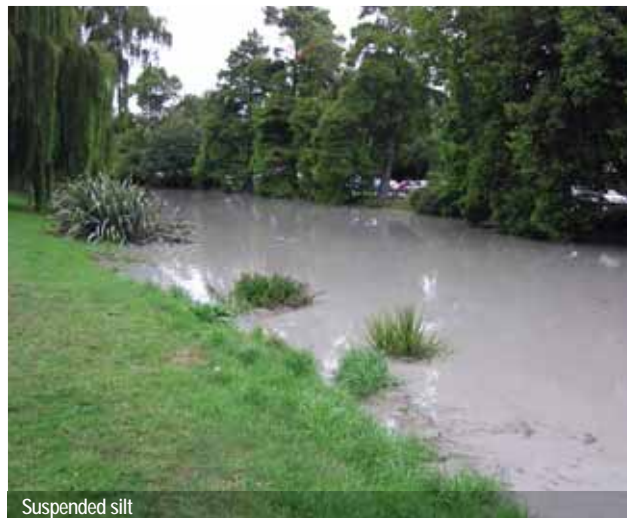
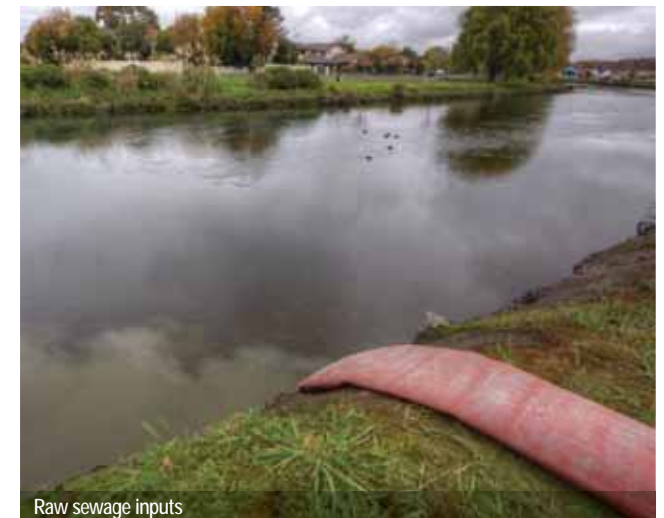
The devastation wrought by the 22 February 2011 earthquake extended to Christchurch's waterways. Large amounts of sediment were released that smothered the aquatic plants and riverbed which is habitat for many aquatic animals (Fig. 1). In places the banks slumped and the riverbed was uplifted altering physical habitat characteristics of the river (e.g., depth, water velocities, channel width, and substrate composition). Numerous broken wastewater pipes discharged untreated sewage to rivers (Fig. 1). Such organic material input can result in a spike in oxygen-demanding bacterial activity that can deplete dissolved oxygen levels and raise ammonia levels; and in extreme situations kill aquatic life.

FIGURE 1
Some of the physical effects of the earthquake on Christchurch's waterways that has the potential to also adversely affect the fauna that live in them.

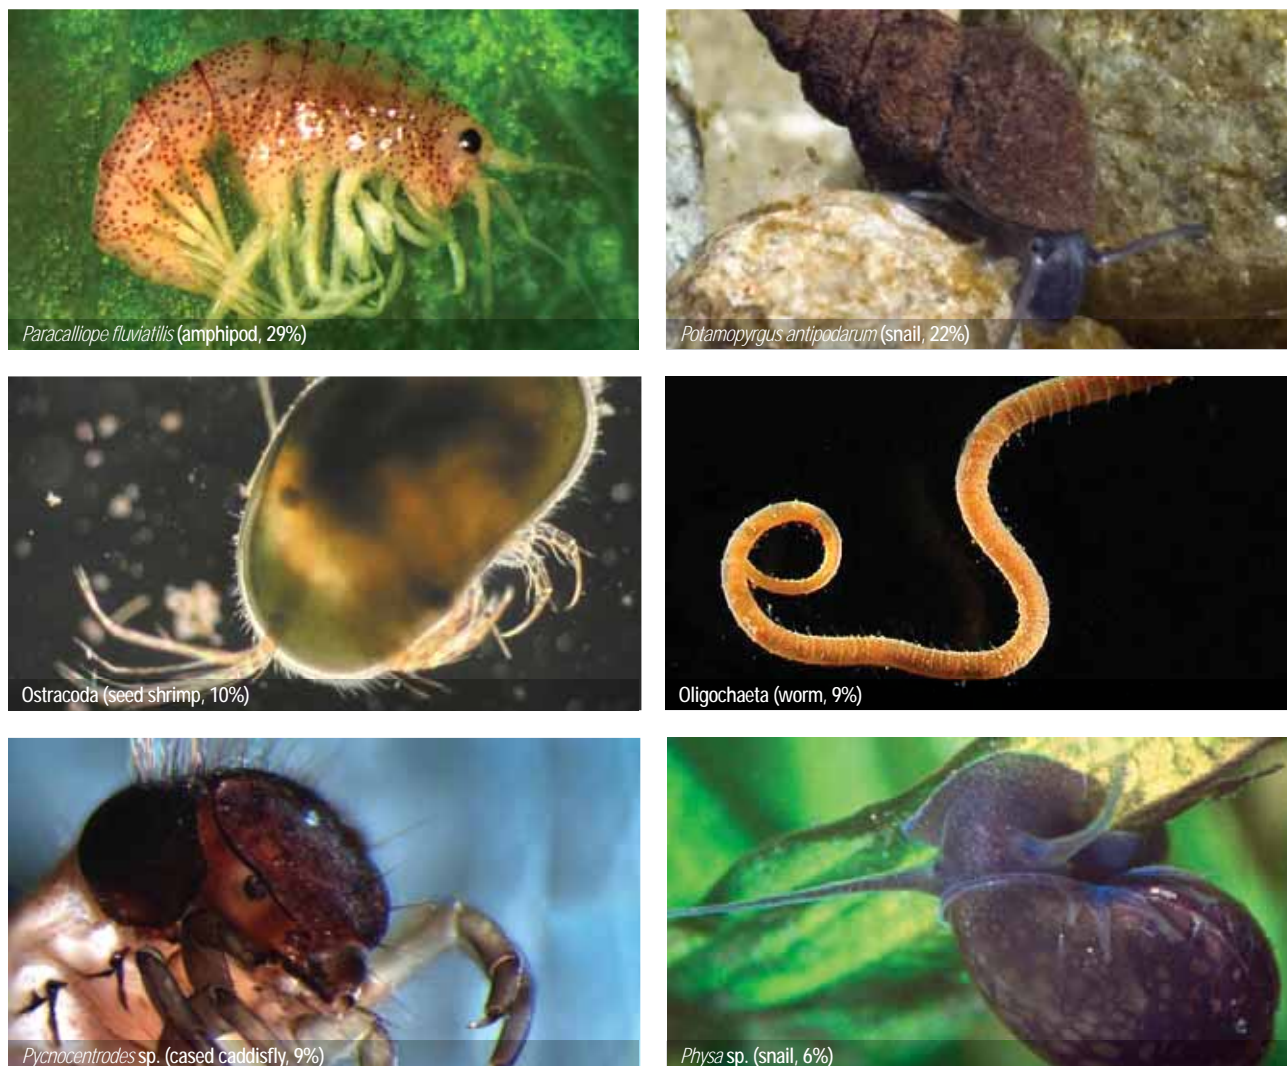
FIGURE 2

Some of the more common aquatic invertebrates in Christchurch and their relative abundance pre-earthquake (from McMurtrie, 2009). The caddisfly *Pycnocentroides* is the only pollution-sensitive taxa found in moderate abundance.

Long before the recent earthquakes, Christchurch's waterways had already been impacted by urbanisation. With development a catchment becomes more impervious to stormwater run-off, causing flashier floods and lower summer flows (Suren & Elliott, 2004). Pollutants and fine sediment accumulate in the river sediment, while the addition of buildings, bridges, culverts, and light pollution impede dispersal and influence behaviour of adult aquatic insects (Suren, 2000; Blakely *et al.*, 2006). These factors detrimentally affect the health of our waterways and make them suitable for only a subset of the aquatic invertebrates that would usually be found there. While we do not have any quantitative data on aquatic invertebrates present prior to the development of Christchurch, we do know that some species have disappeared from the more urbanised Avon and Heathcote River catchments (e.g., mayflies, stoneflies, and sensitive caddisflies). Despite this, our waterways are still home to dozens of aquatic invertebrate species. In the Avon River catchment the invertebrate fauna consists of animals that are tolerant of urban stream conditions (such as snails, worms, crustaceans, and midge larvae), although a few caddisfly taxa still persist (Fig. 2).

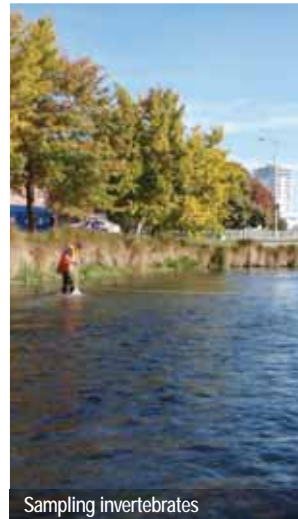
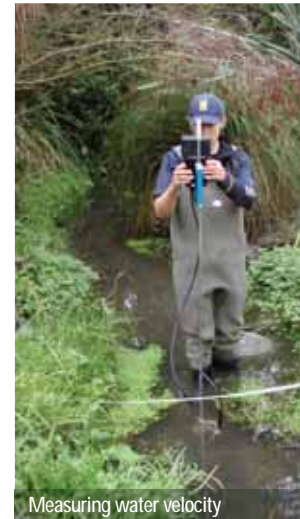
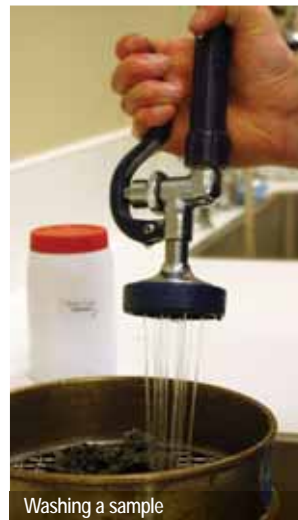
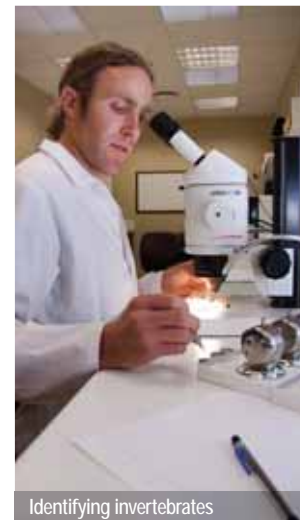
FIGURE 3: METHODS PHOTOS

Aquatic benthic invertebrates were collected at each transect by disturbing the substrate across an approximate 1.5 m width immediately upstream of a conventional 500 µm mesh kicknet (Fig. 3). Samples were preserved in isopropyl alcohol. All invertebrates were counted and identified to the lowest practical level using a binocular microscope and several identification keys (Fig. 3). Sub-sampling was utilised for particularly large samples and the unsorted fraction scanned for taxa not already identified. Habitat data was also measured across each of the transects, including soft sediment depth and substrate composition.

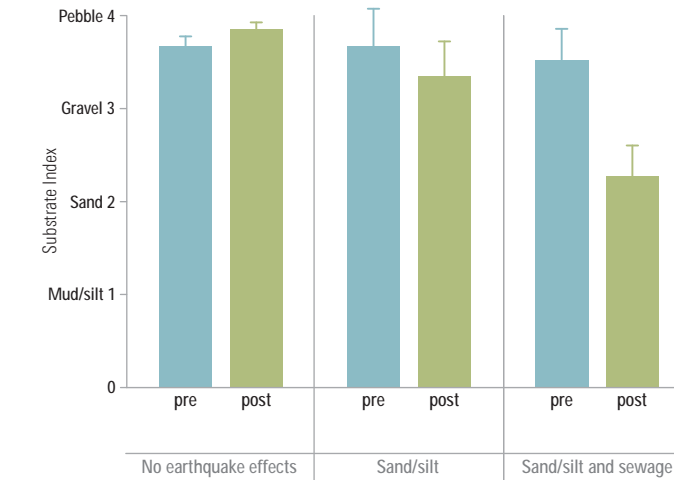
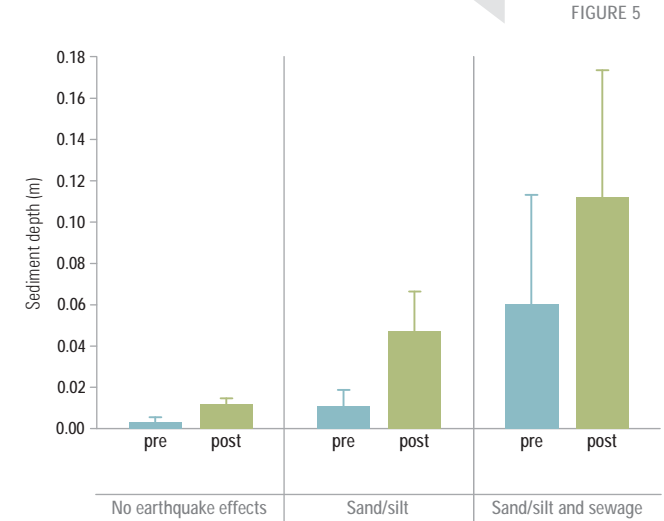
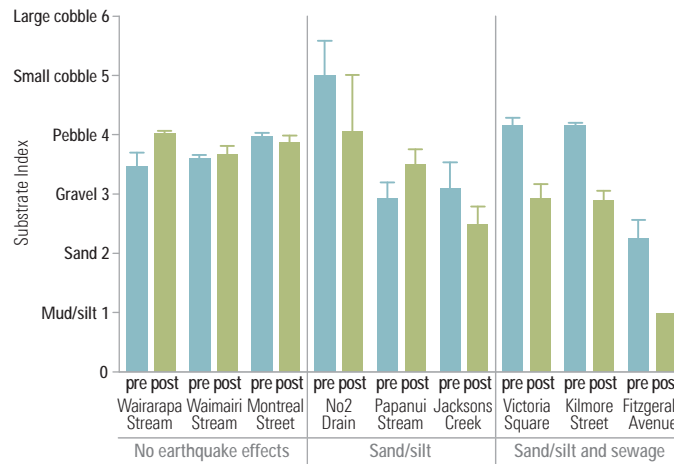
Sediment depth was greater for all three categories of impact after the earthquake but the change was greatest for the “sand/silt & sewage” sites (Fig. 5). Of all the sites Fitzgerald Ave had the thickest layer of fine sediment and lowest substrate index value before and after the earthquake. This may be explained by the depositional nature of this site, which is slightly tidally influenced and so has slower water velocity during high tide. The smallest increase in sediment depth and change in substrate index was observed at the “no earthquake effect” sites (Fig. 5). Substrate index decreased at all the “sand/silt & sewage” sites after the earthquake but the response was more variable at the “sand/silt” sites; although there was still an average decrease in substrate size at these sites (Fig. 5). The small increases in fine sediment depth at one “no earthquake effect” site (Montreal St), all three “sand/silt” sites (No. 2 Drain, Papanui Stm, & Jacksons Ck), and the two other “sand/silt & sewage” sites (Victoria Sq & Kilmore St) may be enough to smother some of the interstitial space of cobbled areas of the streambed and potentially affect the populations of some invertebrates sensitive to fine sediment (e.g., some caddisfly taxa) if they are present.

FIGURE 5
Sediment depth and substrate index grouped for each earthquake impact category (top) and for each individual site (bottom) before (pre) and after (post) the 22 February 2011 earthquake..

The substrate index is a method of converting substratum size measurements of a site to a single value. Derived values for the substrate index range from 1 (i.e., a substrate of 100% silt) to 7 (i.e., a substrate of 100% boulder); the larger the index, the coarser the overall substrate.

Sediment depth refers to the depth to which a 3 cm diameter pole can be pushed into the substratum with minimal resistance. Typically it is greatest in silt-bottomed streams and least in stony streams where measurements can be 0. It is of interest as fine sediment can smother larger substrates leading to a reduction in habitat quality.

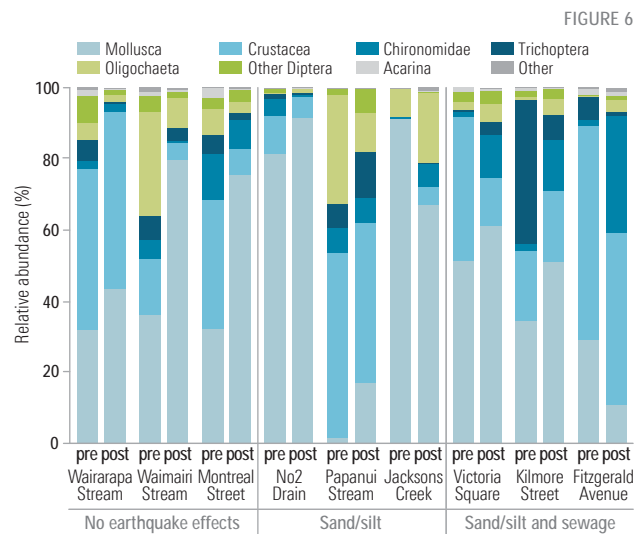
FIGURE 6.

Relative contributions of higher-level taxonomic groupings to the total invertebrate community. Relative abundance graphs can show if there are shifts in the relative numbers of major taxonomic groups in response to some disturbance.

Some before-after earthquake shifts in community composition were observed, such as an increase in relative abundance of snails (Mollusca) post-earthquake at some sites not affected by the earthquake (Waimairi Stm & Montreal St), and a decrease in worms (Oligochaeta) post-earthquake at Papanui Stm that was affected by liquefaction (Fig. 6). At the three sites affected by sewage (Victoria Sq, Kilmore St, & Fitzgerald Ave) there was a post-earthquake increase in midges (Chironomidae) at the expense of snails (Mollusca) or crustaceans (Crustacea). Of note is the vast reduction in caddisflies (Trichoptera) post-earthquake at Kilmore St (dropping from 40% to less than 10%); the only site where caddisflies contributed a sizeable portion of the invertebrate community prior to the earthquake (Fig. 6).

The relative abundance of aquatic invertebrate faunal groupings before and after the 22 February 2011 earthquake.

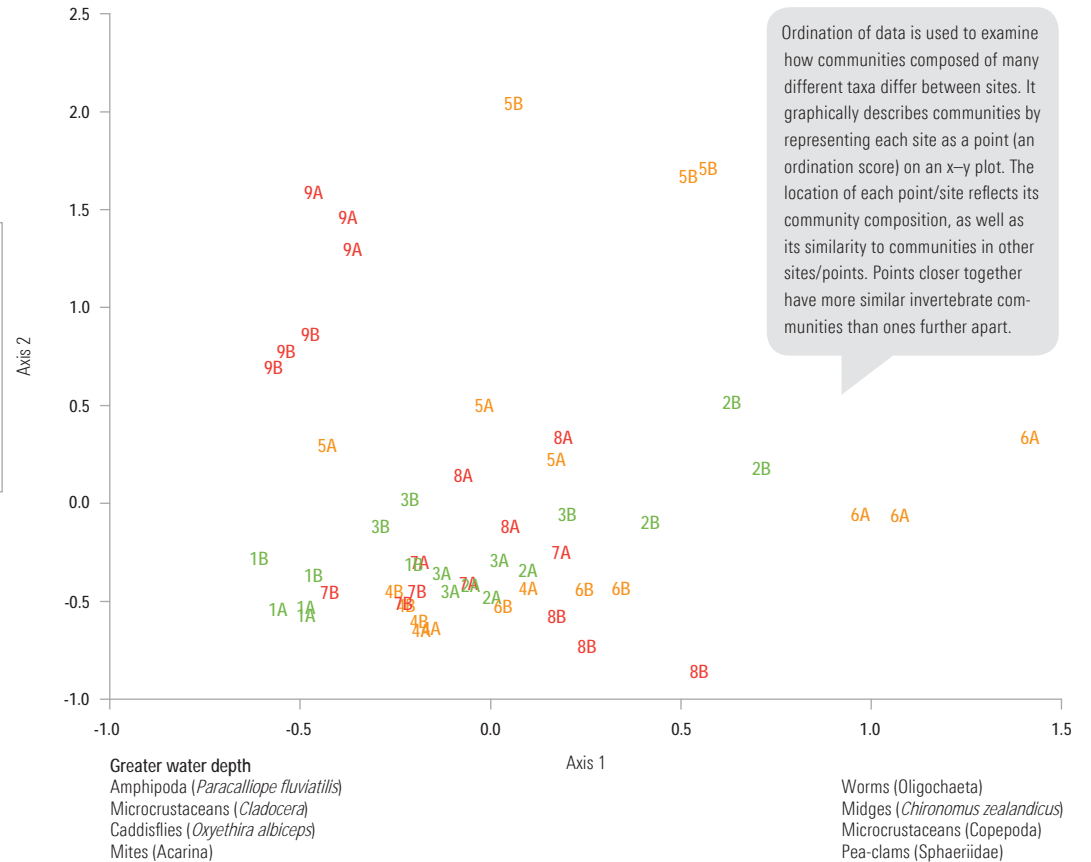
FIGURE 8

Ordination of invertebrate community data showed that the “no earthquake effect” sites (Wairarapa Stm, Wairarapa Stm, & Montreal St) had invertebrate communities that clustered relatively closely together and did not change to any great extent after the earthquake (Fig. 8). These sites were characterised by having a coarse substratum, snails, amphipods, caddisflies, and mites.

Of the three sites that received sand/silt inputs (but no sewage) the invertebrate community of one (No. 2 Drain) was unchanged, while those of the other two (Papanui Stm & Jacksons Ck) displayed a distinct before-after earthquake separation in ordination space (Fig. 8). Along Axis 1 the post-earthquake Jackson Ck samples were distinct from all others and associated with worms, midge larvae, copepod microcrustaceans, and pea-calms. These are taxa that often are found in or on fine sediment, thus it would appear sediment inputs at this site may have shifted the community. Pre-earthquake samples from Papanui Stm were distinct and characterised by ostracod microcrustaceans (Fig. 8). After the earthquake the Papanui Stm samples had a higher abundance of amphipods which appeared to be at the expense of ostracods.

The sites that received sand/silt and sewage inputs (Victoria Sq, Kilmore St, & Fitzgerald Ave) displayed less community separation compared to the liquefaction affected sites (Papanui Stm & Jacksons Ck) (Fig. 8). Of these three sites Kilmore St and Fitzgerald Ave showed a greater community shift than Victoria Sq. The Fitzgerald Ave samples before and after the earthquake were distinct from the others along Axis 2 and characterised by midge larvae, ostracod microcrustaceans, and greater fine sediment depth.

FIGURE 8. Non-metric multidimensional scaling (NMS) ordination of invertebrate community data before (A) and after (B) the 22 February 2011 earthquake. Invertebrate taxa and habitat variables correlated with the axes are shown.

Community shifts at the “sand/silt” impact sites (as shown by the ordination graph) were most dramatic at Jacksons Ck and Papanui Stm, and may have been the result of liquefaction inputs. There was still clear evidence of liquefaction almost two months after the earthquake and it is probable this was the remnants of greater quantities of lique-

faction that had since been eroded or cleared away. A much greater area of the beds at these sites may have been smothered immediately after the earthquake leading to the community changes seen.

- » Removal of liquefaction deposits from Jacksons Creek and Papanui Stm where practicable. Such deposits will affect downstream habitats through the transport of fine sediment. If required, the stony bed of some areas may need to be reinstated by adding appropriately sized coarse substrate.

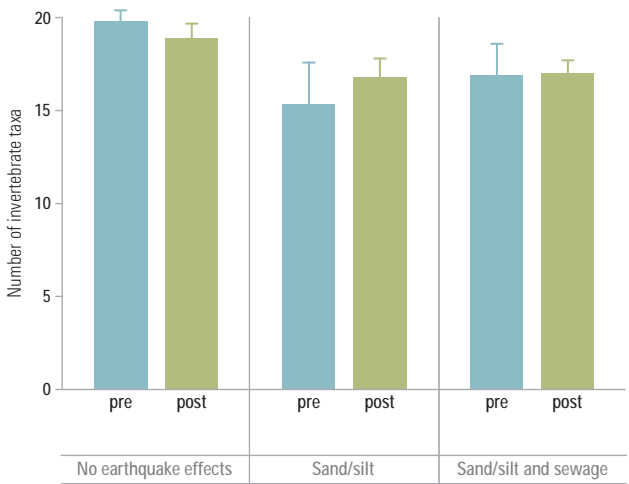
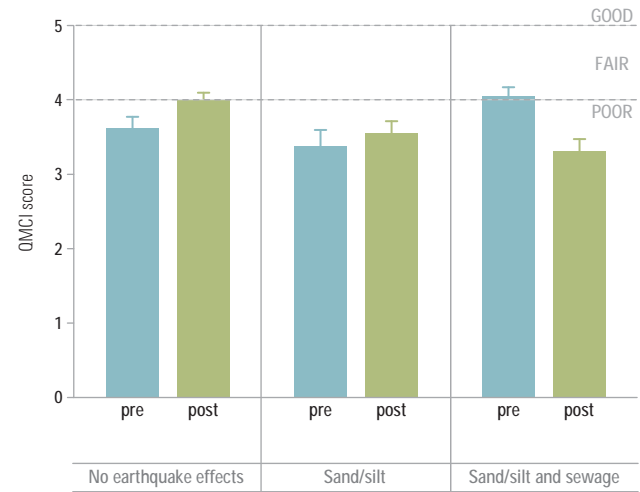
FIGURE 9

Taxa richness remained similar before and after the earthquake for all impact categories (Fig. 9). For QMCI the “no earthquake effect” sites improved slightly after the earthquake, while the “sand/silt & sewage” sites decreased from the “fair” water quality category to the poor water quality category after the earthquake (Fig. 9). Pollution sensitive EPT taxa only comprised a significant component of the invertebrate community (i.e., greater than 10%) in the “sand/silt & sewage” sites, with this primarily being at the

Kilmore St site where approximately 40% of the invertebrates were EPT taxa (mostly the cased caddisfly *Pycnocentodes* sp.). After the earthquake the %EPT declined to around 10% at this site indicating a possible earthquake effect from either sand/silt deposition and/or sewage (Fig. 9).

The number of taxa at a site refers to the number of different animals captured. A large decrease (or increase) in taxa as a result of some disturbance may indicate an effect. However, small differences often are a result of rare taxa being missed during sampling, rather than changes in the core taxa that make up most of the community at a site.

The Quantitative Macroinvertebrate Community Index (QMCI) is a metric derived from a pollution-tolerance score that has been assigned to all the commonly encountered aquatic invertebrates in New Zealand (Stark & Maxted, 2007). It gives an indication of organic pollution and is often used as a proxy for water quality. Higher scores indicate higher water quality (i.e., a community with a greater abundance of invertebrates that are sensitive to degraded water quality).

FIGURE 9. Invertebrate community metrics for each impact category before (pre) and after (post) the 22 February 2011 earthquake (means + one standard error are shown). The QMCI graph has the water quality categories of Stark & Maxted (2007) superimposed. For %EPT the individual site means are also shown to highlight the effect at Kilmore St.

EPT refers to the orders Ephemeroptera (mayflies), Plecoptera (stoneflies), and Trichoptera (caddisflies). Invertebrates from these orders are considered to be sensitive to pollution. Thus a higher percentage abundance of EPT invertebrates is a good indication of better water and habitat quality. The exception is the Hydroptilidae family of caddisflies (purse caddisflies) that thrive in high nutrient and algae conditions, and thus they are excluded from the %EPT calculation.

- » Monitoring of the caddisfly (*Pycnocentroides* sp.) population at the Kilmore St site to determine if the decline observed persists and if so, investigate the possibility of reintroducing them from other parts of the catchment or the nearby Otukaikino River.

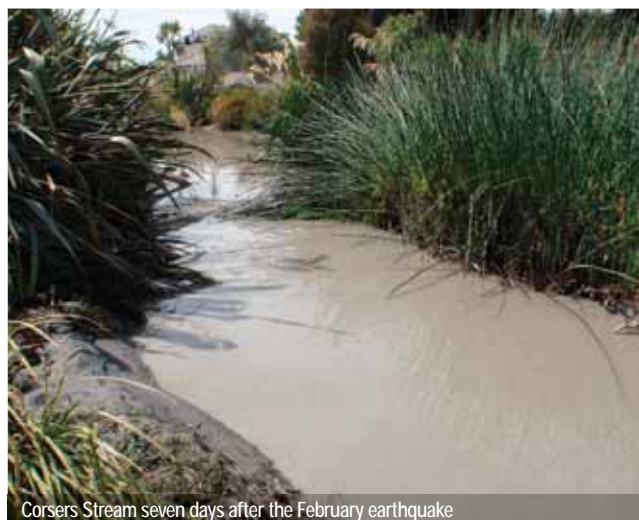
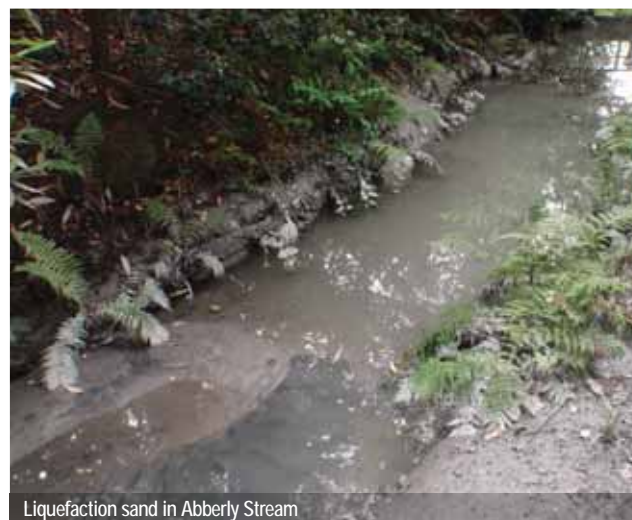
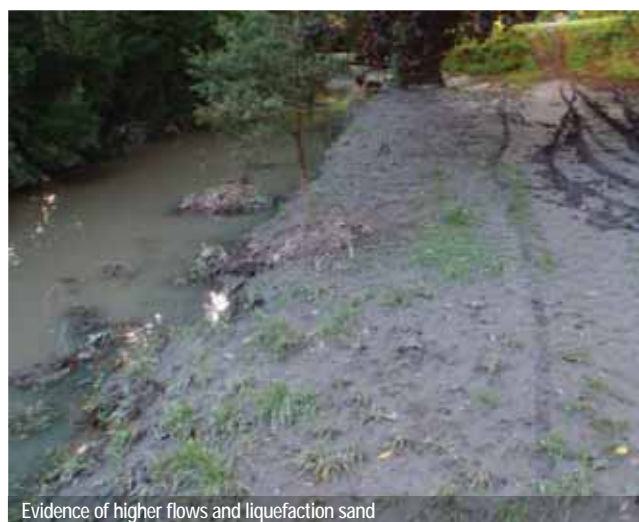
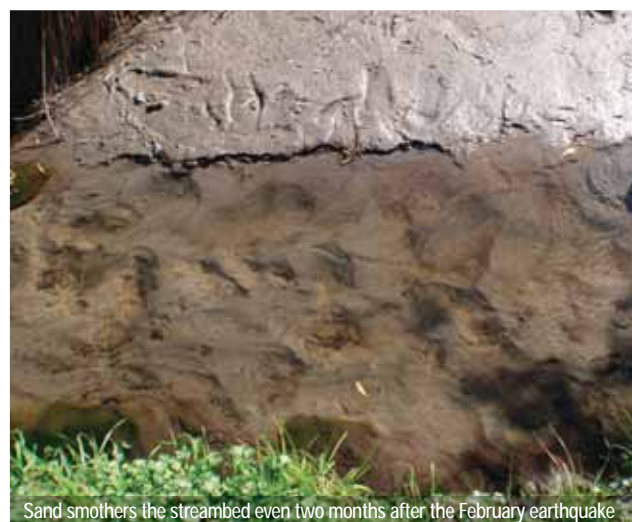
FIGURE 10

Unprecedented amounts of liquefaction sand has entered Christchurch streams following the 22 February and 13 June earthquakes. These sites were not surveyed due to lack of any 'before' biological data, but there is no doubt that the impacts to the stream biota would be severe, and without mitigation these impacts would persist. Photos courtesy of Assoc Prof Jon Harding, University of Canterbury.

In light of these observations and the latest significant earthquake, we would recommend that tributary waterways of the Avon, Heathcote, and part of the Styx River catchments be surveyed so as to plot the extent of liquefaction sand in these systems (including a rough assessment of volume). Sand and silt will then need to be removed from areas of severe or extensive liquefaction to improve the local conditions and prevent this fine sediment from being redistributed into the lower reaches of the catchment. Recovery of the aquatic biota should be monitored at key areas where liquefaction is most severe.

Options for removal of the sand and silt will vary depending on the depth and extent of the liquefaction. Mechanical removal by digger will not be without its own impacts (through the release of silt and possible bank and bed damage), although this will still be less than the impact of leaving the fine sediment in the system. There are other viable options for smaller sections of waterway, including the use of a sand wand (like a water vacuum cleaner), which should be seriously considered for use in the upper catchment.
