Akaroa Wastewater Disposal Alternative Sites Stage 2 - Geotechnical Report

Prepared for Christchurch City Council

Prepared by CH2M Beca Ltd

4 November 2016

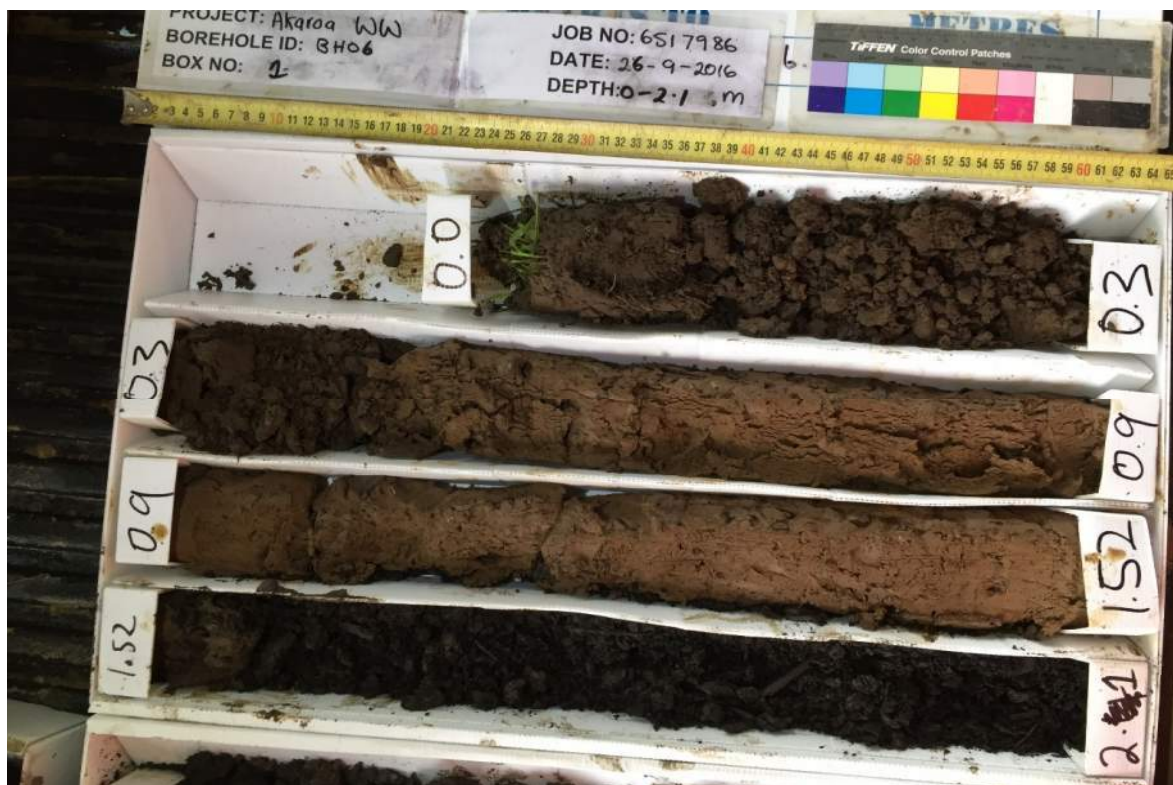
BOX: 1/3

DEPTH: 0.0 to 2.1 m

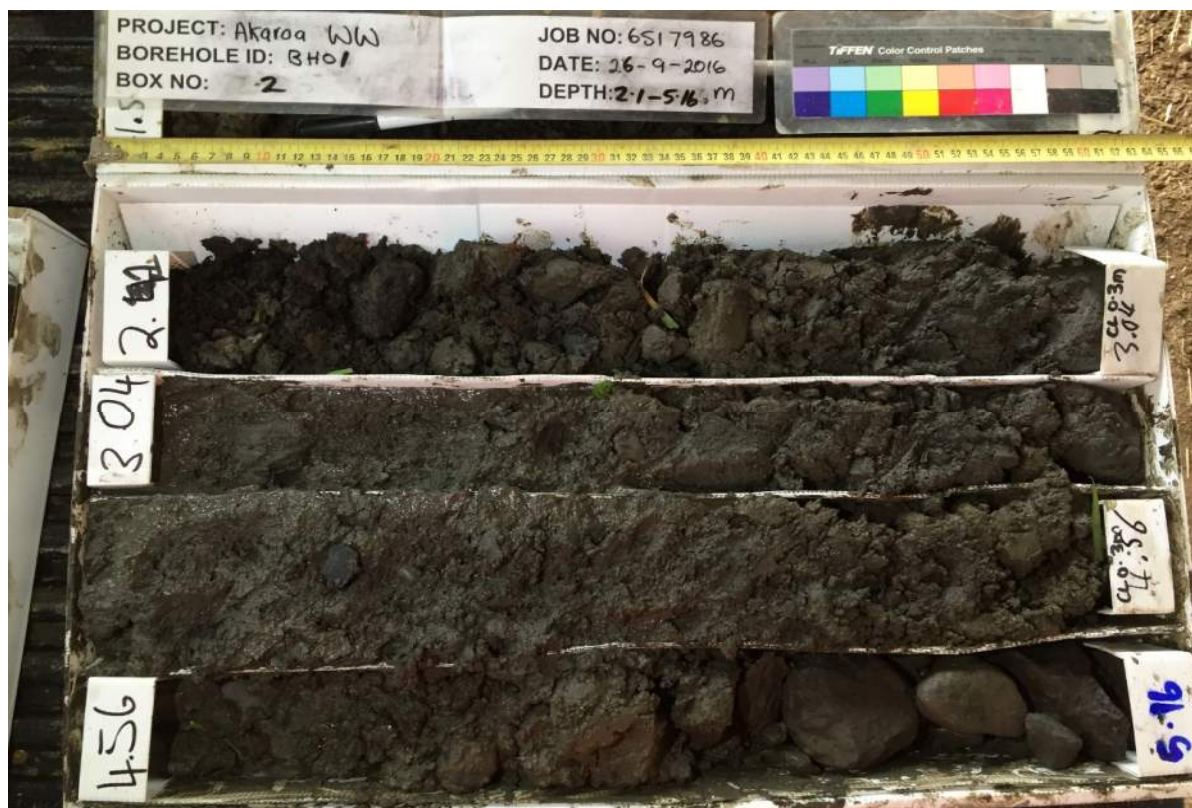
BOX: 2/3

DEPTH: 2.1 to 5.16 m

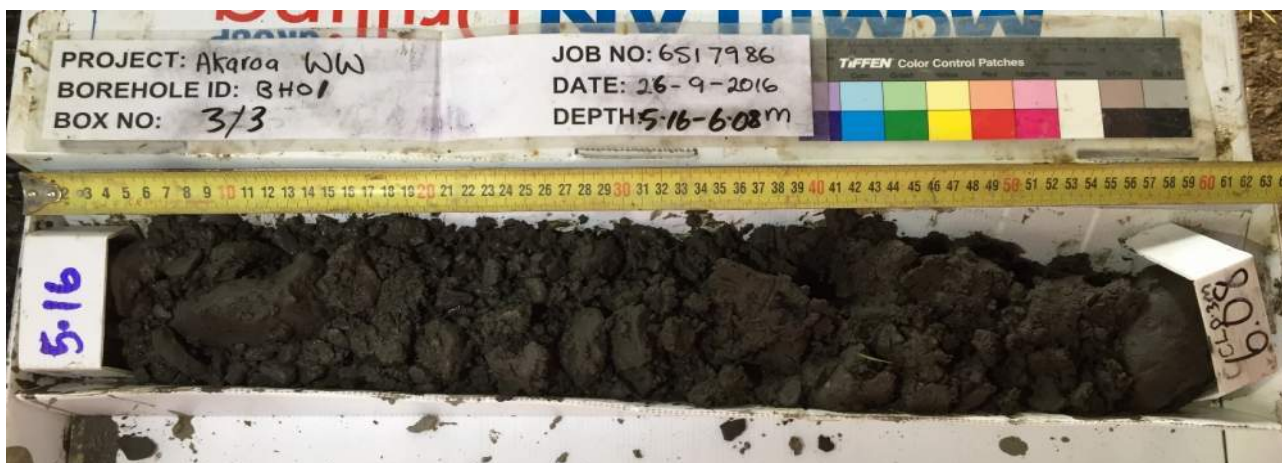
BOX: 3/3

DEPTH: 5.16 to 6.08 m

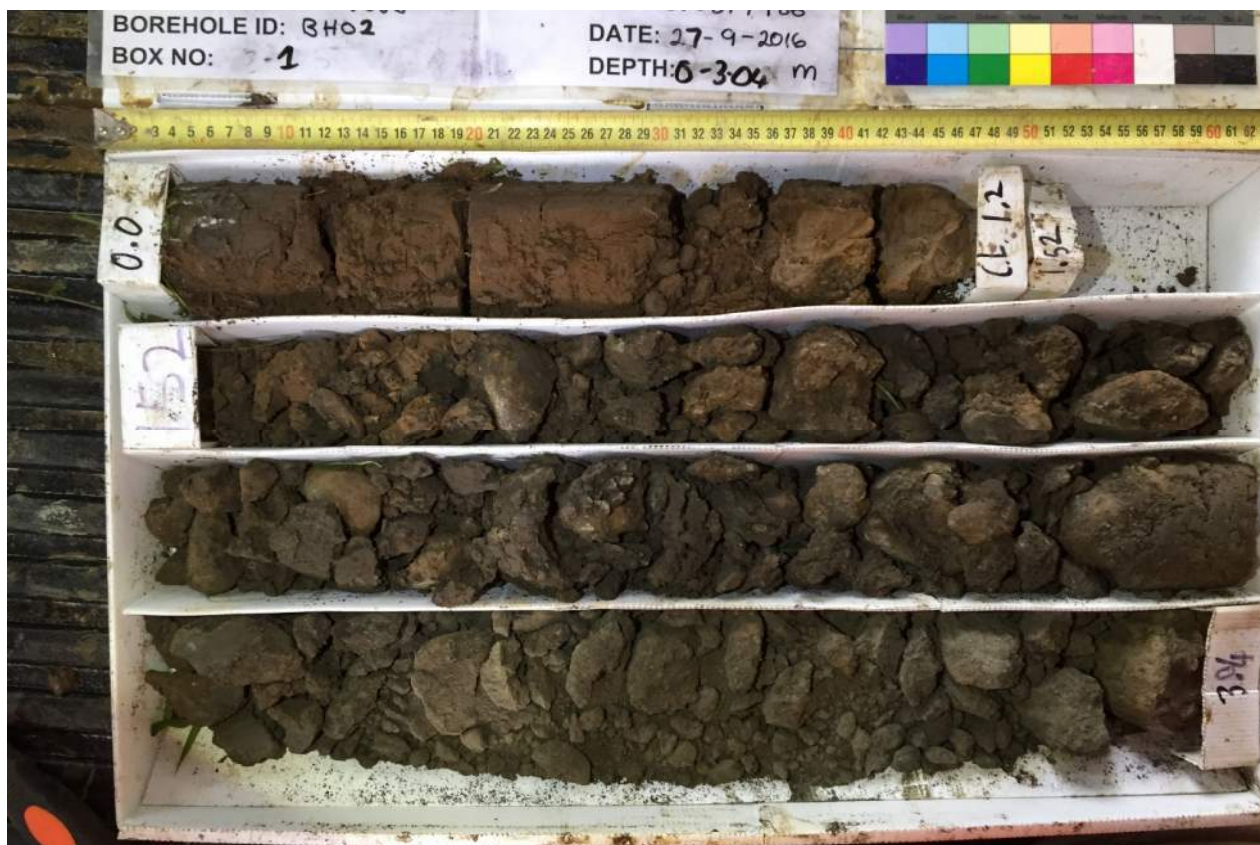
BOX: 1/3

DEPTH: 0 to 3.04 m

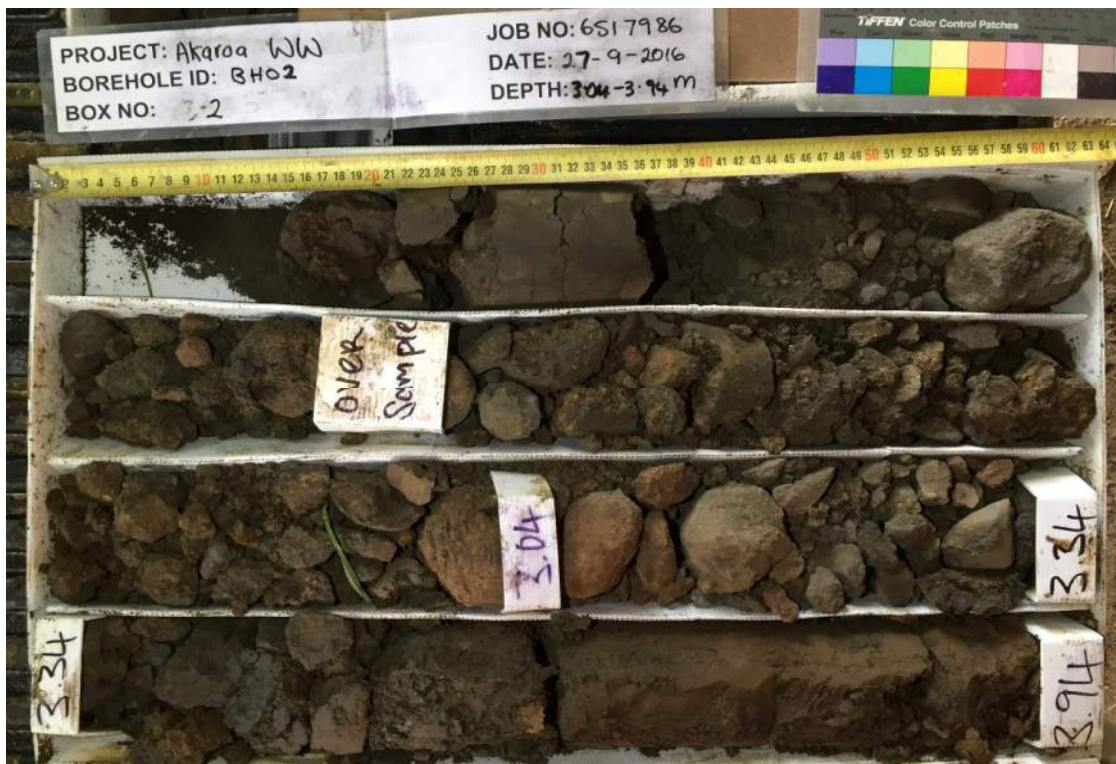
BOX: 2/3

DEPTH: 3.04 to 3.94 m

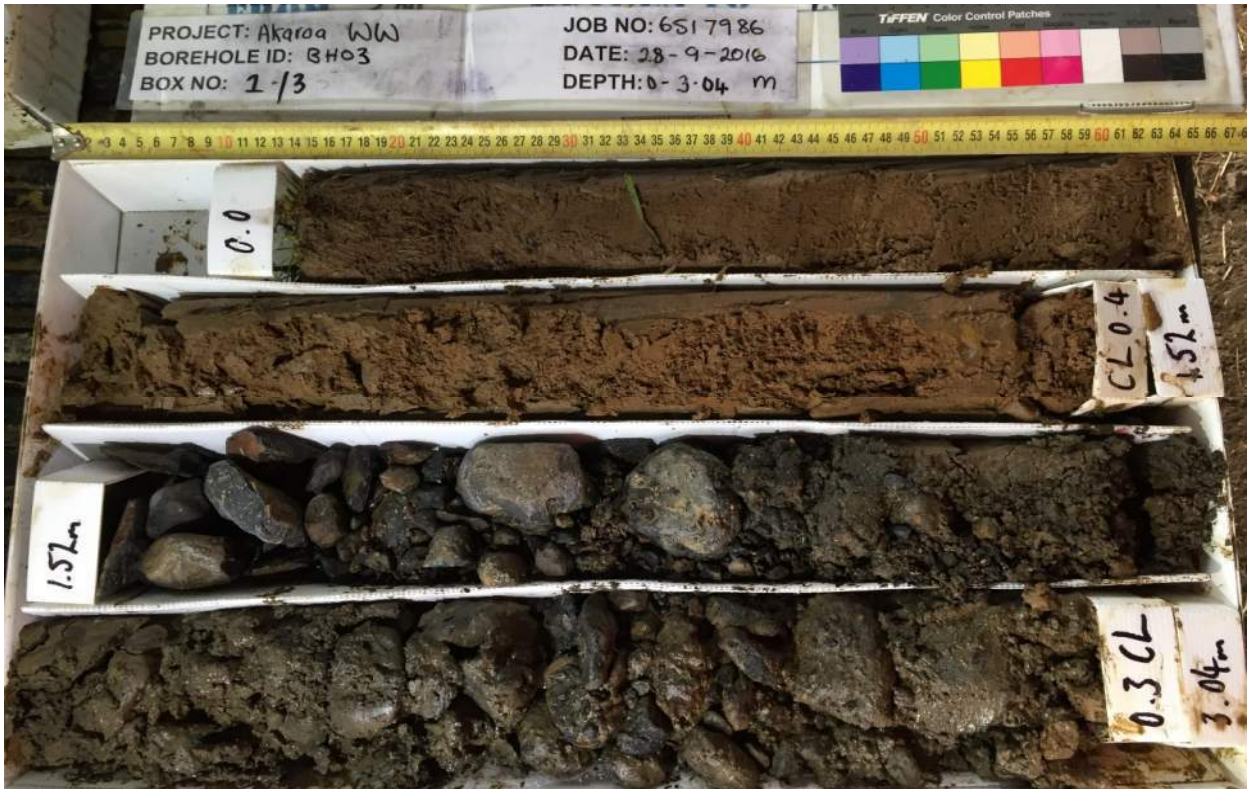
BOX: 1/3

DEPTH: 0.0 to 3.04 m

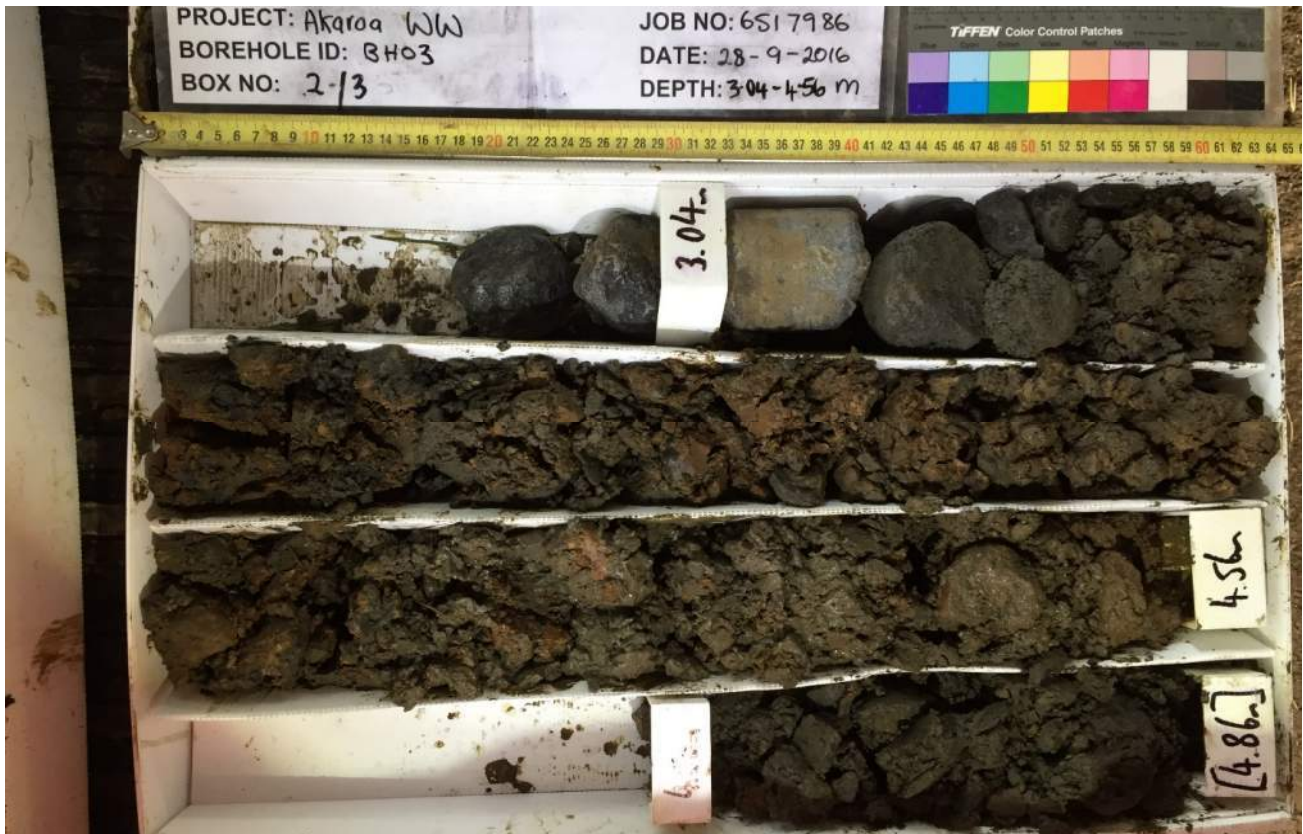
BOX: 2/3

DEPTH: 3.04 to 4.86 m

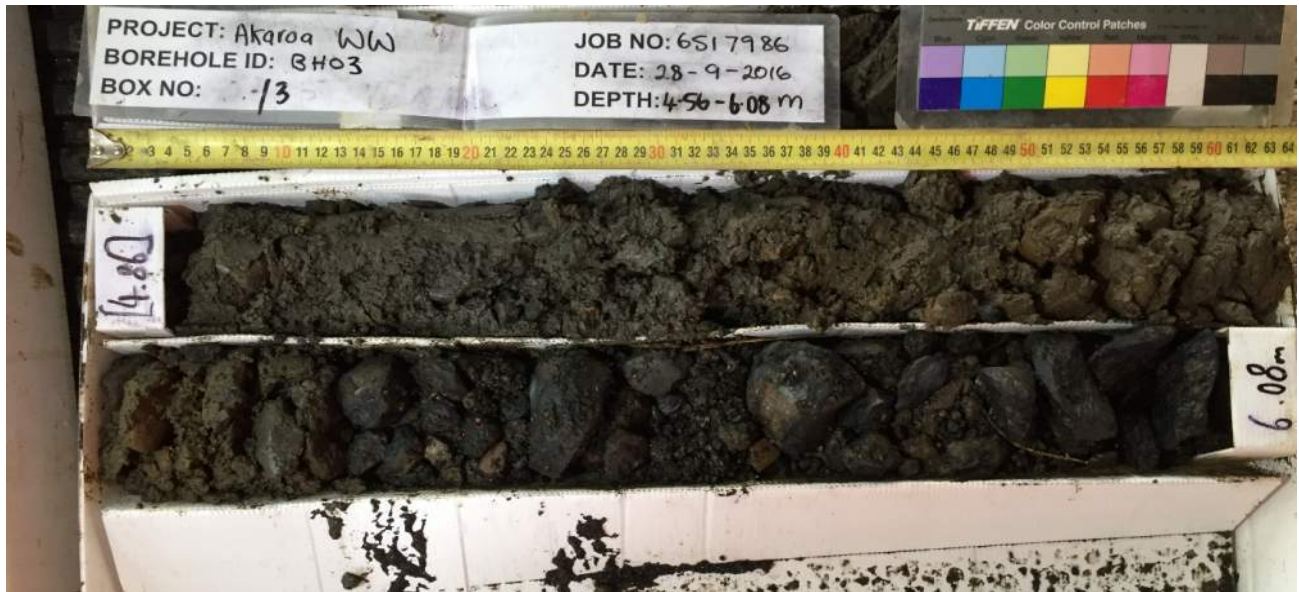
BOX: 3/3

**DEPTH: 4.56 to 6.08 m
BH3**

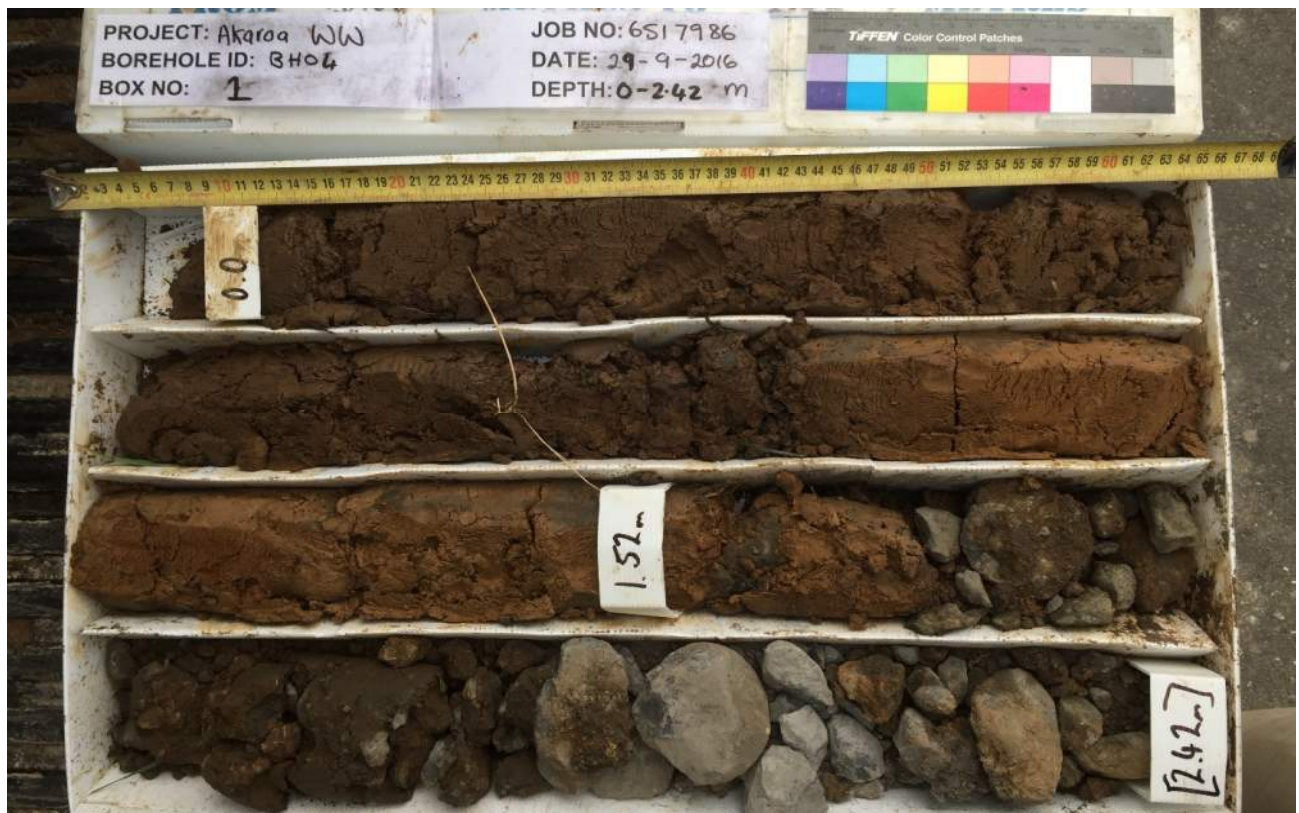
BOX: 1/2

DEPTH: 0.0 to 2.42 m

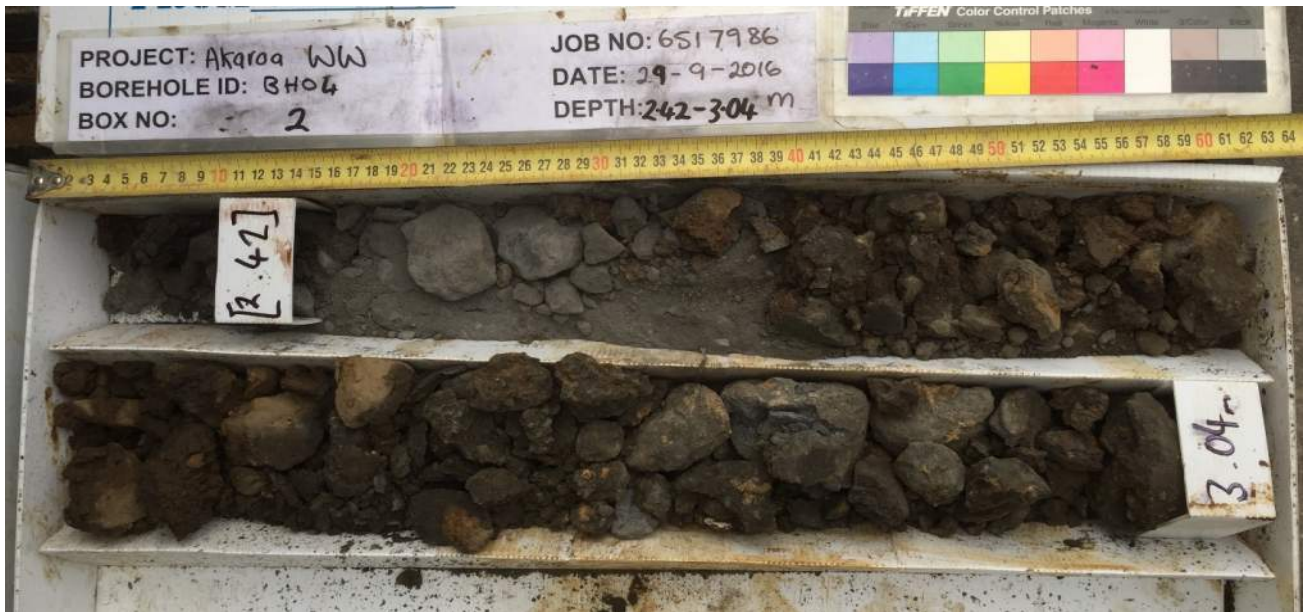
BOX: 2/2

DEPTH: 2.42 to 3.04 m

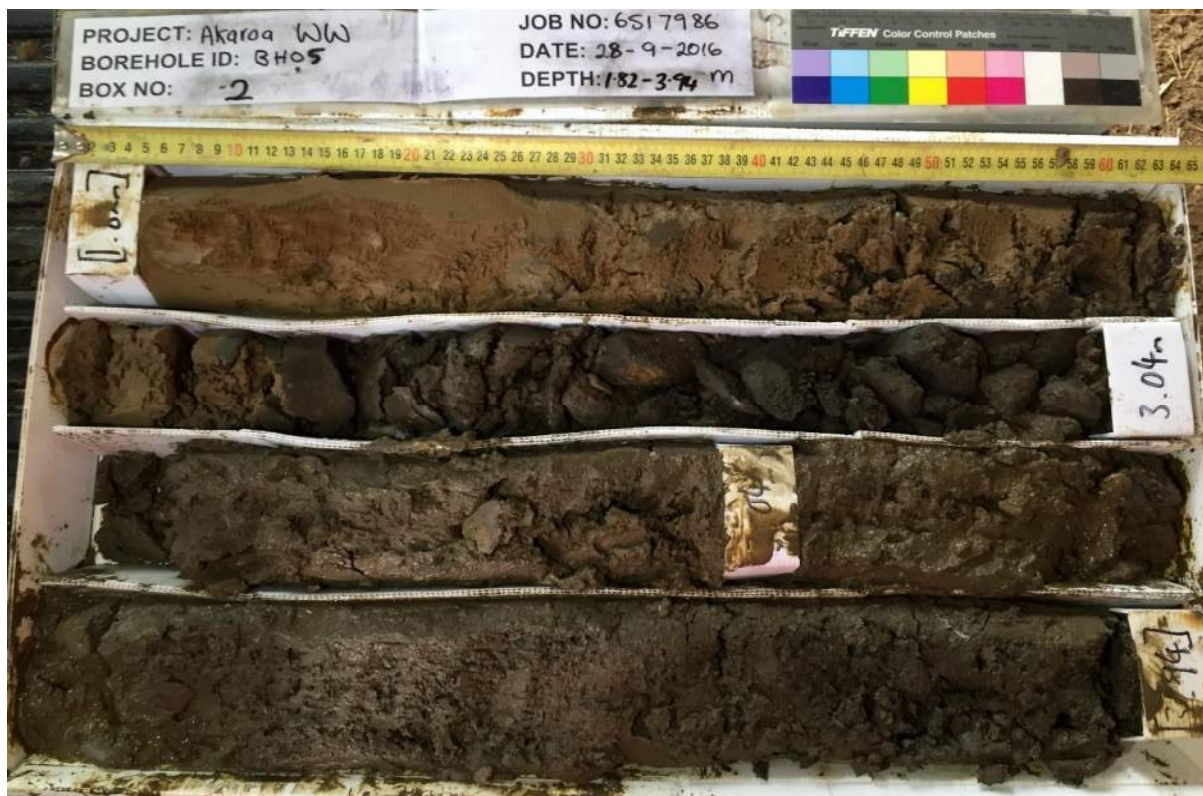
BOX: 2/3

DEPTH: 1.82 to 3.94 m

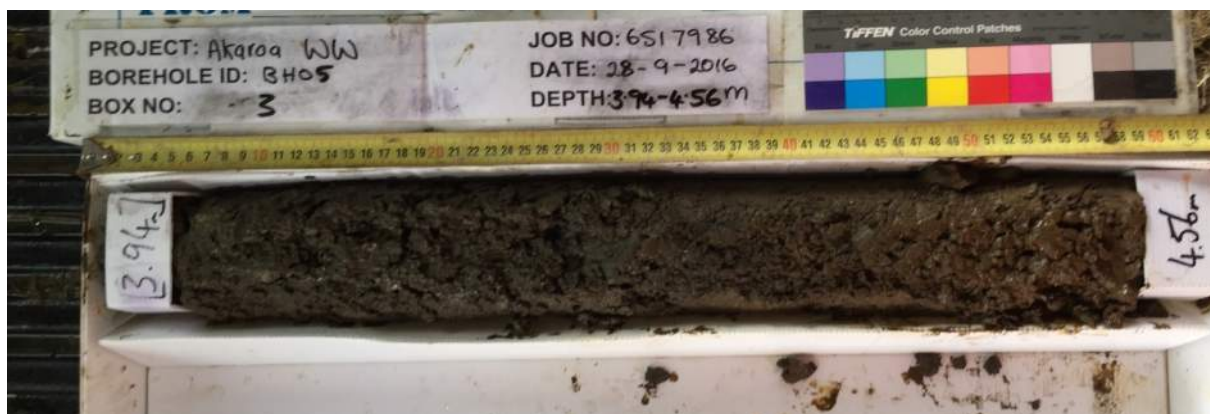
BOX: 3/3

DEPTH: 3.94 to 4.56 m

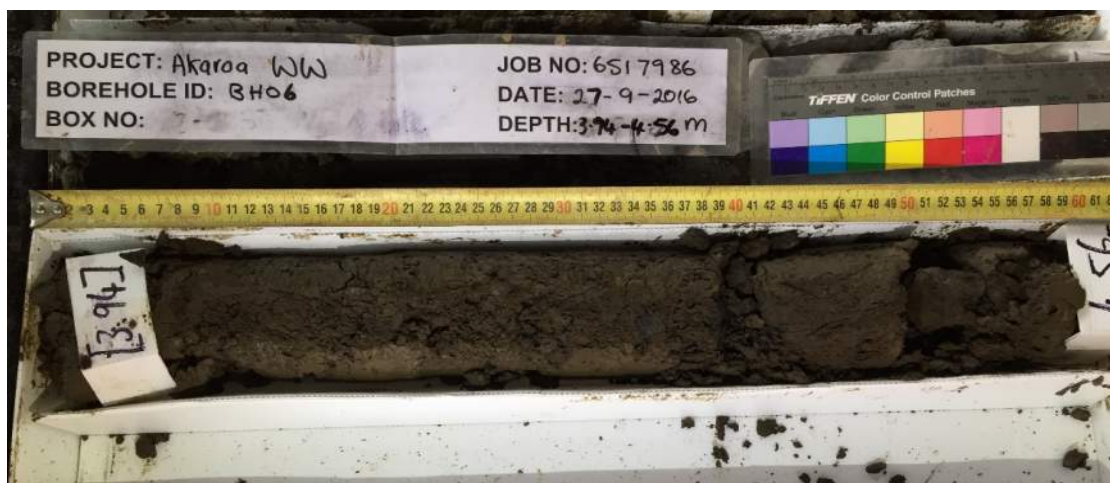
BOX: 2/2

DEPTH: 3.94 to 4.56 m

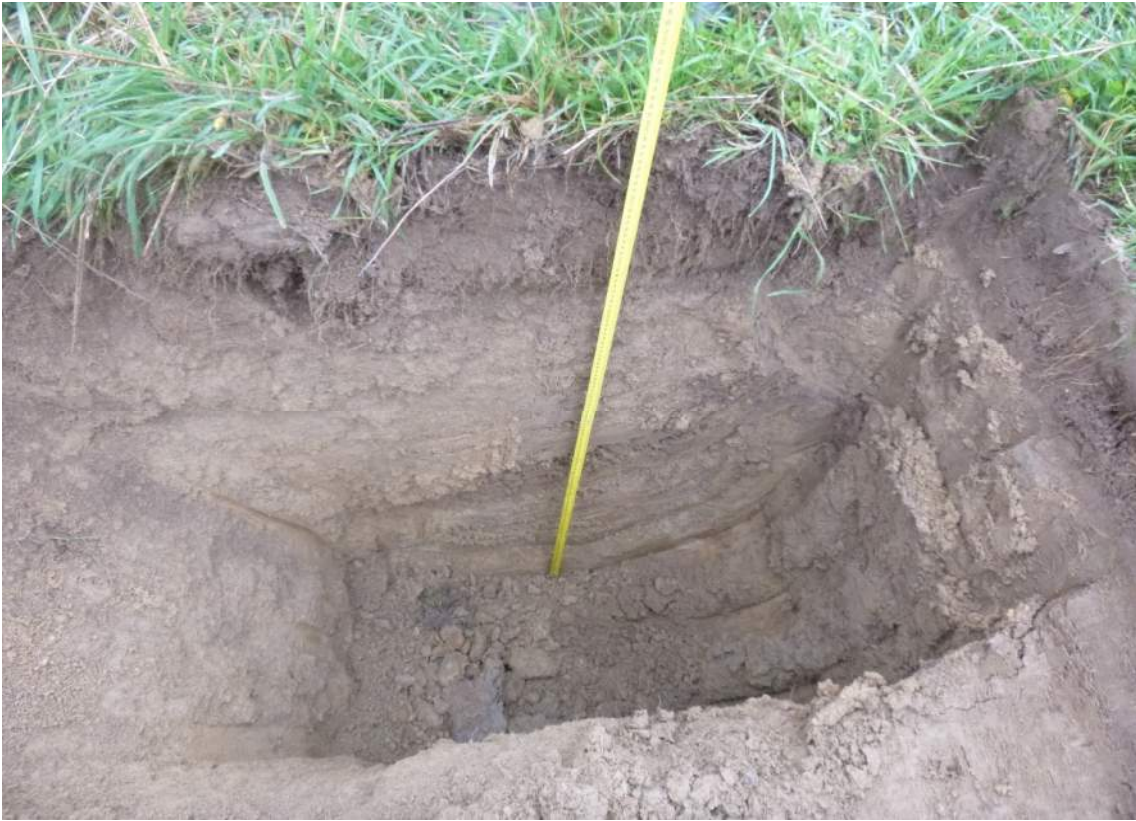
TP05

View E

DEPTH: 0.0 to 2.0 m

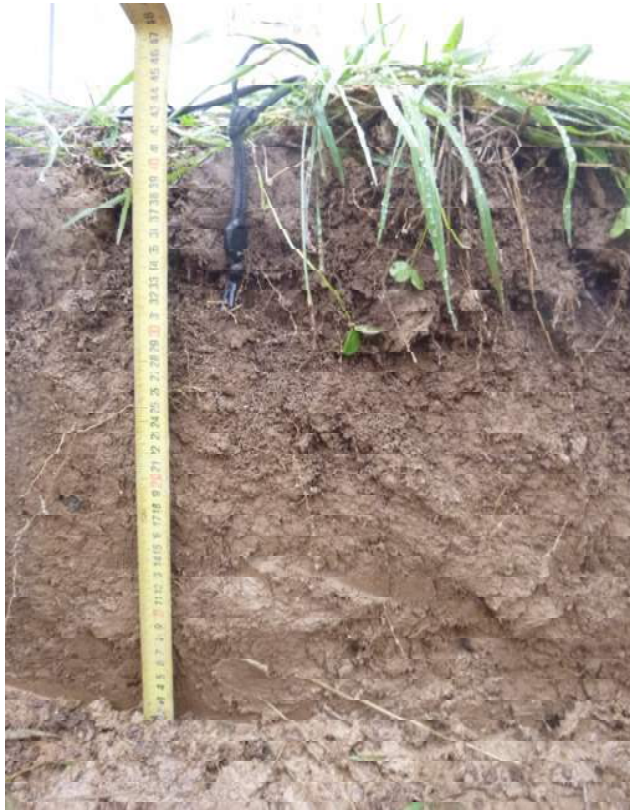
IP05 view W

DEPTH: 0.0 to 0.43 m

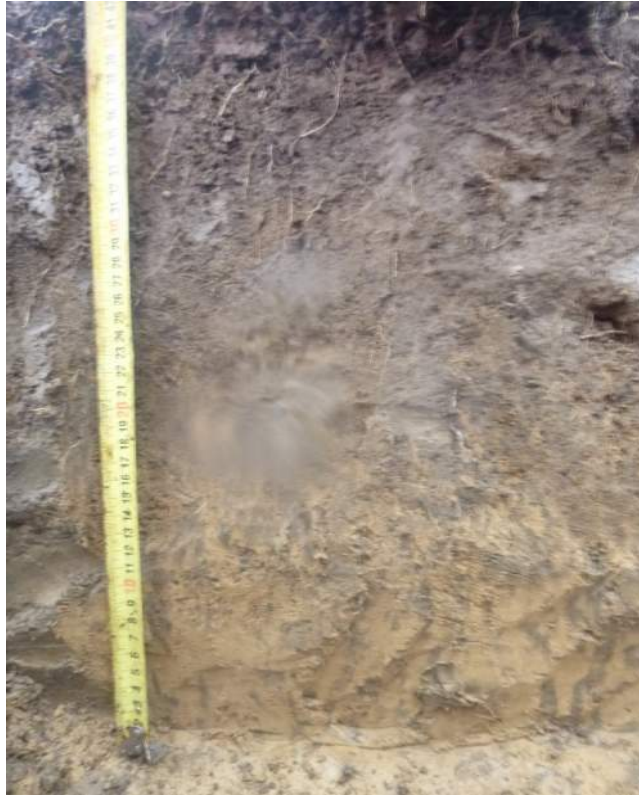
View W

DEPTH: 0.0 to 0.4 m

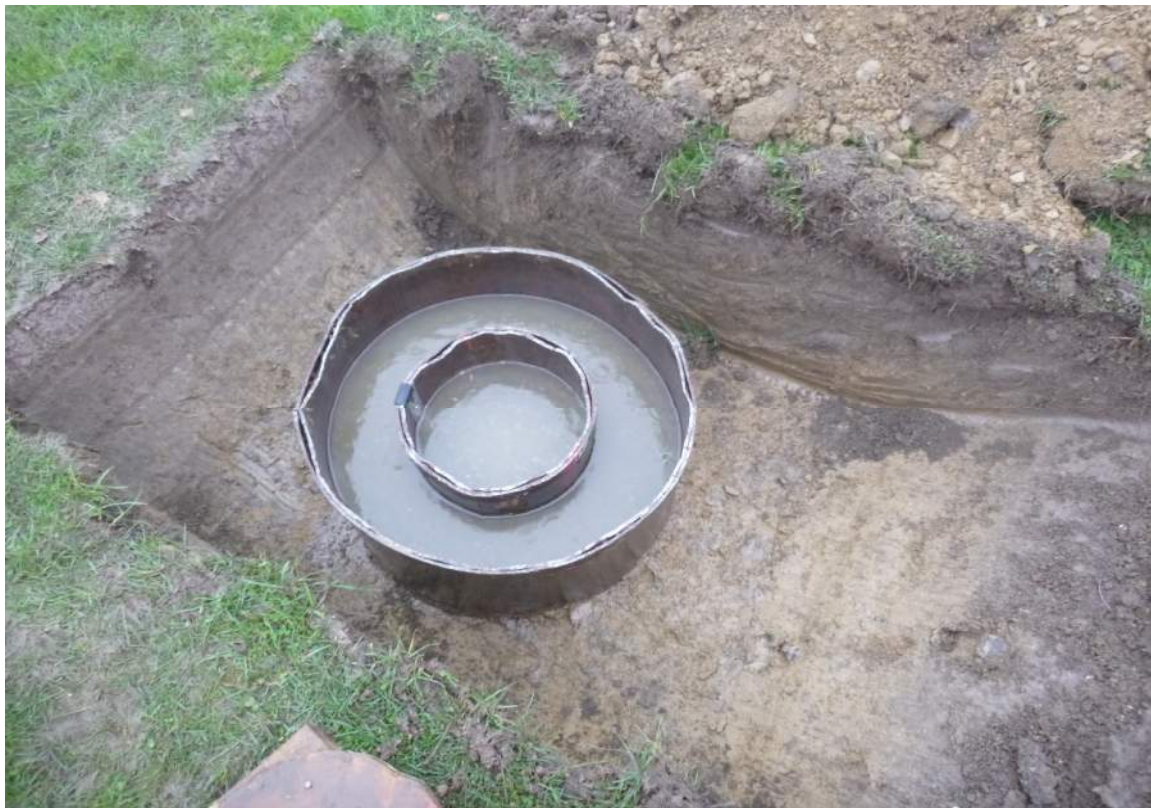
Outer ring = 800 mm

Top down view

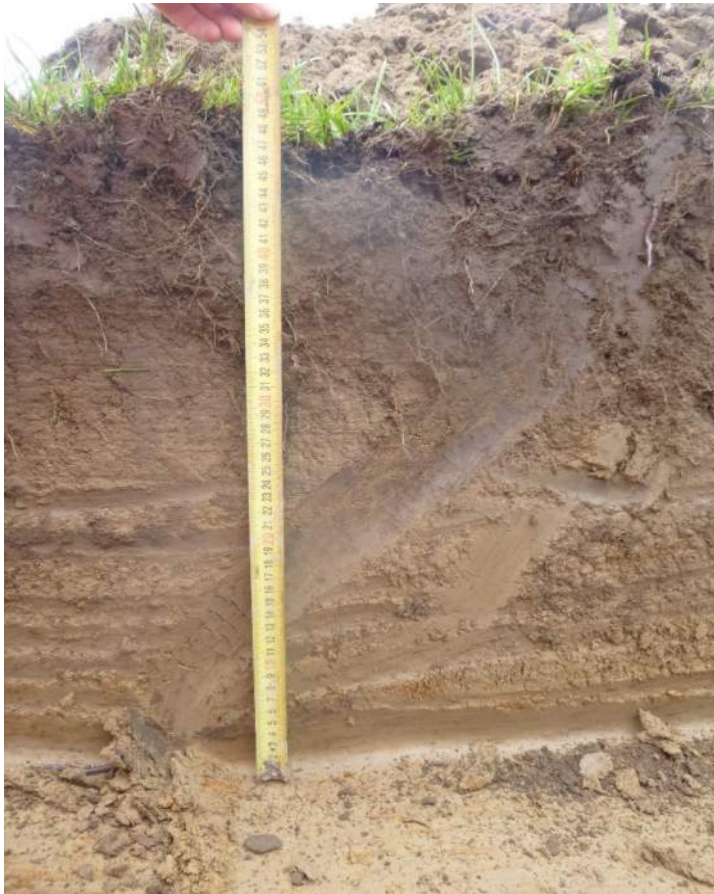
IP09

View SW

DEPTH: 0.0 to 0.48 m

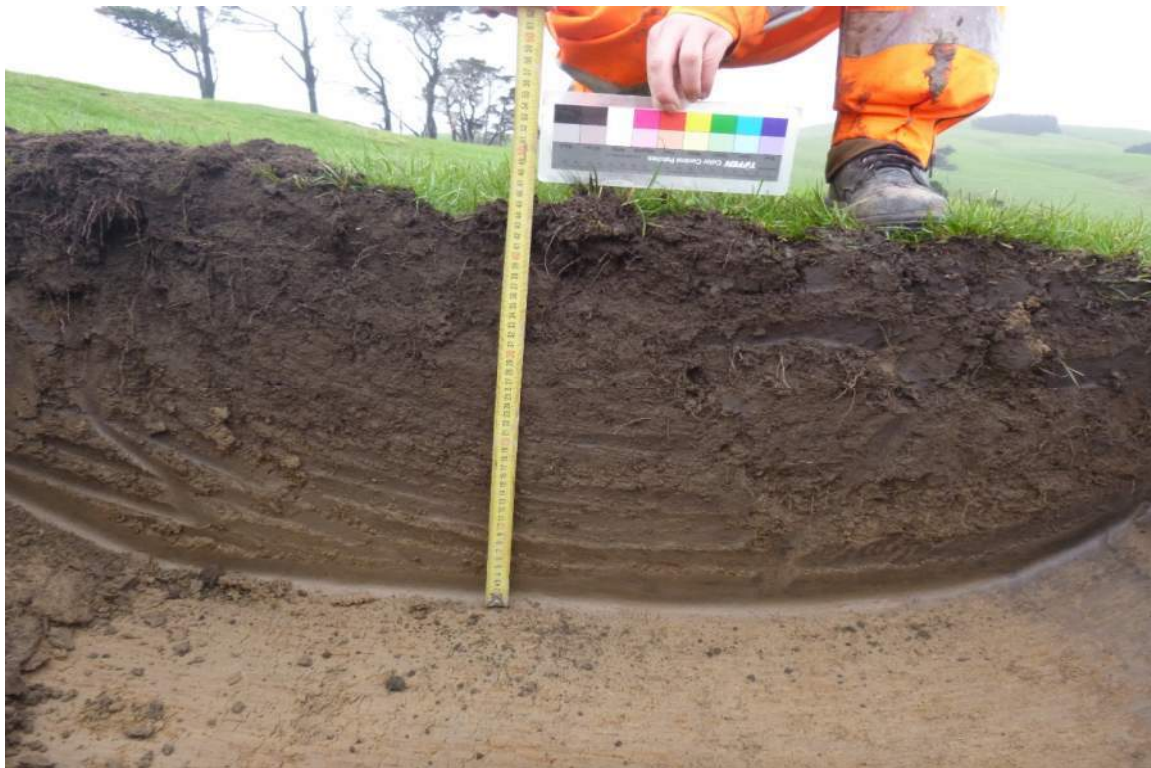
View W

DEPTH: 0.0 to 0.46 m
