Annual Report

# Akaroa Wastewater Treatment Plant

FY25 - 1 July 2024 to 30 June 2025

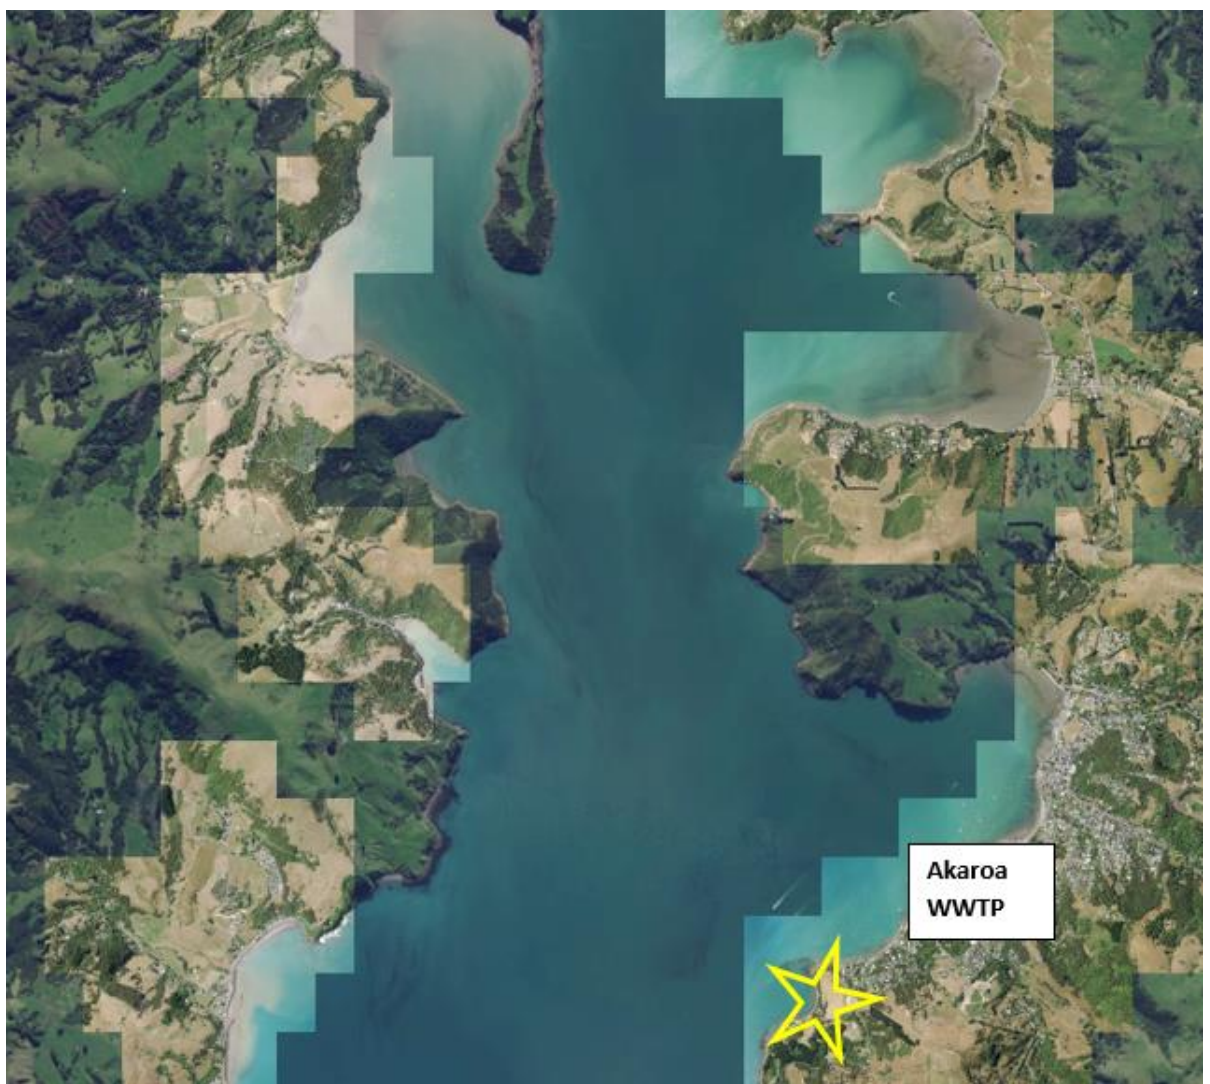
Figure 1 Akaroa WWTP Location

The WWTP is situated at Red House Bay on the east side of Akaroa Harbour as shown in Figure 1. The edge of the bay is defined by rocky outcrops that are exposed at low tide, with the northern rocky outcrop commonly referred to as Green Point (Kingett Mitchell Ltd, 2006). The WWTP outfall extends approximately 100 m offshore, to a depth approximately six to eight metres of water depending on the tidal cycle (MWH New Zealand Limited, 2006).
