NAVAL POINT/ MAGAZINE BAY, LYTTELTON: AN ARCHAEOLOGICAL ASSESSMENT

HAMISH WILLIAMS
UNDERGROUND OVERGROUND ARCHAEOLOGY LTD

JUNE 2017

UNPUBLISHED REPORT FOR CHRISTCHURCH CITY COUNCIL

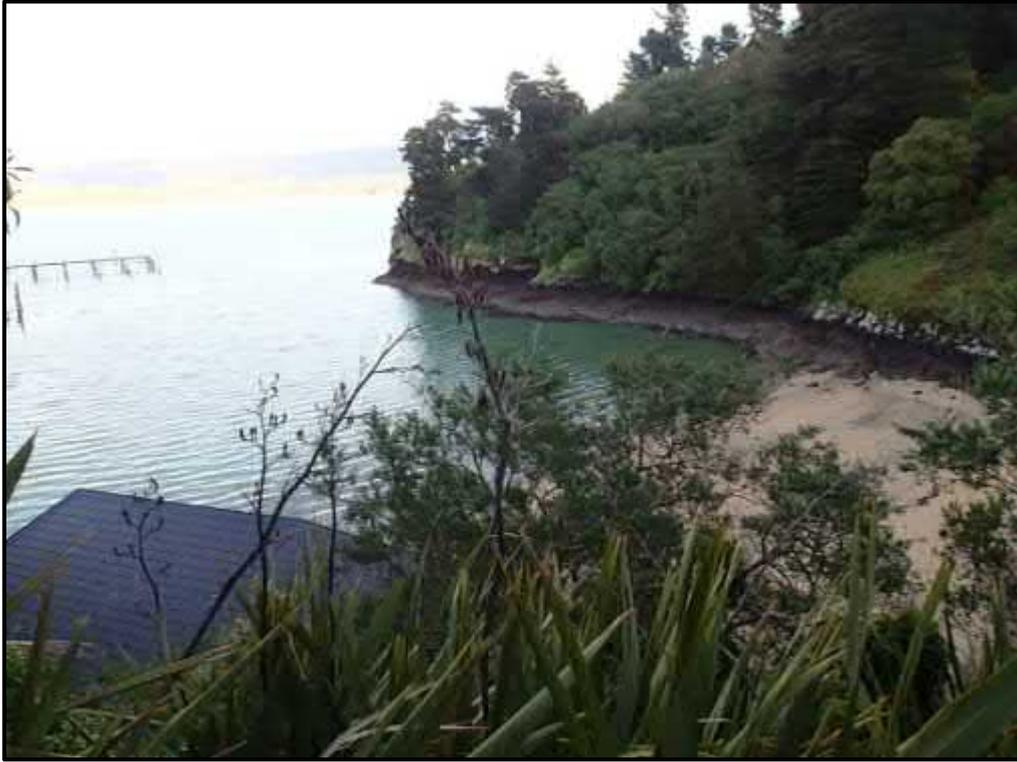
Magazine Bay lies around a small rocky point or promontory, west of the Lyttelton Marina which is known as Naval Point (also sometimes referred to as Erskine Point) and is in close proximity to the Naval Point Yacht Club (Figure 3). Fringed by volcanic bluffs and covered in a mixture of native and introduced vegetation, Magazine Bay is the smallest of the three bays west of Rapaki Bay that form part of a larger public recreation reserve. Excluding access by boat, there are three main points of public access to Magazine Bay. From the north, there is public access off Park Terrace, from the east, a walking track from Corsair Bay, and from the south east, a steep walking track that starts at the back of the Naval Point Yacht Club (Figure 4 and Figure 5). Although there is vehicle access off Park Terrace, this is for service vehicles only and links Magazine Bay with Corsair Bay. Unlike at Corsair Bay, Magazine Bay has no public vehicle access or car park.

Figure 3. Magazine Bay, looking northwest.

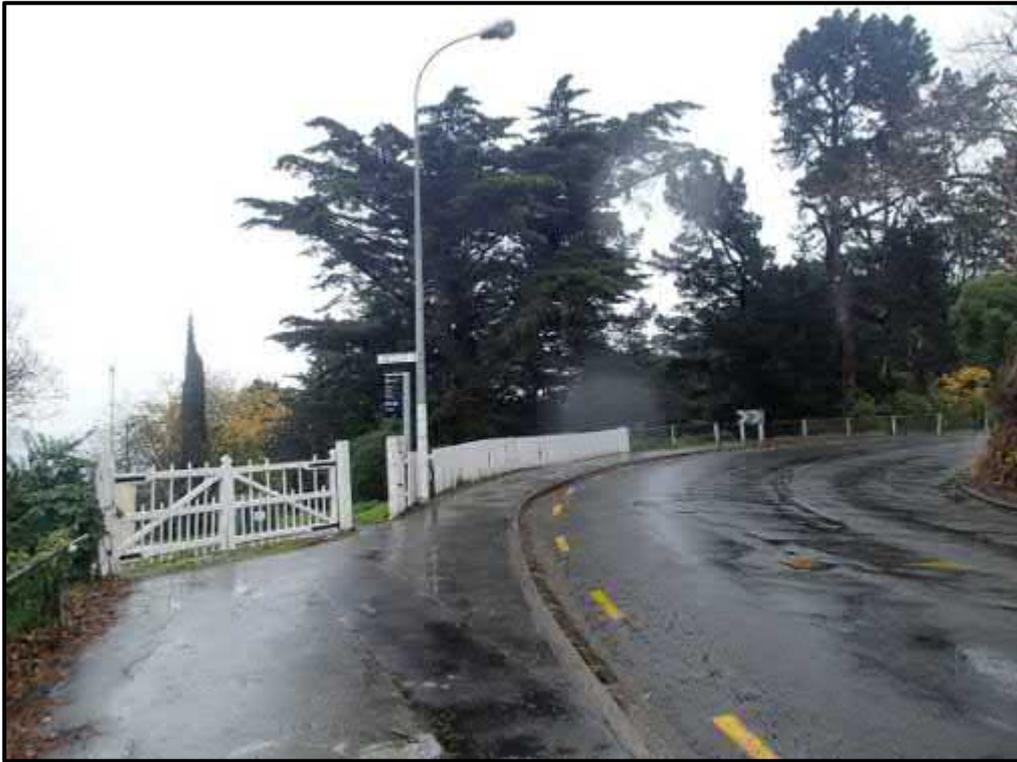
Figure 4. The northern entrance to Magazine Bay off Park Terrace, looking west.

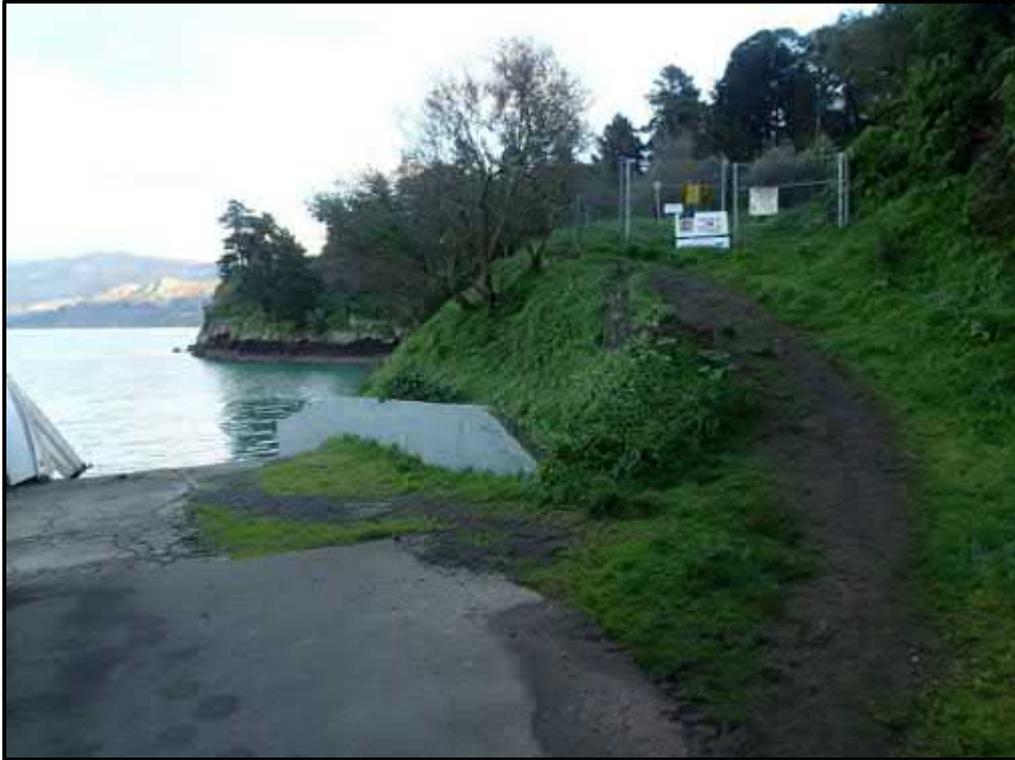
Figure 5. The walking track entrance to Magazine Bay at the rear of the Naval Point Yacht Club, looking west. The boat ramp access at left of image.

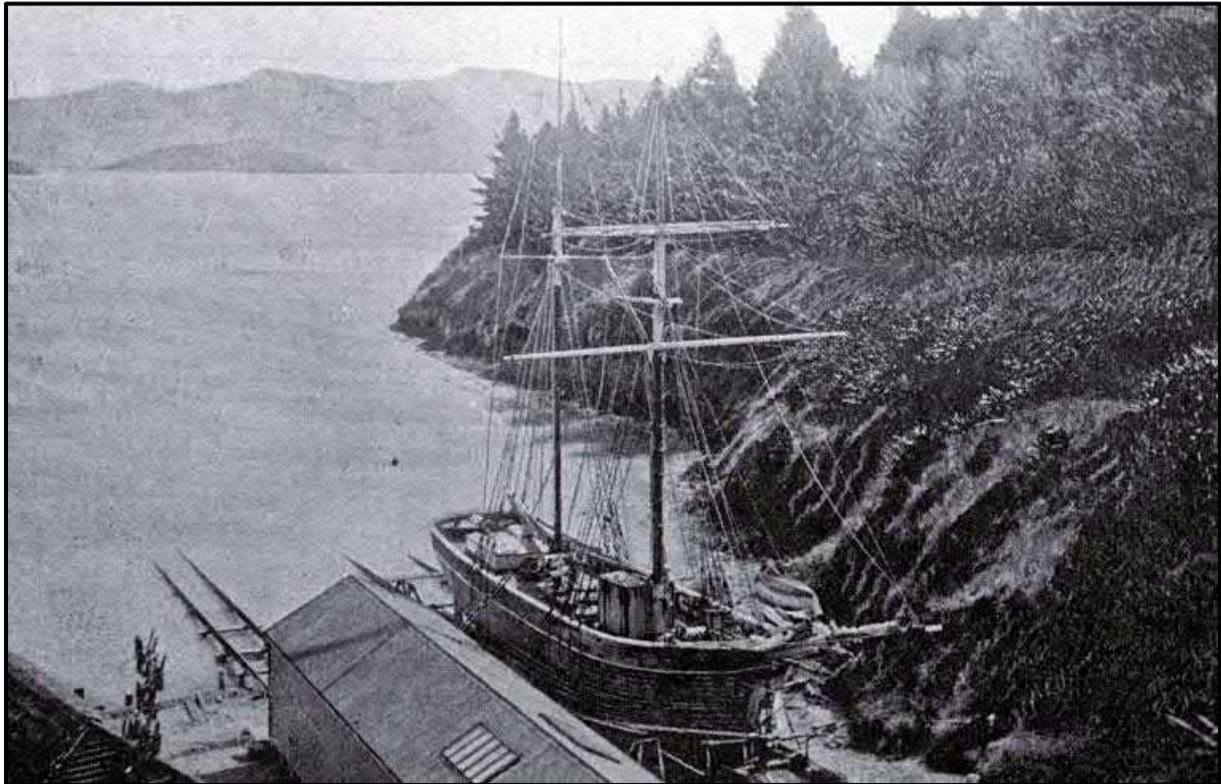
shows the Croydon Lass, (a schooner) on Grubb's slip (Figure 8). It is not known at what time after this photo was taken that Grubb ceased his shipbuilding operations in Bakers Bay.

Figure 8. 1897 image of Bakers Bay, showing the schooner Croydon Lass on Grubb's slip. Grubb's workshop building is partly visible at lower left of image, with the torpedo boat shed in between. Image: Christchurch City Library, Photo CD 10, IMG0039.

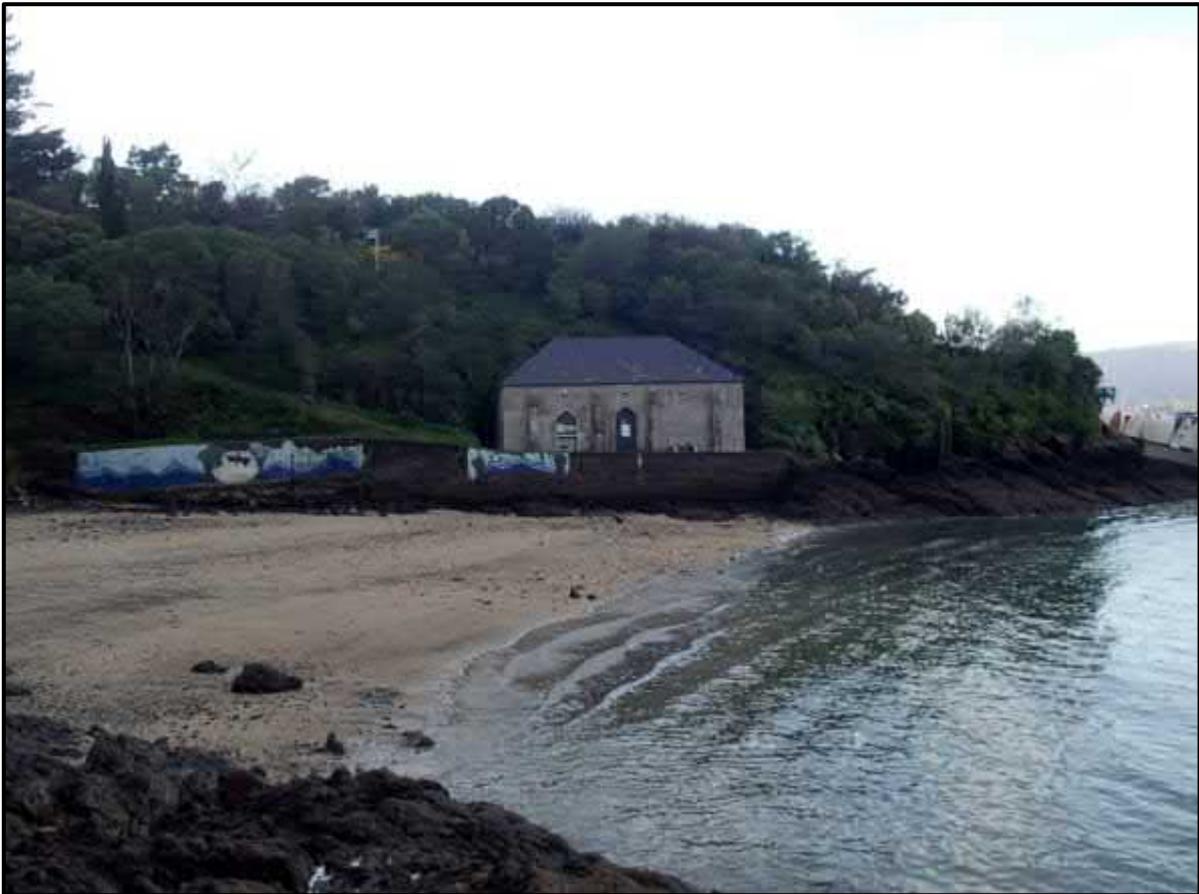
Figure 12. The 1874 magazine and seawall, June 2017.

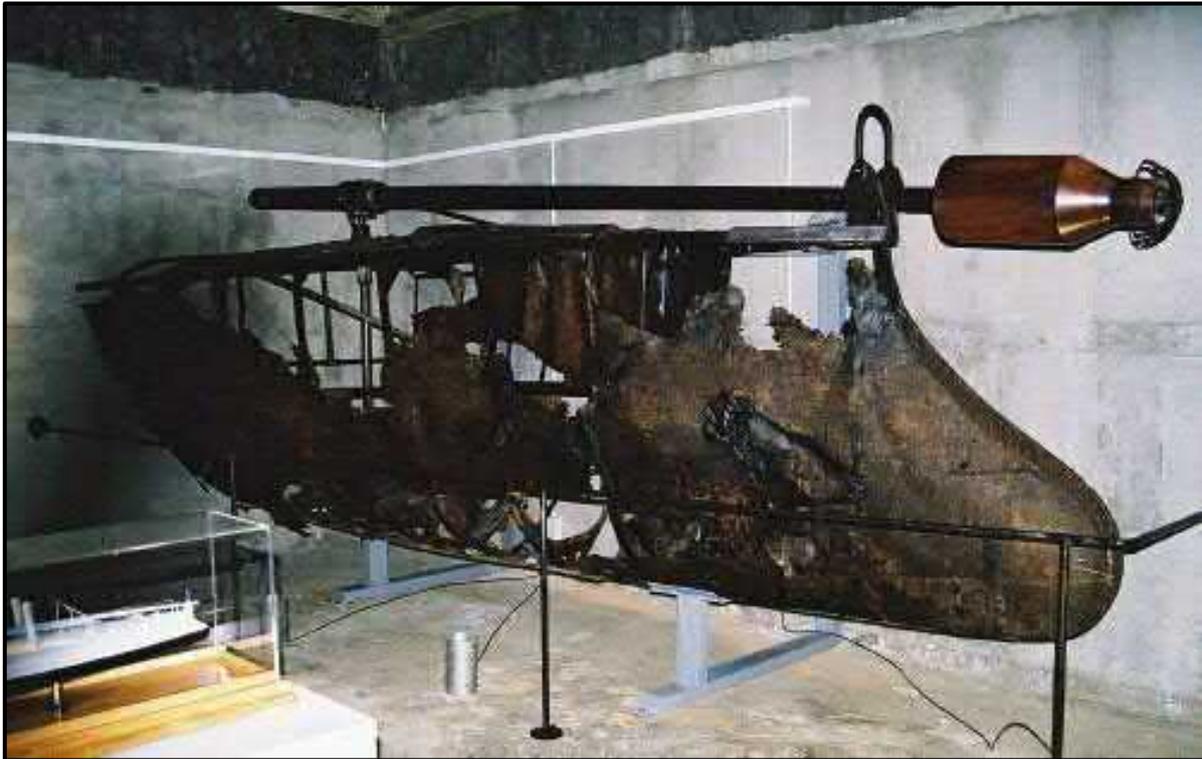
The torpedo of the Lyttelton torpedo boat was never fired (nor were those of any of the other torpedo boats), but trials of the boat were undertaken (mostly to assess its speed) and it was at one time used during a regatta in the Lyttelton Harbour. By 1899 the boat was thoroughly outmoded, and was decommissioned the following year. It was sold to Mark Thomas, who operated a steam launch in the Lyttelton Harbour. Thomas stripped the boat before abandoning it on the foreshore at Purau (Scotter 1968:146). A group of local people relocated the remains of the boat in 1999 and in 2003 established a small museum in the restored Magazine building. Here the partial remains of the Defender's hull and other torpedo boat related artefacts are on display (Figure 13).

Figure 13. The partially reconstructed hull of the Defender torpedo boat, on display inside the Torpedo Boat Museum, Magazine Bay. Image: nzmaritime.co.nz.

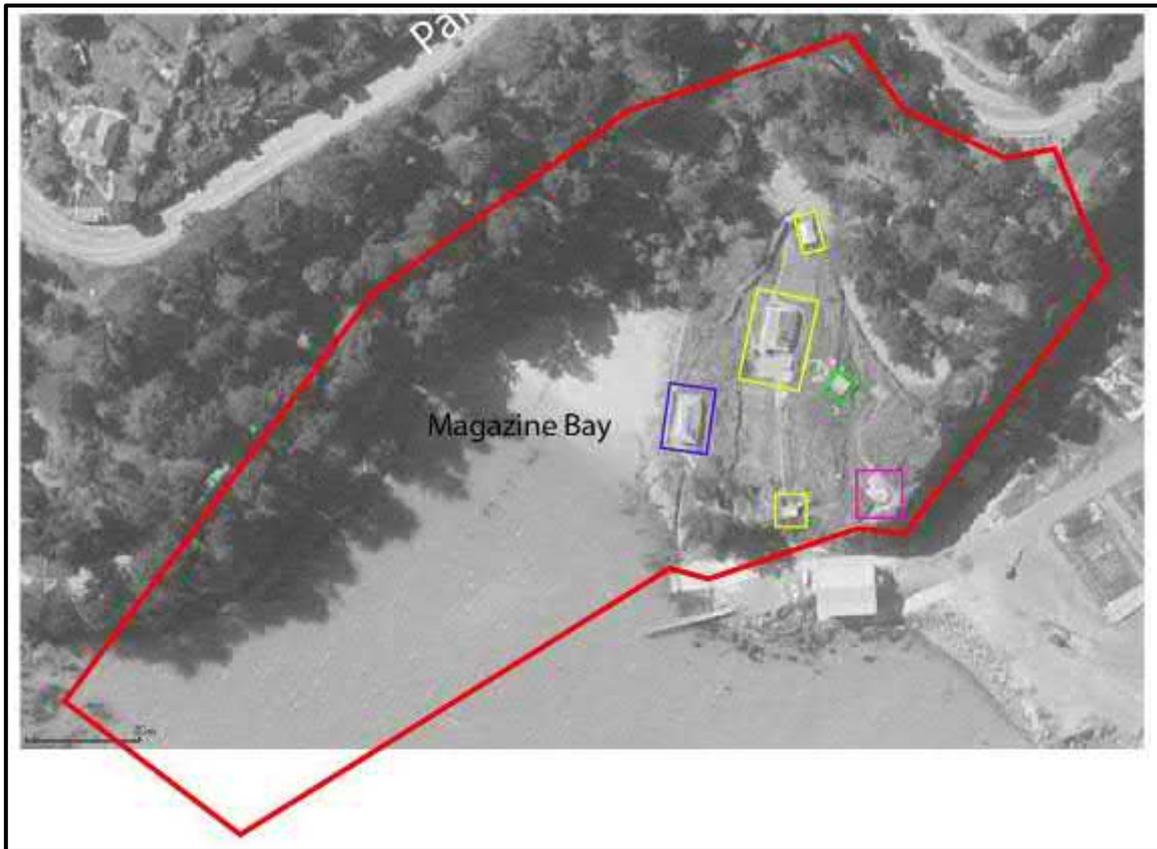
Figure 15. 1965 aerial imagery of Magazine Bay, showing the project area outlined in red. Outlined in blue is the 1874 Magazine building, in yellow the caretakers cottage, garage, and small shed, in pink the 1890 Fort Erskine gun mount, and in green, a smaller building suspected to be the Fort Erskine barracks building or similar structure. Image: after canterburymaps.govt.nz.

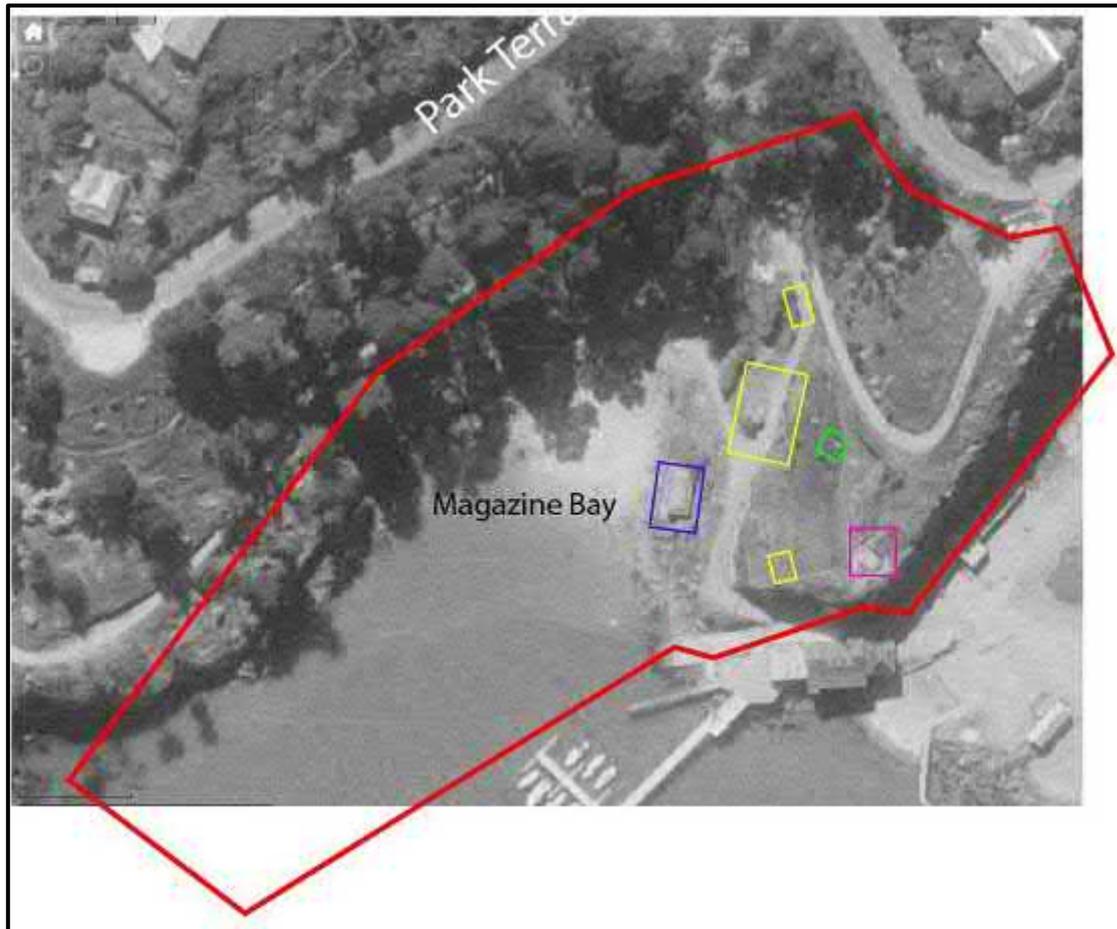
Figure 17. 1980 aerial imagery of Magazine Bay, showing the project area outlined in red. Outlined in blue is the 1874 Magazine building, in yellow the locations of the caretakers cottage, garage, and small shed, in pink the 1890 Fort Erskine gun mount, and in green, the location of a smaller building suspected to be the Fort Erskine barracks building or similar structure. Only the 1874 magazine and 1890 gun mount are still extant, all other buildings/structures visible on earlier aerial imagery have by this time been demolished. Image: after canterburymaps.govt.nz.

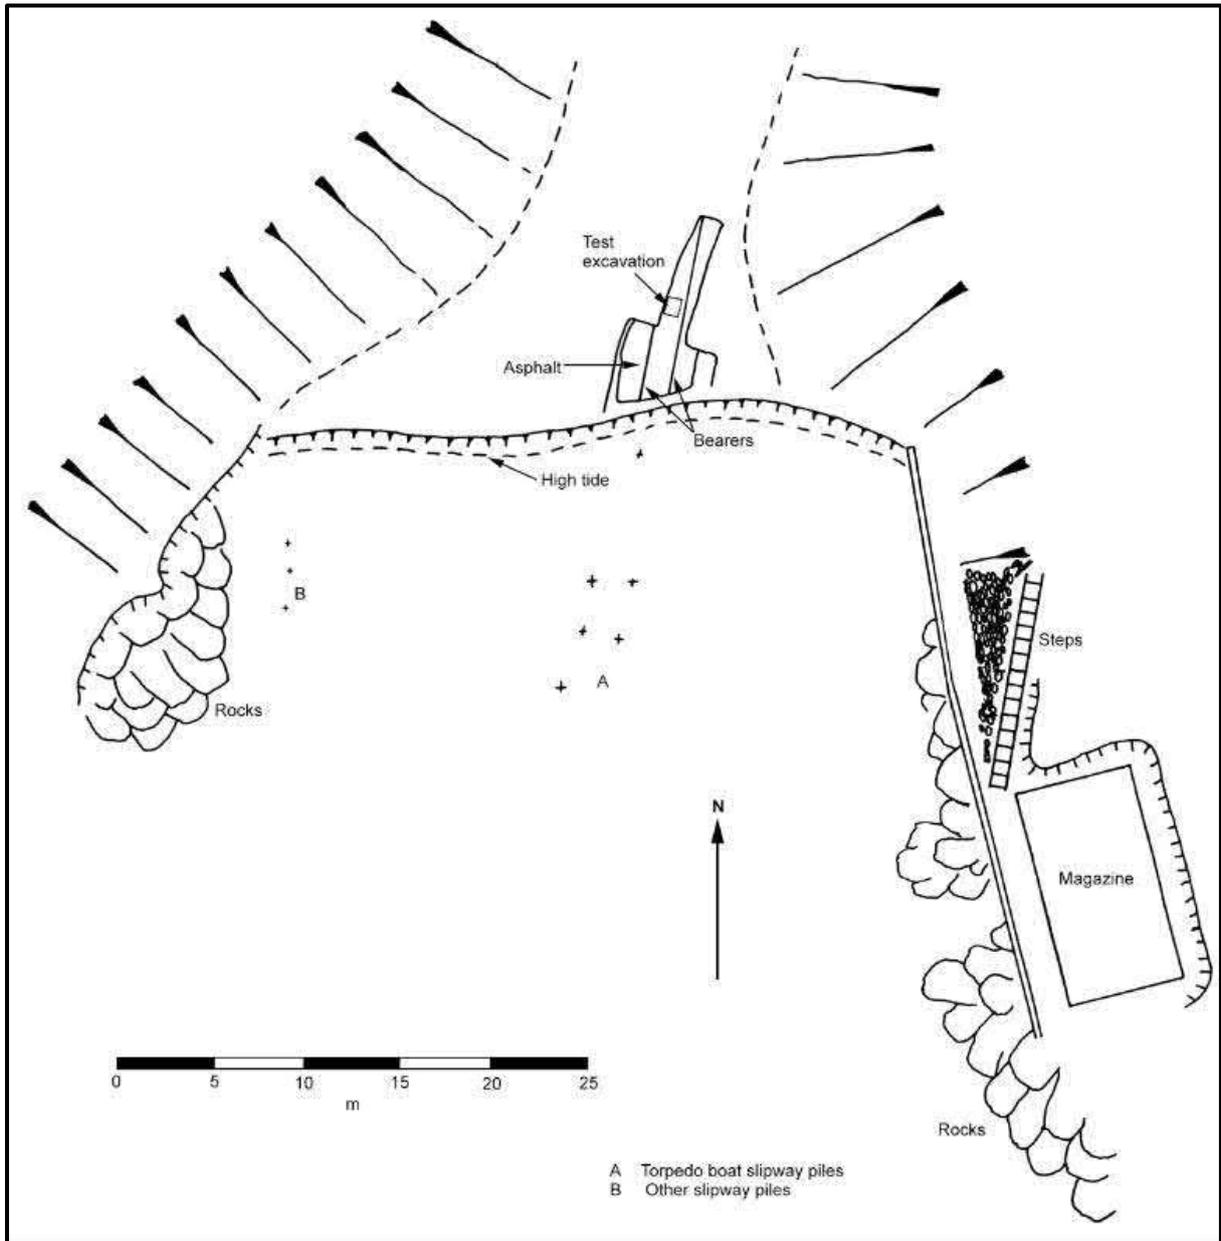
Figure 18. 2002 site plan of Magazine Bay, showing the location of the 2002 torpedo boat shed excavation and other historic features. Image: Watson 2004: 7 after base map by Peter Petchey.

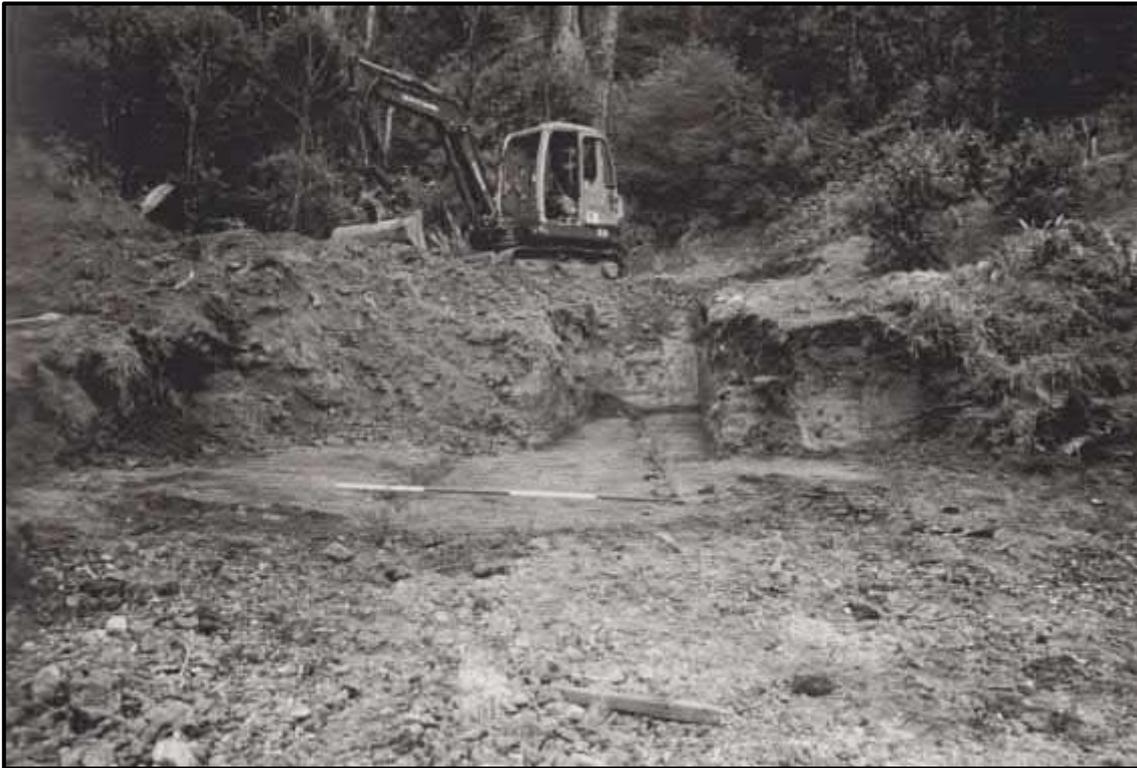
Figure 19. View of the 2002 torpedo boat shed excavation area, showing the asphalt/coal tar floor and timber rail bearers, looking north. Scale increments are 500 mm. Note the depth of fill. Image: Watson 2004: 11.

The **condition** of the site is medium-high, as the 2002 excavation confirmed not only the location of the boatshed but also that it is reasonably intact, with the exception of the rear part of the building that was destroyed by the installation of a LPG pipeline.

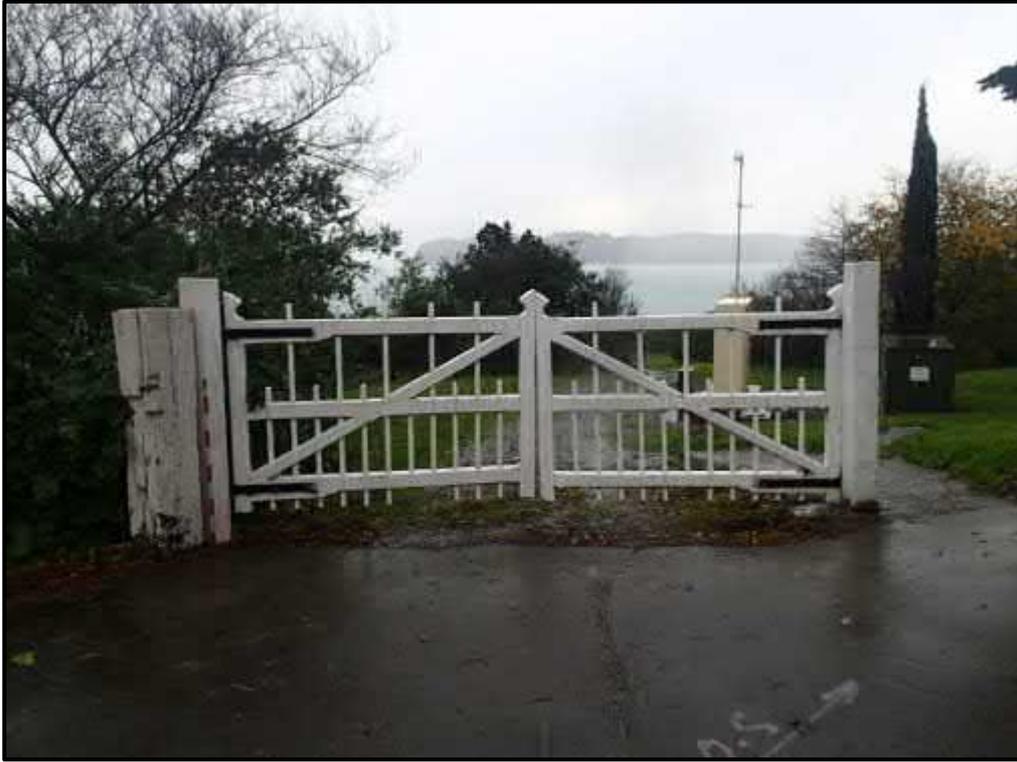
A thorough walkover of the combined service vehicle/pedestrian track that runs from Park Terrace in the north to Corsair Bay in the west was undertaken as the Council is intending to improve this track. An attractive white painted timber gate on the Park Terrace boundary marks its upper end, but it is not known if this is an original 19th century gate (Figure 20). Up to 4 m wide, this single lane access way is gravelled its entire length, but in some places was observed to be rutted and bumpy. Along the steeper parts of the track the fine gravel had been washed away making these sections slippery– this unsealed service road has no roadside channelling or adequate provision for stormwater drainage (Figure 21 and Figure 22). Although not shown on any of the 19th century plans, it is strongly suspected that this track was formed (either in whole or in part) in 1875 when the bay first became a recreational reserve (though this cannot be proven conclusively). 20th century aerial imagery shows that the location of this track has not changed much at all over this time, though has likely been subject to some form of repairs or remetalling. Access to all of the different historic sites in the reserve is off this track, and these smaller branch tracks are well signposted (Figure 23).

Figure 20. The Park Terrace entrance gate to the service vehicle track, looking south.

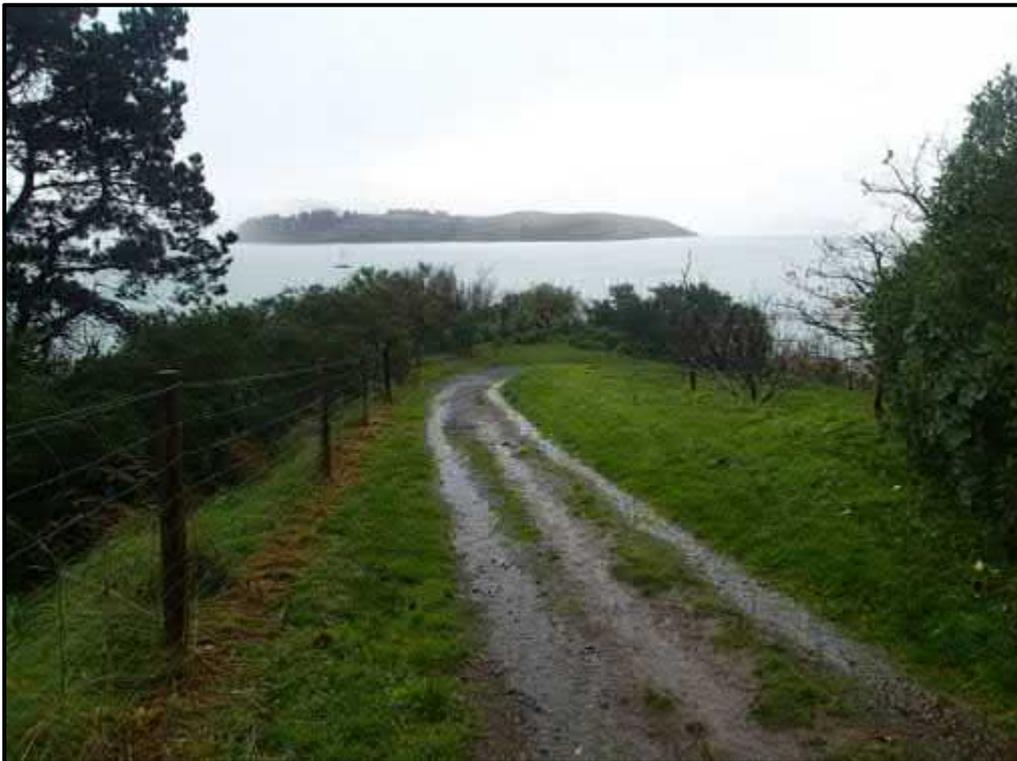
Figure 21. The start of the main service vehicle/pedestrian track off Park Terrace, Looking south. Ōtamahua/Quail Island is in the distance.

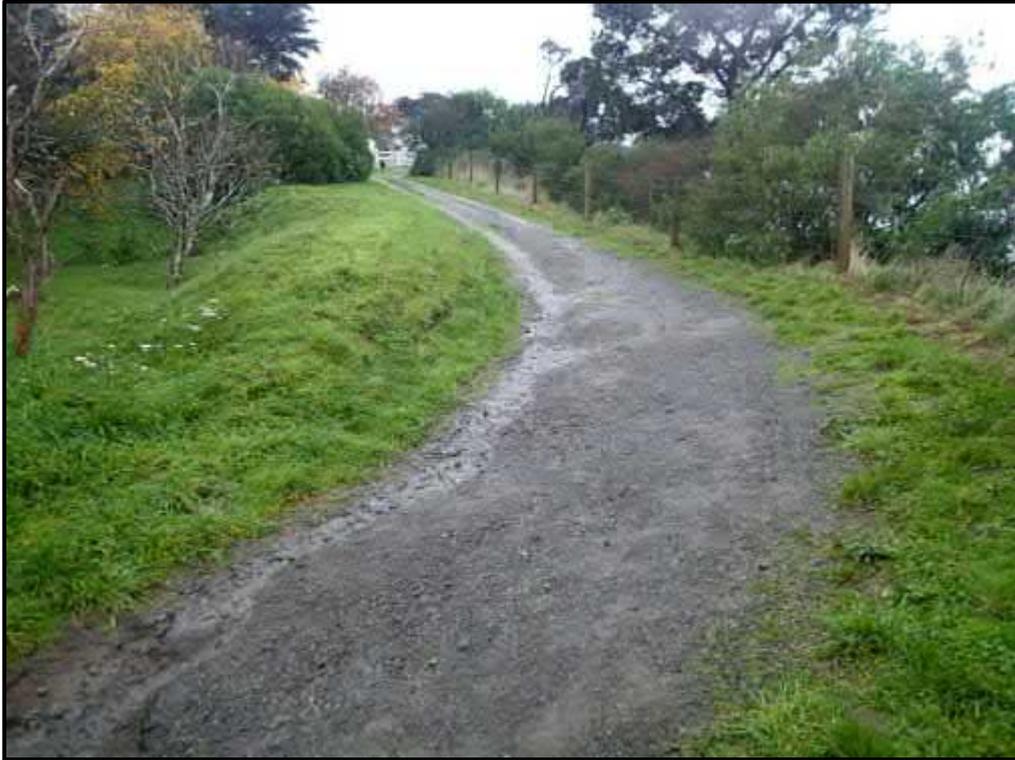
Figure 22. Looking north up the main vehicle/pedestrian access track, with the Park Terrace access gateway in centre distance. Raining at the time this photo was taken, note also the flow of water along the left hand side of the track, which has washed away the gravel in this location.

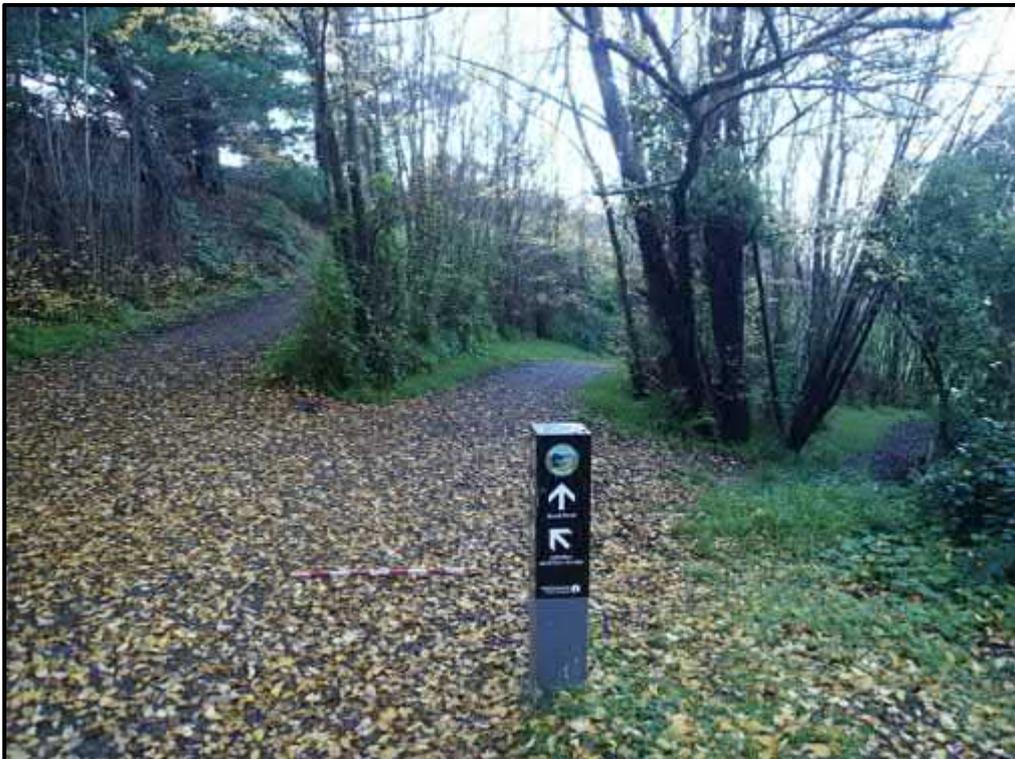
Figure 23. The main service vehicle/walking track, looking east from where the track branches off into smaller tracks leading the site of the caretakers cottage and down to the magazine building and bay. These smaller branch tracks are well signposted.

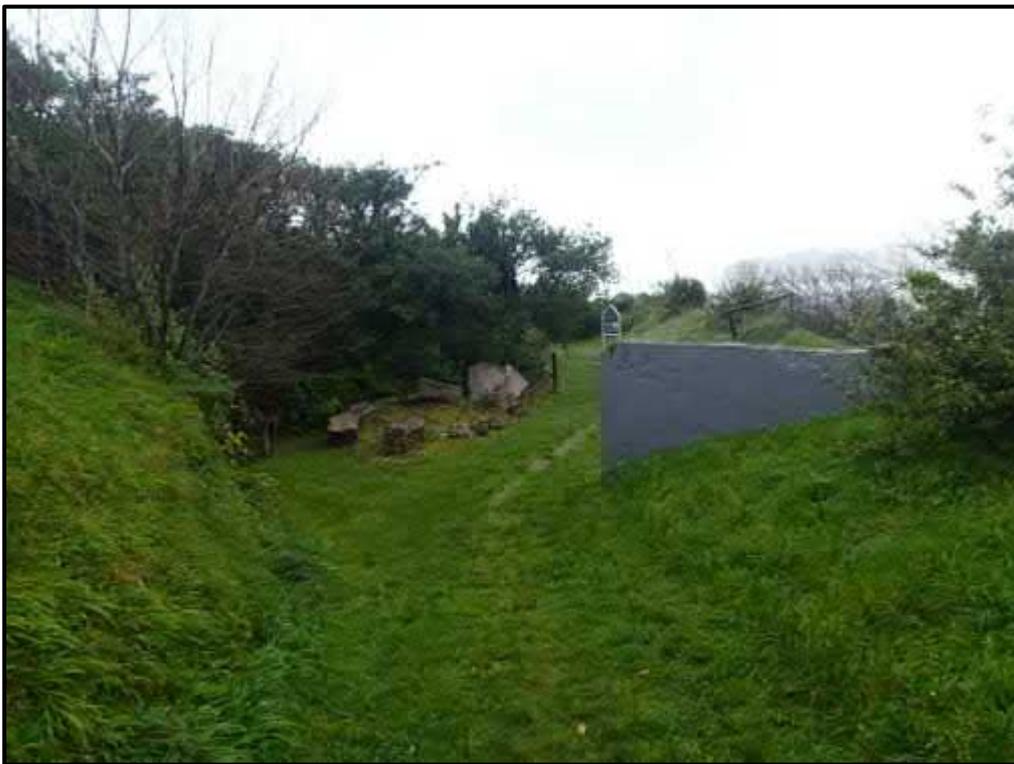
The Fort Erskine Battery is the uppermost historic site on the eastern slope of the bay, and contains a number of different and relatively intact features associated with this short lived fort. The first of these is a 4.2 m long 2.2 m tall concrete perimeter wall, this with the remains of pins that would have held an entrance gate (Figure 24 and Figure 25). The main battery consists of the raised concrete gun mount platform which stands 760 mm tall, complete with its central pivot mount and 3.4m diameter rail on which sat the gun carriage (Figure 26 and Figure 27). The gun mount is surrounded by a 500 mm thick concrete parapet wall which is up to 2 m in height, though a 4 m long eastwards facing portion has broken away. Although this parapet wall is largely intact, there are a number of large cracks to the wall, which has spraypainted graffiti. To the north east of the gun mount are steps leading to the site of the ammunition magazine, and to the south west a concrete musketry parapet (Figure 28). An information panel outlines the history and significance of the site, which notes that the ammunition magazine was demolished by the Lyttelton Borough Council in the 1950s (Figure 29).

Figure 24. The entrance to Fort Erskine off the main access track, looking south. The concrete perimeter wall is shown at right.

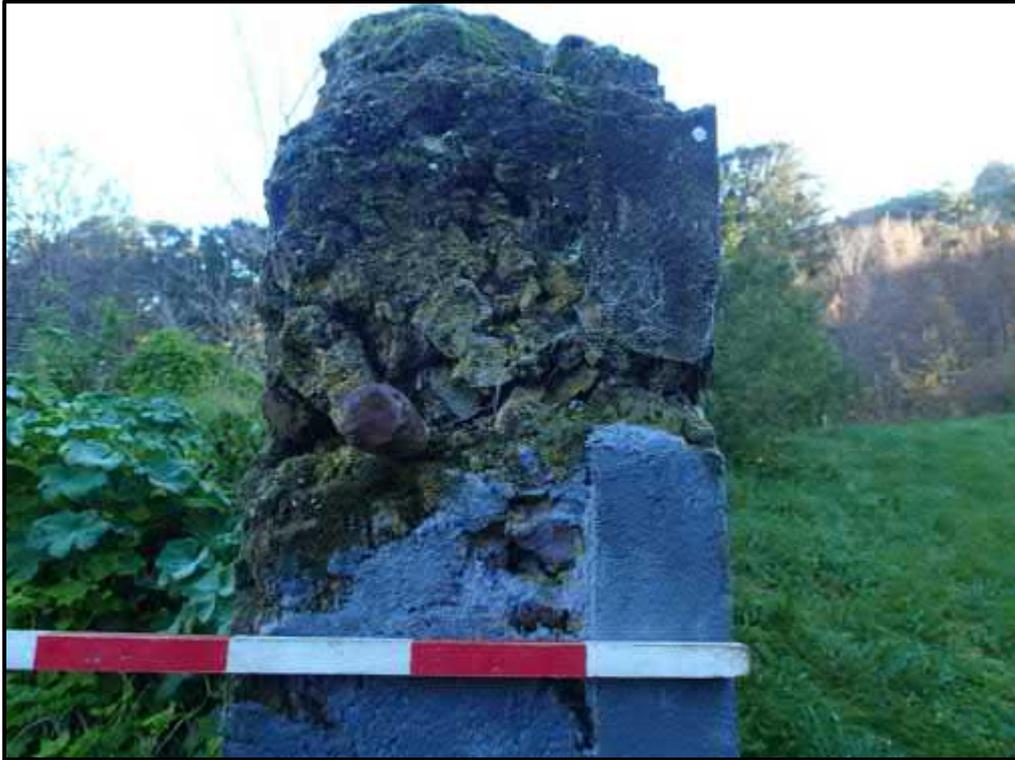
Figure 25. The Fort Erskine concrete perimeter wall, showing the local volcanic rock as aggregate and pin that would have held the entrance gate.

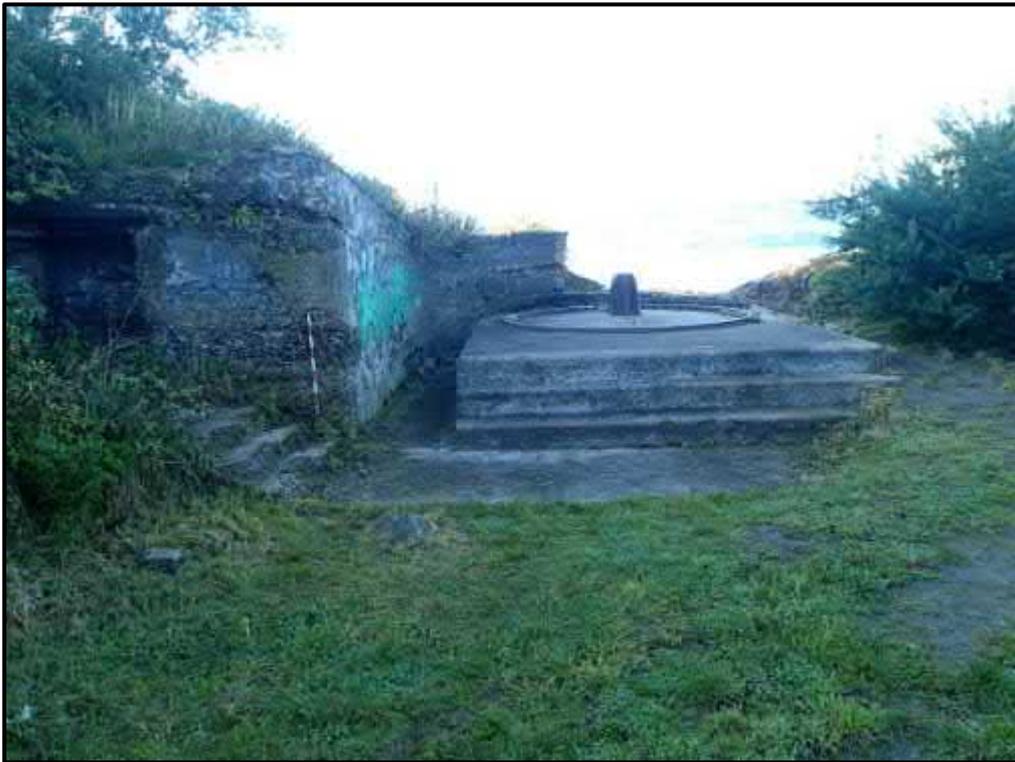
Figure 26. The Fort Erskine gun mount and surrounding concrete parapet wall, looking south east.

Despite some damage and vandalism, the **condition** of the site can be considered high, as the gun mount and most of the surrounding parapet walls are all still in situ.

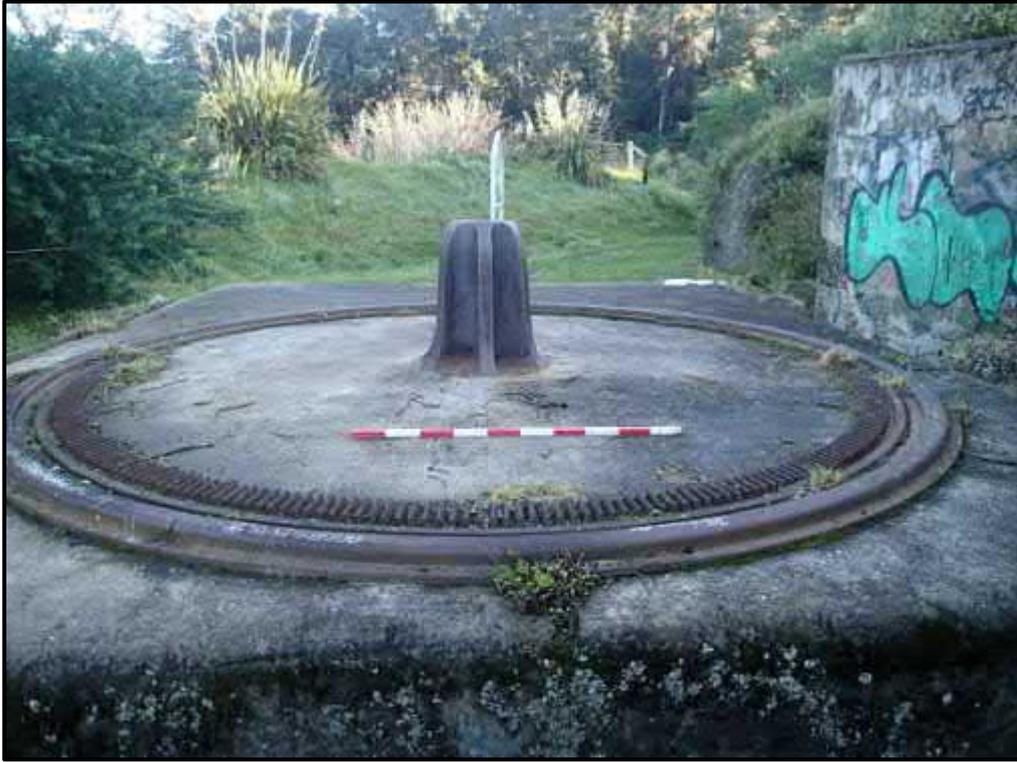
Figure 27. The Fort Erskine gun mount, looking north east.

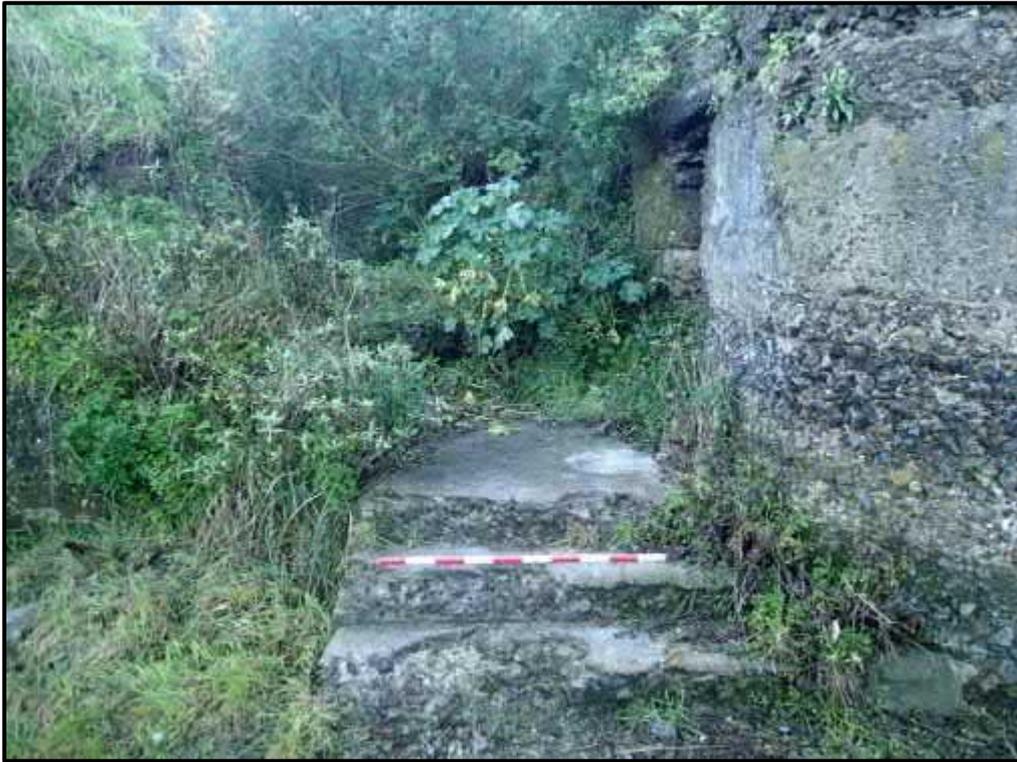
Figure 28. Steps to the north of the gun mount that lead to the site of the ammunition battery.

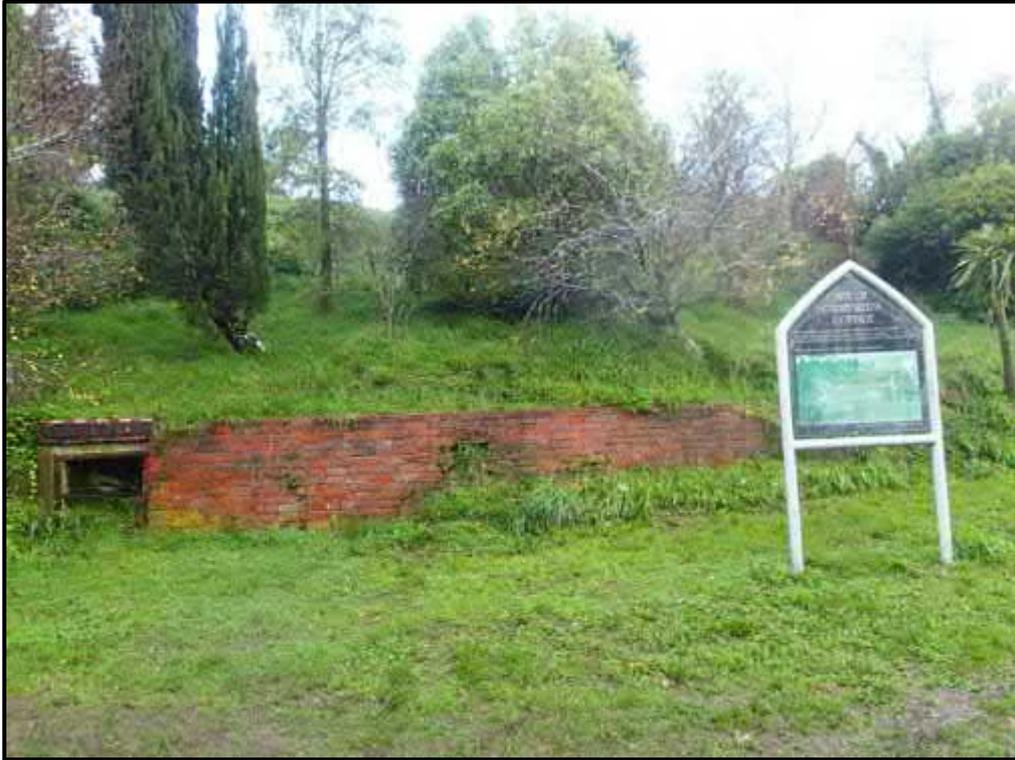
Figure 30. The Caretaker's cottage site, looking east, showing the brick retaining wall.

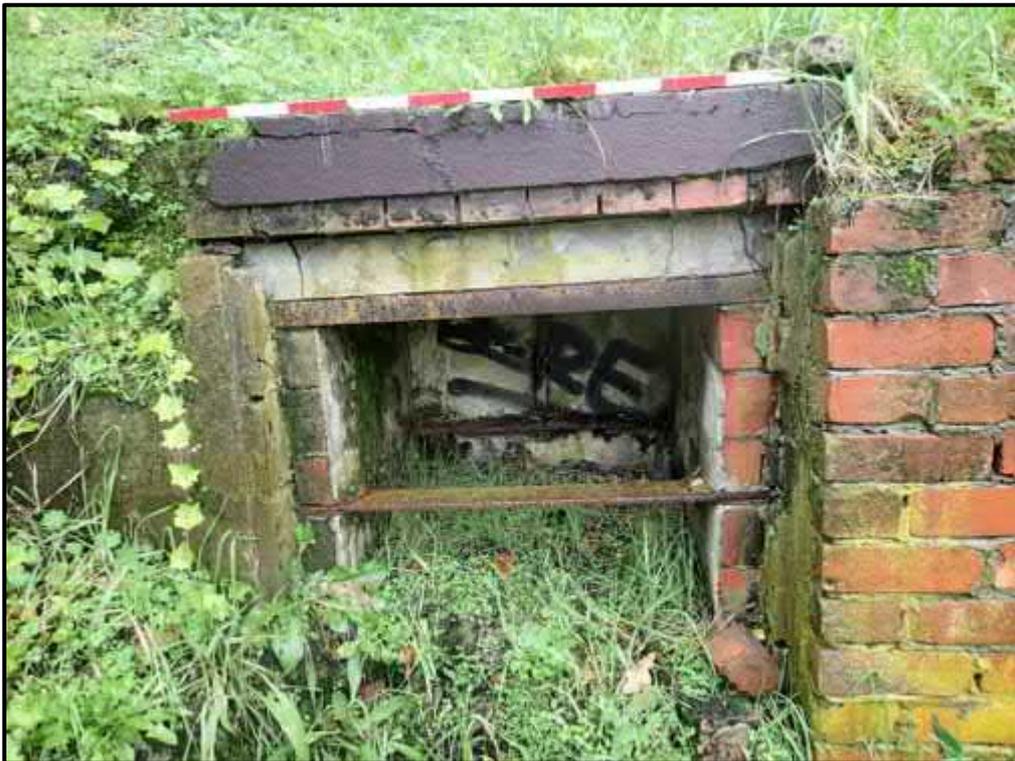
Figure 31. The meat safe built into the northern end of the retaining wall.

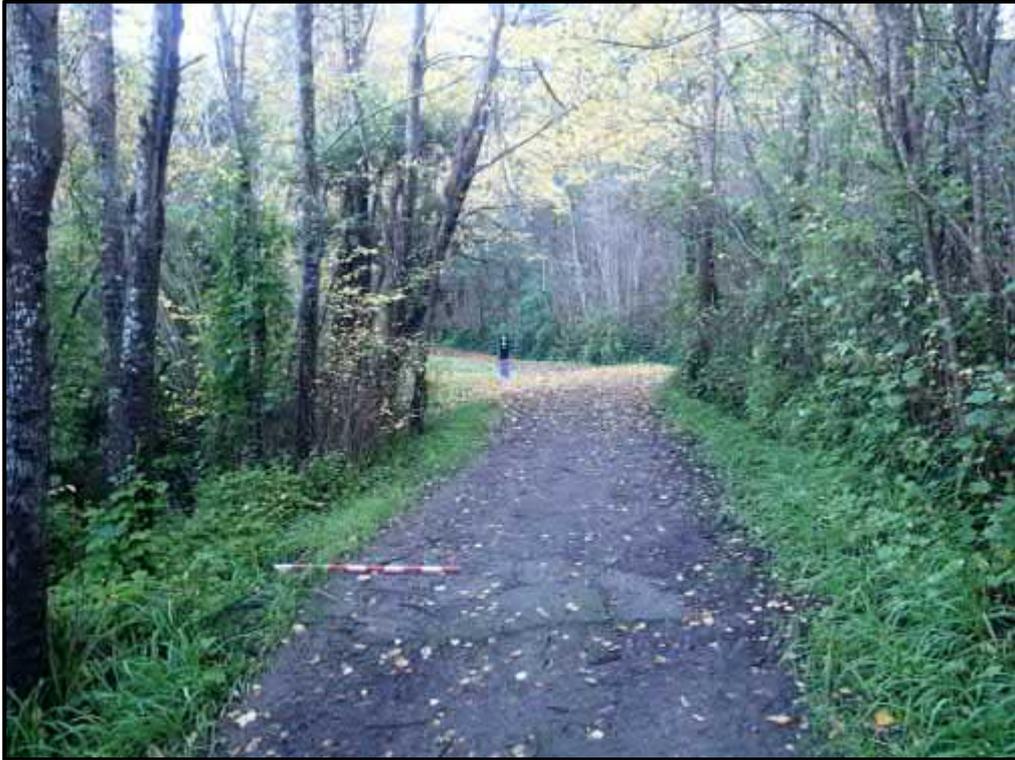
Figure 32. The track linking the site of the caretaker's cottage and the main track (in centre distance), looking north. This track is partially concreted, as can be seen at centre image near the photo scale, and historic aerial imagery shows that a garage, shed or other similar small building once stood in this general location.

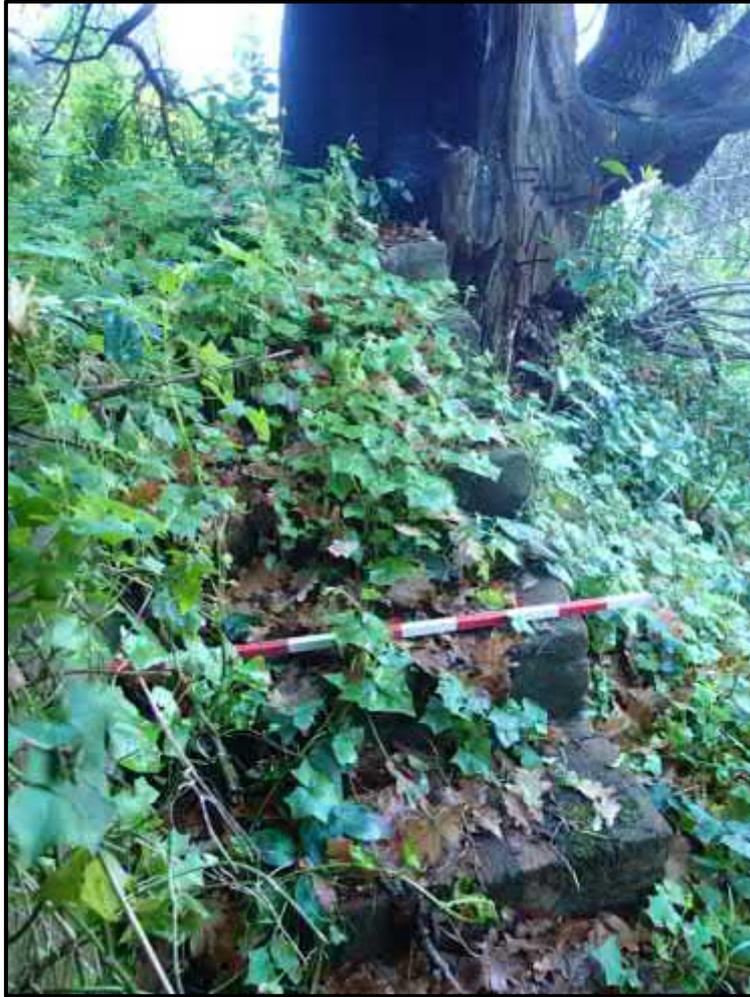
Figure 33. Brick steps located downslope of the caretaker's cottage site. These steps and an associated brick retaining wall are partially visible from the steps that lead down from the cottage site to the Magazine building.
