NAVAL POINT/ MAGAZINE BAY, LYTTELTON: AN ARCHAEOLOGICAL ASSESSMENT

HAMISH WILLIAMS
UNDERGROUND OVERGROUND ARCHAEOLOGY LTD

JUNE 2017

UNPUBLISHED REPORT FOR CHRISTCHURCH CITY COUNCIL

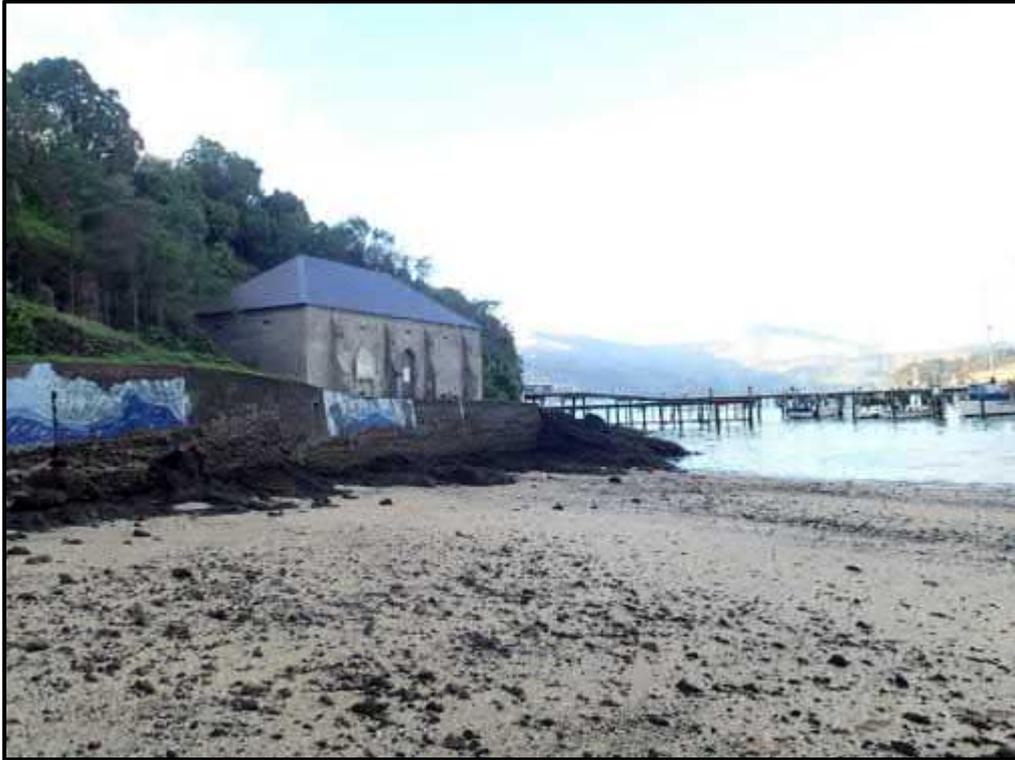
The 1874 Magazine building is in good condition, having been restored from 1999 to 2002 during the course of its transformation into the torpedo boat museum. An interpretation panel in front of the building explains the history, function, and significance of the structure (Figure 34). The concrete sea wall that was built atop of the rocks in this location is also in good condition, (and partially covered in a colourful mural) though there is noticeable weathering to that portion of the outer face of the wall which lies below the high water mark (Figure 35). No evidence of the associated jetty (as shown on the 1925 photo, (refer Figure 11)) survives today. The southern end of this sea wall terminates at a rocky bluff. These rocks extend around the base of the cliff to the edge of the Naval Point Boat Club's concrete boat ramp. A new pedestrian accessway is being considered in this location, sitting across the top of the rock. There were no archaeological features observed in this area (Figure 36).

Figure 34. The 1874 Magazine building and sea wall, looking south east.

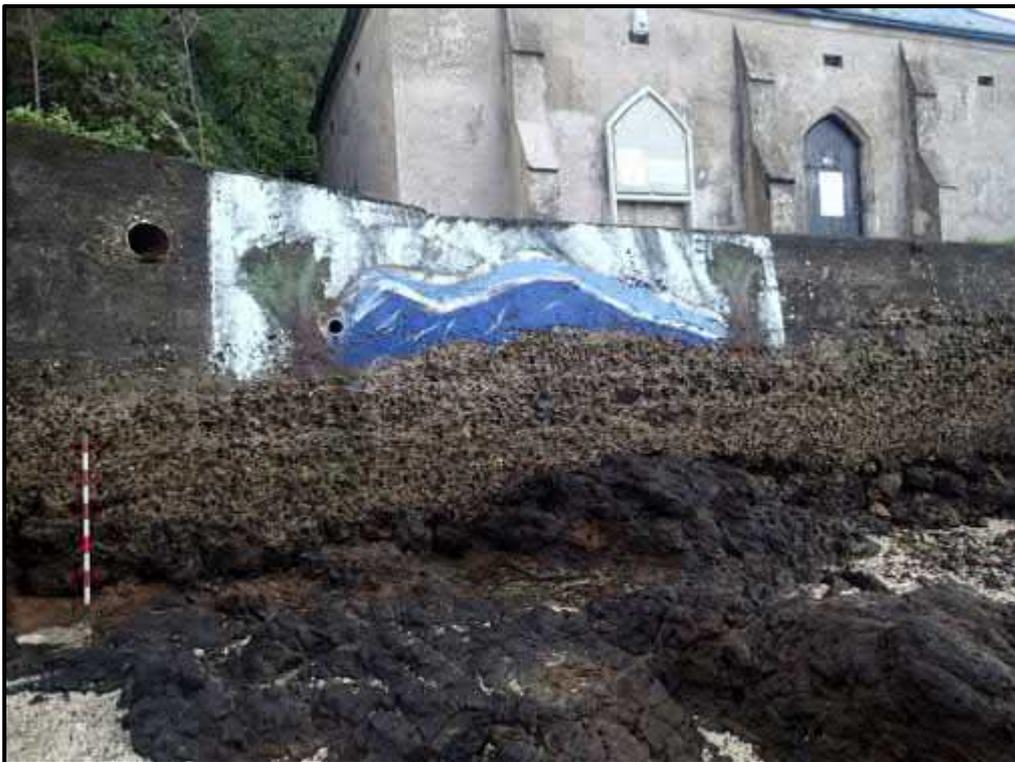
Figure 35. The 1874 sea wall with magazine building in the background. Note how the sea wall has been constructed directly atop the existing rocks, and that there is weathering of the lower part of the wall from the action of the sea.

The **condition** of the site is good, as the Magazine building was recently restored. The seawall is also in good condition, though there is some deterioration of the outer face of the wall that lies below the high water mark.

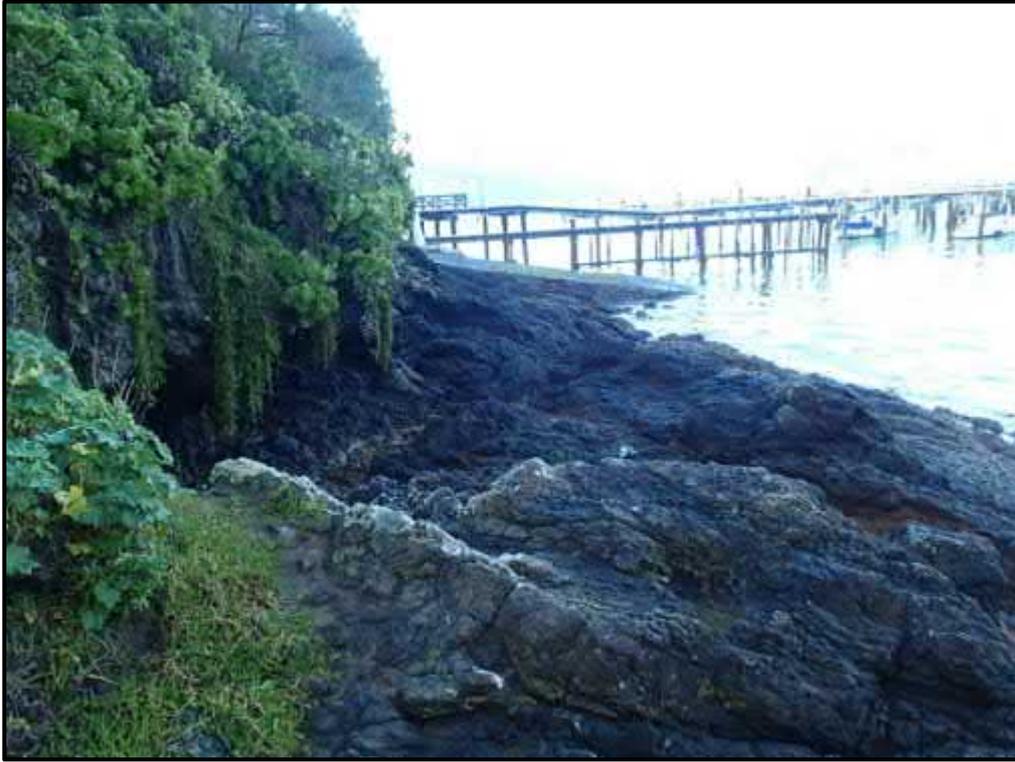
Figure 36. The volcanic rocks that extend out from the base of the cliff south of the Magazine building and sea wall, with the Naval Point Yacht club marina and boat ramp visible in the distance. No archaeology is present in this location, where the construction of a new pedestrian access route into the bay is being considered.

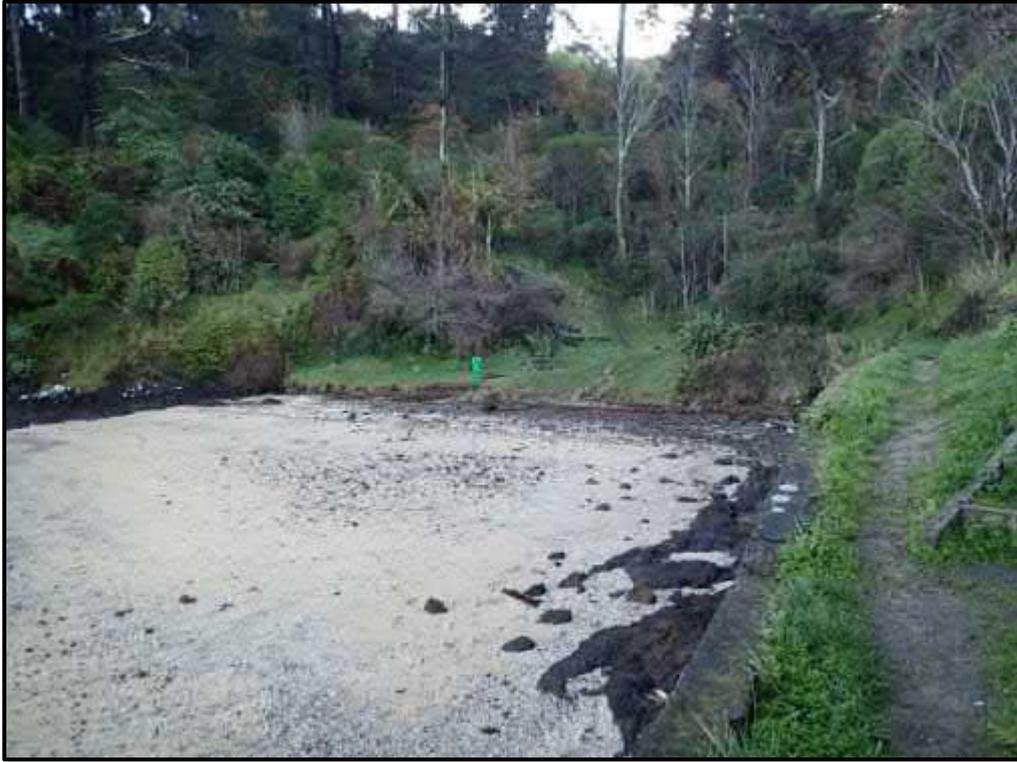
No visible surface remains of John Grubbs 1874 shipyard and slipway, or the 1885 Torpedo Boat shed and slipway that was built adjacent, are visible today (Figure 37). The 2001-2002 Torpedo boat shed excavation confirmed that the main beach terrace on which these structures were constructed has since been built up in height by up to 1 metre, and that some of the clay fill covering this area is likely to be derived from slips. A picnic table is sited in this location, as is an information panel that marks the location of the Torpedo Boat shed (Figure 38). No piles or pile stubs associated with either of these 19th century slipways were observed in the bay.

Figure 37. The Magazine Bay beach terrace on which Grubb's slipway and workshop, and the torpedo boat shed and slipway were constructed, looking north.

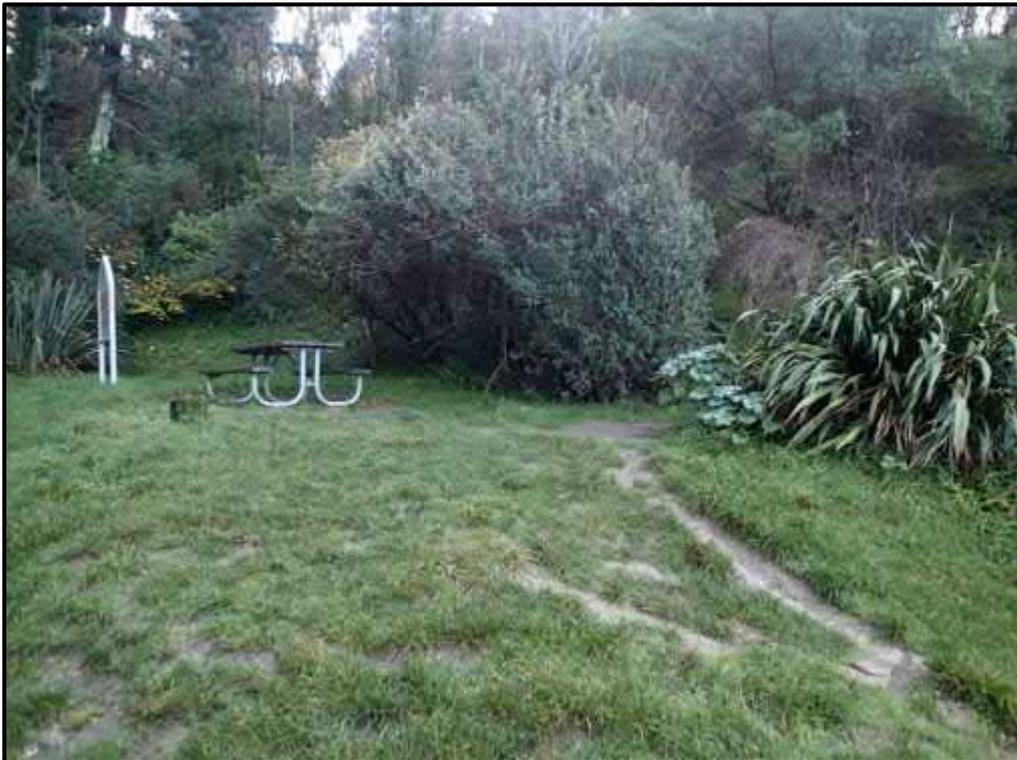
Figure 38. The site of Grubb's slipway/workshop and the torpedo boat slipway and shed, looking north east. An interpretation panel, visible at left, outlines the history of the site.

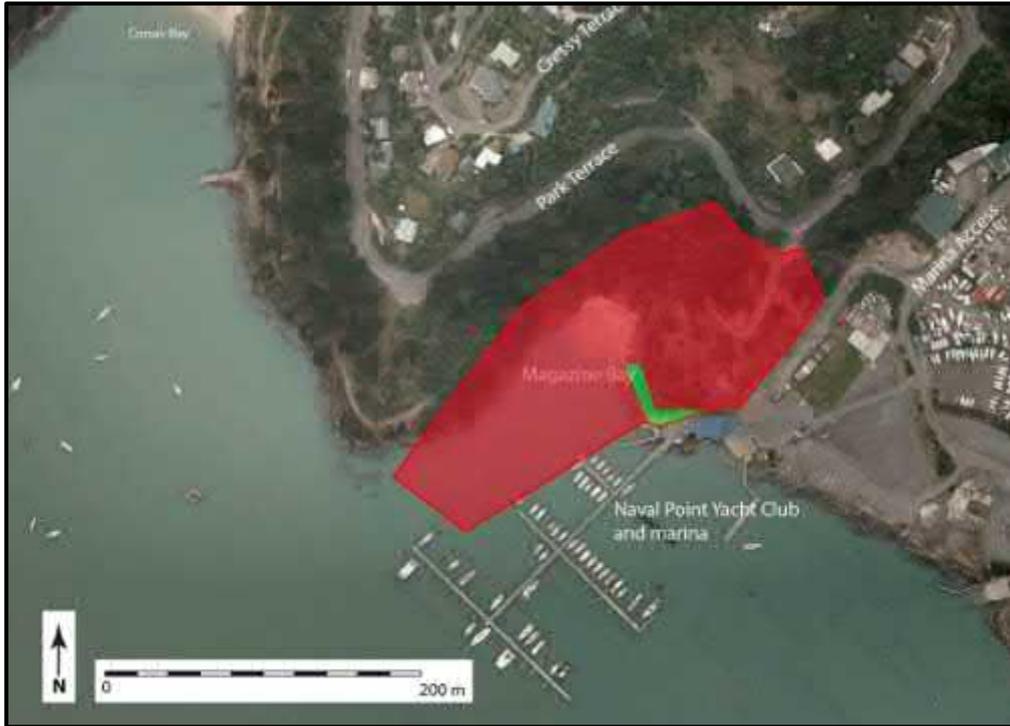
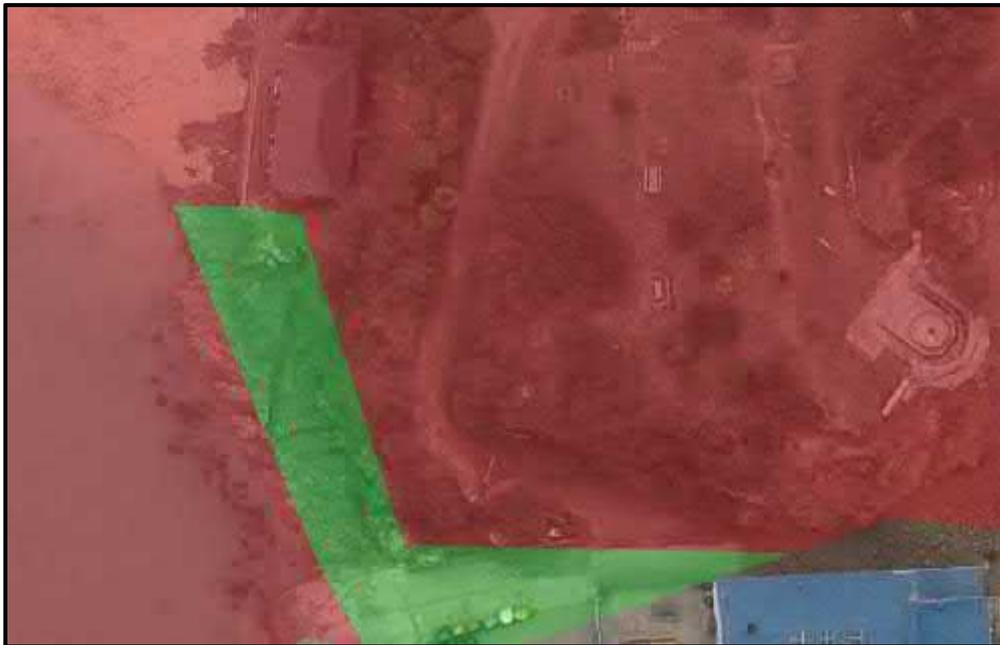
Figure 40. The Naval Point/Magazine Bay area that was assessed, showing in red, those parts of the reserve where an archaeological authority will be required prior to earthworks taking place, and in green, where an archaeological authority will not be required.

Figure 41. Close up detail of Figure 40, showing highlighted in green that part of the assessed area where an archaeological authority will not be required.

The proposed construction of a new pedestrian access route into Magazine Bay that would start at the Naval Point Yacht Club and follow the base of the cliff to the Magazine building would greatly improve access to the bay, which is otherwise accessible only via mostly steep tracks/steps. It is suspected that if such a new track were built, it would greatly benefit the Torpedo Boat Museum, as improved access would likely facilitate an increase in museum visitor numbers. Because there is no archaeology in this particular location at the base of the cliff, and any earthworks required for construction of this new section of walking track would only be on top of or into natural volcanic rock, an archaeological authority for the construction of this new section of track would not be required. However, any upgrades of the **existing track adjacent to, and north of, the 1874 magazine and seawall** that would likely be carried out in association with the construction of the new section of track has the potential to impact on subsurface archaeological deposits in particular those related to site M36/681 – the 1874 Magazine and seawall. As such, an archaeological authority would be required for this work. A colour coded plan of the area that was assessed shows those parts of the reserve where an archaeological authority should be obtained by the Christchurch City Council prior to any earthworks taking place in the area marked in red (Figure 40 and Figure 41).
