CHRISTCHURCH CITY COUNCIL
Slope Hazard Susceptibility
Akaroa Harbour Settlements
Takamatua Air Photo Interpretation

Preliminary Geotechnical Assessment of Takamatua Headland
Coastal Piped Options

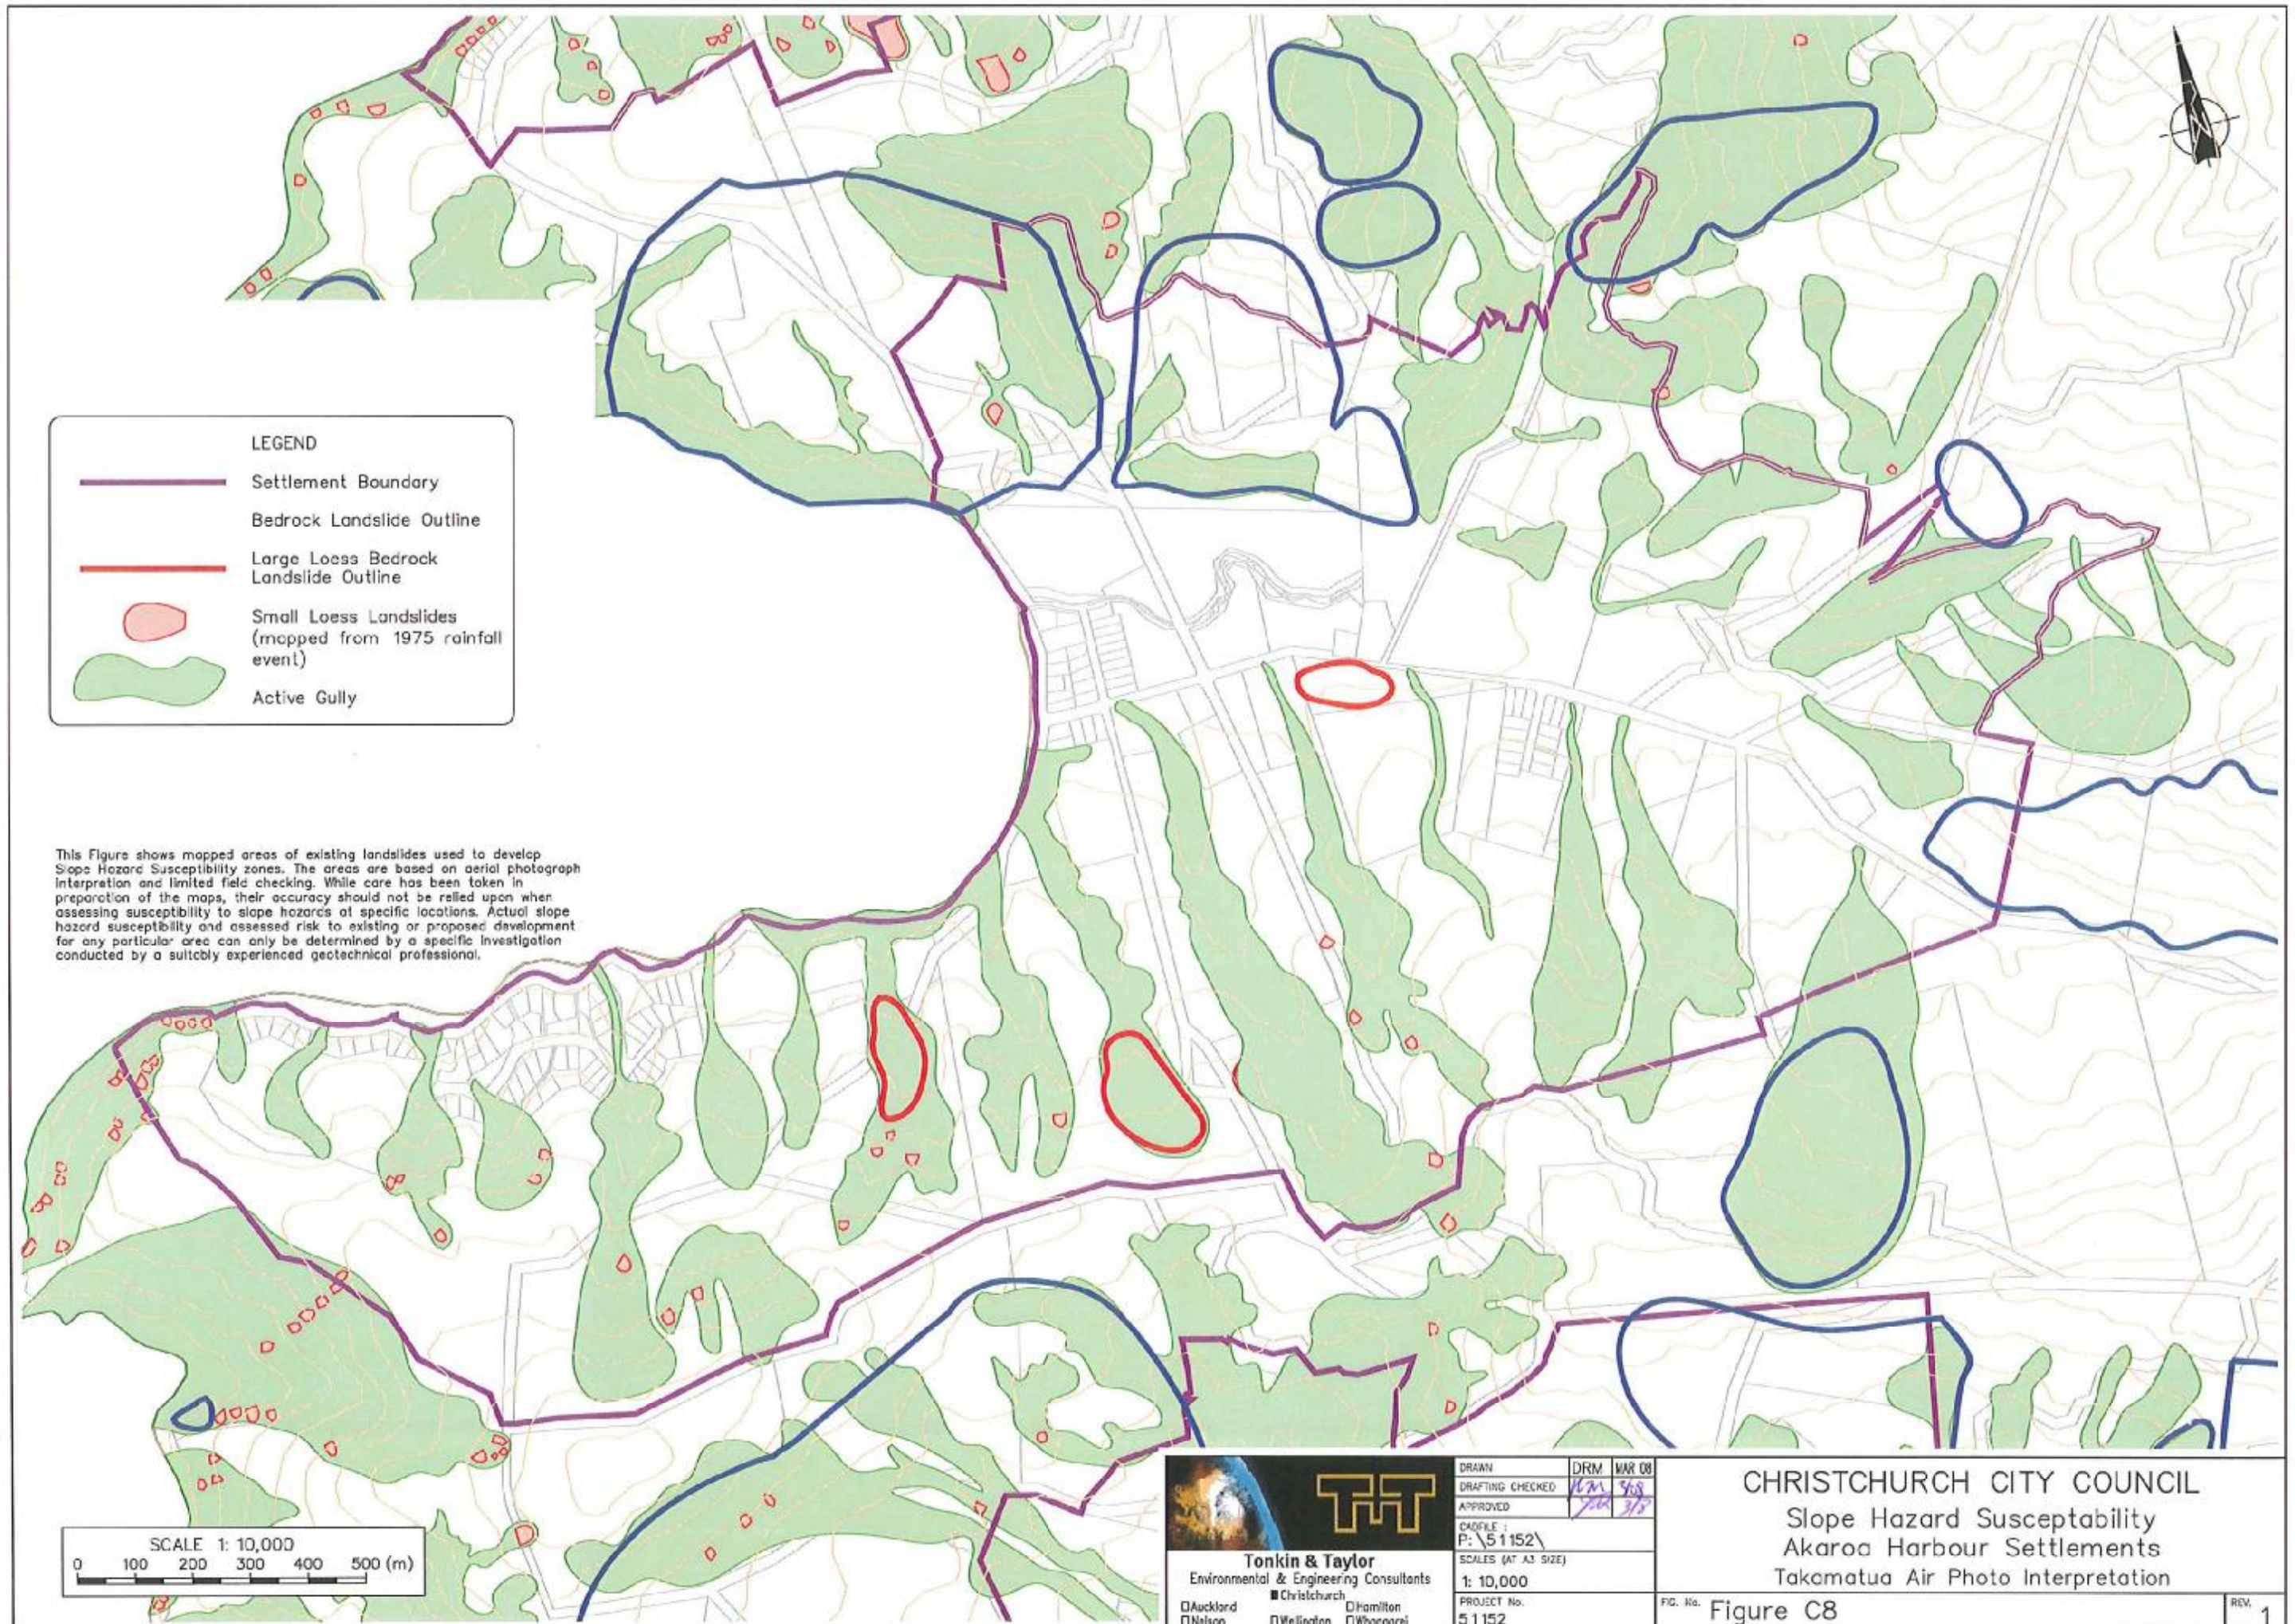
P:\51152\workingmaterial\CAD\Figures\Report\UPDATE of Figure C3-C5.dwg, Figure C8, 28/03/2008 9:10:19 a.m., 1:1

- Settlement Boundary
- Bedrock Landslide Outline
- Large Loess Bedrock Landslide Outline
- ▲ Small Loess Landslides (mapped from 1975 rainfall event)
- Active Gully

This Figure shows mapped areas of existing landslides used to develop Slope Hazard Susceptibility zones. The areas are based on aerial photograph interpretation and limited field checking. While care has been taken in preparation of the maps, their accuracy should not be relied upon when assessing susceptibility to slope hazards at specific locations. Actual slope hazard susceptibility and assessed risk to existing or proposed development for any particular area can only be determined by a specific investigation conducted by a suitably experienced geotechnical professional.

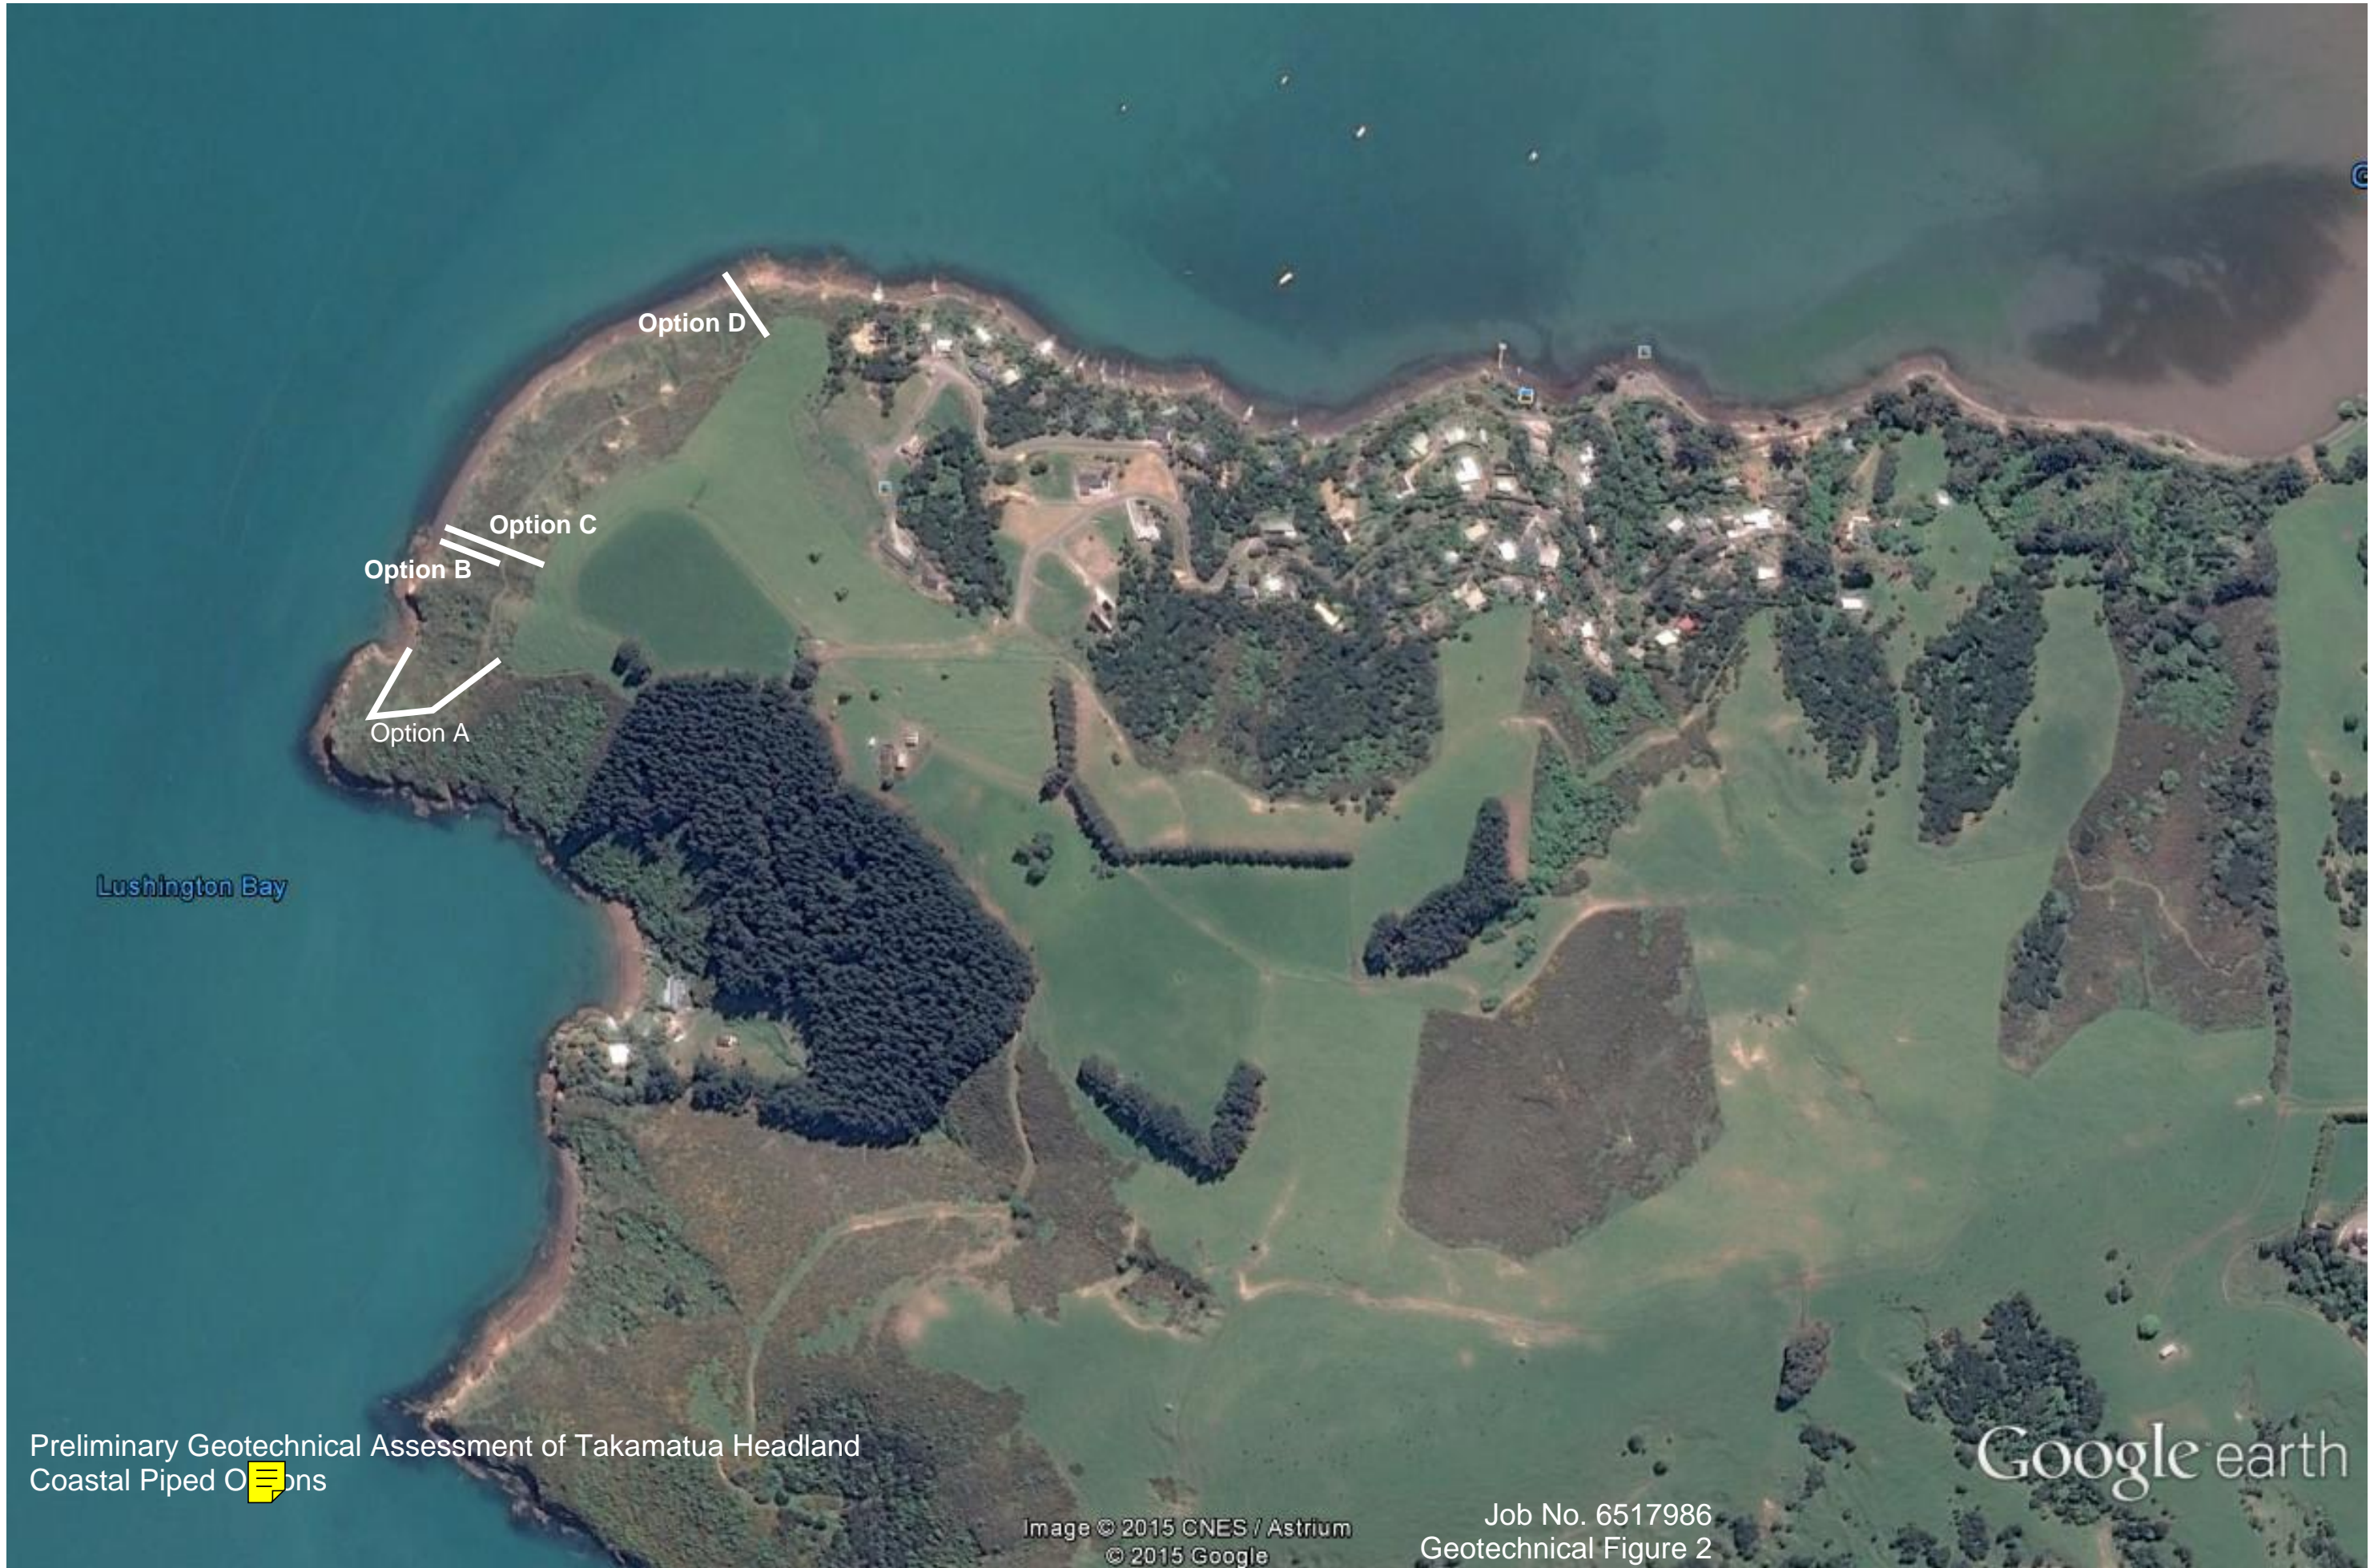
Job No. 6517986
Geotechnical Figure 2

Option D
Option C
Option B
Option A
