Community Facilities and Heritage Programme

NOTE: For reporting purposes, the status of a project will no longer be reported once the public opening has occurred. Completion of projects can take up to a year depending on the Defect Notification period.

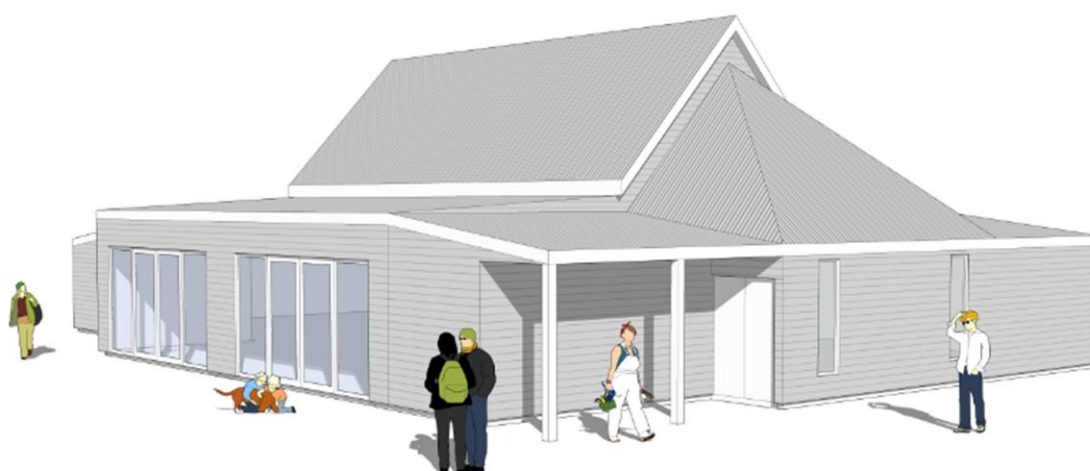
Allandale Community Centre 3D concept design

Carry out earthquake repairs and strengthening to a minimum of 67% NBS. Return the building to the Allandale Reserves Committee to manage. Committee will have a voluntary role in tidying up and landscaping the grounds.

Detailed design is underway. This will be completed in January. A building consent will be applied for at this stage and a QS will carry out a cost estimate for the work. The hall will be cleaned out in December ready for the contractor to start work in May /June 2017.

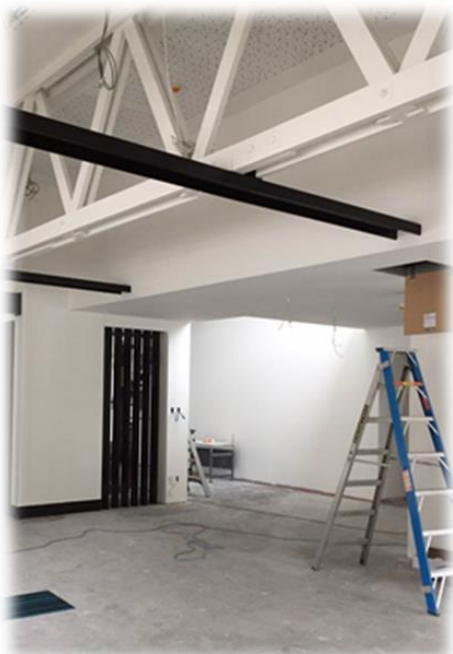
Looking at new service desk area

- Construction is ongoing
- The second fix of electrical and mechanical services has commenced
- Prepping of floor has started to allow soft coverings to be laid
- Gib board has been installed, stopping and painting ongoing
- Internal architectural details are underway

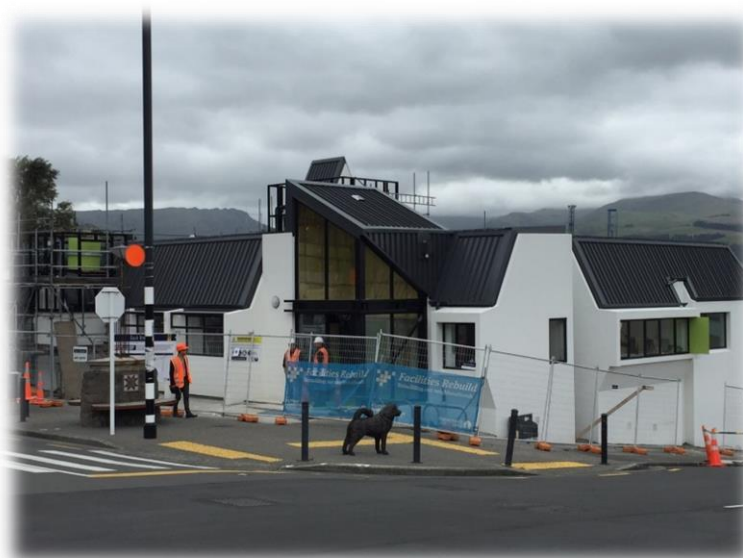
Scaffolding down around building looking at new entrance

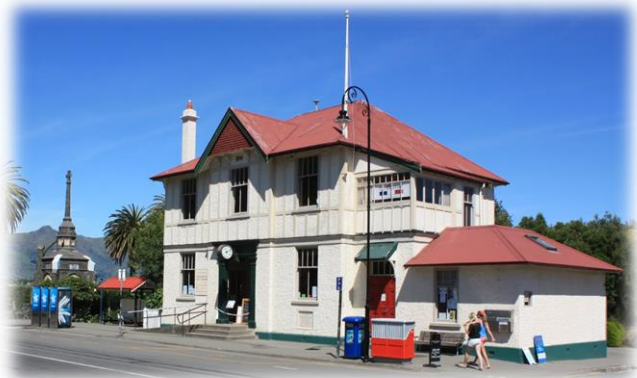
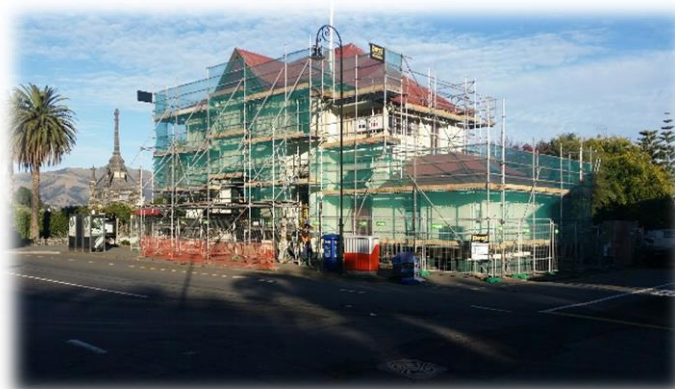
Stage 1 - Exterior. Scaffolding has been erected, the roof has been replaced and first story decorative works have been completed, plaster and painting works only remain to the ground floor.

Stage 2 – Internal Fit-out. Detailed design has been completed, documentation is being prepared for consent.

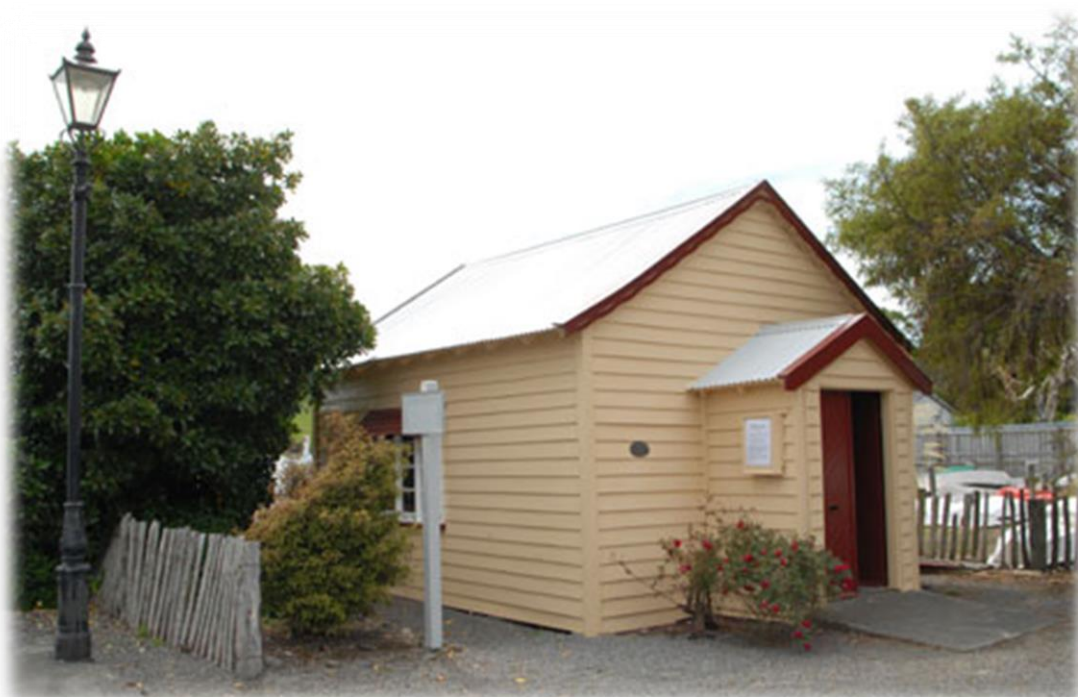
The Custom House in Akaroa currently has 41%NBS and is open for viewing only as repairs are required to the heritage fabric.

The chimney will be reconstructed in a lightweight method inclusive of steel frame and ply bracing to necessary walls. Internal repairs and a full exterior paint will also be undertaken.

Structural steel has been installed. The chimney is currently being reinstated. An amended resource consent to include the internal linings has been approved. These works and the painting are expected to commence in January 2017.

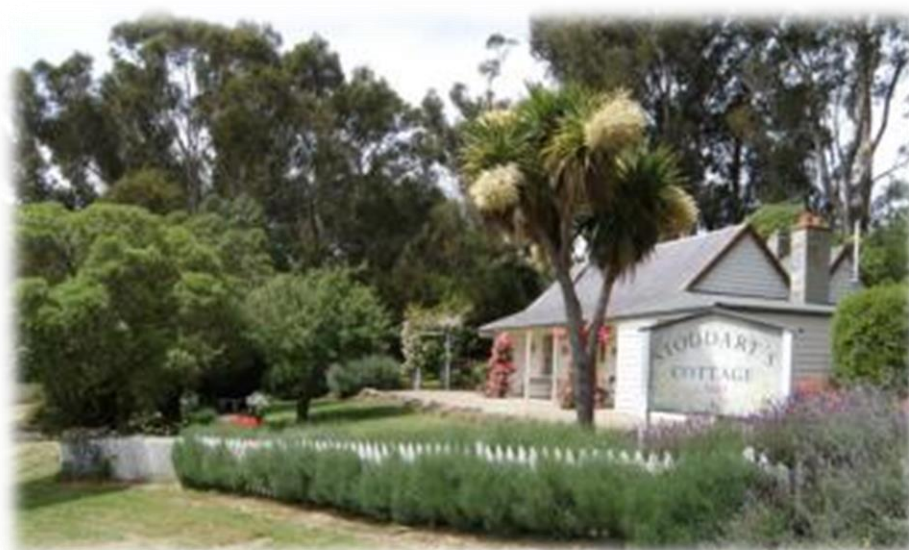
Stoddarts Cottage currently has a 34%NBS and is closed. This is due to deconstruction of the chimneys and to protect against further damage to the heritage fabric.

Although this building has suffered minimal earthquake damage, the collapse of the chimneys has reduced the building's seismic capacity to approximate 34%NBS.

Progress to date includes: The internal brick chimneys to the gallery, back room and kitchen have been deconstructed and the new foundations have been installed. All steel framework, portal frames to support the new chimneys have been completed and the timber framing for the kitchen chimney has also been installed. The new brick chimneys together with the fireplaces are finished and all fire surrounds and mantelpieces have been re-installed. The building has been scaffold and the exterior painting is underway with removal of the old paint and preparation for the new painting approximately 50% complete.

On removal of the roof slate tiles to install the new timber flashings we discovered that the timber battens for the tiles were badly deteriorated with borer. The tiles themselves were also badly damaged. We have sourced slate tiles to match the existing and will be replacing the battens and slate roof. This has meant that the programme will need to be extended by approximately three weeks.

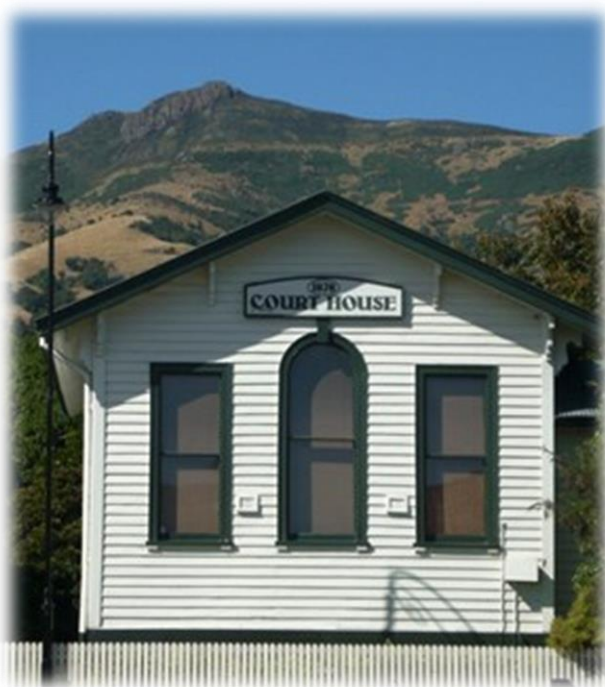
Replacement of the weatherboards and decayed framing to the back elevation have been completed. Building has been stripped, preparations prior to painting are currently underway.

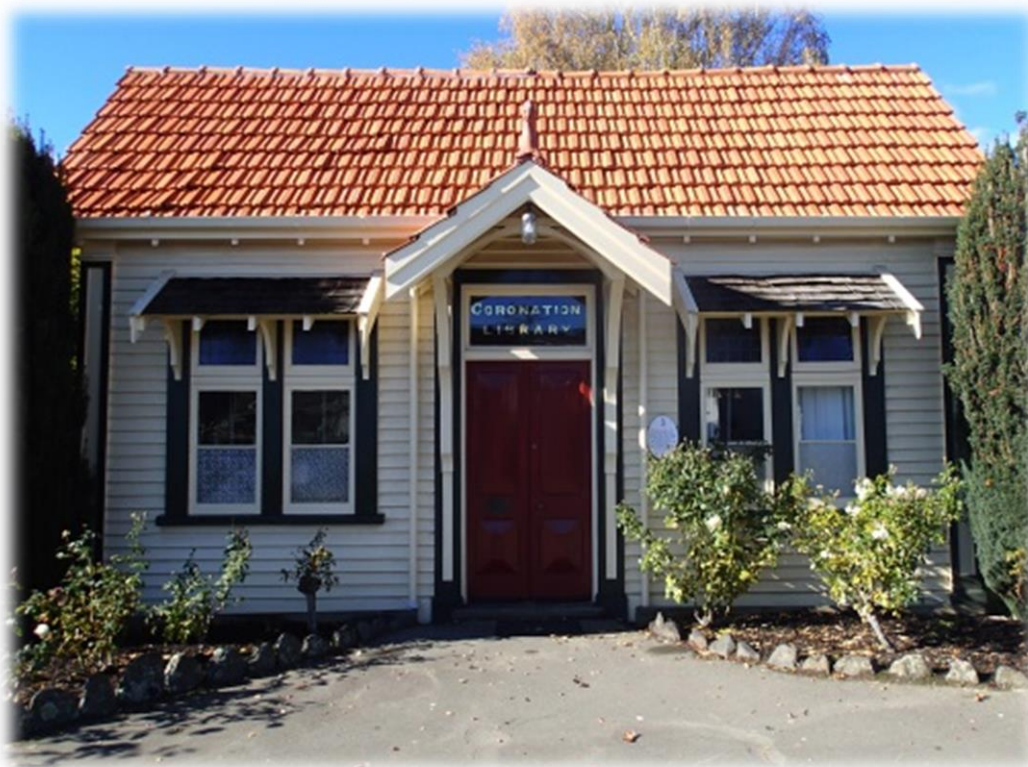
Install new heating system and repair earthquake and maintenance items, full strip and repaint.

The chimney has been made safe, foundations repaired and cracks to kitchen repaired. The heating system is currently being installed. Exterior painting will commence in January.

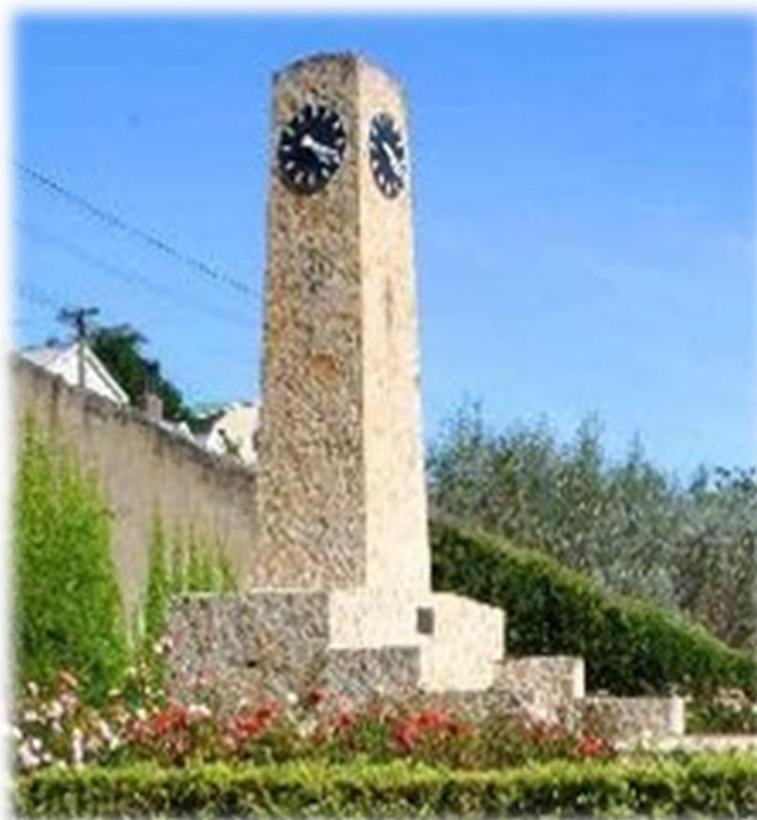
The Lyttelton (Upham) Clock tower currently has a 25%NBS and is closed. The structure currently exhibits a prominent crack through the midpoint of the structure as well as various points of displaced stonework. The design involves removing the roof and installing four steel angles down the full length of the internal cavity to strengthen the shear core.

Detailed design to 67% NBS has been completed. Building consent exemption has been approved. Documentation for resource consent has been approved. Contractor has been appointed, works are to commence in January 2017

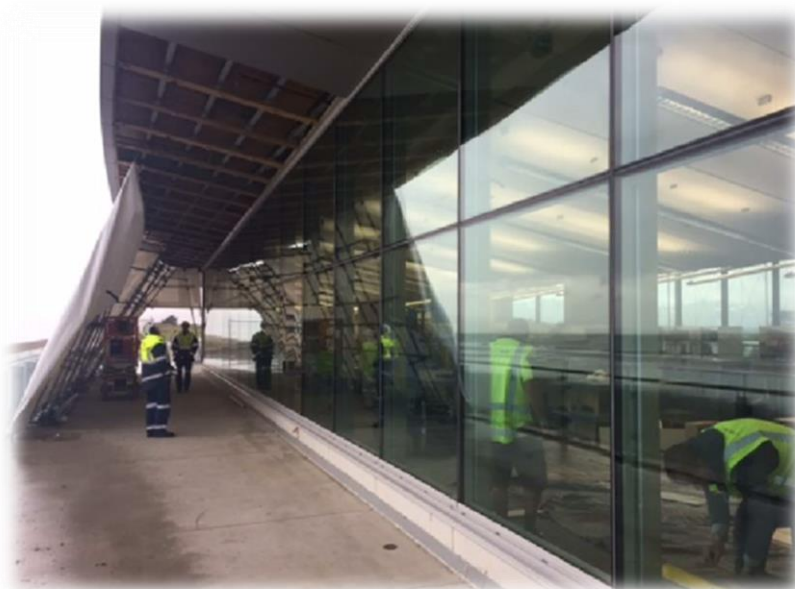
Windows installed, finishing reinstatement works

- Construction complete scheduled for 16th December 2016 with defect items to be corrected the following week
- Installation of sails to be completed w/c 19th December
- Code Compliance Certificate, due to holiday period, likely to be received mid-January

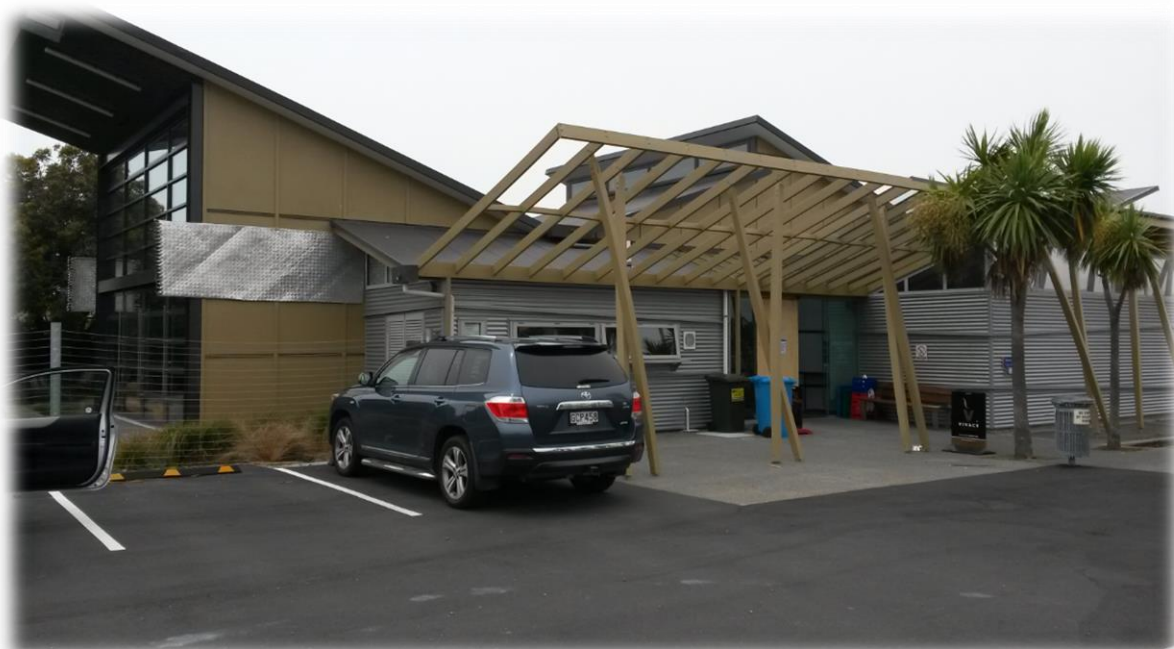
Parklands library main entrance

Stage 1 of the project is to repair underground services and to replace the wooden lintel above the rear door. A site meeting on Tuesday 13th December took place where the scope was confirmed to include drainage and storm water pipework repair, landscaping and south door lintel replacement. Project scheduling plan will be done in January.

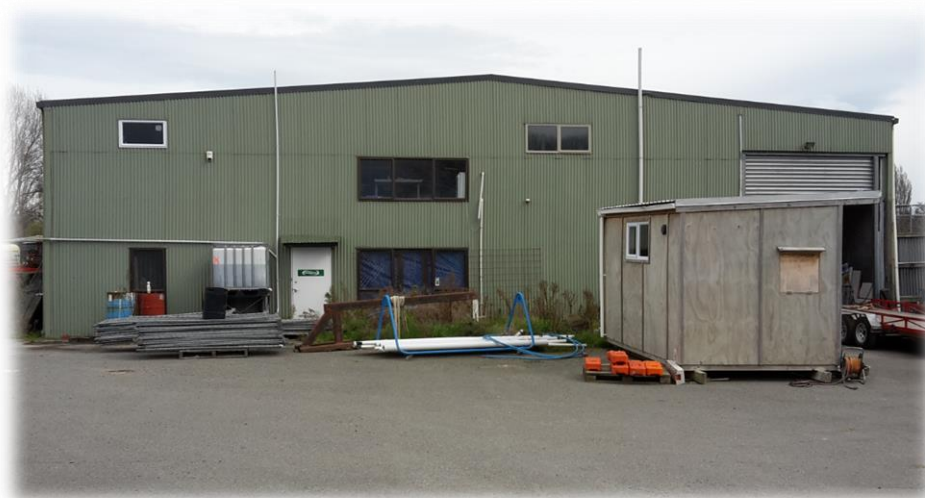
Existing Workshop on QEII grounds.

The QEII Workshop will be demolished once the replacement workshop is completed at Nga Puna Wai.

The concept design created for the Workshop on the QEII site will be transferred along with remaining budget to the project management team working on NPW for further action. No further reporting will be undertaken through the Community Facilities Programme.

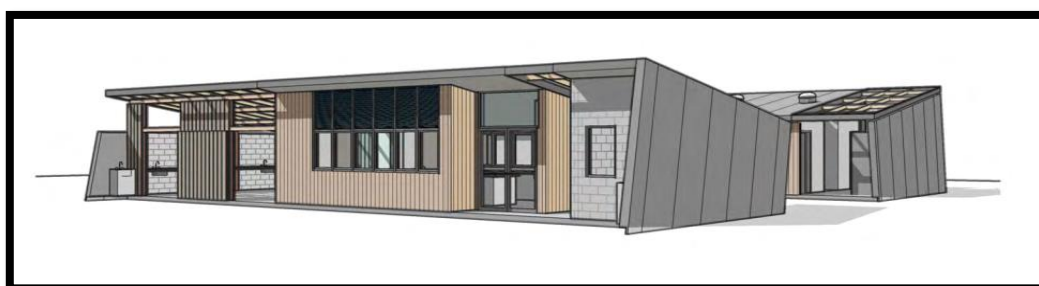
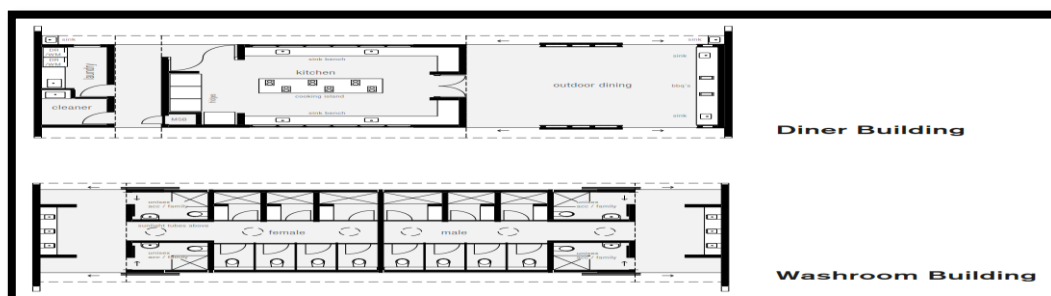
Spencer Park New Building

The concept design has been amended and is currently being professionally estimated to ensure delivery can be achieved and further work around the budget and the asset owner's intention can be finalised. This project will then move into developed design.

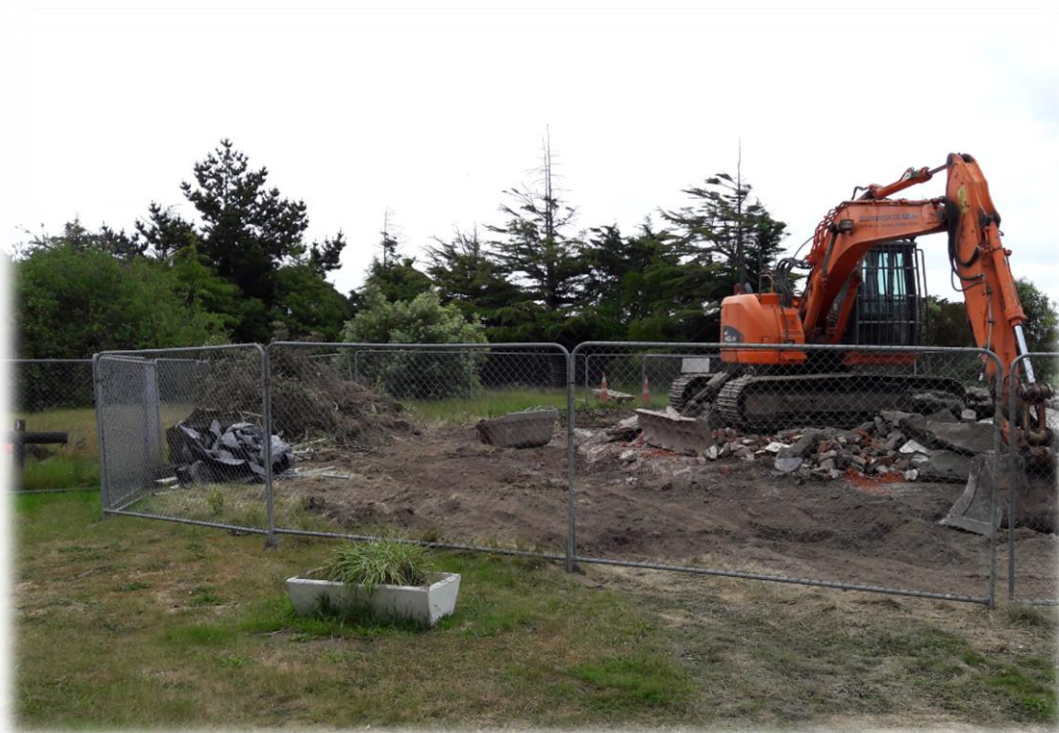
Ablution Block No. 2 being demolished December 2016

Demolition of earthquake damaged Ablution Block No. 2 building.

Repairs to earthquake damaged underground services (sanitary wastewater lines)

Underground services are being replaced by an all new sanitary waste system, which is being designed by Council Engineers. Project is on track to begin construction in late February 2017.

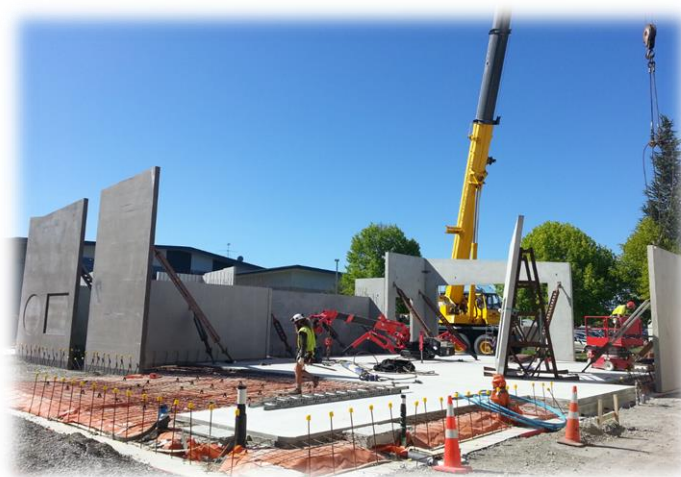
Arrival of pre-cast concrete panels on site

Work is progressing well and remaining pre-cast concrete panels are on site. Structural steel will be delivered and erected before Christmas. Work in the new year will include getting the roof on, framing up walls and making the building water tight so that internal work can commence. The Community Board received a project briefing on 12 December 2016

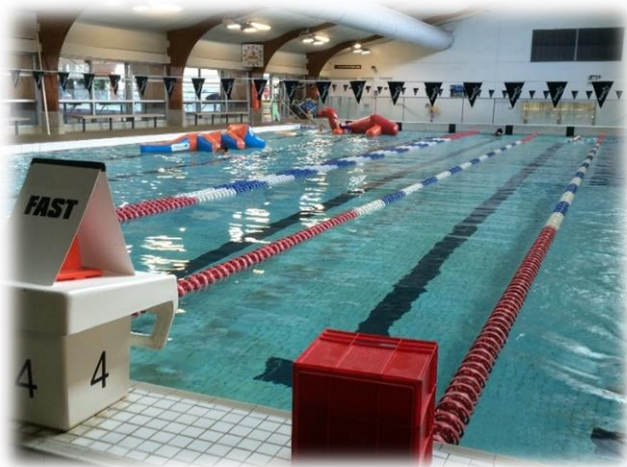
Recreation Pool at Jellie

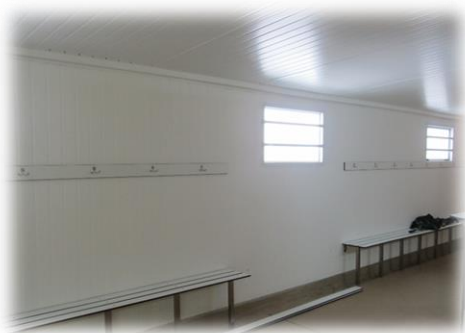
Ladies' change room

This project is very close to completion. All three changing rooms are complete with an outstanding item in two. All of the steel reinforcement has been installed.

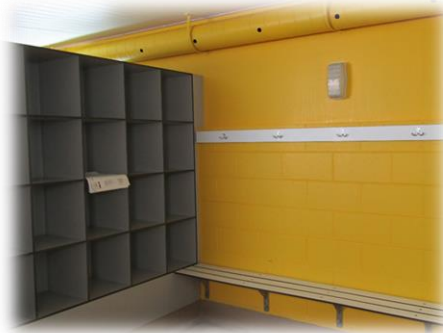
Ladies' change room

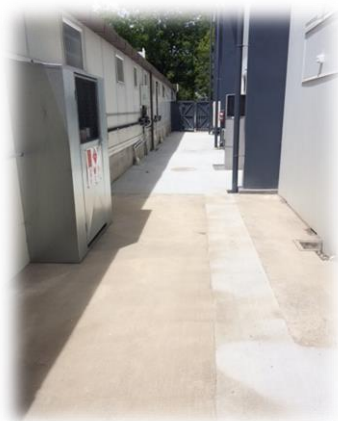
Alley between pool building and rec centre laid with new concrete

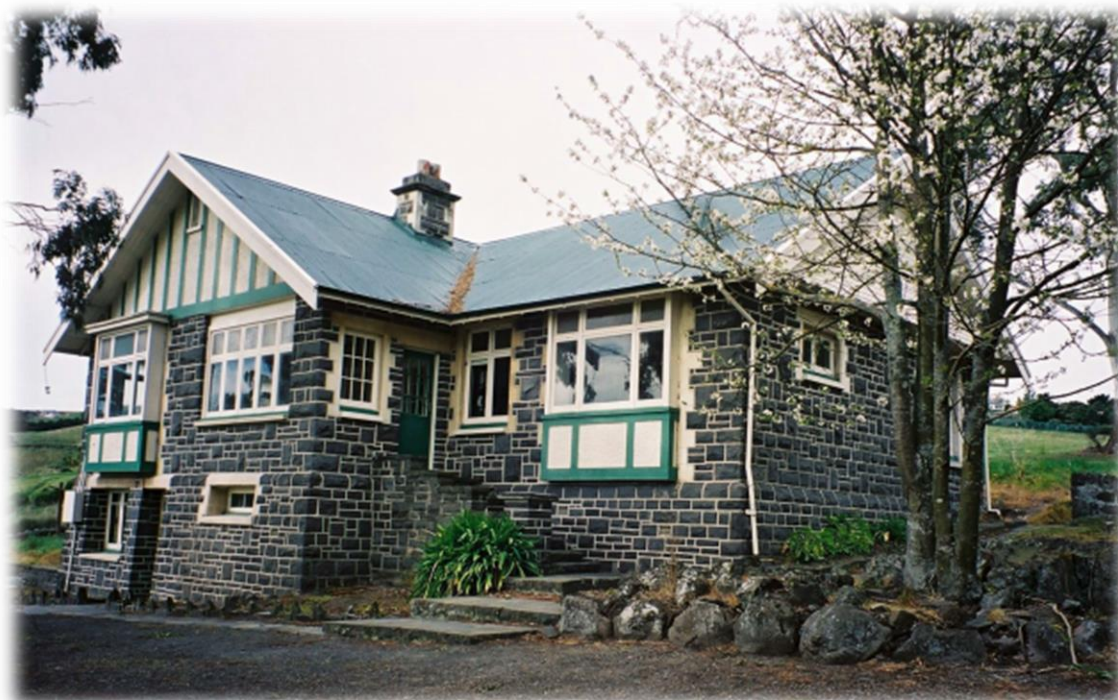
The Halswell Quarry Old Stone House currently has a 40%NBS but remains closed. This is due to the temporary stabilisation of the damaged chimney and state of disrepair due to earthquake damage of the internal linings.

The works will include reconstruction and strengthening of the chimney, improvement of the structural tie element and connections of both the roof and walls as well as a full programme of repair/reinstatement of internal linings.

Site was established in October with strengthening and repair works underway including chimney and internal bracing of floor and ceiling elevations.

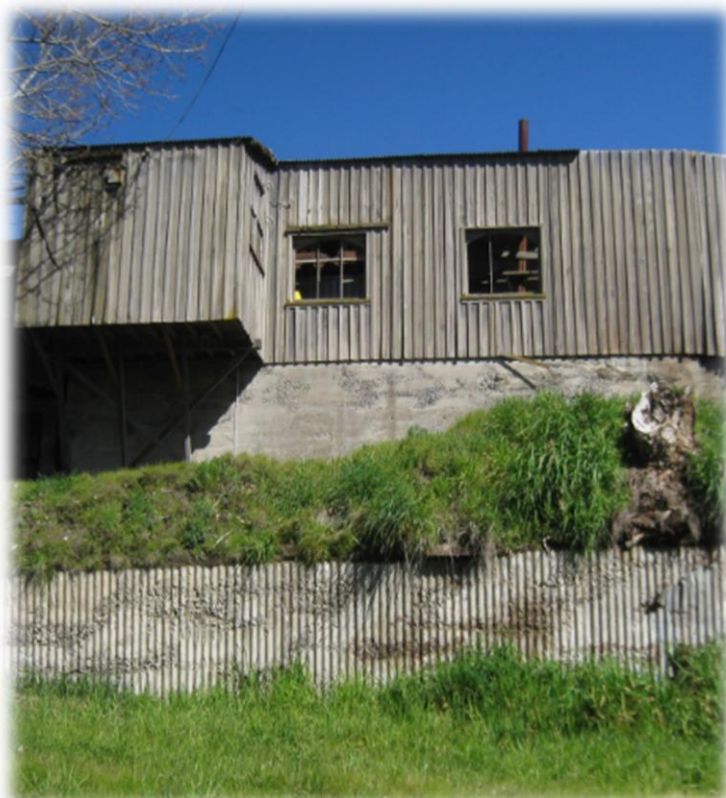
The Halswell Quarry Crusher Building currently has a 35%NBS but remains closed to the public as there are adjacent areas of the building which are considered unsafe.

The works will include improvement of the foundation/building connections, reinstatement of timber framing and an associated comprehensive package of maintenance works resulting from the buildings historic lack of use.

Site was established in October with strengthening and repair works underway including end gable reconstruction and complex ground remediation.

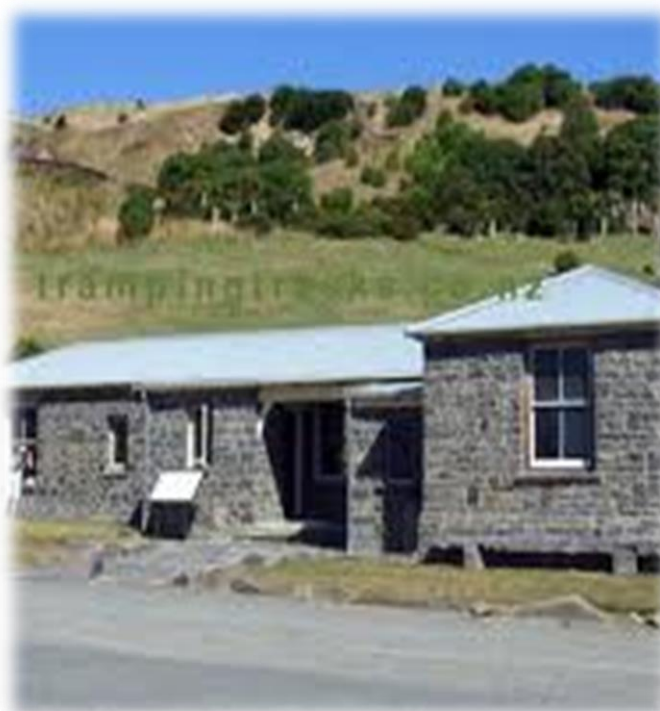
The works includes repair and strengthening to 67% NBS. There is a programme of strengthening to external masonry walls and roof, and the connections that are resultant. A system of post tensioning will be included to vertical sections of the elevations.

Site was established in October with strengthening and repair works underway with wall bracing, masonry repairs and complex post tensioning.

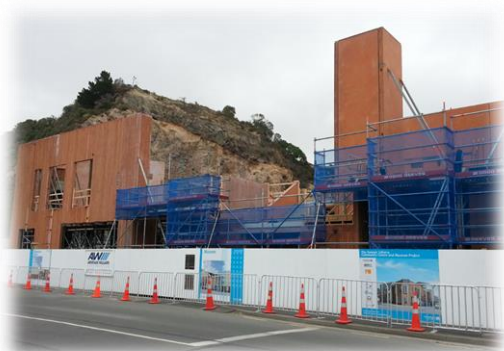
The new building, as seen from Wakefield Street

- Foundations, ground work and services are largely complete
- Pre cast concrete panels and structural steel have been arriving on site throughout November and December and the building structure is taking shape
- The project team are working with Fayne Robinson, (Maori artist and carver) on the fit out detail

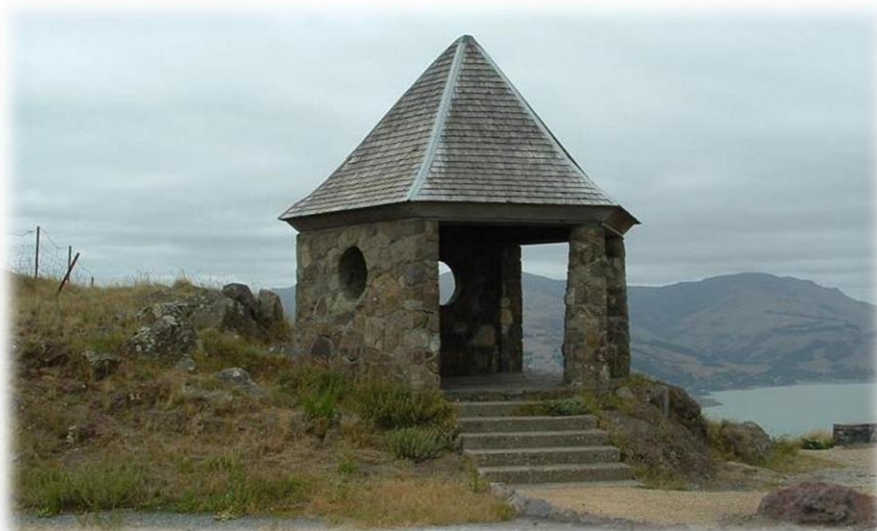
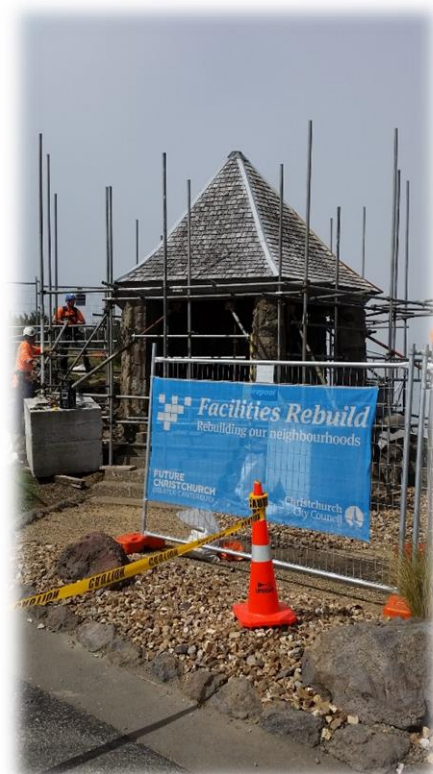
The contractor has been procured and has installed the required Resource Consent protections. The roof repairs and the replacement flashings are complete. Upon the start of deconstruction of the first column it was found not to be solid stone but have a concrete core. Engineering and Heritage Team have reviewed the situation, the works have now restarted with the second column being deconstructed.

Following review of the asset, strengthening of the roof ties to the wall as well as repairs to the columns is required. The Engineer Detailed Design have been received and approved. The Building Consent Exemption and the Resource Consent has been received.

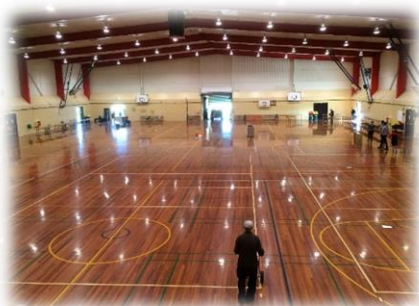
Stadium at Pioneer

Stadium (19 December 2016 – 22 January 2017)

- Foundation repairs
- Lighting replacement to energy efficient fixtures
- Painting
- Floor finishing (regular maintenance)

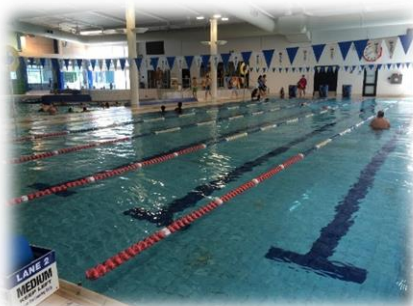
Pioneer Lane Pool

- Repairs to the pool tank – cracked and damaged tiles
- Drainage
- Replacement of the existing flooring from tile to Traxxite non-slip surface

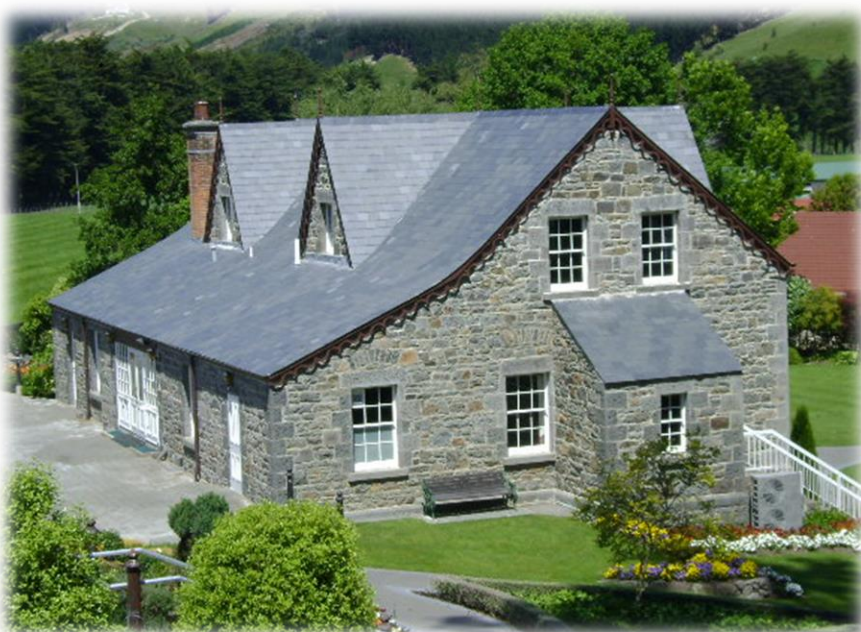
Progress to date is as follows: The areas within the building at the corners of the hall, the mezzanine connections and the window lintels have been deconstructed. Expansion joints in the entry lobby walls have been cut and filled. The drilled in hold down devices for the connection of the floor slab to the walls have been completed. Deconstruction of the chimney and fireplace has also been completed.

The building has been scaffolded and wrapped and the slate tiles have been removed ready for the installation of the new steel framework. The store areas on both sides of the gable ends have been deconstructed for the installation of new ring beams. On completion of this we have discovered a large amount of deteriorated stone work. These areas are now to be propped and new concrete beams positioned to the underside of the windows before the walls are made good.

This asset has been approved for repair and strengthening to 67%NBS. The works will involve reinstatement of the mezzanine connections, new diaphragm wall and roof connections, lateral wall support works, deconstruction and reconstruction of the chimneys as stone veneers around steel frames, the replacement of the stone lintels and the sealing of the concrete walls and foundations with pressure injected epoxy.

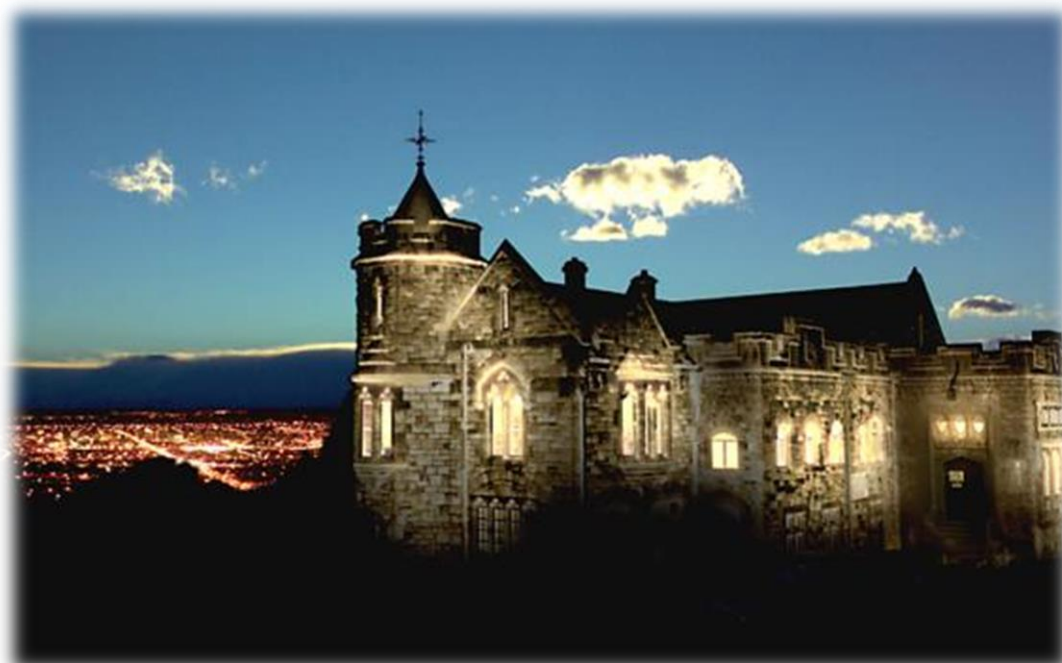
Further internal strip out of ancillary equipment is underway due to invasive works required by the strengthening design. Complex underfloor strengthening has commenced and is ongoing as well as the upper external roof section being shrink wrapped and roof works are ongoing which includes the associated detailed strengthening. Complex diaphragm roof works and deep core pinning to the parapets is ongoing with post tensioning to the tower also.

Upgrade and improvement of emergency lighting, fire and safety equipment has commenced.

Works to include extensive strengthening and reconstruction of the roof structure and external perimeter parapets including stainless tying and post tensioning works to the tower section. Internal deconstruction and reconstruction of chimneys including strengthening, complex and detailed tie configuration to the first floor level.
