**Canterbury Earthquakes 2010/11 Port Hills Slope
Stability: Risk assessment for Clifton Terrace**

**GNS Science Consultancy Report 2014/76
August 2014 FINAL**

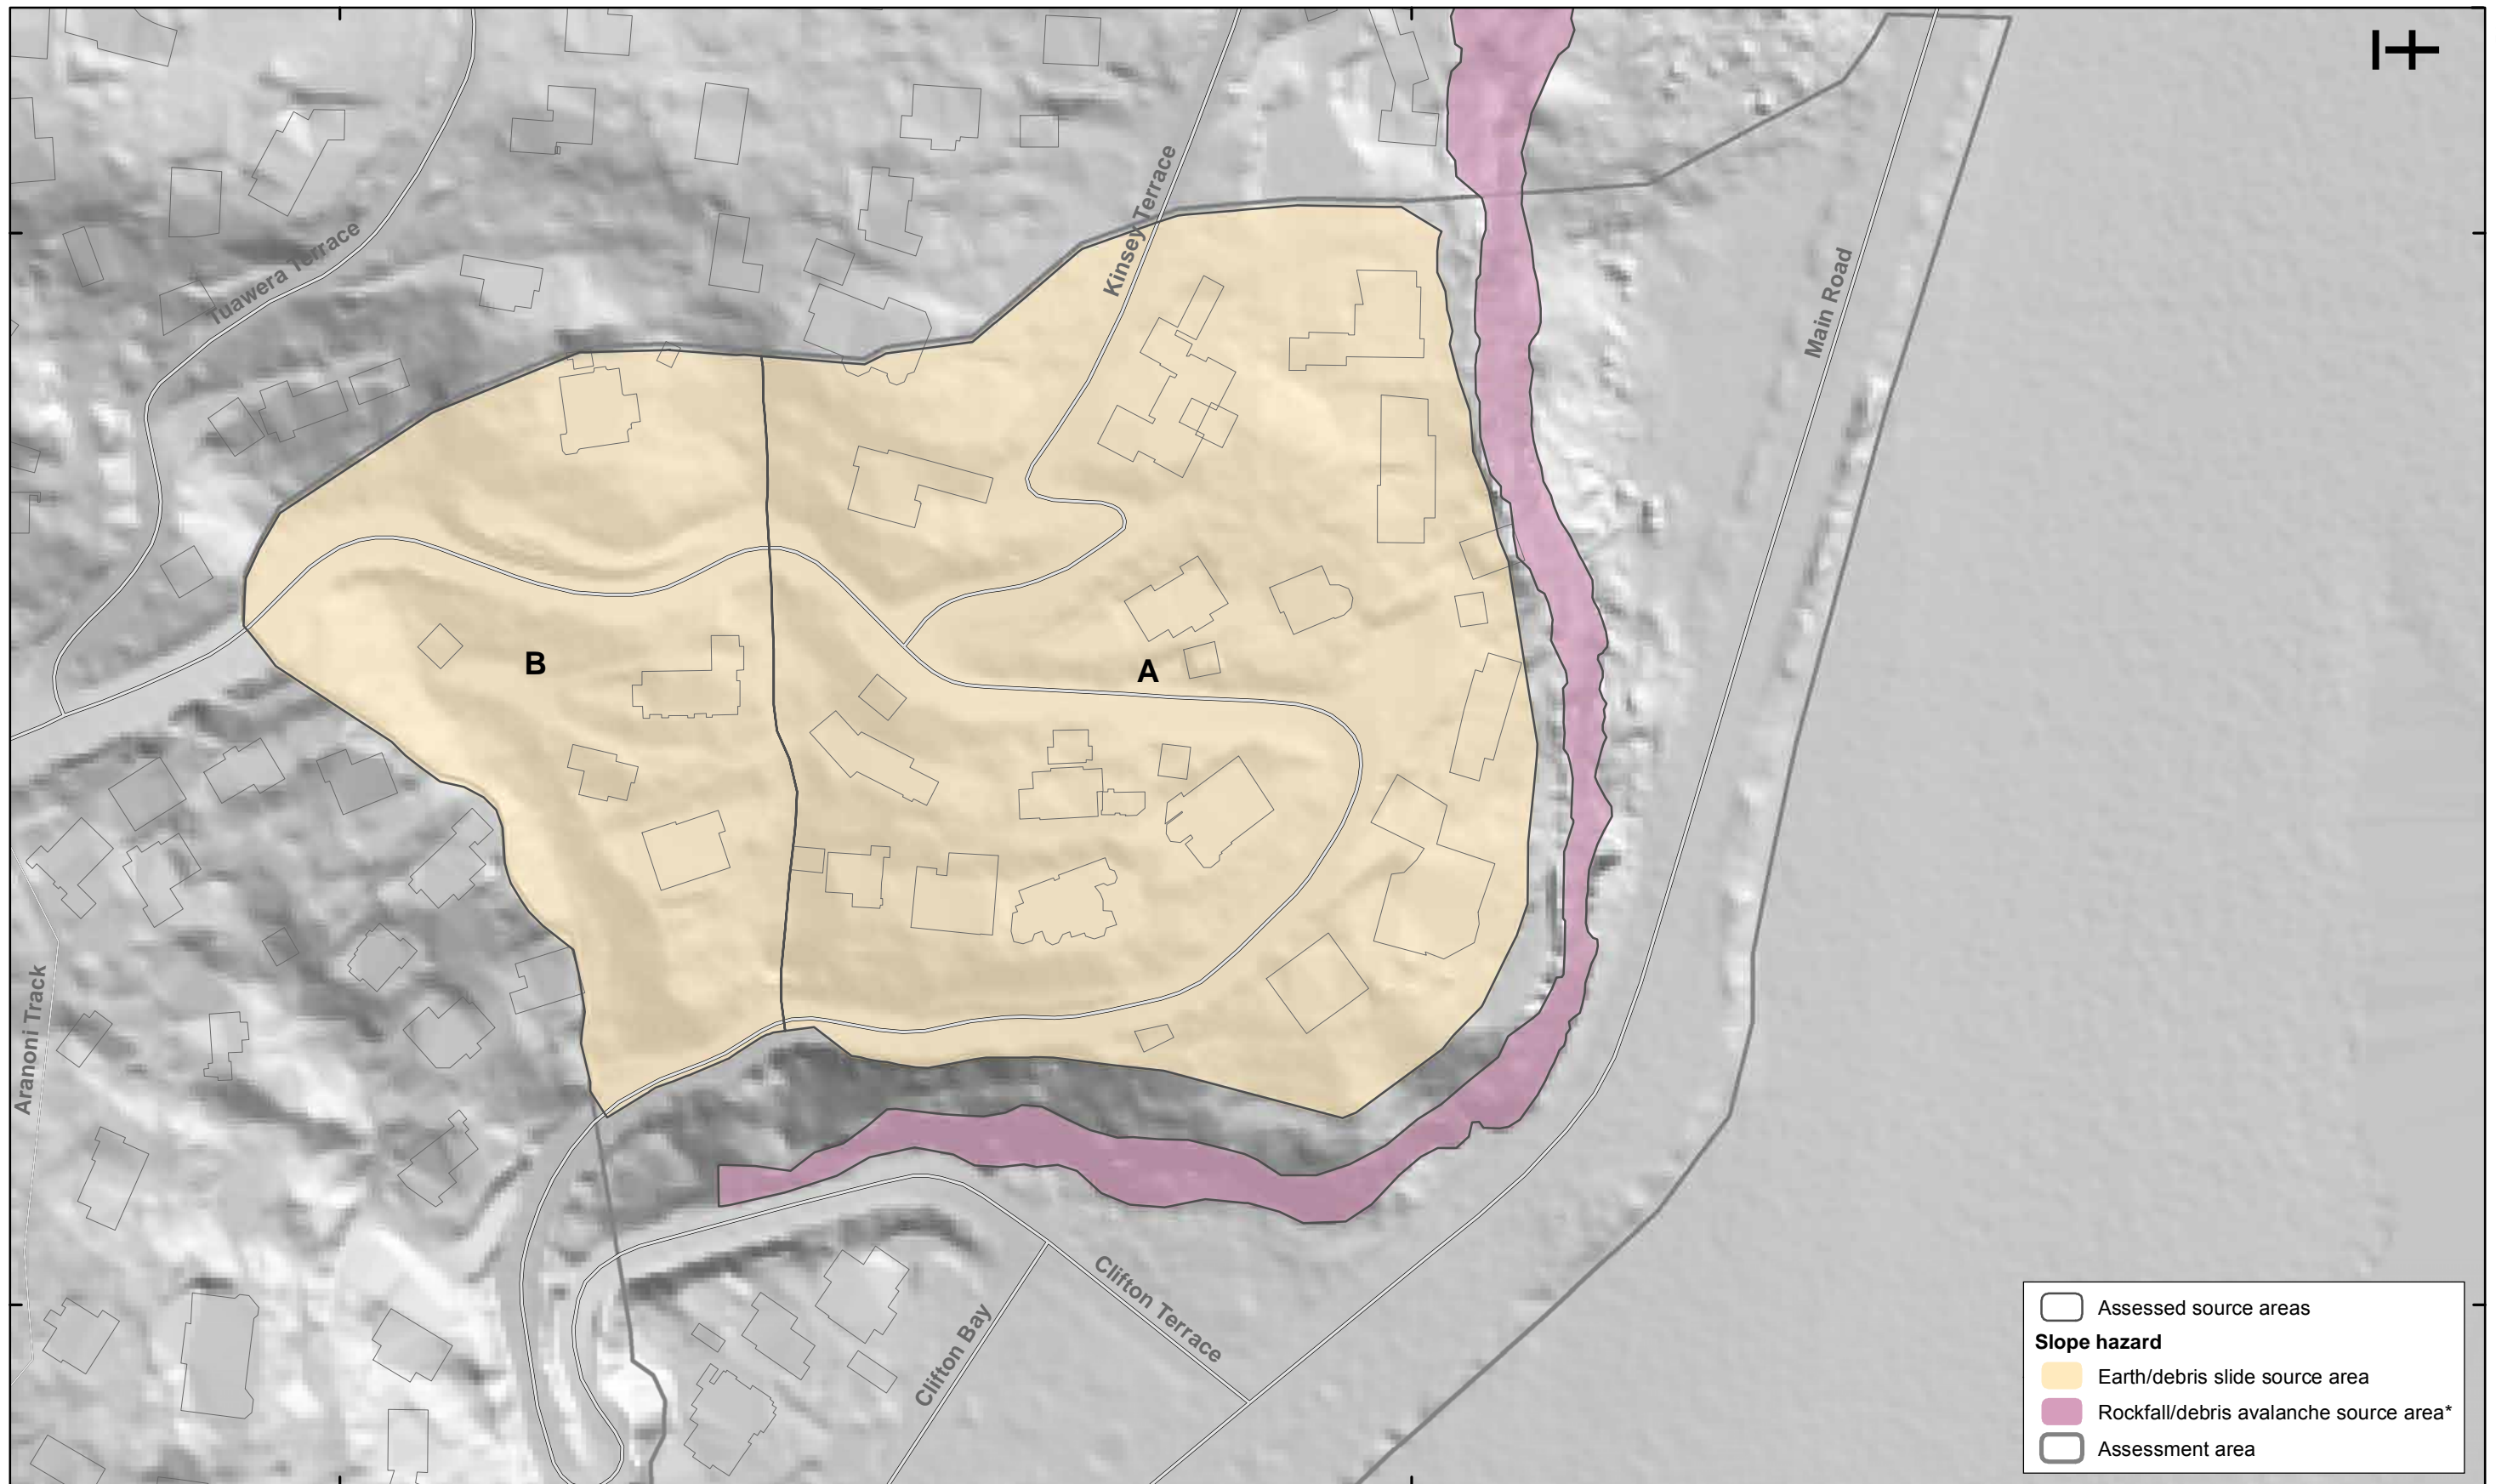
FIGURE 2

This report presents the risk-assessment results for both the Clifton Terrace Class I and Class II mass movements located above the cliff crest. The map in Figure 2 outlines the assessment area and the revised assessed source areas A and B, which as a result of these investigations differ slightly to the original boundaries shown in Figure 1.

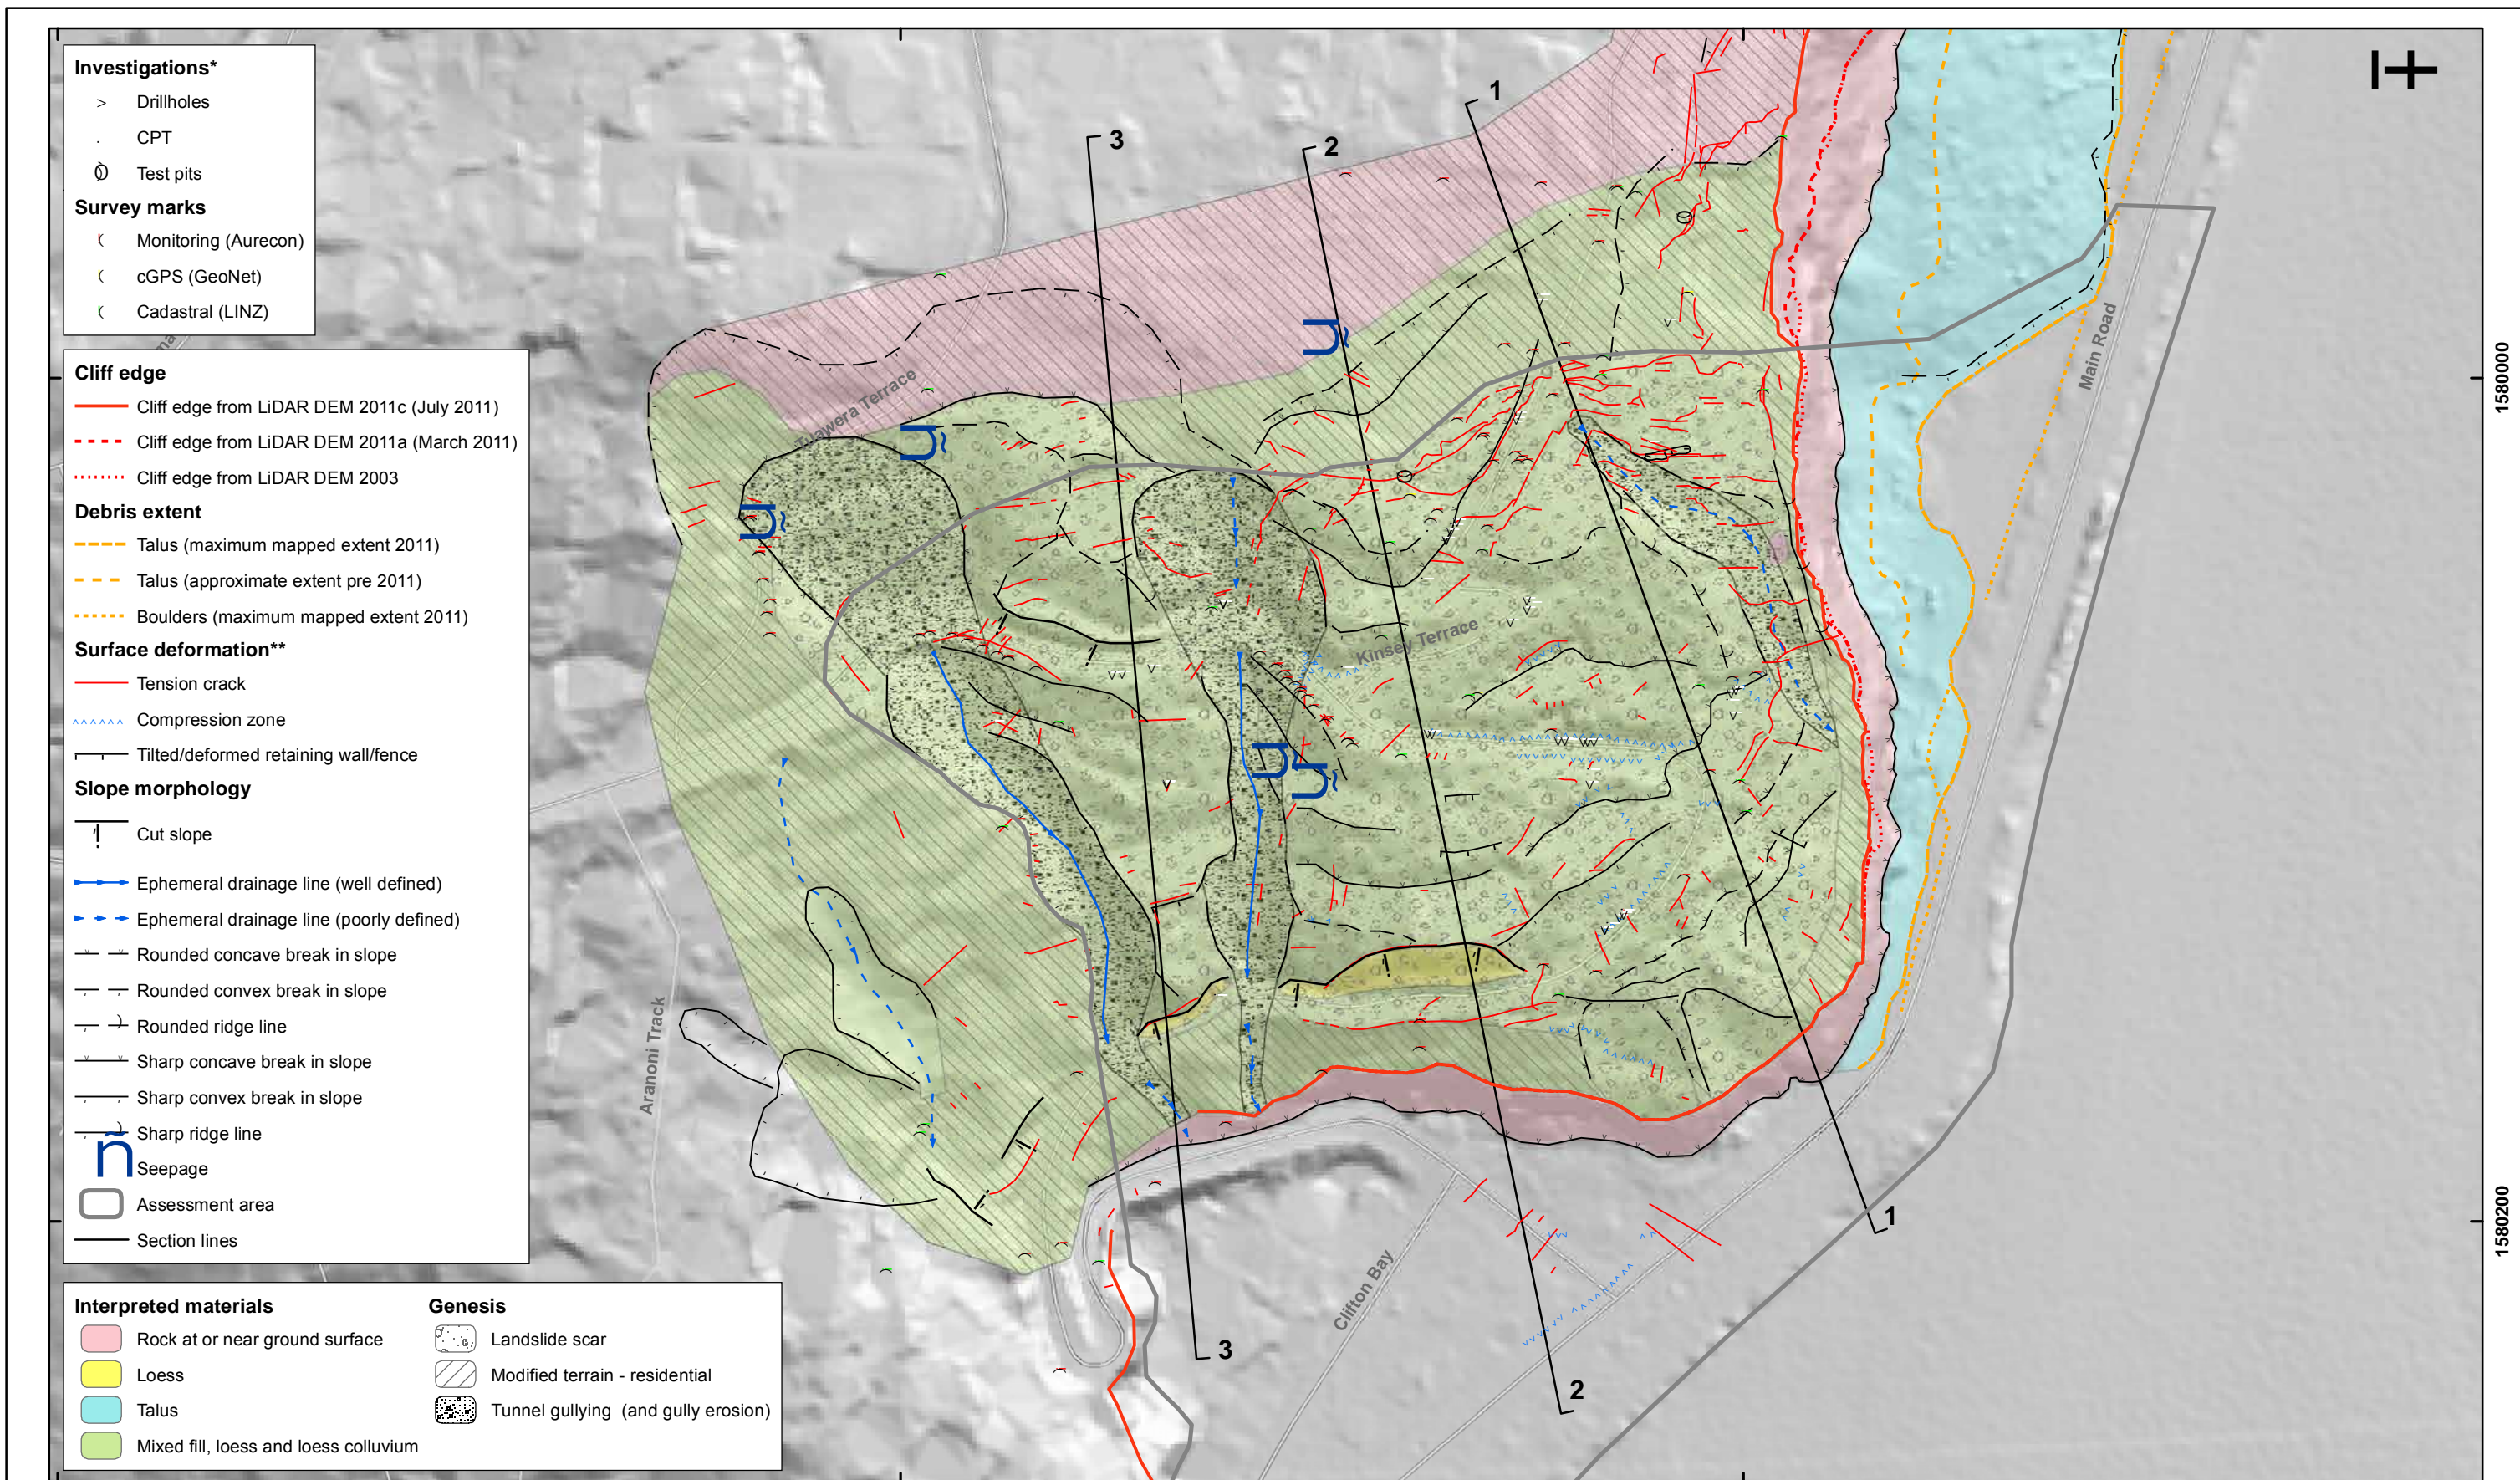
ENGINEERING GEOLOGY MAP Clifton Terrace Christchurch		FIGURE 7	
EXPLANATION: * For details refer to site investigation map ** Taken from report 2012/317 Background shade model derived from NZAM post earthquake 2011c (July 2011) LiDAR survey resampled to a 1 m ground resolution. Roads provided by Christchurch City Council (20/02/2012). PROJECTION: New Zealand Transverse Mercator 2000		DRW: BL CHK: CM, FDP						FINAL REPORT: CR2014/76 DATE: August 2014

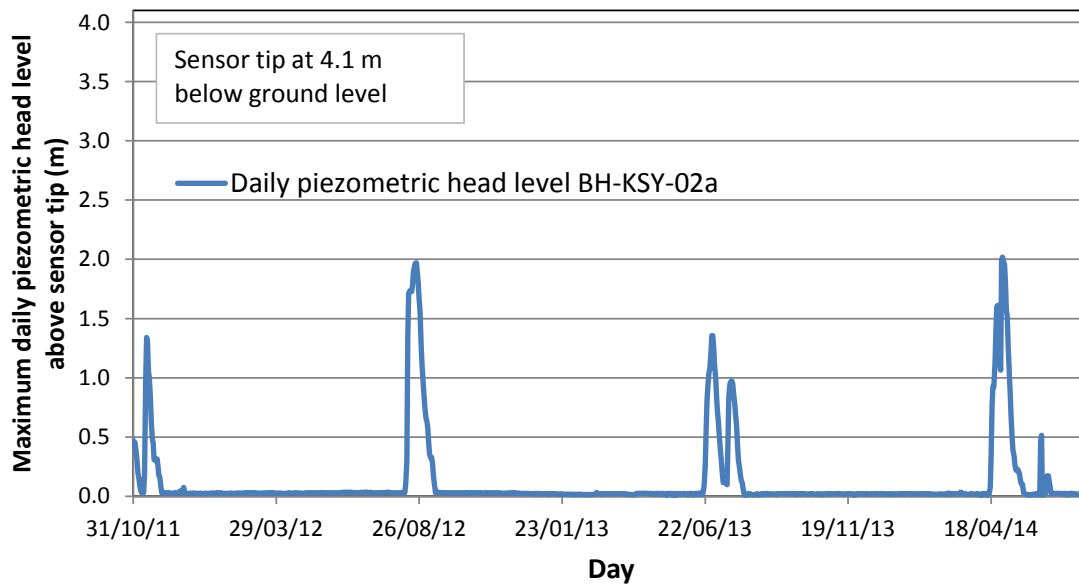
Figure 9 Piezometric head levels recorded above the sensor tip installed in the standpipe in drillhole BH-KSY-2a. The sensor tip is at 4.1 m below ground level and 2.0 m above rock head.

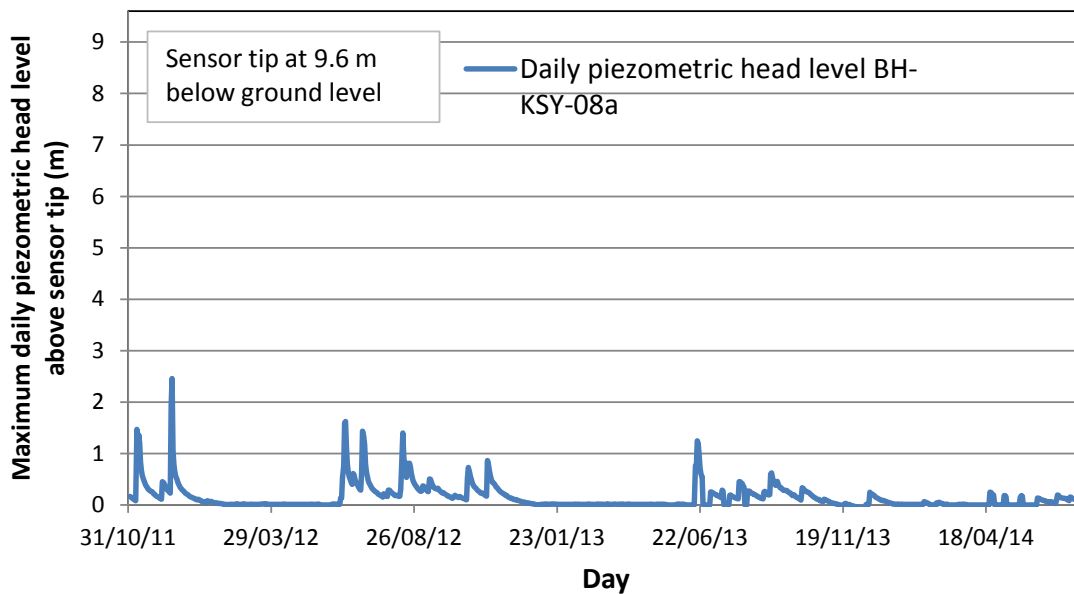
Figure 10 Piezometric head levels recorded above the sensor tip installed in the standpipe in drillhole BH-KSY-8a. The sensor tip is at 9.6 m below ground level, and 0.8 m above rock head.

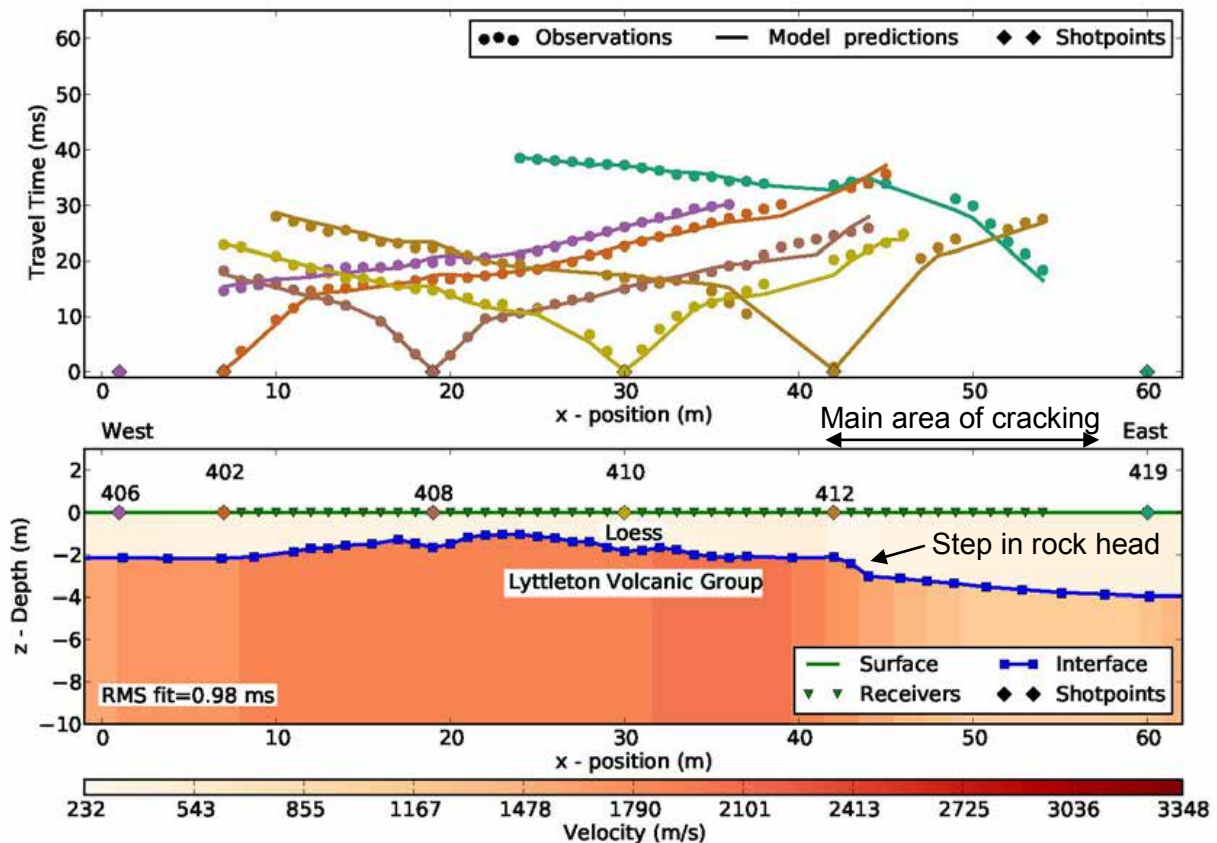
A vertical step in rock head of about 1.5–2 m was interpreted from geophysical refraction surveys across the head scarp of source area A, in the main area of cracks (Clarke, 2012). Clarke (2012) refers to this step as a “fault scarp”. On the upslope side of the step, outside the main cracked area, the loess is 1–2 m thick, and on the downslope side of the step, in the cracked area, the loess is 4 m or more thick (Figure 15). Tonkin and Taylor (2012a) excavated a test pit (TPK-1) to rock head (about 4 m below ground level) across a prominent tension crack, down slope and offset 20 m from the seismic line. The depth of rock head in the test pit is consistent with the inferred depth from the seismic line. However, no obvious step in rock head was identified in the base of the test pit, although rock head did vary in the base of the pit, from four to five below ground level, across a distance of five metres. The prominent tension crack, exposed in the wall of the test pit, terminated in the loess about one metre above rock head.

The seismic-line data also show a change in the P-wave velocity recorded in the rock downslope of the step in rock head, and within the cracked area. The P-wave velocity in this area was about 500–1,000 m/s, compared to >1,500 m/s for the rock upslope away from the step in rock head and area of cracking (Figure 15).

Figure 15 Results from the refraction seismic collected across the head scarp of assessed source area A (Clarke, 2012). The location of the survey line is shown in Figure 6. The data shown are taken from Clarke (2012) and are Inversion models adopting the root mean squared fit. Note: from x-position 0 to 7 m and from 55 to 60 m there is no data.

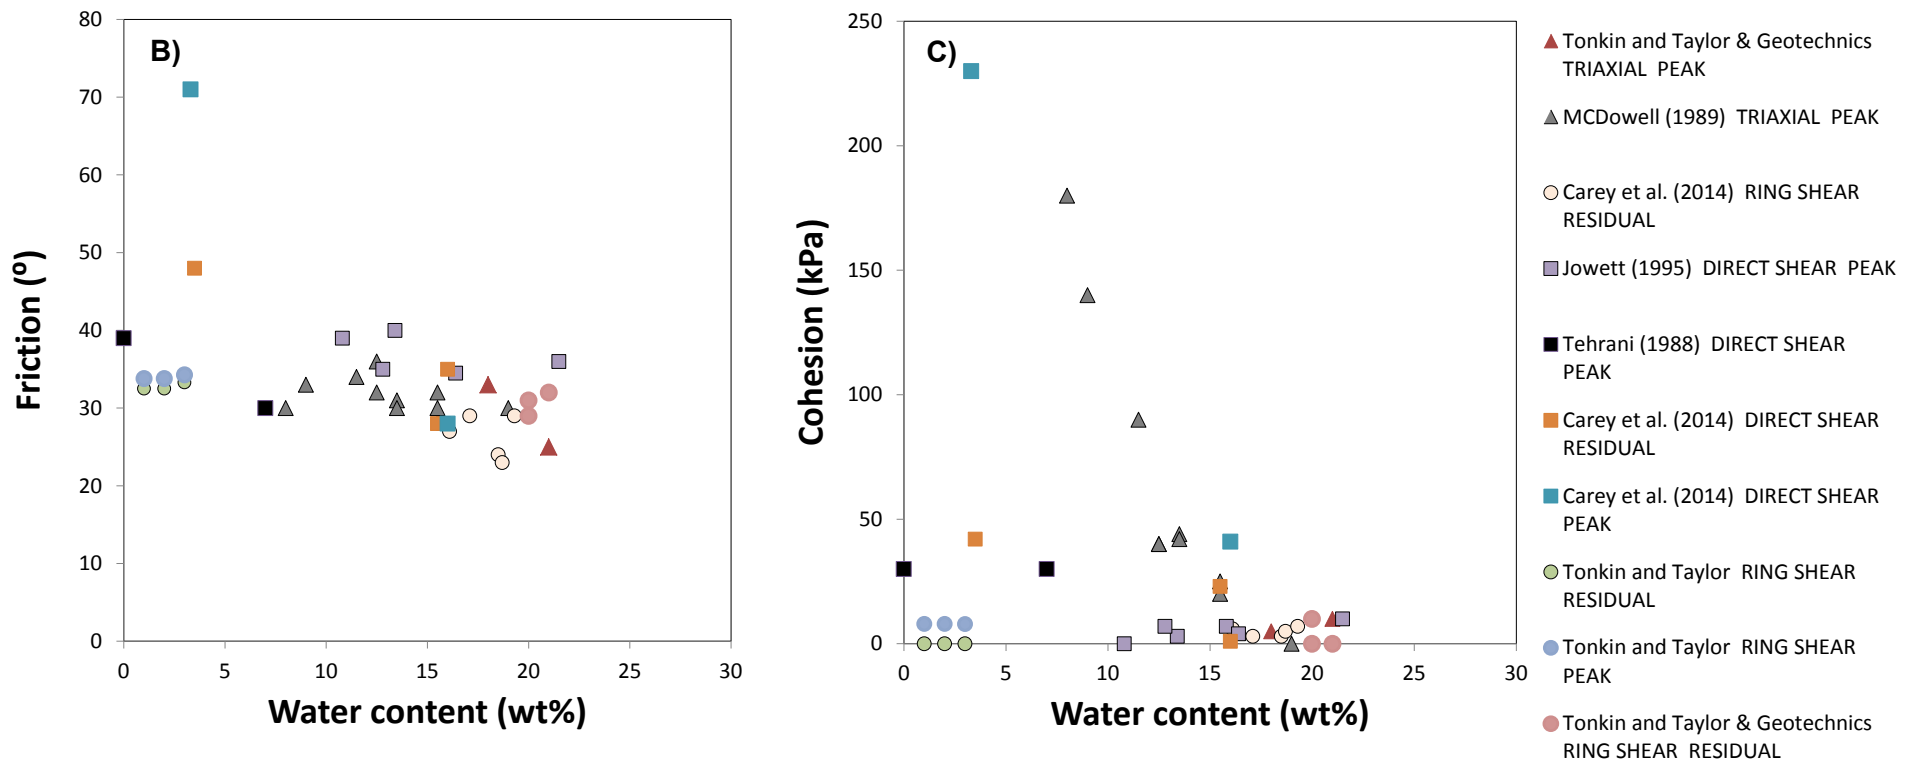
For water contents less than 20 wt% the cohesion of the tested loess is very sensitive to changes in water content. These results illustrate a large variability in the strength parameters of the loess in the Port Hills, and show that the loess strength is critically dependent on water content. These results are consistent with the findings of others (e.g., McDowell, 1989; Goldwater, 1990).

During periods of prolonged wet weather it is feasible for water contents in the loess to increase leading to a reduction in the cohesion and increased susceptibility to failure. The data plotted in Figure 17 probably represent the range of strength parameters at the likely range of moisture contents that could be anticipated in the Port Hills loess.

Figure 17 Loess residual shear strength results (from Table 11 and Table 12). A) Cohesion and friction laboratory results plotted for loess. B) Loess residual cohesion plotted against water content. C) Loess residual friction plotted against water content. The Tonkin and Taylor Ltd. and Geotechnics Ltd. triaxial results are from samples of loess taken from drillhole BH-KSY-9a.

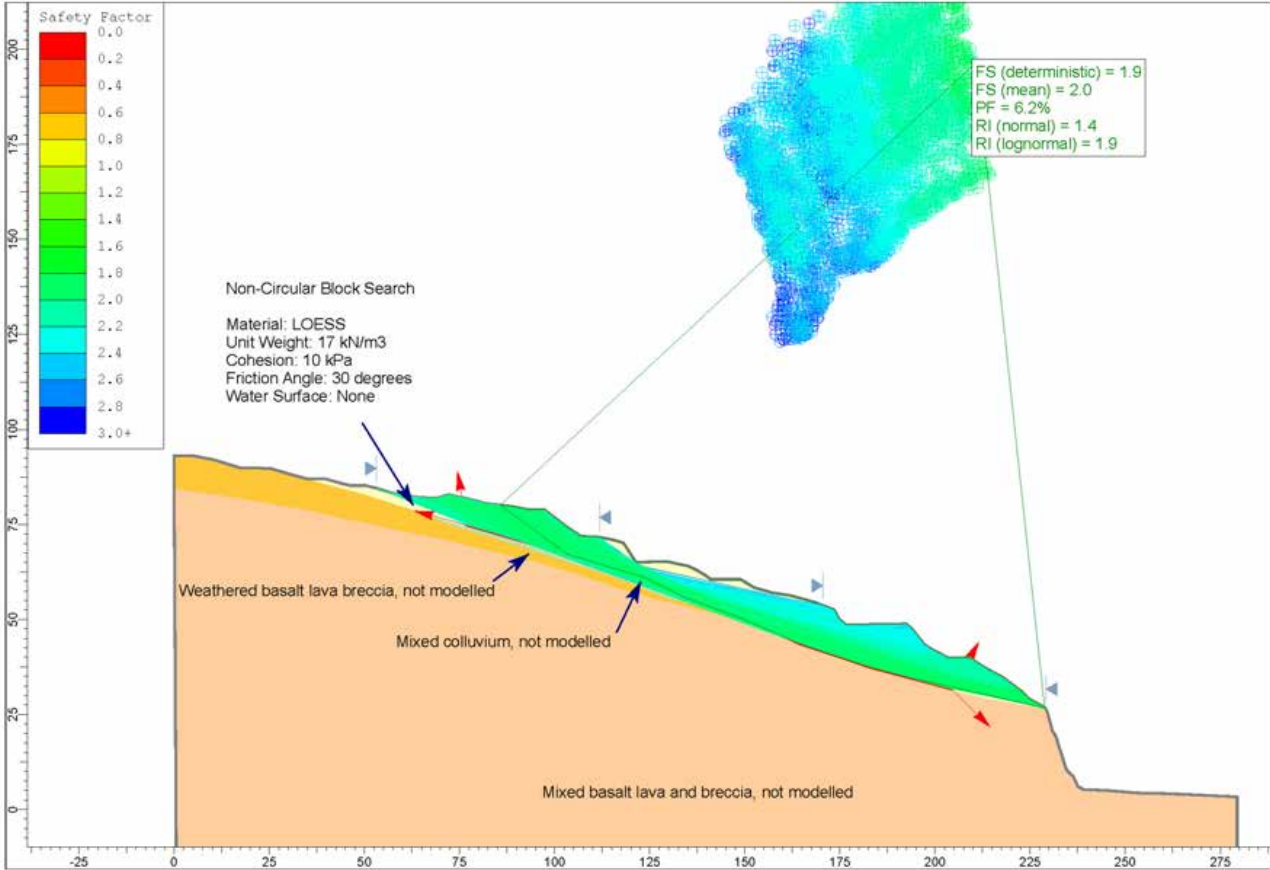
Figure 18 and Figure 19a show the results from numerical slope stability back-analysis for failure surfaces confined to the loess, for cross-section 2 (Figure 8), representing assessed source area A, overlain with the results from the laboratory testing of loess (Figure 17). The failure surfaces adopt the path-search surface function in the RocScience program Slide and no water is included in the model. The purpose of this plot is to show the range in the back analysed slope factor of safety with regards to the range of the laboratory test results, for loess.

Figure 18 Numerical slope stability back-analysis of the loess material for cross-section 2, representing source area A. Note: each modelled slide surface adopts the “path search” function.

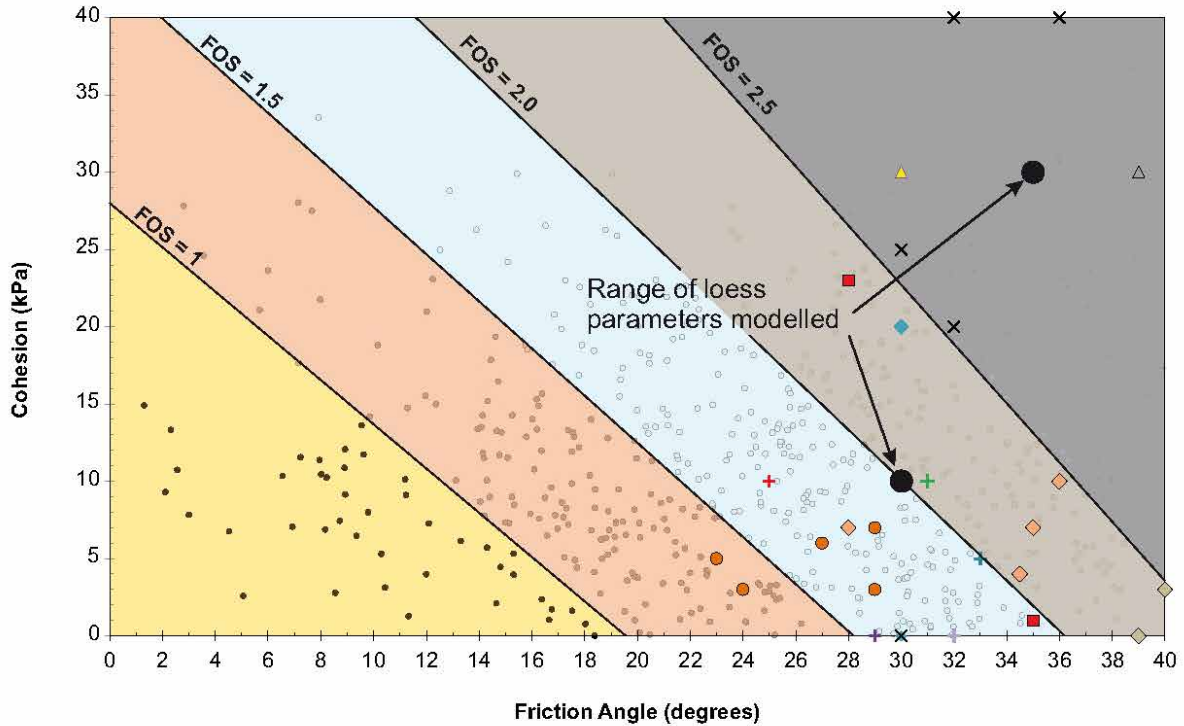
A lower estimate of the shear strength of the loess, needed to derive a static factor of safety for the slope of one, was a friction (ϕ) of 20° and cohesion (c) of 0 kPa, or any other combination of friction and cohesion on the factor of safety = one line. Such values are much lower than the range of shear strengths derived from laboratory testing of the loess, and they are even lower than those test results on samples where water contents were close to the liquid limit of the loess. The slope isn't moving, therefore the factor of safety is greater than 1.0 and the material strength parameters have to be greater than the black dots in Figure 19a.

Typical lower estimates of the bulk shear strength parameters of loess in the Port Hills adopted by local geotechnical consultants are friction (ϕ) = 30° and cohesion (c) = 10 kPa (Port Hills Geotechnical Group personal communication, 2013). These data are shown as black circles on Figure 19a. The results show that for the typical range of loess parameters adopted by engineering consultants in Christchurch, the factors of safety of slide surfaces in the loess are typically greater than 1.9, under dry conditions.

Figure 19a Numerical slope stability back-analysis of the loess material for cross-section 2, representing source area A. Note: each datapoint represents a modelled slide surface, adopting the geometries shown in Figure 18, at a given combination of cohesion and friction adopted for the loess. Those slide surfaces (adopting the path-search function), shown as black dots, represent those combinations of cohesion and friction that would yield a static factor of safety of less than one. The results from the laboratory testing (Figure 17) are also shown for comparison purposes.

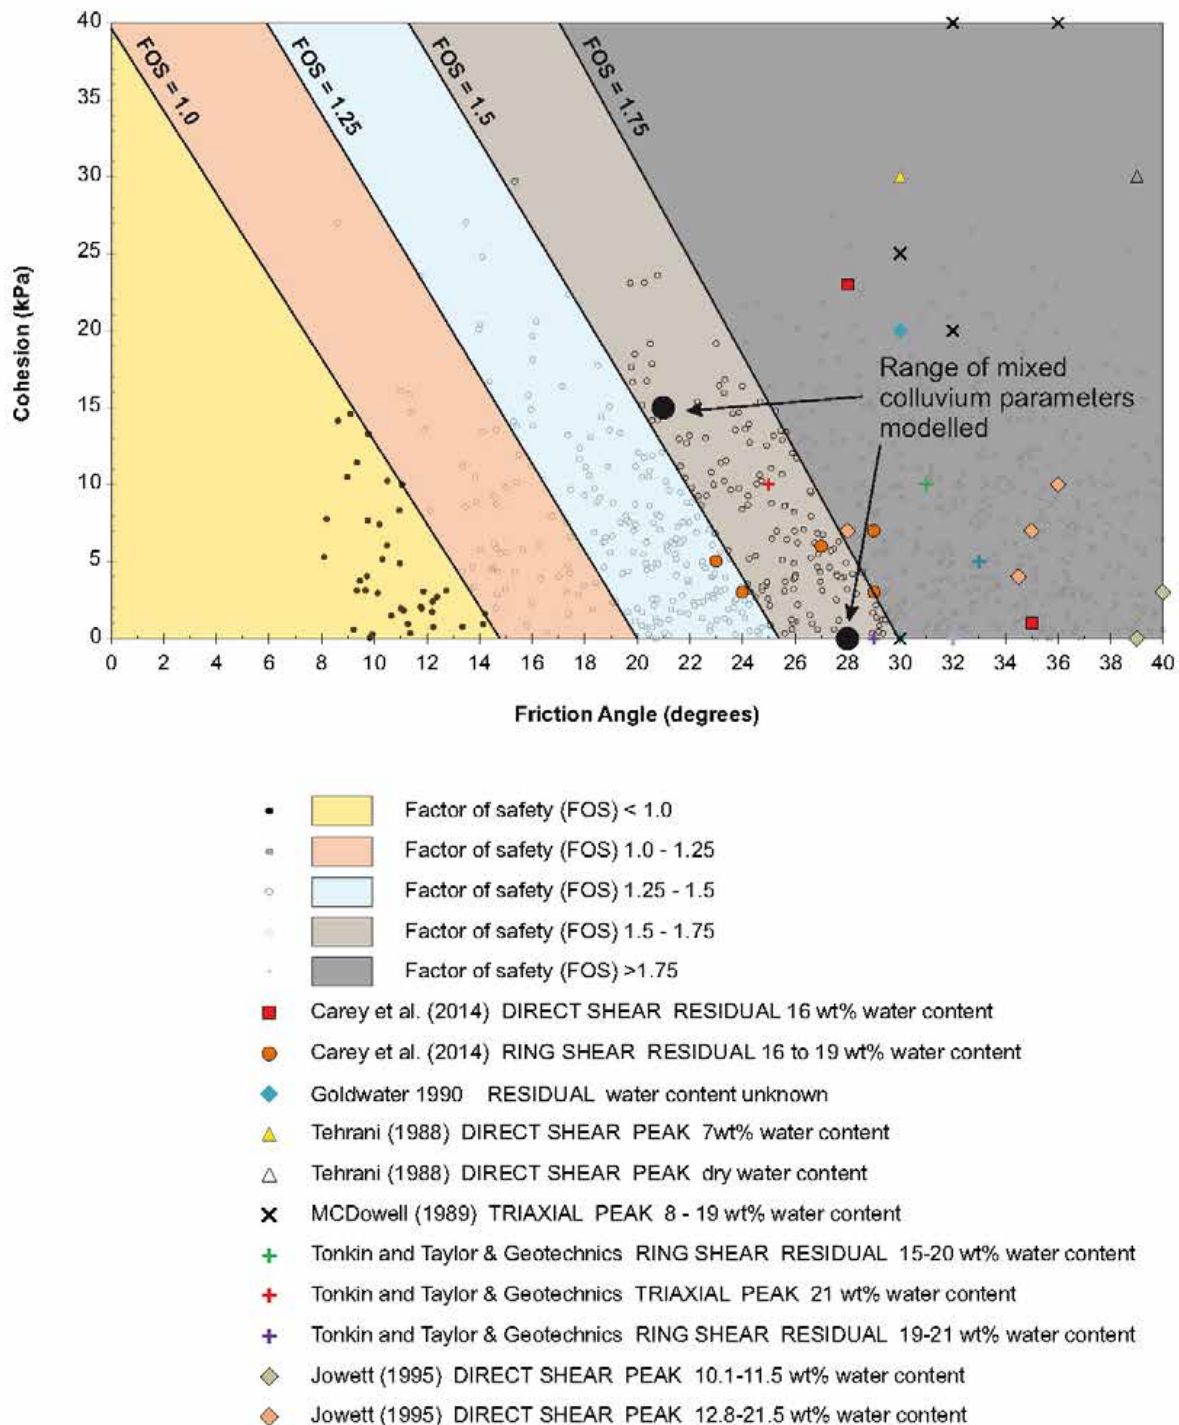
Figure 19b show the results from numerical slope stability back-analysis for failure surfaces confined to the mixed colluvium, for cross-section 2 (Figure 8), representing assessed source area A, overlain with the results from the laboratory testing of loess (Figure 17). The failure surfaces adopt the path-search surface function in the RocScience program Slide, and the model assumes the mixed colluvium is continuous, below the loess and above rock head, over the entire length of the slope within source area A.

The results show that by including a weak layer of mixed colluvium in the model the factors of safety of the modelled slide surfaces reduce. A lower estimate of the shear strength of the mixed colluvium, needed to derive a static factor of safety for the slope of one, was a friction (ϕ) of 15° and cohesion (c) of 0 kPa, or any other combination of friction and cohesion on the factor of safety = one line. Such values are significantly lower than the range of shear strengths derived from laboratory testing of the loess. The slope isn't moving, therefore the factor of safety is greater than 1.0 and the material strength parameters have to be greater than the black dots in Figure 19b.

The results from ring-shear testing of the matrix material from the drillcore sample of clay from the highly weathered basalt breccia (friction (ϕ) of 21° and cohesion (c) of 15 kPa) are shown on the Figure 19b, and correspond to factors of safety of about 1.5–1.7. Although this material is clay dominated, the lower ranges of results from ring-shear testing of the loess (silt dominated) also yield similar factors of safety.

Figure 19b Numerical slope stability back-analysis of the mixed colluvium for cross-section 2, representing source area A. Note: each datapoint represents a modelled slide surface, adopting geometries similar to those shown in Figure 18, at a given combination of cohesion and friction adopted for the mixed colluvium. Those slide surfaces (adopting the path-search function), shown as black dots, represent those combinations of cohesion and friction that would yield a static factor of safety of less than one. The results from the laboratory testing (Figure 17) are also shown for comparison purposes.

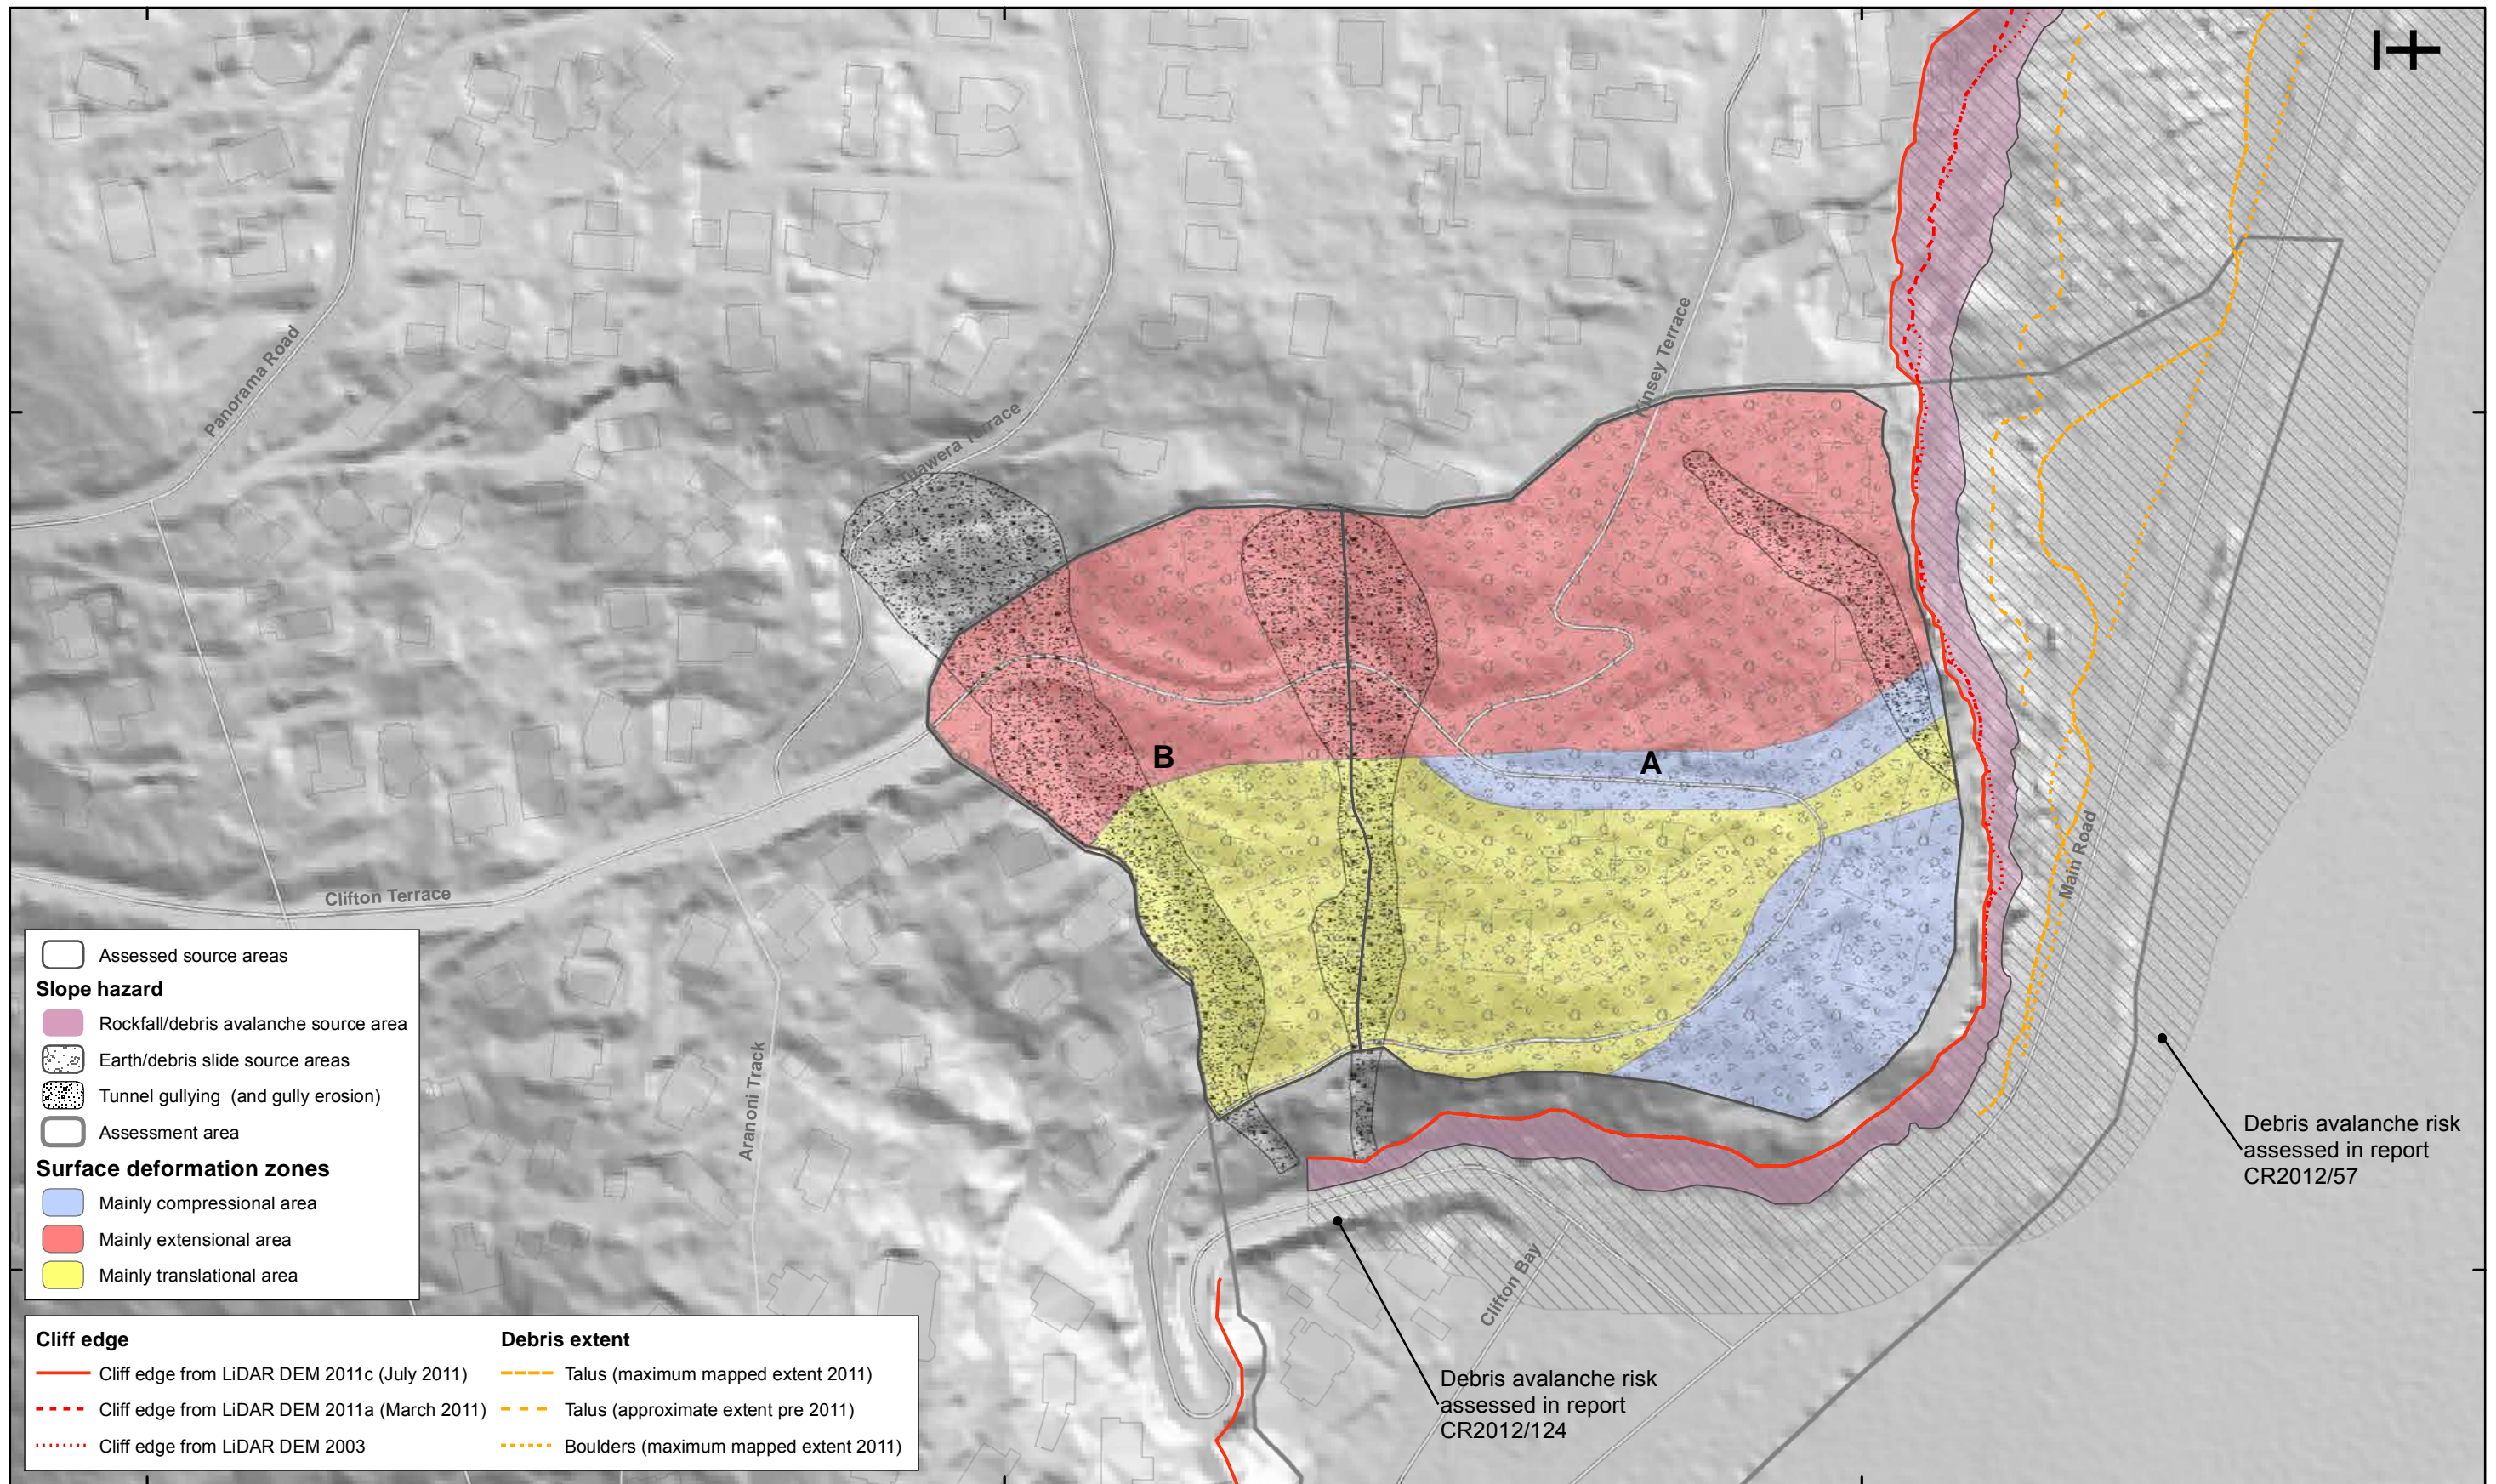
FIGURE 26

An engineering geological model showing the main landslide hazards affecting the site is presented in Figure 26, which is a simplified version of Figure 7.

Figure 26, from earlier in the report, is a map showing the locations of the different types of landslide hazard identified in the assessment area. These landslide hazards are:
