**Canterbury Earthquakes 2010/11 Port Hills Slope
Stability: Risk assessment for Clifton Terrace**

**GNS Science Consultancy Report 2014/76
August 2014 FINAL**

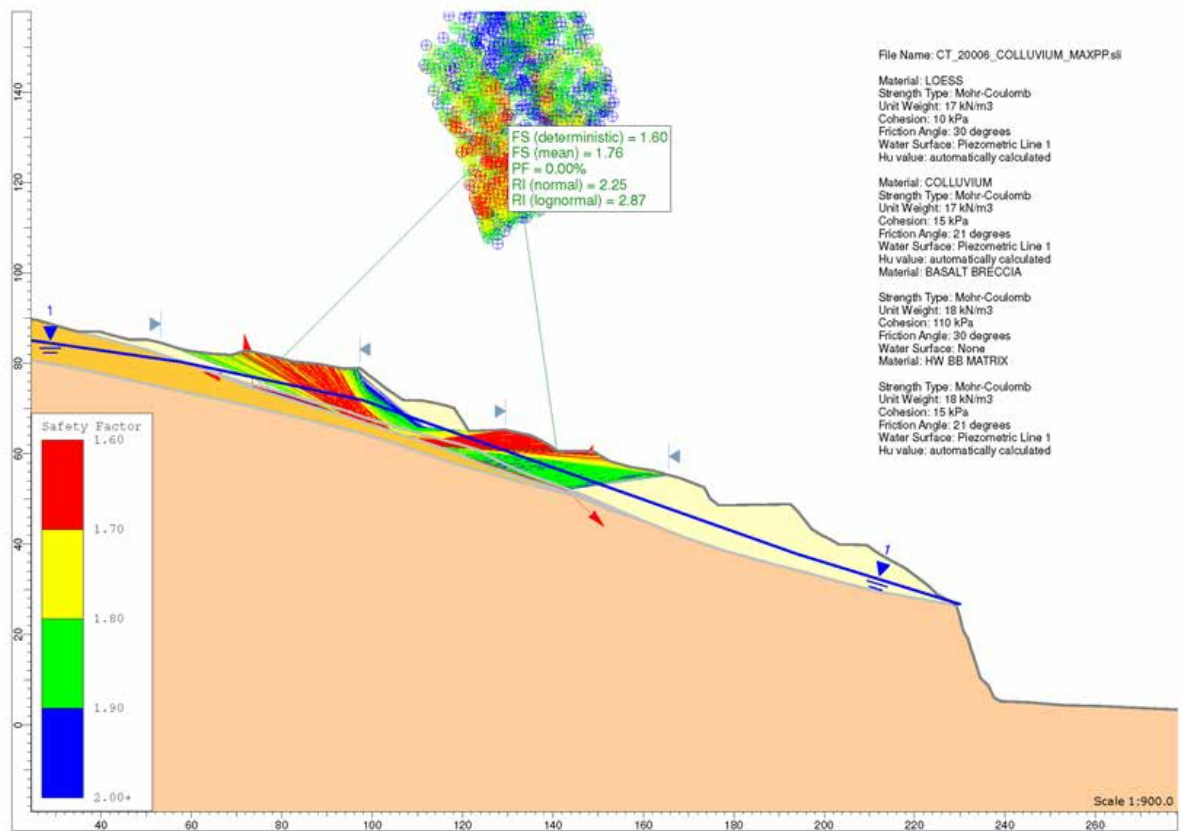
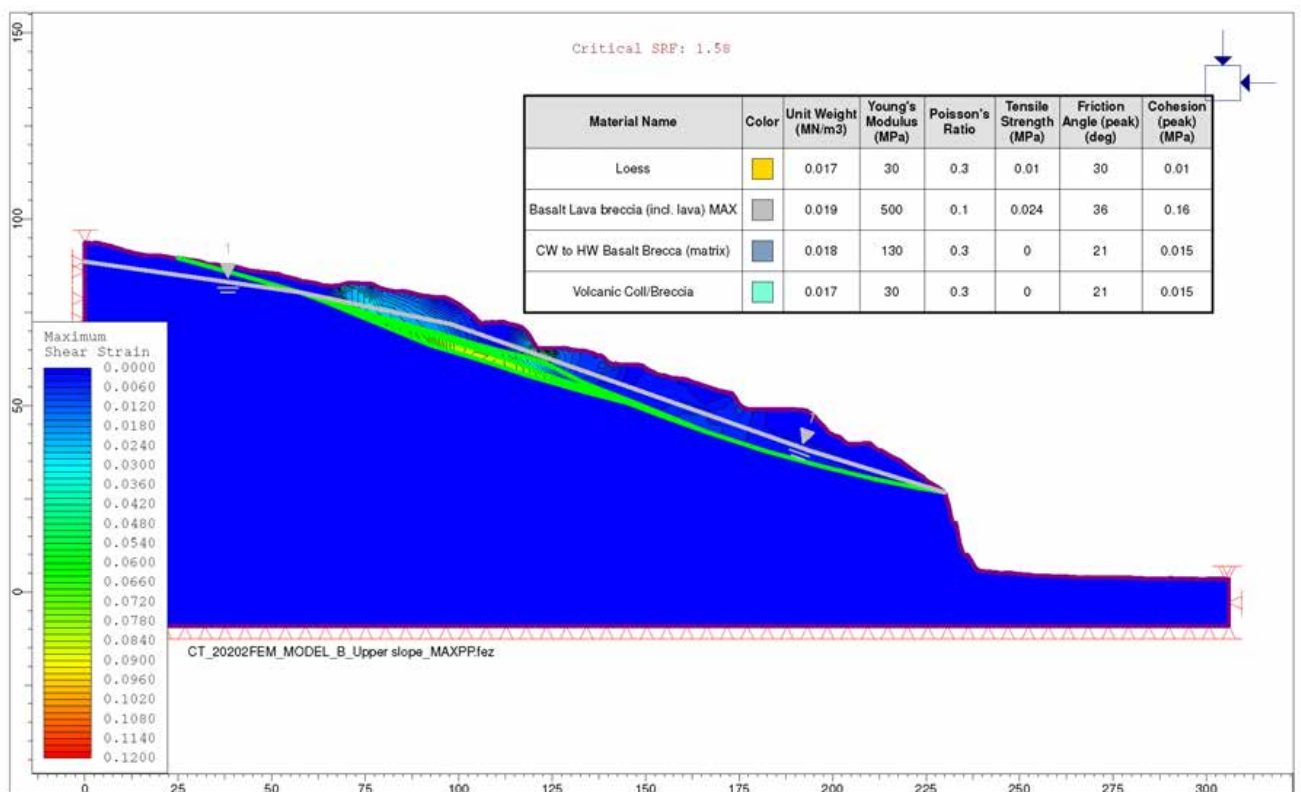
- *Mechanism 2 – failure through the mixed colluvium layer (Figure 27–Figure 29, cross-section 2):* The presence of the weak mixed colluvium layer results in slide surfaces with a lower factor of safety than those through the loess. When a weak mixed colluvium layer is included in the model, the factor of safety for the upper and entire part of cross-section 2 is about 1.6–1.8 and for the lower part is 1.4, for the range of material parameters assumed, under drained conditions. The factors of safety for the upper and entire parts reduce to 1.3–1.6 and 1.2 for the upper slope if the maximum recorded piezometric head levels are used.

Figure 27 Failure mechanism 2, upper part of cross-section 2. Example of limit equilibrium and finite element modelling results for cross-section 2, representing failure of colluvium in source area A, adopting the maximum recorded piezometric head levels.

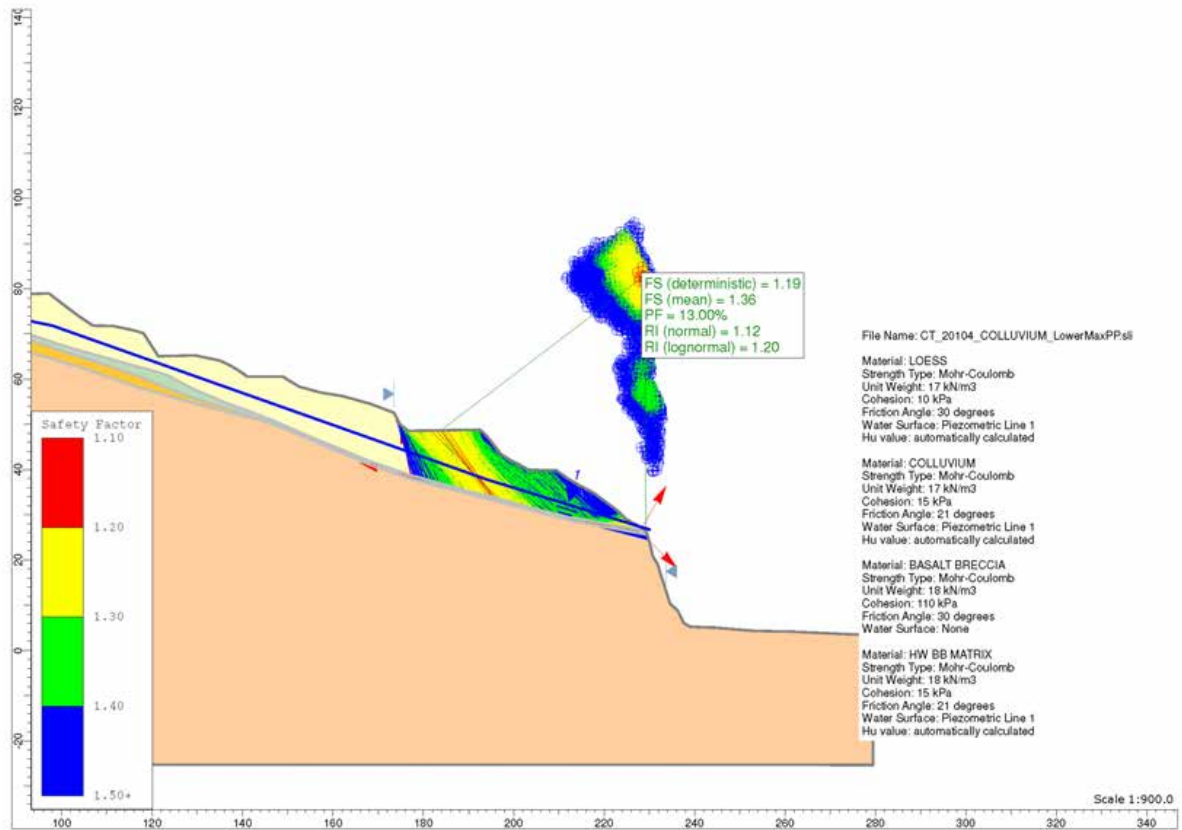
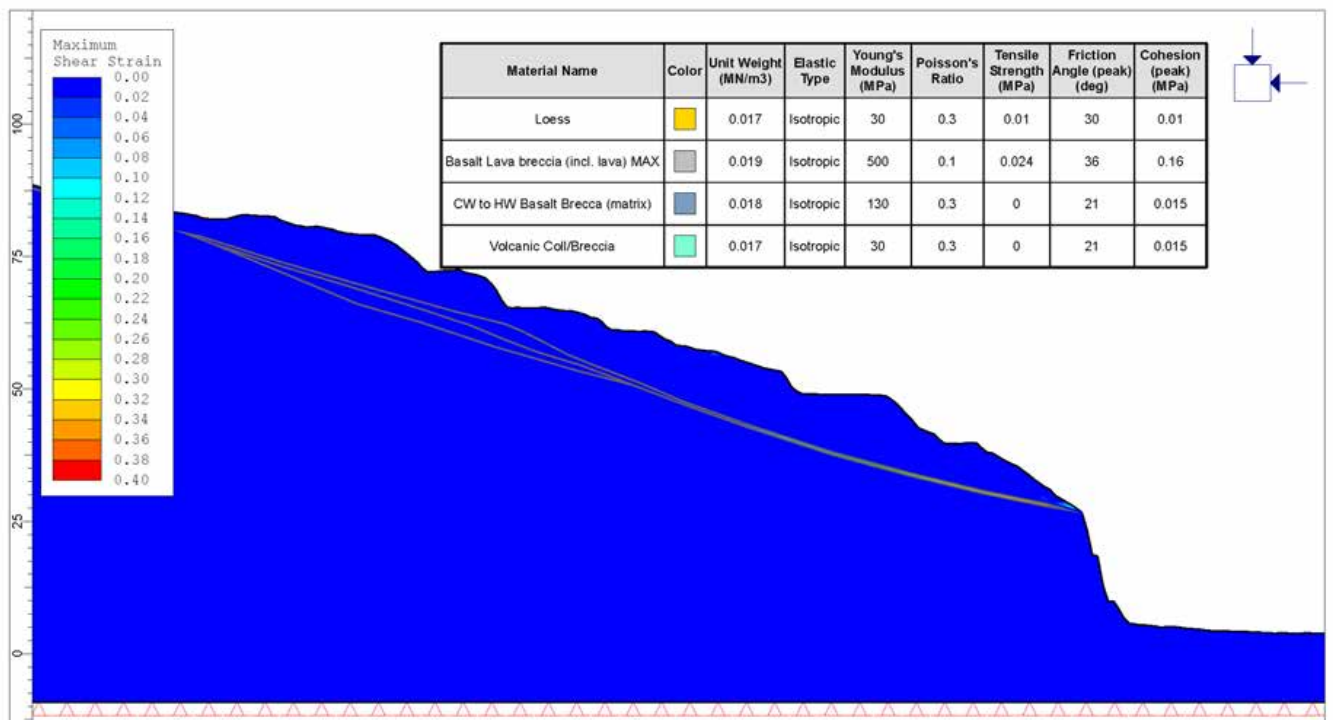
Figure 28 Failure mechanism 2, lower part of cross-section 2. Example of limit equilibrium and finite element modelling results for cross-section 2, representing failure of colluvium in source area A, assuming the colluvium layer extends across the entire slope, adopting the maximum recorded piezometric head levels.

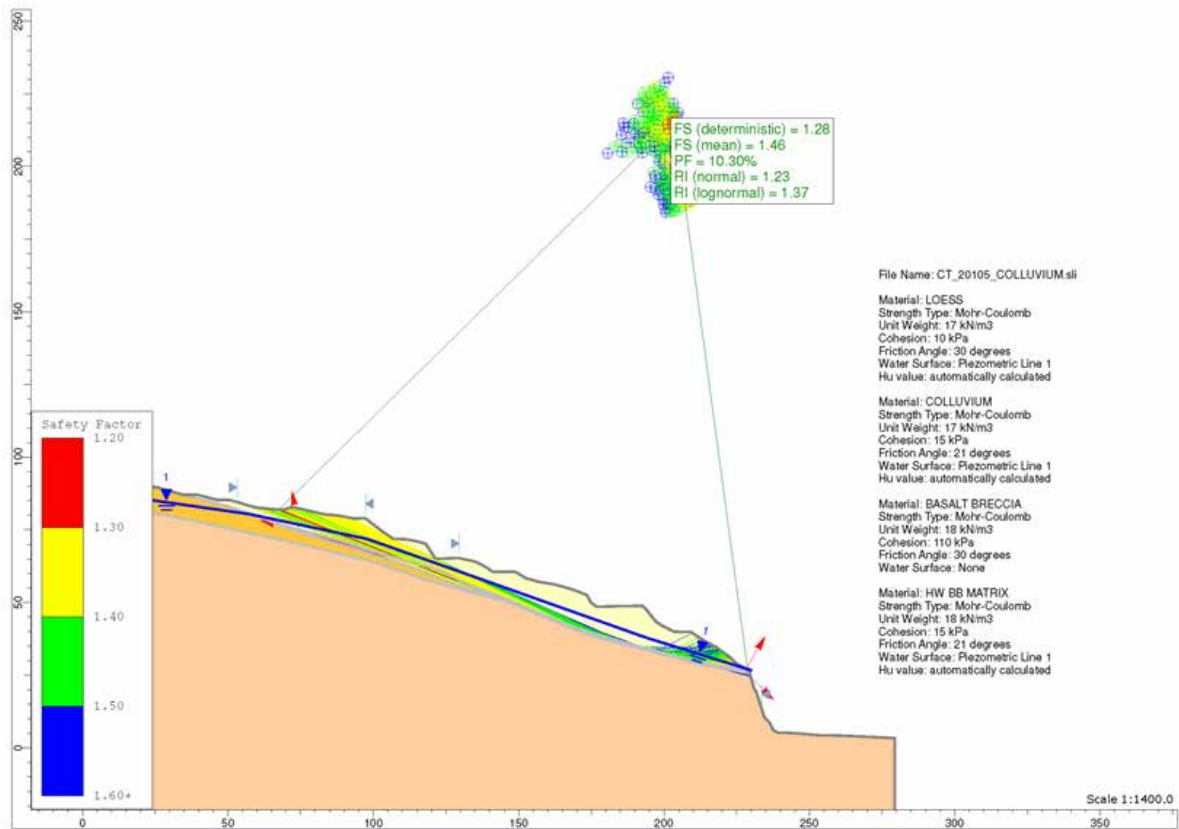
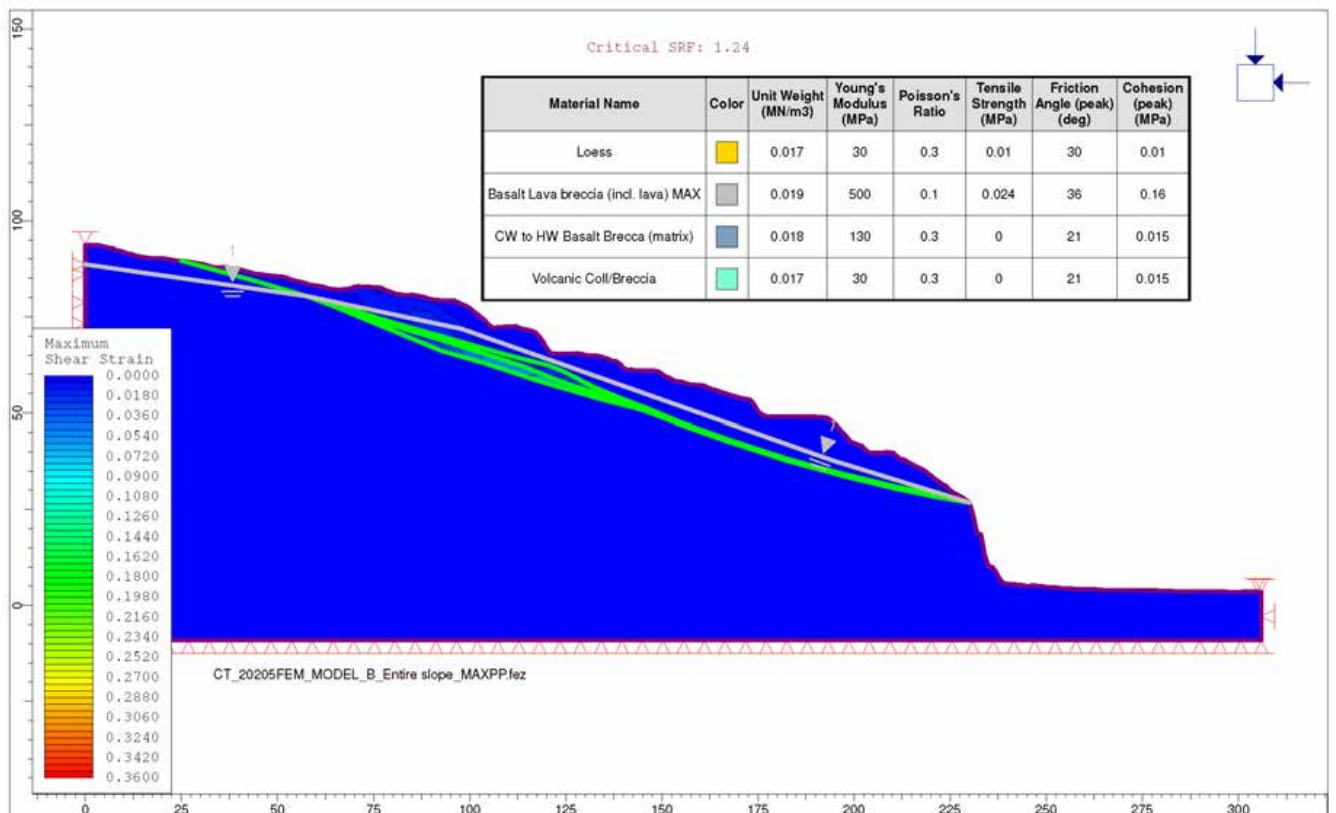
Figure 29 Failure mechanism 2, entire part of cross-section 2. Example of limit equilibrium and finite element modelling results for cross-section 2, representing failure of colluvium in source area A, adopting the maximum recorded piezometric head levels.

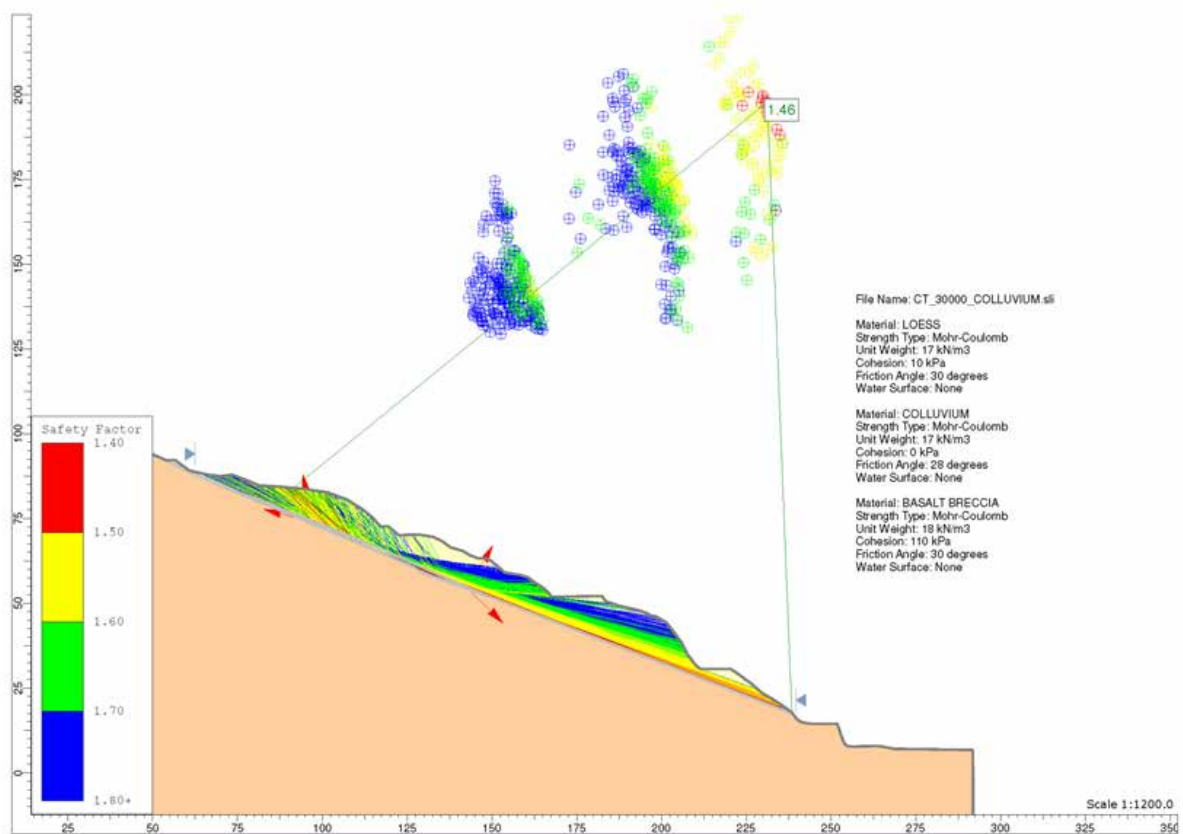
- *Mechanism 2 – failure through the mixed colluvium layer (Figure 30 and Figure 31, cross-section 3):* the presence of the weak mixed colluvium layer results in slide surfaces with a lower factor of safety than those through the loess. When a weak mixed colluvium layer is taken into account, the factors of safety for the upper and entire slope are about 1.5 and 1.4 respectively, for the range of material parameters assumed, under drained conditions. These are also lower than the factors of safety estimated for cross-section 2 (source area A) under drained conditions, and also are due to the steeper dip angle of rock head.

Figure 30 Failure mechanism 2, entire part of cross-section 3. Example of limit equilibrium results for cross-section 3, representing failure of colluvium in source area B, and adopting dry conditions.

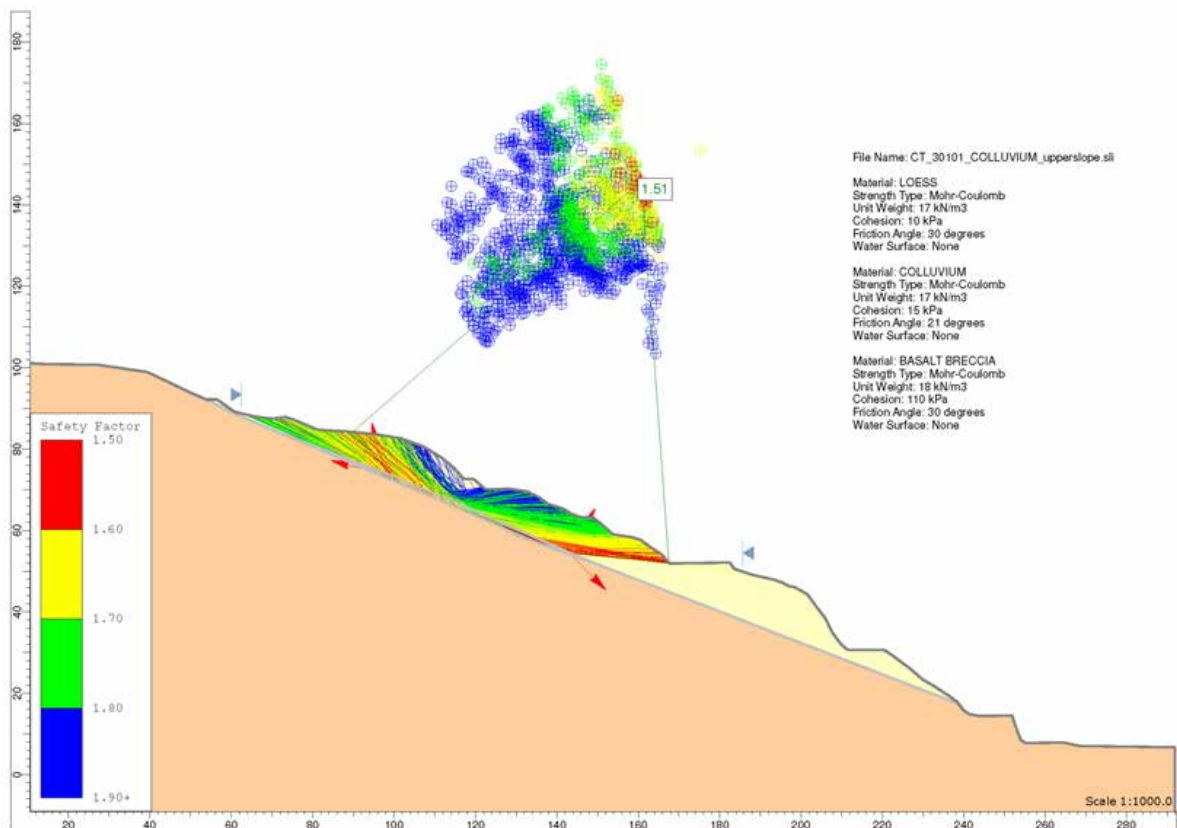
Figure 31 Failure mechanism 2, upper part of cross-section 3. Example of limit equilibrium results for cross-section 3, representing failure of colluvium in source area B, and adopting dry conditions.

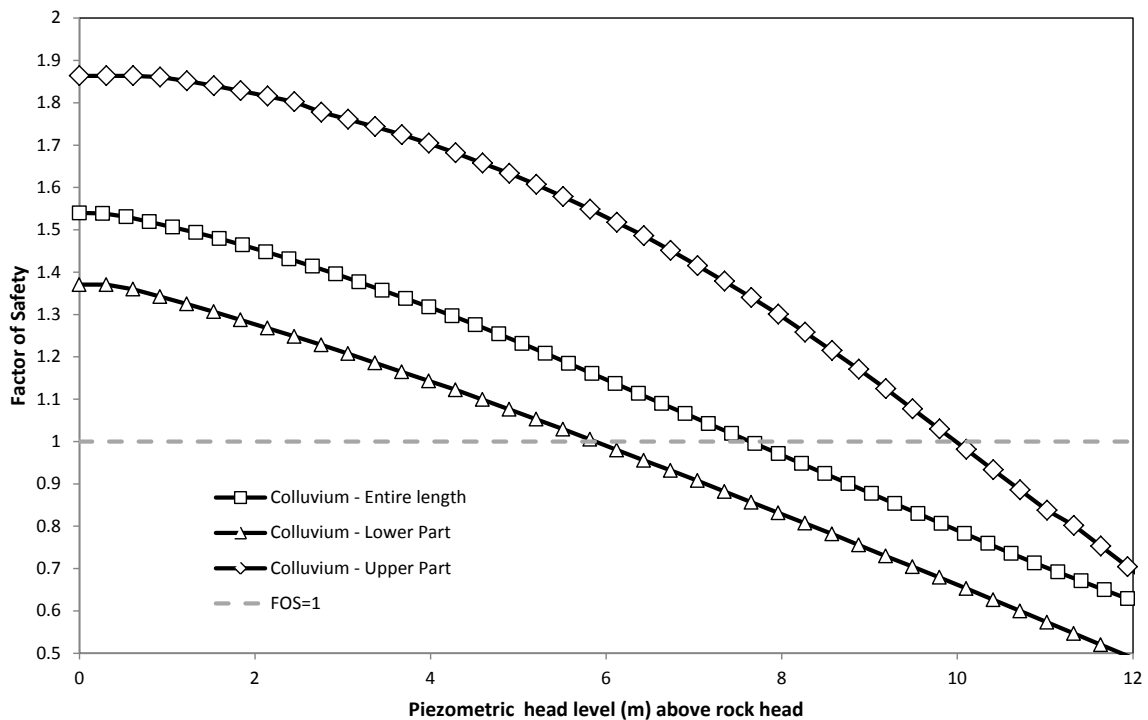
For failure surfaces in the colluvium and weathered breccia (mechanisms 2 and 3), the results show that an increase in piezometric head levels of about 6–10 m above rock head reduces the factor of safety to about one, adopting the lower estimates of the colluvium and weathered breccia shear strength (cohesion (c) = 0-15 kPa and friction (ϕ) = 21–28°). Adopting the maximum recorded piezometric head levels, the factor of safety is between 1.2 and 1.5 for the upper, lower and entire parts of cross-section 2.

The groundwater levels recorded by GeoNet in standpipe piezometers (BH-KSY-2a and BH-KS8a) in loess, have reached levels of 4.0 and 3.3 m above rock head respectively, which are significantly lower than those needed to initiate movement (factor of safety equal to one).

Figure 32 Sensitivity assessment of the slope factor of safety (cross-section 2, source area A) in response to changing piezometric head levels above rock head for slide surface in the lower, upper and entire parts of source area A. The assessment assumes pore pressures increase uniformly across the entire rock head boundary.

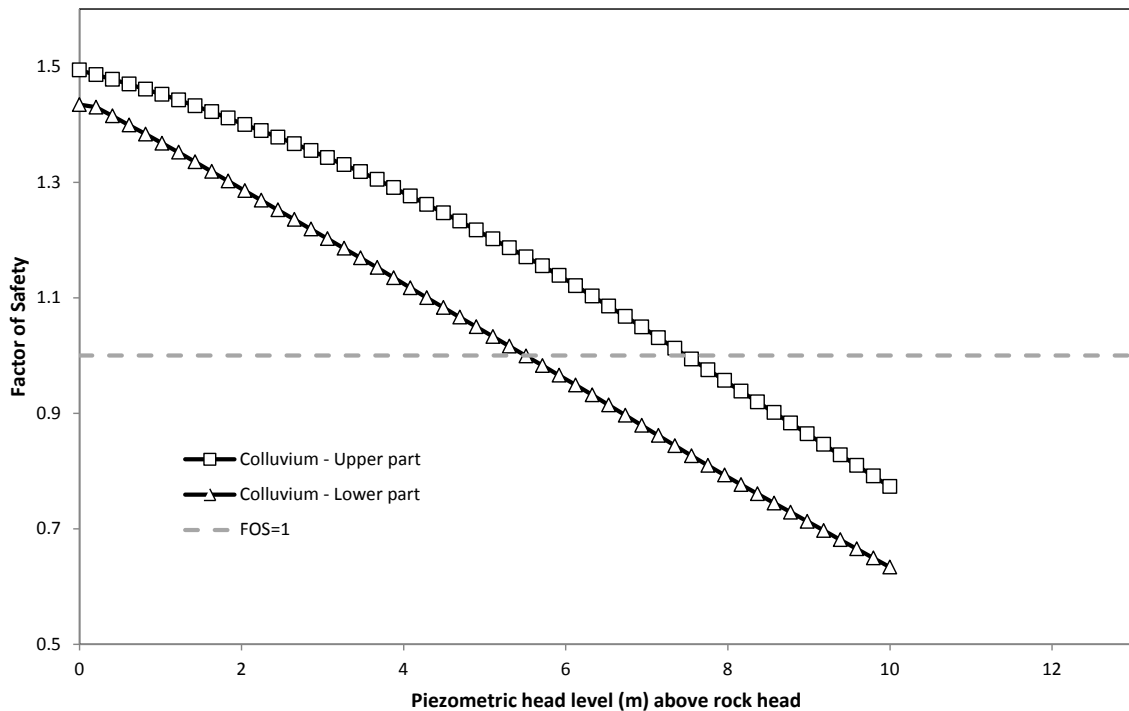
For failure surfaces in the loess or colluvium (mechanisms 1 and 2), the results show that an increase in piezometric head levels of about 5.5–7.5 m above rock head reduces the factor of safety to about one, for the lower estimates of the loess and colluvium shear strength (cohesion (c) = 10 kPa and friction (ϕ) = 30°).

There are currently no groundwater records from this area of the site. Therefore it is not known whether a piezometric head level rise of between 5.5 and 7.5 m above rock head and across the entire slope is feasible, or under what weather conditions such increases might occur. The groundwater levels in this area are not currently being monitored.

Figure 33 Sensitivity assessment of the slope factor of safety (cross-section 3, source area B) in response to changing piezometric head levels above rock head for slide surfaces in the upper and entire parts of source area B. The assessment assumes that pore pressures increase by a given amount across the entire rock head boundary.

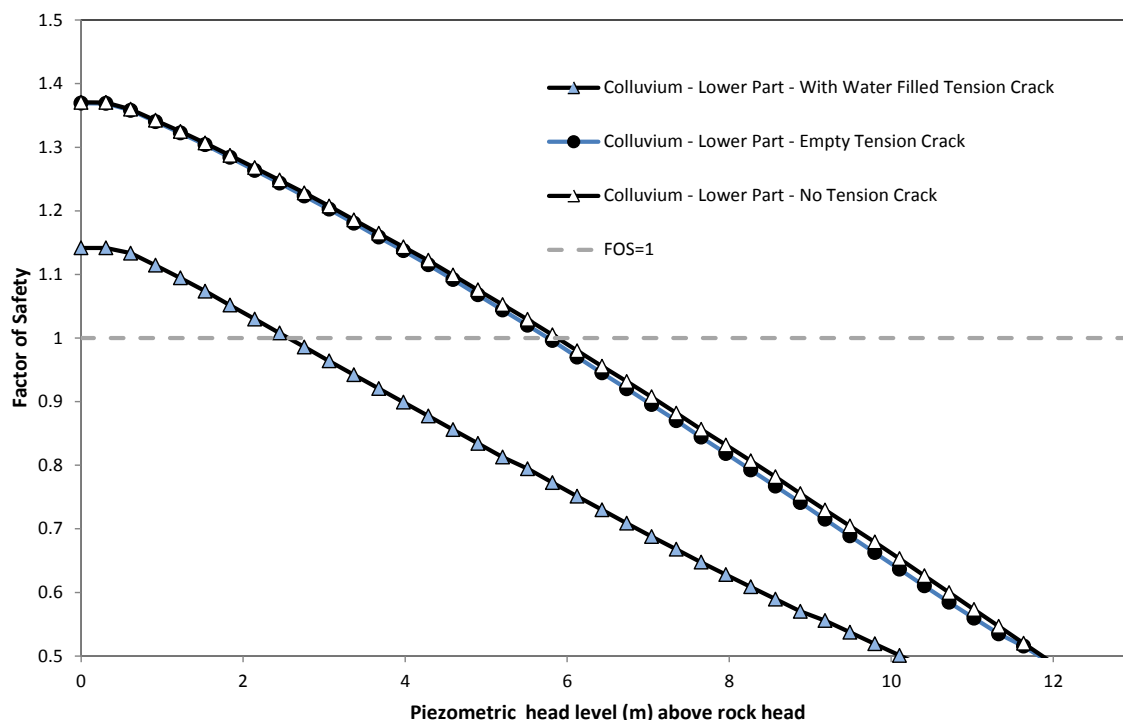
Water filled tension cracks have been included in the model as a zone extending from the surface to rock head. It should be noted that the mapped tension cracks logged in test pits do not extend all the way down to the base of the loess. The inclusion of water filled tension cracks within the model reduces the piezometric head levels needed to yield a factor of safety of one, for slide surfaces in the lower part of assessed source area A, from 6 m to about 2.5 m, when adopting colluvium shear strengths of cohesion (c) of 15 kPa and friction (ϕ) 21° . However, 3.3 m of piezometric head, above rock head, has been recorded in drillhole BH-KSY-8a, in the lower slope near the section line, and no such slope movement has been recorded.

The results show that the factor of safety for the modelled slide surfaces is sensitive to the inclusion of water filled tension cracks in the model. However, the absolute modelled factors of safety are thought to be conservative, as it has been inferred that the weak colluvium extends into the lower slope, although drillhole records do not support this, and that the lower slope contains tensions cracks, which have not been mapped on the ground. Further work is needed to quantify the effects tension cracks have in the model.

Figure 34 Sensitivity assessment of the lower slope factor of safety (in source area A, section 2) in response to including filled tension cracks in the model. Tension cracks were assumed to be 100% filled.

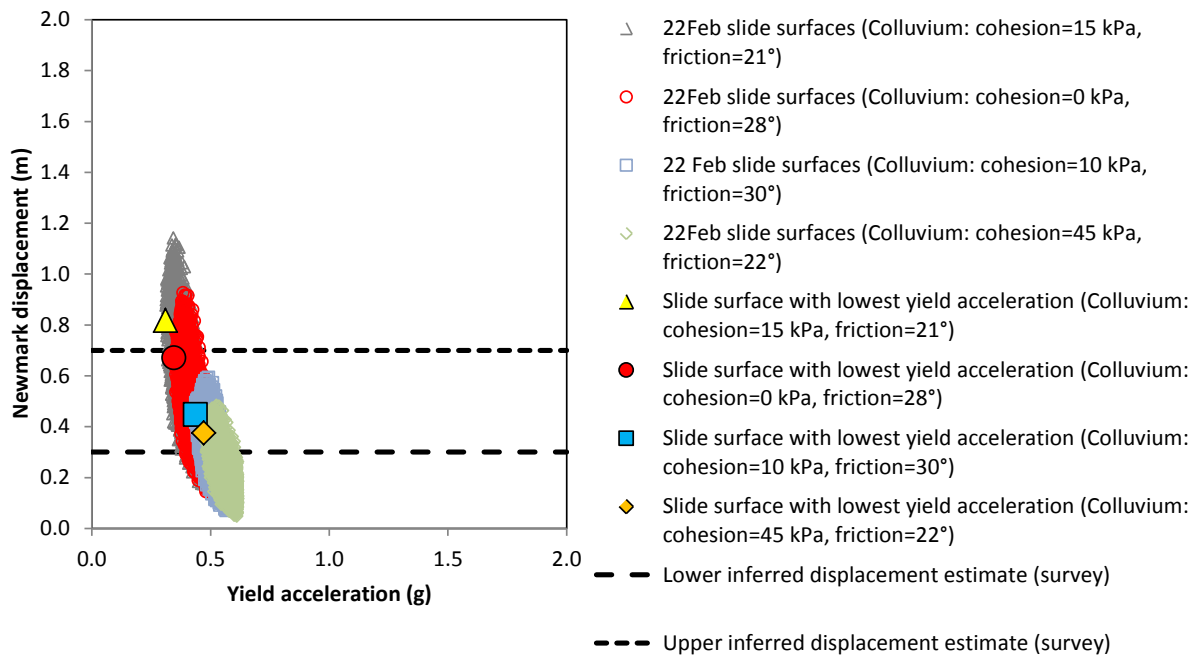
Failure mechanisms 2 and 3, 22Feb 2011 Section 2

Figure 41 Failure mechanisms 2 and 3. Modelled Slope/W decoupled displacements of cross-section 2 for the 22 February 2011 earthquake and adopting variable estimates of the material strength of the colluvium and weathered breccia. Each data point represents a modelled slide surface and the corresponding estimate of its displacement as a result of the 22 February 2011 earthquake – adopting the synthetic free-field rock outcrop earthquake acceleration time histories. The dashed lines represent the total inferred coseismic permanent displacement of the slope along the cross-section during the given earthquake.

- The results show a good match between the recorded permanent coseismic displacement and modelled displacements for the 22 February and 13 June earthquakes, with the lower bound colluvium and weathered basalt lava breccia material strength parameters, if slope conditions are assumed to have been dry at the time of the 22 February 2011 earthquake (which occurred in summer) (Figure 41), and wet during the 13 June 2011 earthquake (which occurred in winter) (Figure 44).

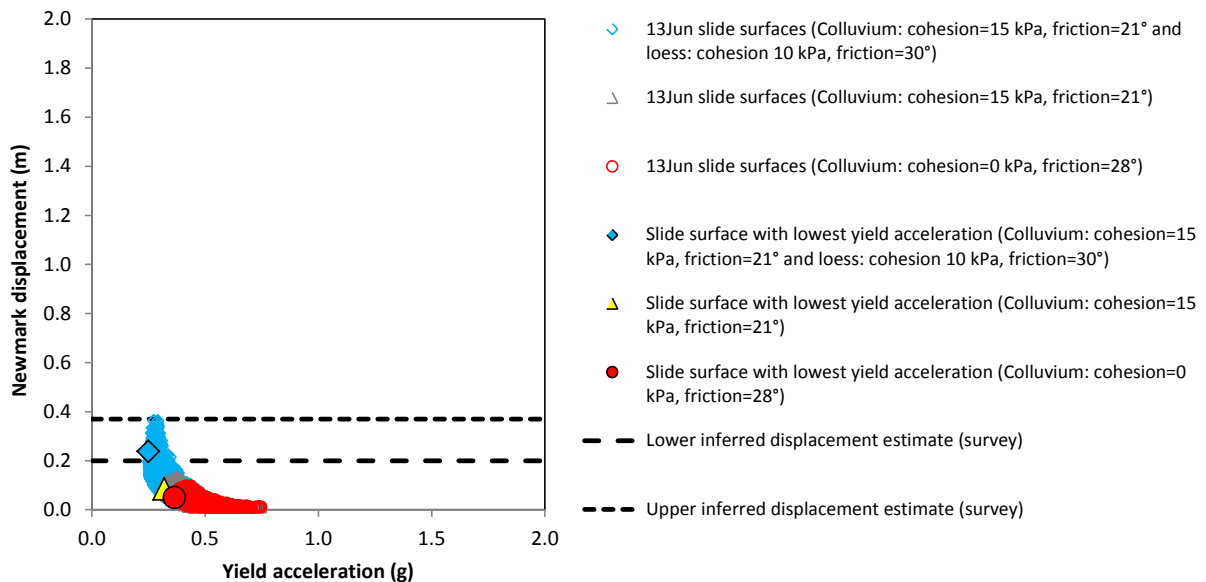
Failure mechanisms 2 and 3, 13 Jun 2011 Section 2

Figure 42 Failure mechanisms 2 and 3. Modelled Slope/W decoupled displacements of cross-section 2 for the 13 June 2011 earthquake and adopting variable estimates of the material strength of the colluvium and weathered breccia. Each datapoint represents a modelled slide surface and the corresponding estimate of its displacement as a result of the 13 June 2011 earthquake – adopting the synthetic free-field rock outcrop earthquake acceleration time histories. The dashed lines represent the total inferred coseismic permanent displacement of the slope along the cross-section during the given earthquake.

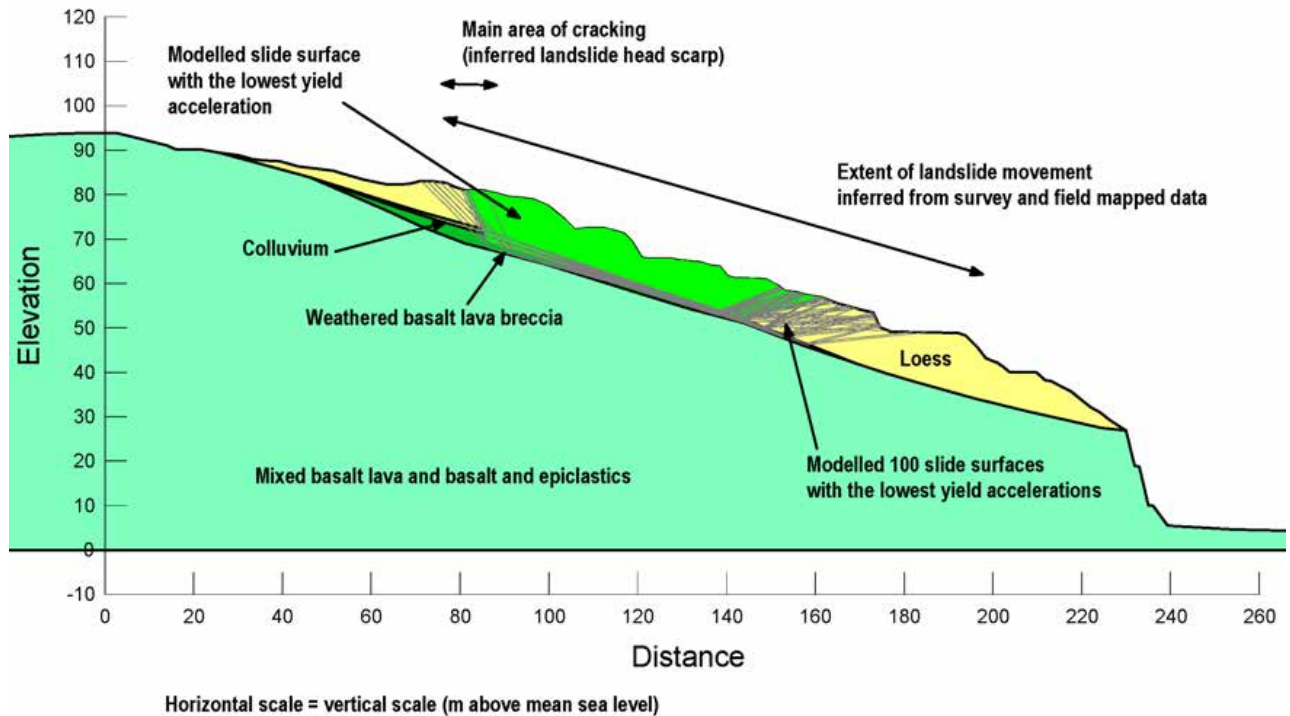
Figure 43 Results from the seismic slope stability assessment for failure mechanisms 2 and 3, cross-section 2, for the 22 February 2011 earthquake.

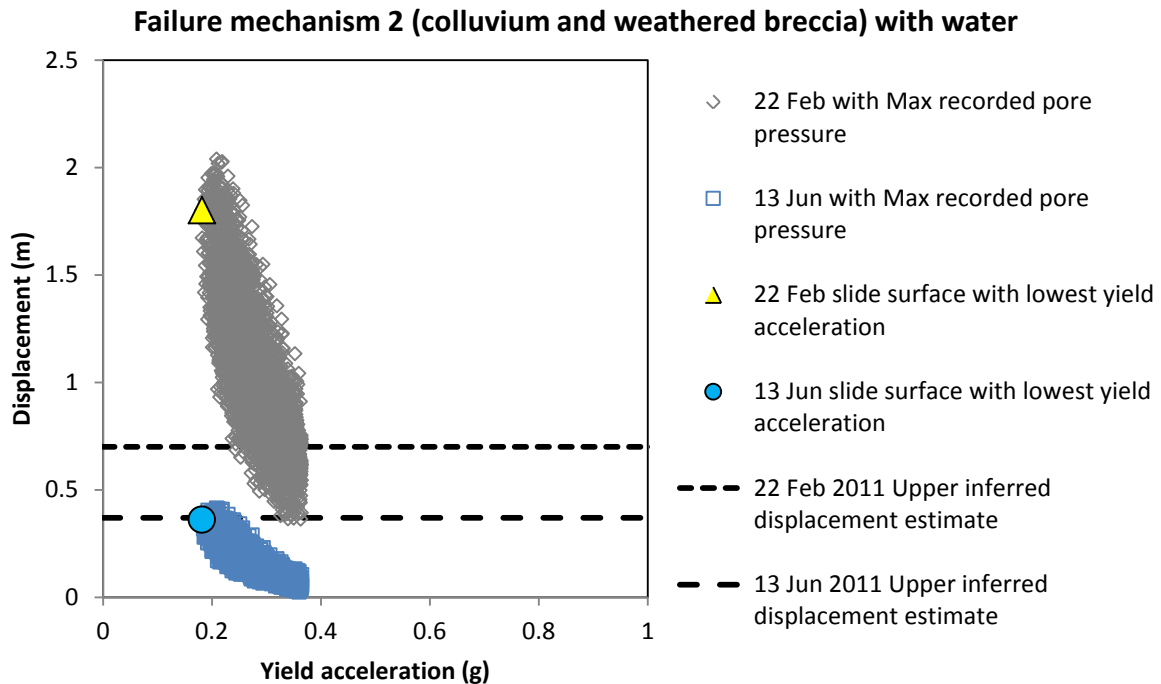
- The results where water levels (Figure 44) were included in the modelling suggest, as expected, permanent displacements would be greater when the slope is wet, as the factors of safety and therefore yield accelerations reduce (from 0.3 to 0.2 g) when modelled using the maximum recorded piezometric head levels.

Figure 44 Failure mechanisms 2 and 3. Modelled Slope/W decoupled displacements of cross-section 2 for the 22 February and 13 June 2011 earthquakes. Adopting the maximum recorded piezometric head levels and material strength parameters for the mixed colluvium and weathered basalt lava breccia of cohesion (c) = 15 kPa, and friction (ϕ) = 21°, and for the loess of cohesion = 30 kPa and friction = 35°. Each data point represents a modelled slide surface and the corresponding estimate of its displacement as a result of the modelled earthquakes – adopting the synthetic free-field rock outcrop earthquake acceleration time histories. The dashed lines represent the total inferred coseismic permanent displacement of the slope along the cross-section during the given earthquake.

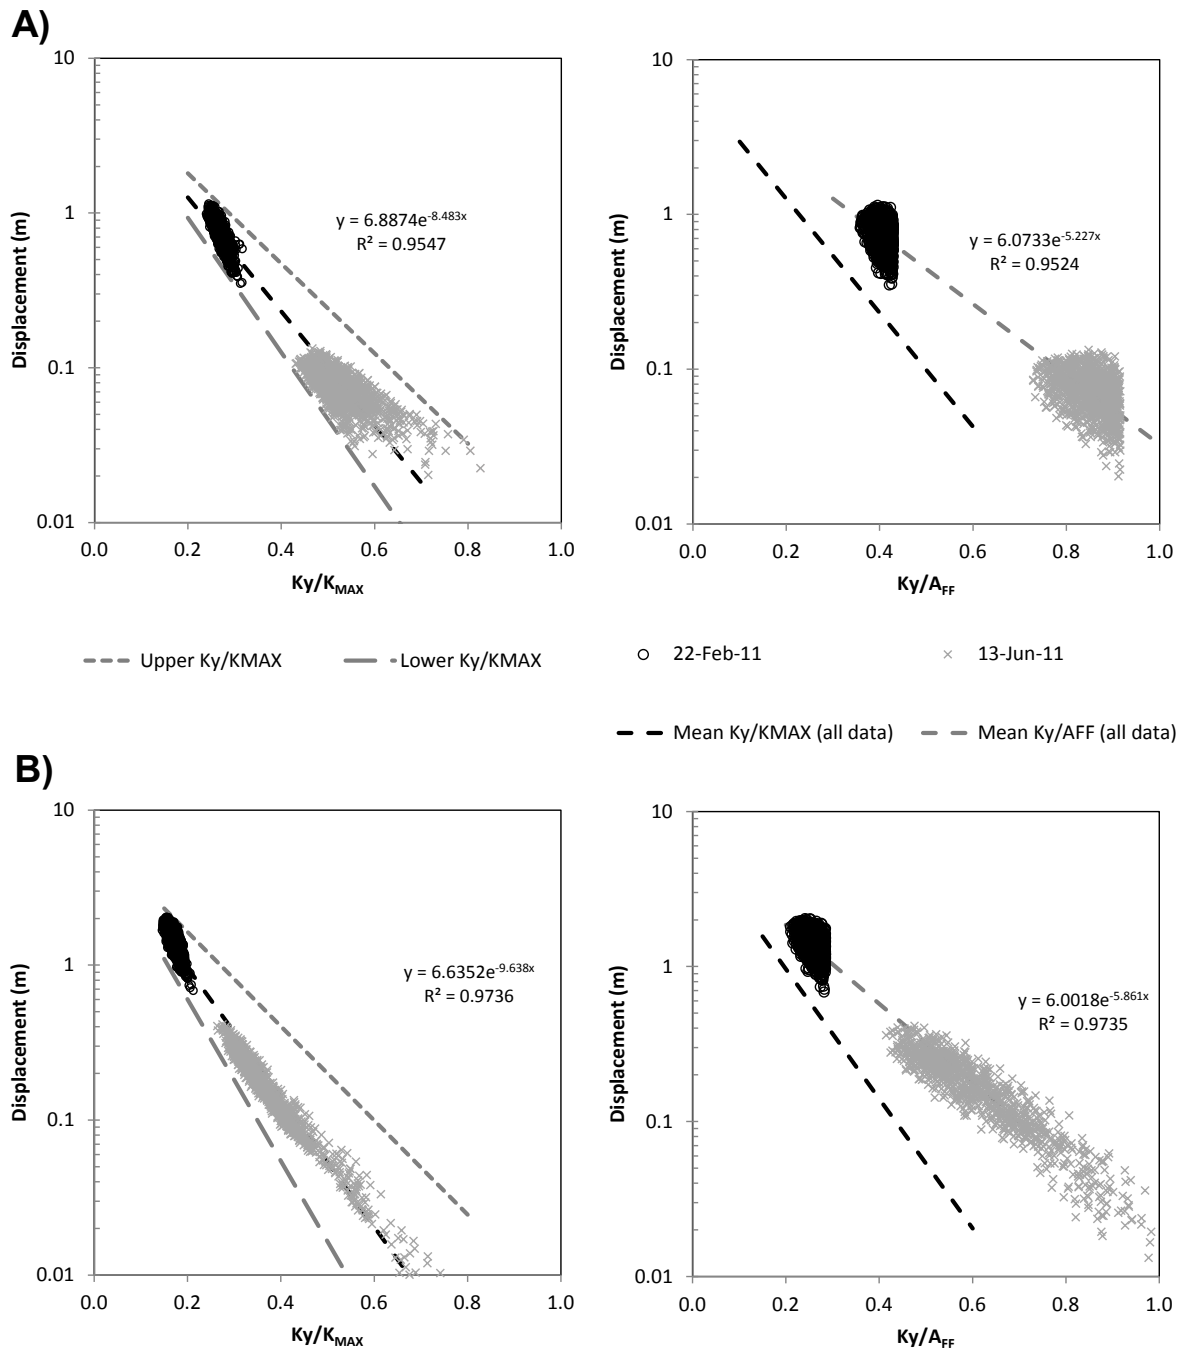
The results from the assessment, adopting failure mechanisms 2 and 3, are shown in Figure 45, for those slide surface shown in Figure 39. The results indicate that between K_y/K_{MAX} values of 0.1 and 0.6, and K_y/A_{FF} values of 0.2 and 0.7, the data are well fitted to a straight line (an exponential trend line) in semi-log space. The coefficient of determination (R^2) is 0.96 for K_y/K_{MAX} and 0.95 for K_y/A_{FF} , and includes all of the plotted data (N = 2000).

The peak ground acceleration of the input motion (A_{FF}) does not take into account amplification caused by the slope geometry, or at this site, the material contrasts within the slope, between the loess/colluvium and the underlying rock (Appendix 4). From the data in Figure 45, the mean ratio of K_{MAX} to A_{FF} for cross-section 2 is 1.6 (± 0.1 at one standard deviation), meaning that K_{MAX} is 1.7 times greater than the peak horizontal ground acceleration of the input motion, if assuming the mean plus one standard deviation of the mean.

For ratios of K_y/A_{FF} in Figure 45, the estimated displacements are consistent with those reported by Jibson (2007), where these data plot between the ranges for earthquakes of M6.5–7.5 as reported by Makdisi and Seed (1978) and plotted by Jibson (2007).

Figure 45 Cross-section 2, failure mechanisms 2 and 3. Decoupled Slope/W displacements calculated for different ratios of yield acceleration to maximum average acceleration of the mass (Ky/K_{MAX}), and maximum acceleration of the mass (Ky/A_{MAX}), for selected slide-surface geometries, and material shear strength parameters of cohesion (c) of 0-15 kPa and friction (ϕ) of 21-28°. A_{FF} is the peak acceleration of the input earthquake time acceleration history. Synthetic rock outcrop time acceleration histories for the 22 February and 13 June 2011 earthquakes were used as inputs for the assessment ($N = 2000$). The dashed lines are exponential trend lines fitted to the semi-log data. The formula and the coefficient of determination (R^2) for the trend lines are shown. **A)** Results for dry conditions. **B)** Results for when the slope is wet, when piezometric head levels are at the maximum recorded levels.

The relationship in Figure 45 is based on past performance of the slope. However, the slope moved about one metre during the 2010/11 Canterbury earthquakes and so future displacements may be larger, given the material strengths may have been lowered by past movement, and a future larger earthquake could occur in winter when the slope is wet.

The displacements at different ratios of K_y/K_{MAX} were calculated using the synthetic earthquake acceleration time histories for the 22 February and 13 June 2011 earthquakes, which were both near-field earthquakes of short duration but high amplitude. The calculated displacements in Figure 45 represent displacements in response to these earthquakes (adopting failure mechanisms 2 and 3). Earthquakes of longer duration may affect the site in different ways. For example, the response of the loess and colluvium (at higher water contents representative of winter conditions) may be non-linear and could lead to larger permanent displacements. Conversely, the peak amplitudes relating to longer duration earthquakes from more distant sources are likely to be lower and may be insufficient to trigger displacement of the slope.

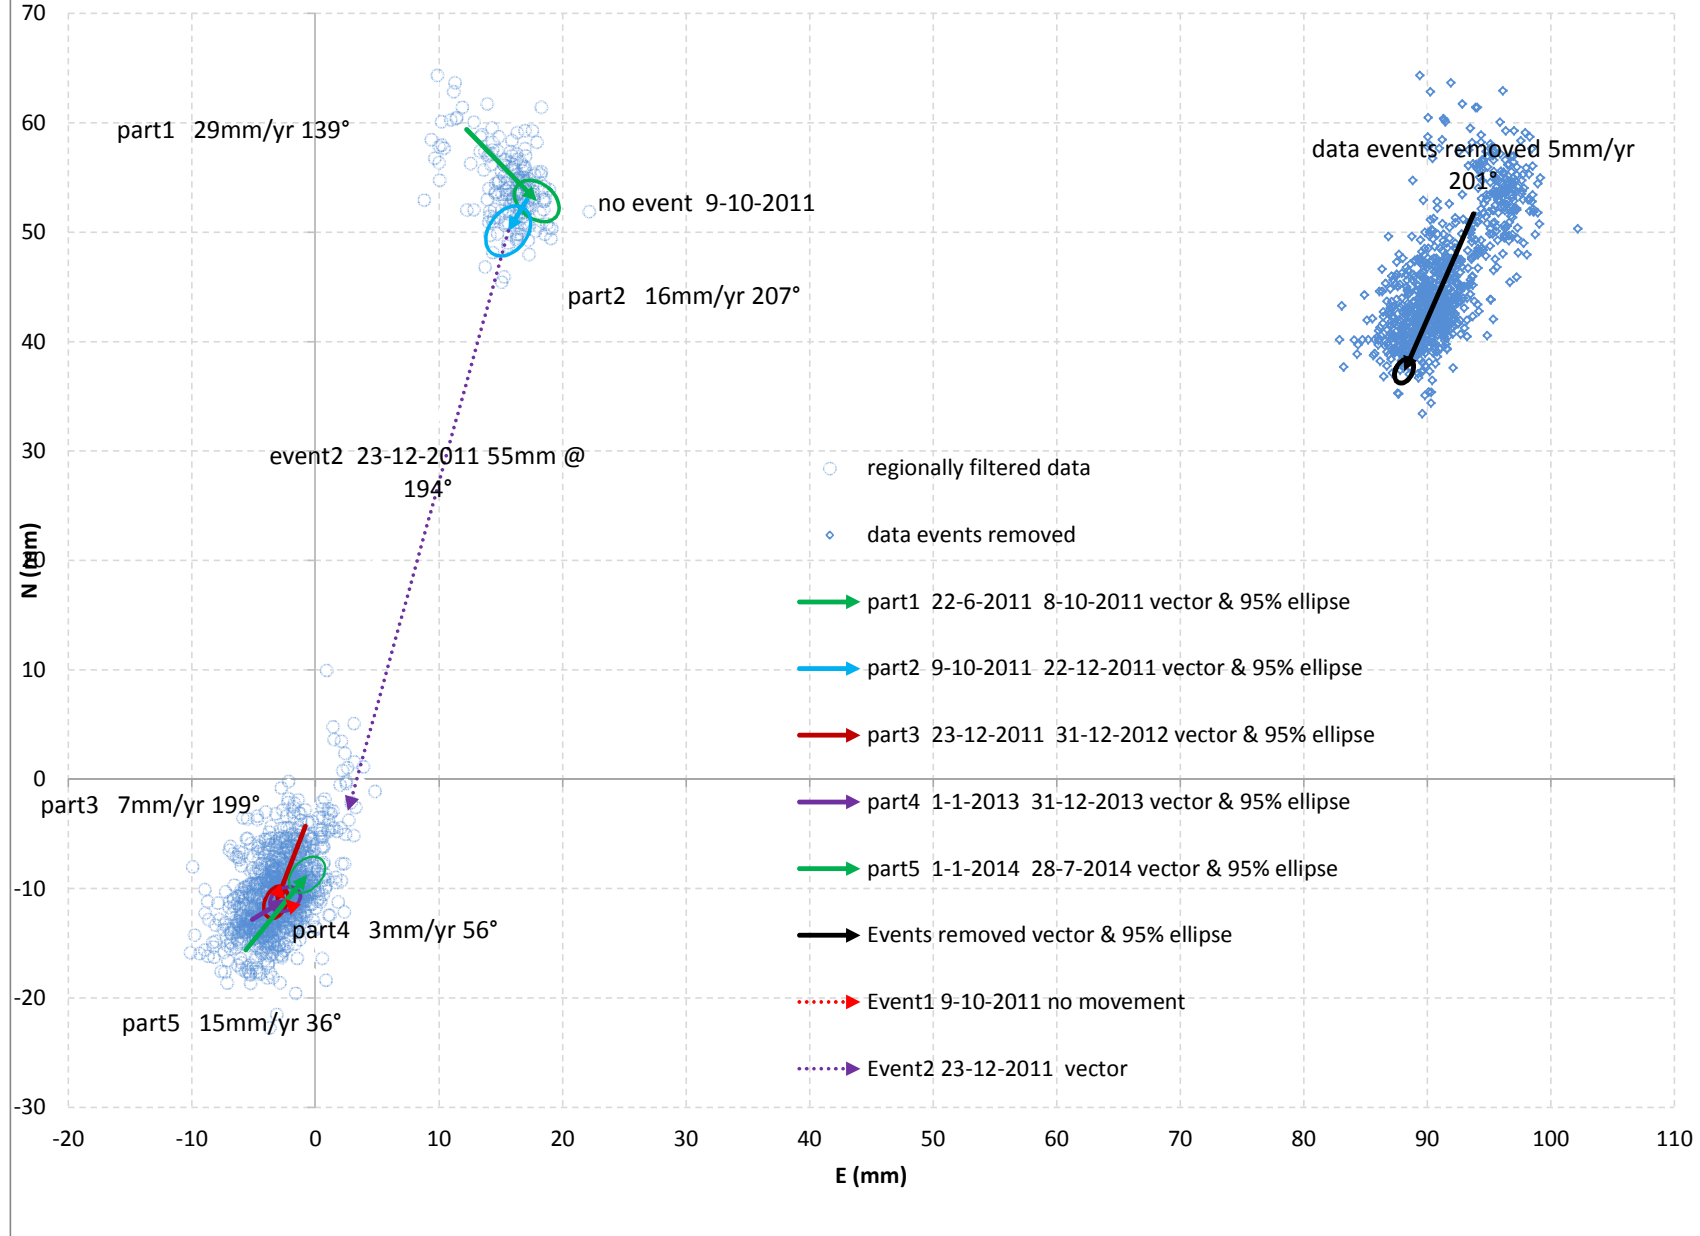
CLS5 22-6-2011 29-7-2014 Movement vectors

CLS5	offset (mm)	bearing (deg)	up (mm)	comments	date	event
Event1					9/10/2011	M5.4
Event2	55	194	-15		23/12/2011	M6.2

rate (mm/yr)	bearing (deg)	95% CE (mm)	#days	#obs	startdate	enddate
Part1	29	139	7	109	103	22/06/2011	8/10/2011
Part2	16	207	12	75	75	9/10/2011	22/12/2011
Part3	7	199	1	375	371	23/12/2011	31/12/2012
Part4	3	56	1	365	361	1/01/2013	31/12/2013
Part5	15	36	3	210	202	1/01/2014	29/07/2014
data events removed	5	201	0	1134	1112	22/06/2011	29/07/2014
