**Canterbury Earthquakes 2010/11 Port Hills Slope
Stability: Risk assessment for Clifton Terrace**

**GNS Science Consultancy Report 2014/76
August 2014 FINAL**

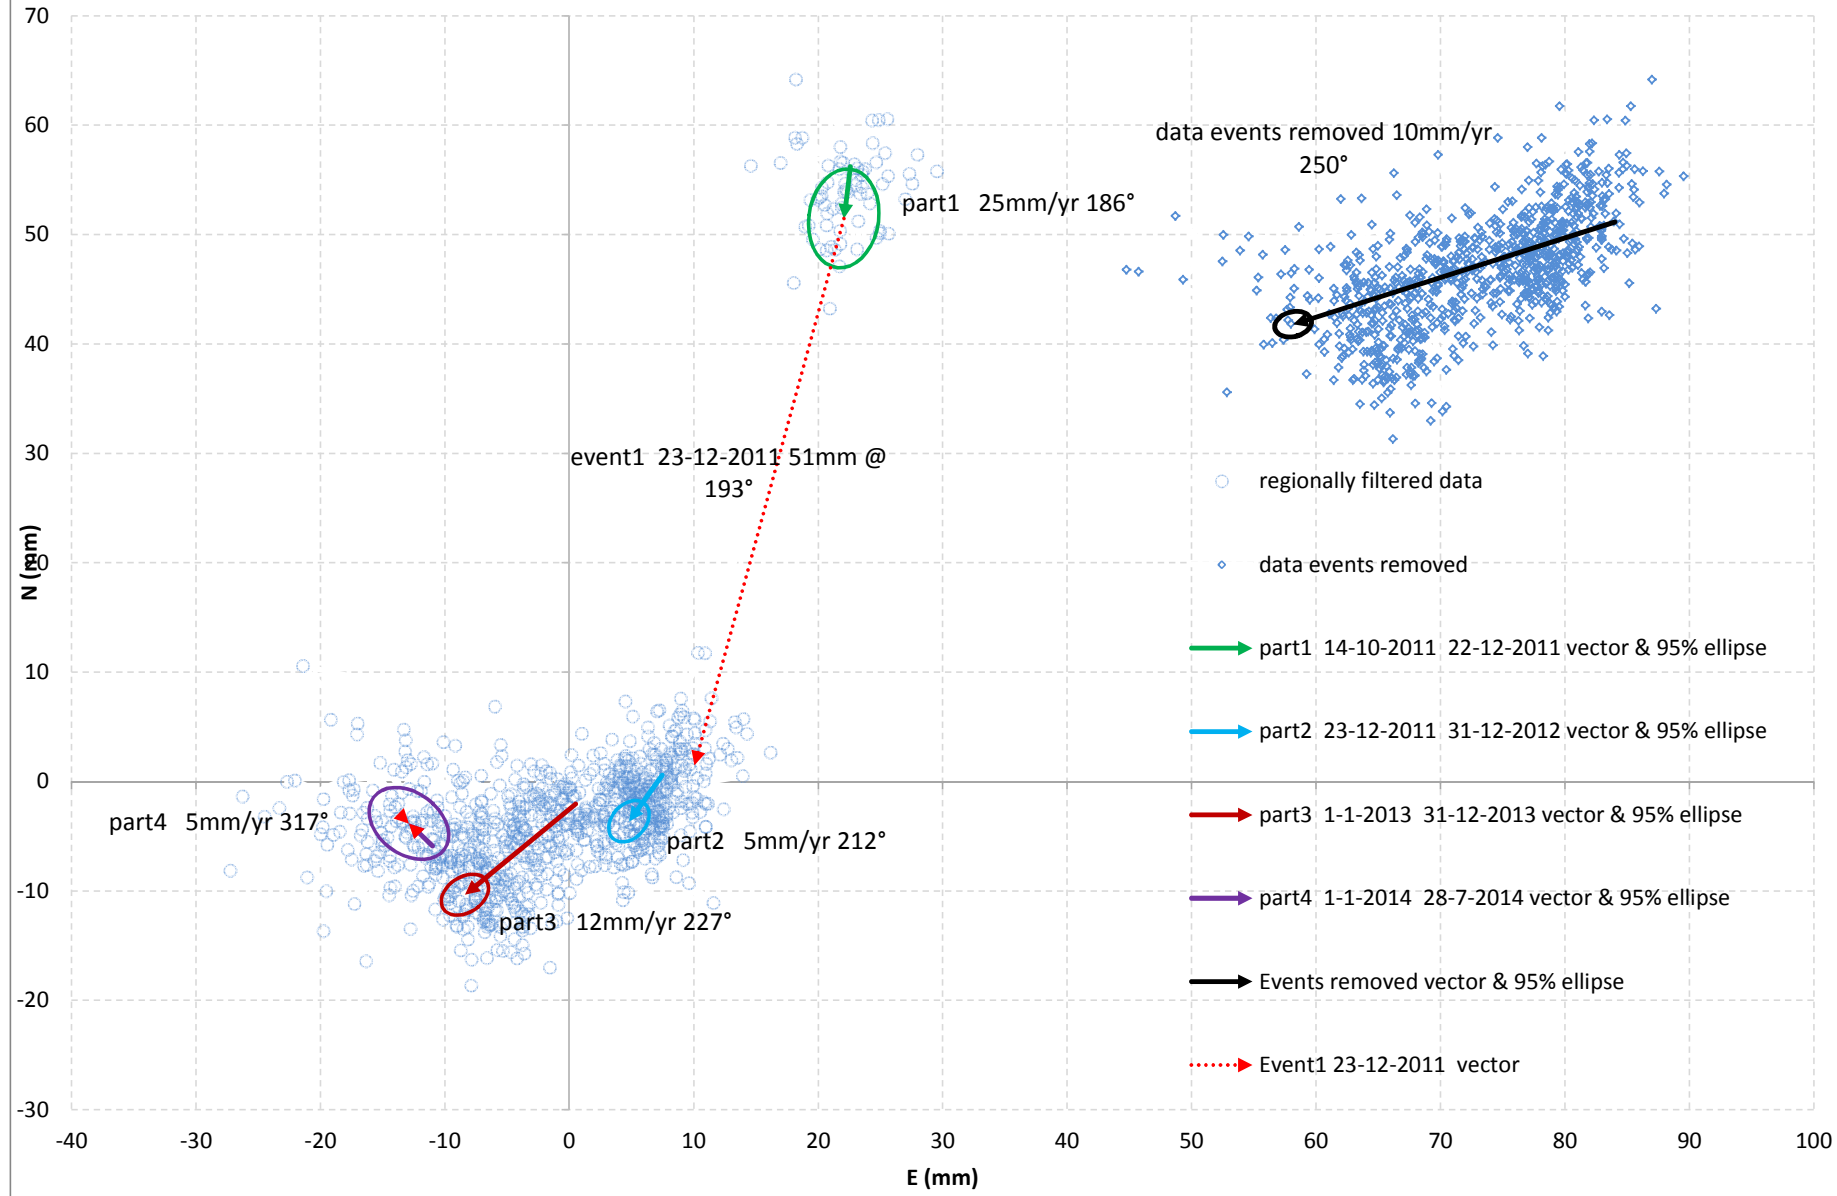
CLS6 14-10-2011 29-7-2014 Movement vectors

CLS6	offset (mm)	bearing (deg)	up (mm)	comments	date	event	
Event1	51	193	-10		23/12/2011	M6.2	
Event2					1/01/2013		
Event3					1/01/2014		
Event4					29/07/2014		
Event5					29/07/2014		
Event6					29/07/2014		
	rate (mm/yr)	bearing (deg)	95% CE (mm)	#days	#obs	startdate	enddate
Part1	25	186	24	70	70	14/10/2011	22/12/2011
Part2	5	212	2	375	370	23/12/2011	31/12/2012
Part3	12	227	2	365	360	1/01/2013	31/12/2013
Part4	5	317	7	210	200	1/01/2014	29/07/2014
Part5							
Part6							
Part7							
data events removed	10	250	1	1020	1000	14/10/2011	29/07/2014

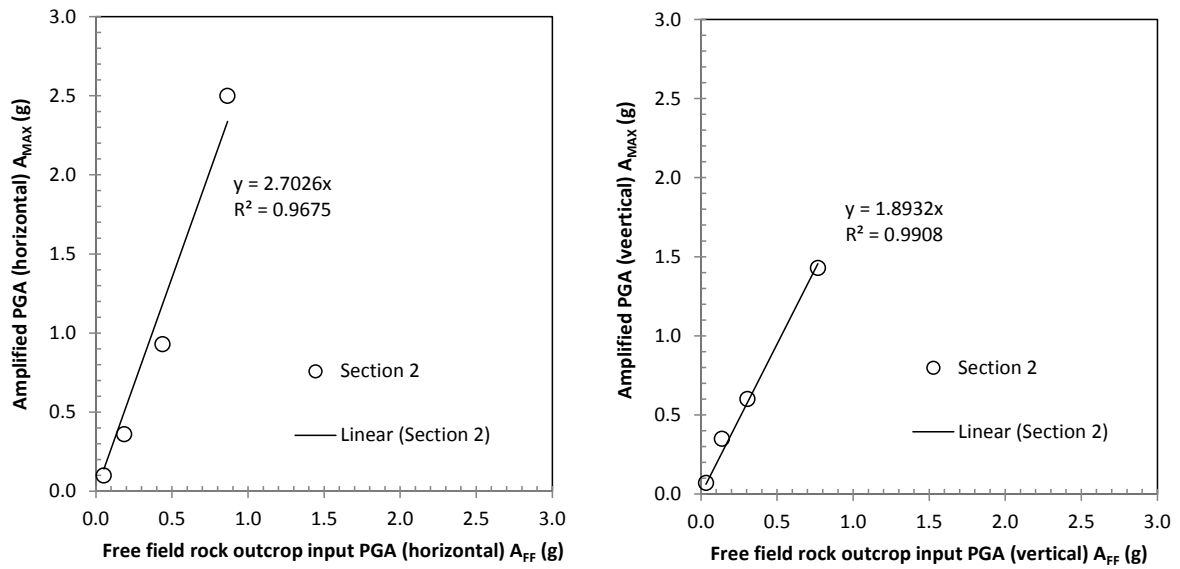
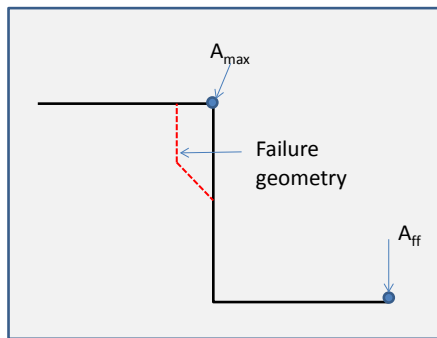
Figure A4.1 Amplification relationship between the synthetic free-field rock outcrop input motions (A_{FF}) and the modelled cliff crest maximum accelerations (A_{MAX}) for cross-section 2. A schematic diagram showing the locations of the various recorded accelerations is shown.

Results from this assessment have shown that the relationship between the peak ground acceleration of the free-field input motion and the corresponding modelled peak acceleration at the slope crest (A_{MAX}) is approximately linear. In the range of modelled peak horizontal accelerations, the horizontal amplification factor (S_T) is typically in the order of about 2.7 times the input free-field peak horizontal acceleration.

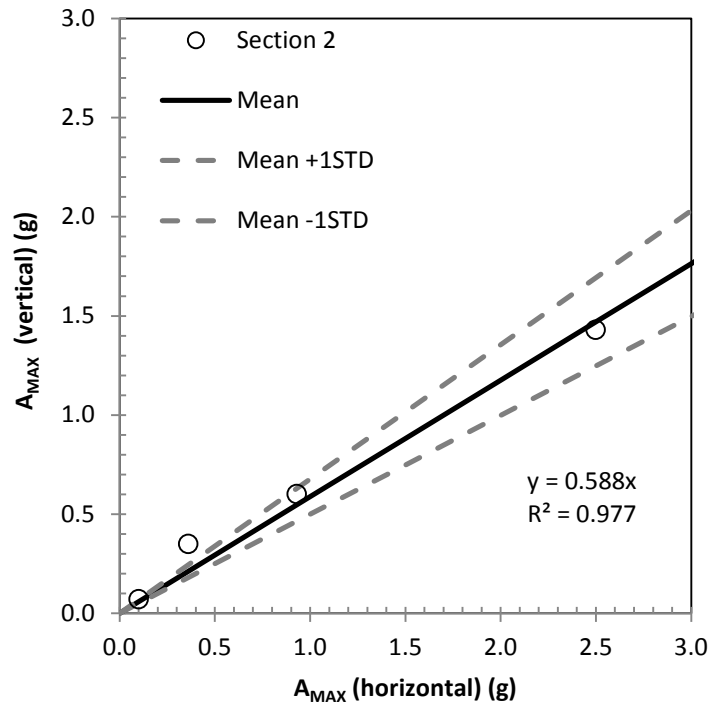
The relationship between the modelled vertical and horizontal peak ground accelerations recorded at the slope crest (A_{MAX}) is shown in Figure A4.3. The gradient of the linear fit is $0.59 (\pm 0.03)$ – errors at one standard deviation. The relationship between horizontal and vertical peak ground accelerations appears more curved than linear.

Figure A4.3 Relationship between the modelled horizontal and vertical maximum accelerations modelled at the convex break in slope (A_{MAX}) for cross-section 2, using the synthetic free-field rock outcrop motions for the Clifton Terrace site by Holden et al. (2014) as inputs to the assessment. The mean and standard deviation trend lines are fitted for A_{MAX} all data. Errors are shown as the mean \pm one standard deviation (1 STD).

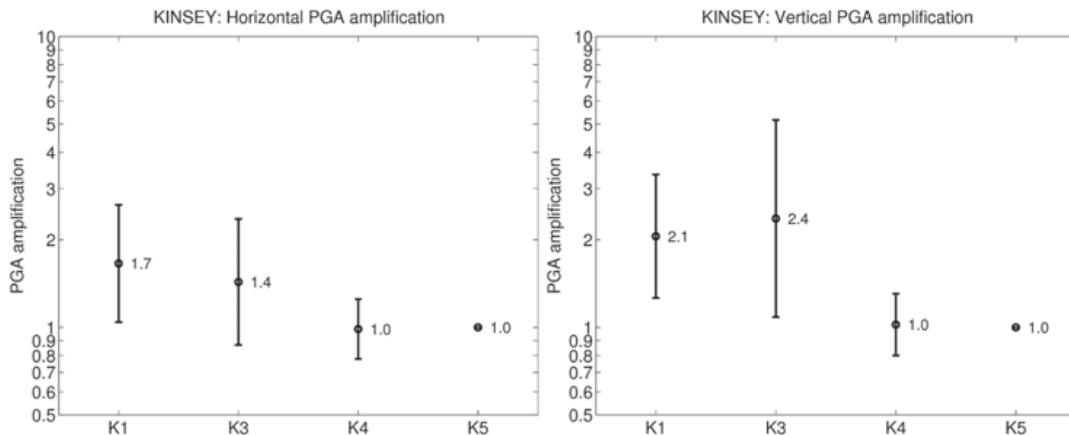
Results from the assessment of the data collected by the seismic array instruments installed on Clifton Terrace reported by Kaiser et al. (2014) show significant differences in mean peak ground acceleration amplification between stations of up to 1.7 times horizontal and 2.4 times vertical (Figure A4.4). Kaiser et al. (2014) report that there was significant variation in these values across individual events, as seen from the range of values within one standard deviation of the mean shown in Figure A4.4. Furthermore, these values are derived from small to moderate sized earthquakes dominated by high-frequency ground motions and

therefore they cannot be considered appropriate for larger magnitude shaking without further study. However, these results do show that the stations located on source area A (station K1 and K3) have higher amplification factors to the ones located outside the area of cracking (K4 and K5, where K5 is the reference station).

Figure A4.4 Peak ground amplification (PGA) with respect to the reference station in the horizontal (left) and vertical (right) directions recorded between stations at Clifton Terrace (Figure 6 for instrument locations). The horizontal PGA is taken to be the larger of the two horizontal components. Geometric mean and standard deviations of the amplification factors across individual events are shown as error bars.
