Banks Peninsula Fish Passage Assessment and Prioritisation: A Pilot Study

September 2019

Prepared for:
Christchurch City Council

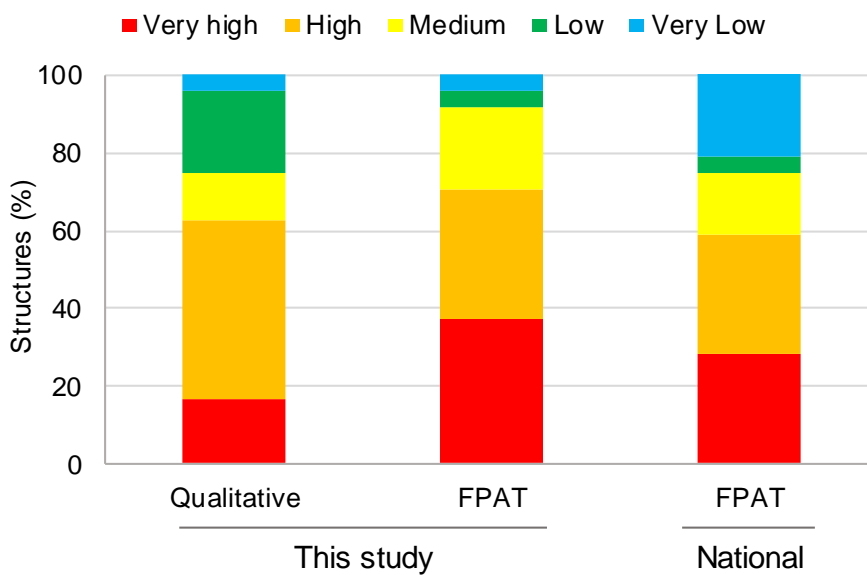
The highest FPAT priority score of 20 (the maximum possible score) was given to a perched culvert on Church Lane Drain (Site 6) in Governors Bay. The lowest FPAT score of 5 (the minimum possible score is 4) was given to two waterfalls (Sites 26 and 28) and a weir (Site 25) on Wainui Valley Stream (Figure 5). Highest priority sites either had no other structures identified elsewhere on the waterway, or a large proportion of the catchment with no other structures. Given the number of additional structures identified during stream walks, it is likely that priority scores would decrease at some sites if stream walks were undertaken upstream

Figure 3: Church Lane Drain (Site 6, left) is a perched culvert assessed as presenting a very high risk to fish passage. The culvert on Wainui Valley Stream Branch (Site 9, right) likely presents a similar risk to fish passage, but the stream location was not mapped in the FPAT app, so a risk score was not calculated for the structure.
