# Sumner Revetment Assessment

Christchurch City Council

## Operational Review Sumner Revetment

IZ103600-NM-RPT-001 | 4

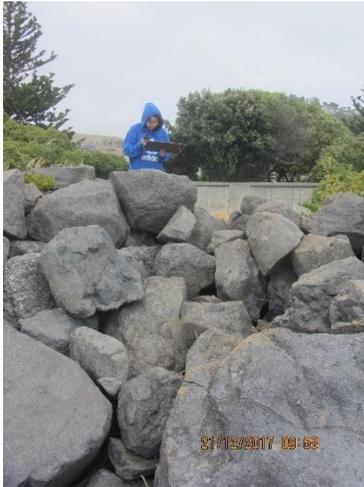
Site 1							
North End Co-ordinates (NZTM)		Length of Area (m)	Crest Elevation from Lidar (m LVD)	Revetment Width from Lidar (m)	Revetment Slope	Est. Armour Rock size if considered issue	Actual Critical Analysis Rank for Priority Assessment
Northings	Eastings						
5176220	1580619	2.2	3.61	5.8	2.89	0.3-0.6	3a
<b>Other issues identified:</b> Localised low spot.

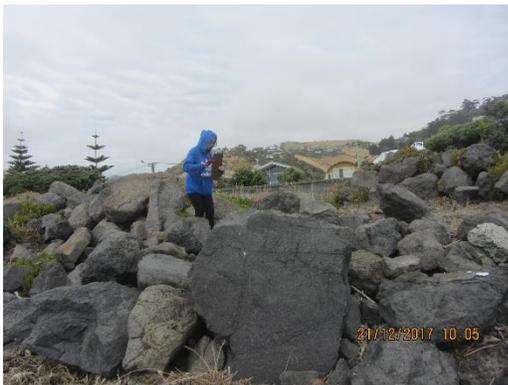
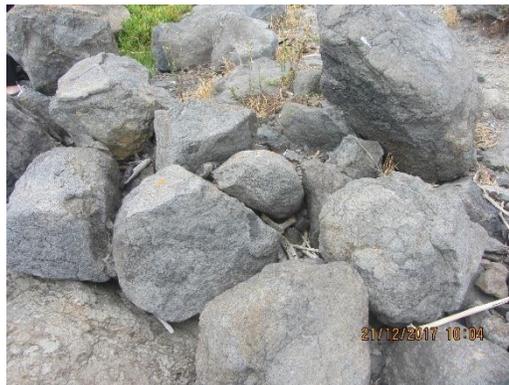
Site 2							
North End Co-ordinates (NZTM)		Length of Area (m)	Crest Elevation from Lidar (m LVD)	Revetment Width from Lidar (m)	Revetment Slope	Est. Armour Rock size if considered issue	Actual Critical Analysis Rank for Priority Assessment
Northings	Eastings						
5176199	1580636	3.8	3.5	8	3.48	0.2-0.3m	2
<b>Other issues identified:</b> Localised low spot at track from promenade to top of revetment.

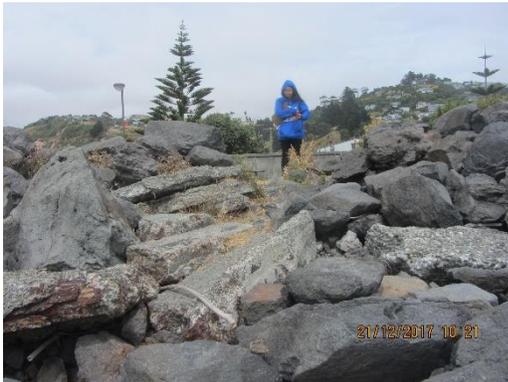
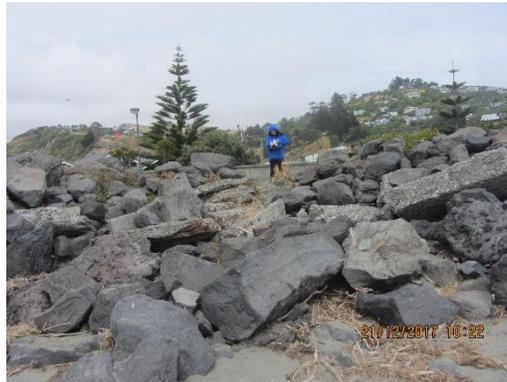
Site 5							
North End Co-ordinates (NZTM)		Length of Area (m)	Crest Elevation from Lidar (m LVD)	Revetment Width from Lidar (m)	Revetment Slope	Est. Armour Rock size if considered issue	Actual Critical Analysis Rank for Priority Assessment
Northings	Eastings						
5176145	1580668	2.8	3.50	9.2	3.54	No issue	1
<b>Other issues identified:</b> Localised low spot at narrow track from promenade to top of revetment, concrete units

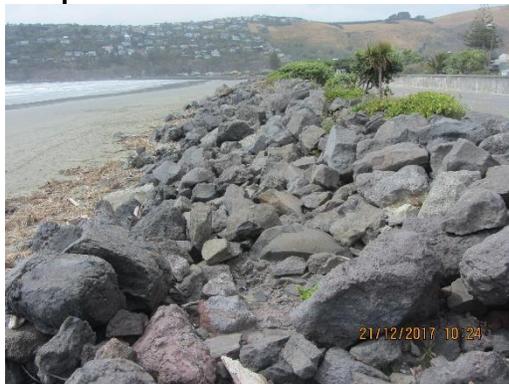
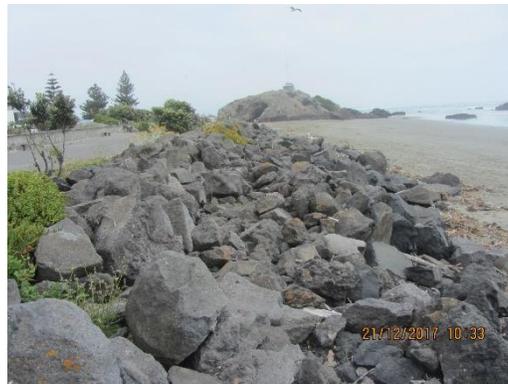
Site 6							
North End Co-ordinates (NZTM)		Length of Area (m)	Crest Elevation from Lidar (m LVD)	Revetment Width from Lidar (m)	Revetment Slope	Est. Armour Rock size if considered issue	Actual Critical Analysis Rank for Priority Assessment
Northings	Eastings						
5176113	1580693	7.3	3.5	10.9	3.92	No issue	1
<b>Other issues identified:</b> Slumped section in front of high crest rocks.

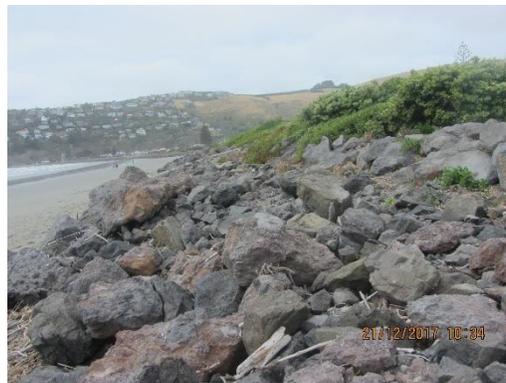
Site 7							
North End Co-ordinates (NZTM)		Length of Area (m)	Crest Elevation from Lidar (m LVD)	Revetment Width from Lidar (m)	Revetment Slope	Est. Armour Rock size if considered issue	Actual Critical Analysis Rank for Priority Assessment
Northings	Eastings						
5176088	1580710	18.4	3.44	11.4	4.16	0.25-0.3m	3b
<b>Other issues identified:</b> Flat slope to front of revetment.

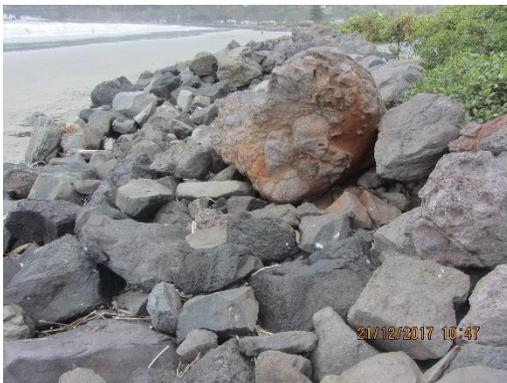
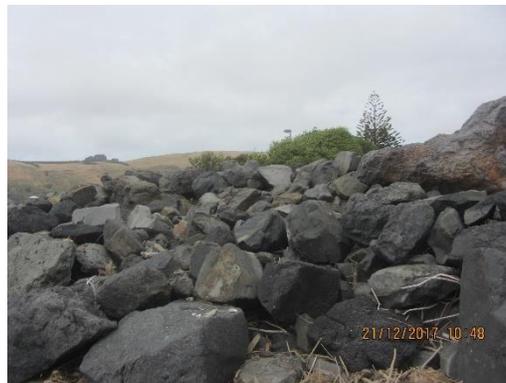
Site 9							
North End Co-ordinates (NZTM)		Length of Area (m)	Crest Elevation from Lidar (m LVD)	Revetment Width from Lidar (m)	Revetment Slope	Est. Armour Rock size if considered issue	Actual Critical Analysis Rank for Priority Assessment
Northings	Eastings						
5176045	1580743	5.8	3.35	9.8	3.66	No issue	1
<b>Other issues identified:</b> Slumped in front of high crest rocks. Large rock in middle of area.

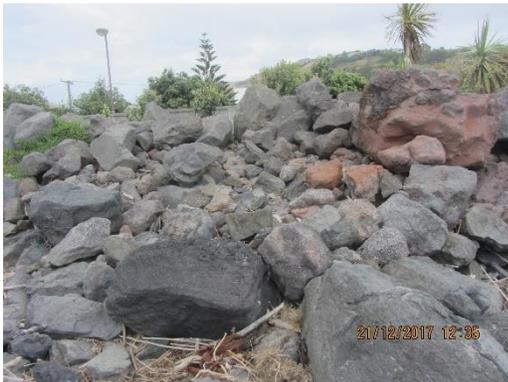
Site 22							
North End Co-ordinates (NZTM)		Length of Area (m)	Crest Elevation from Lidar (m LVD)	Revetment Width from Lidar (m)	Revetment Slope	Est. Armour Rock size if considered issue	Actual Critical Analysis Rank for Priority Assessment
Northings	Eastings						
5175863	1580855	8.5	3.16	7.1	4.03	0.3-0.5m	3b
<b>Other issues identified:</b> Localised low spot.

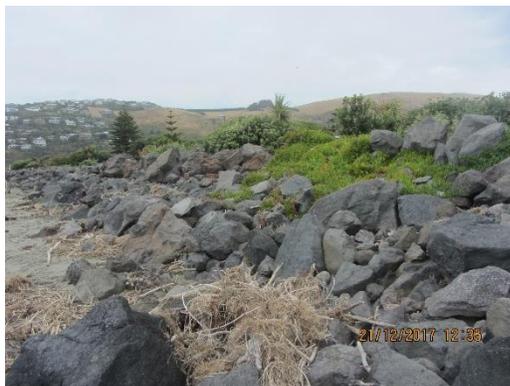
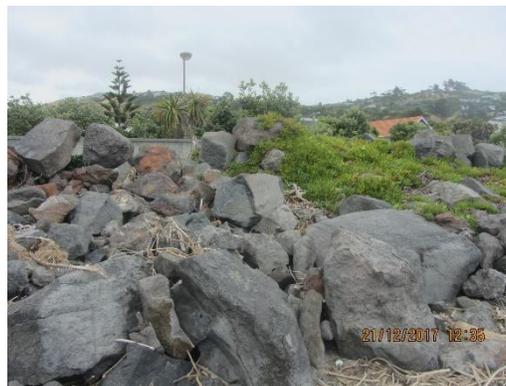
Site 23							
North End Co-ordinates (NZTM)		Length of Area (m)	Crest Elevation from Lidar (m LVD)	Revetment Width from Lidar (m)	Revetment Slope	Est. Armour Rock size if considered issue	Actual Critical Analysis Rank for Priority Assessment
Northings	Eastings						
5175849	1580866	12.0	3.10	8.5	4.15	0.2-0.3	3b
<b>Other issues identified:</b> Localised low spot. Slumped in front of high crest rocks.

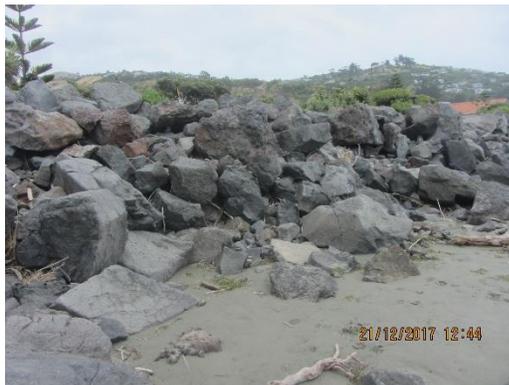
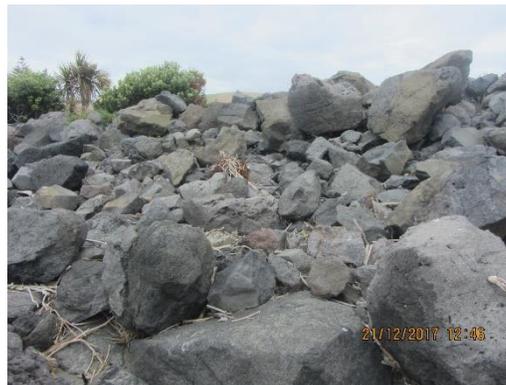
Site 26							
North End Co-ordinates (NZTM)		Length of Area (m)	Crest Elevation from Lidar (m LVD)	Revetment Width from Lidar (m)	Revetment Slope	Est. Armour Rock size if considered issue	Actual Critical Analysis Rank for Priority Assessment
Northings	Eastings						
5175816	1580904	6.3	3.27	10.25	3.91	0.5m	2
<p><b>Other issues identified:</b> Localised low spot. Slumped profile lacking rock with evidence of rock roll down onto the beach. Concrete units.</p>

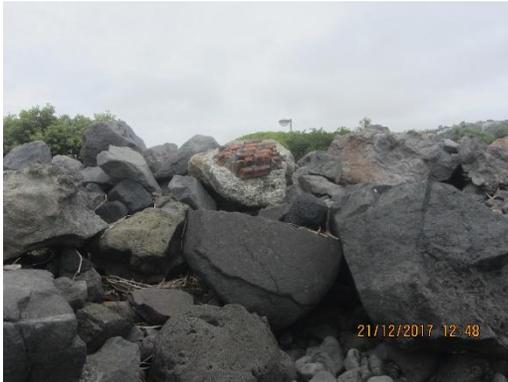
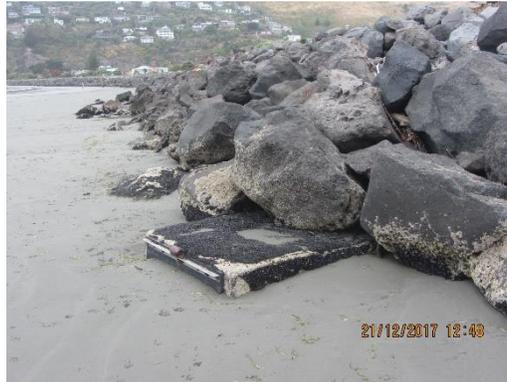
Site 27							
North End Co-ordinates (NZTM)		Length of Area (m)	Crest Elevation from Lidar (m LVD)	Revetment Width from Lidar (m)	Revetment Slope	Est. Armour Rock size if considered issue	Actual Critical Analysis Rank for Priority Assessment
Northings	Eastings						
5175796	1580943	2.0	3.25	9.2	3.35	No issue	1
<b>Other issues identified:</b> Concrete units (with brick) near stormwater outlet.

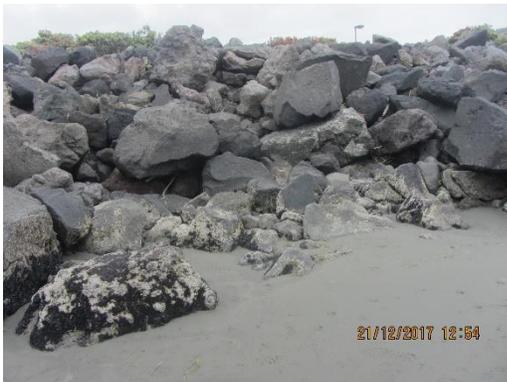
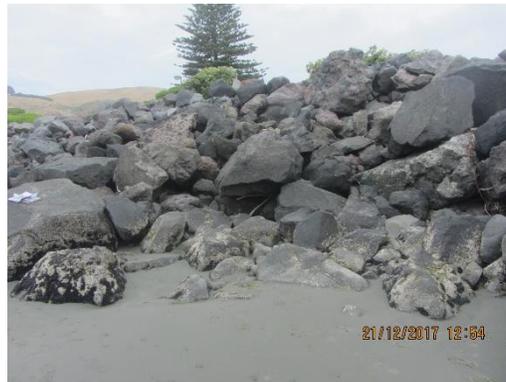
Site 28							
North End Co-ordinates (NZTM)		Length of Area (m)	Crest Elevation from Lidar (m LVD)	Revetment Width from Lidar (m)	Revetment Slope	Est. Armour Rock size if considered issue	Actual Critical Analysis Rank for Priority Assessment
Northings	Eastings						
5175766	1580971	7.2	3.25	9.0	3.22	No issue	1
<b>Other issues identified:</b> Narrow width

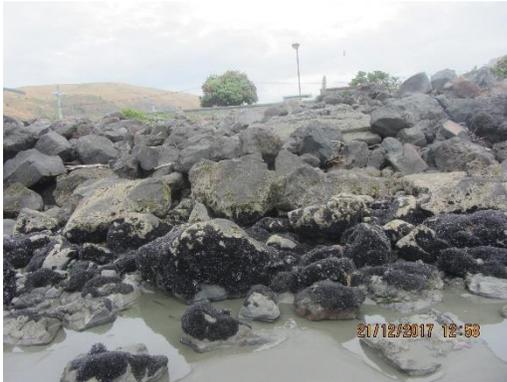
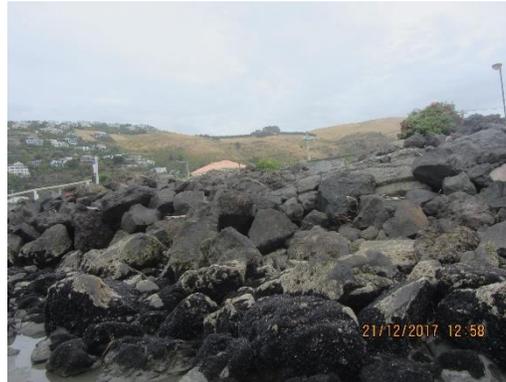
Site 29							
North End Co-ordinates (NZTM)		Length of Area (m)	Crest Elevation from Lidar (m LVD)	Revetment Width from Lidar (m)	Revetment Slope	Est. Armour Rock size if considered issue	Actual Critical Analysis Rank for Priority Assessment
Northings	Eastings						
5175663	1581088	11.2	2.66	11.2	4.55	No issue	2
<b>Other issues identified:</b> Localised low spot. Concrete units.

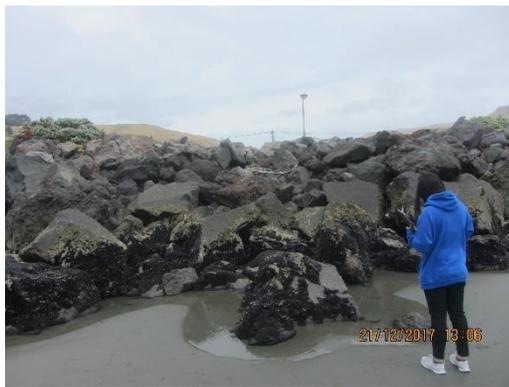
Site 30							
North End Co-ordinates (NZTM)		Length of Area (m)	Crest Elevation from Lidar (m LVD)	Revetment Width from Lidar (m)	Revetment Slope	Est. Armour Rock size if considered issue	Actual Critical Analysis Rank for Priority Assessment
Northings	Eastings						
5175574	1580943	10.2	3.12	9.5	3.19	No issue	1
<p><b>Other issues identified:</b> Narrow width with evidence of rock roll down onto the beach.</p>

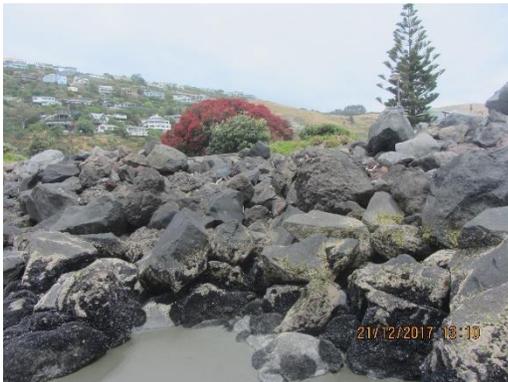
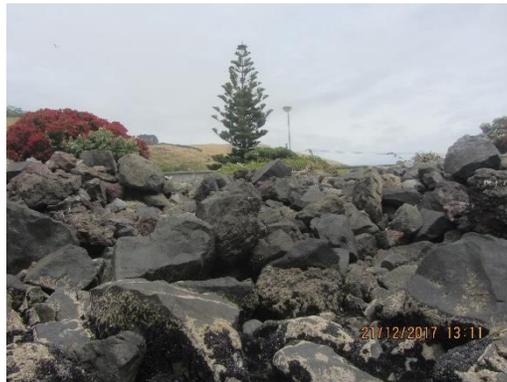
Site 31							
North End Co-ordinates (NZTM)		Length of Area (m)	Crest Elevation from Lidar (m LVD)	Revetment Width from Lidar (m)	Revetment Slope	Est. Armour Rock size if considered issue	Actual Critical Analysis Rank for Priority Assessment
Northings	Eastings						
5175576	1581255	5.0	2.85	10.4	3.85	No issue	1
<b>Other issues identified:</b> Localised low spot

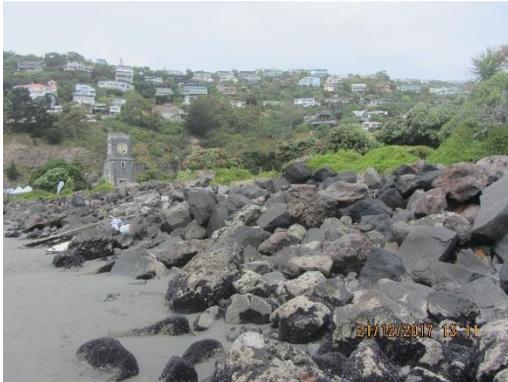
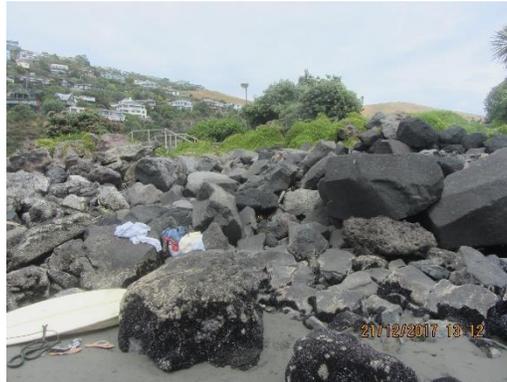
Site 32							
North End Co-ordinates (NZTM)		Length of Area (m)	Crest Elevation from Lidar (m LVD)	Revetment Width from Lidar (m)	Revetment Slope	Est. Armour Rock size if considered issue	Actual Critical Analysis Rank for Priority Assessment
Northings	Eastings						
5175560	1581294	11.7	2.95	11.9	4.58	No issue	2
<b>Other issues identified:</b> Concrete units.

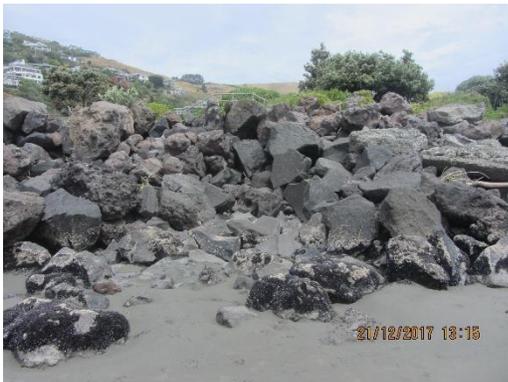
Site 33							
North End Co-ordinates (NZTM)		Length of Area (m)	Crest Elevation from Lidar (m LVD)	Revetment Width from Lidar (m)	Revetment Slope	Est. Armour Rock size if considered issue	Actual Critical Analysis Rank for Priority Assessment
Northings	Eastings						
5175553	1581308	13.9	2.77	8.6	3.74	No issue	1
<b>Other issues identified:</b> Narrow width – appears to lack rock, concrete units.

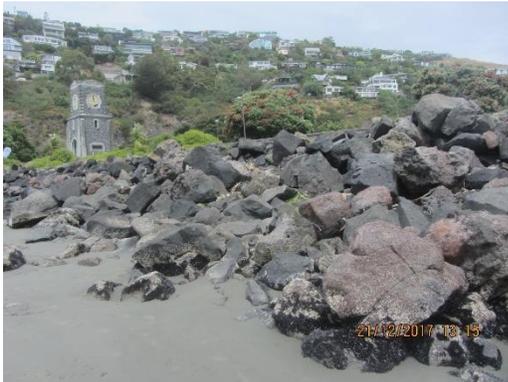
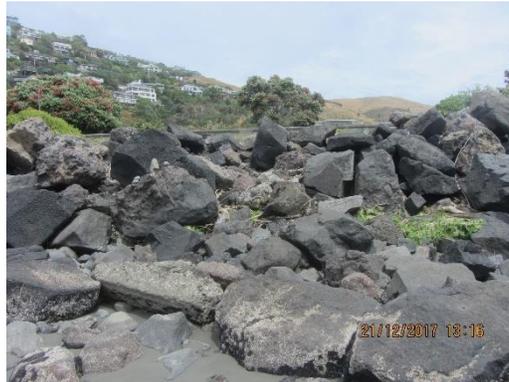
Site 34							
North End Co-ordinates (NZTM)		Length of Area (m)	Crest Elevation from Lidar (m LVD)	Revetment Width from Lidar (m)	Revetment Slope	Est. Armour Rock size if considered issue	Actual Critical Analysis Rank for Priority Assessment
Northings	Eastings						
5175550	1581329	16.5	2.60	7.8	3.92	No issue	1
<b>Other issues identified:</b> Localised low spot, concrete units.

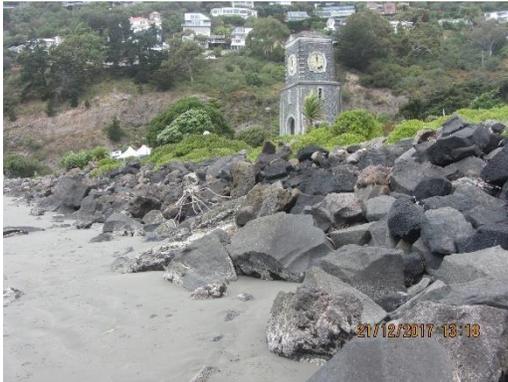
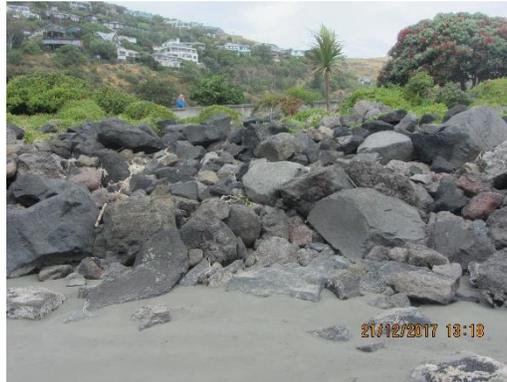
Site 35							
North End Co-ordinates (NZTM)		Length of Area (m)	Crest Elevation from Lidar (m LVD)	Revetment Width from Lidar (m)	Revetment Slope	Est. Armour Rock size if considered issue	Actual Critical Analysis Rank for Priority Assessment
Northings	Eastings						
5175542	1581360	11.2	2.56	7.9	4.25	0.25-0.4m	3b
<b>Other issues identified:</b> Localised low spot. Concrete units.

The seven medium priority (e.g. critical rank 2) sites where armour rock size are an issue should be the third priority to be maintained, so that sufficient size armour material is in place to reduce the likelihood of further rock displacement, which may result in slope issues. The majority of these sites are to the north of Hardwicke St. The above recommended site preparation and rock placement stages should be followed.

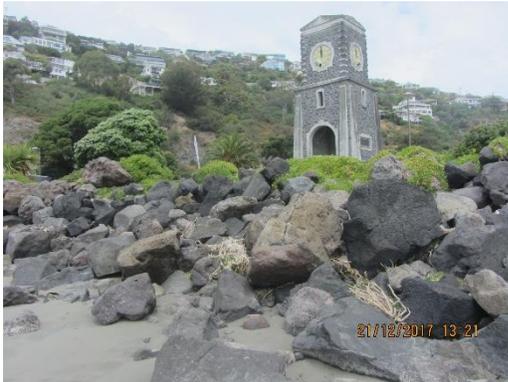
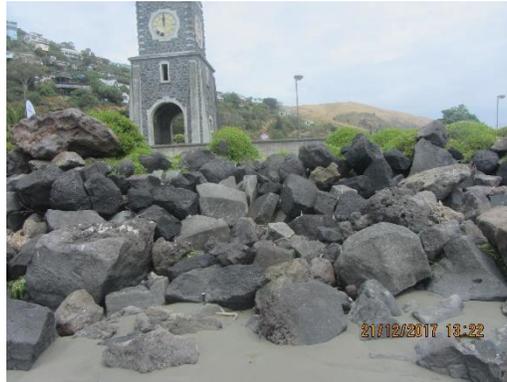
Site 36							
North End Co-ordinates (NZTM)		Length of Area (m)	Crest Elevation from Lidar (m LVD)	Revetment Width from Lidar (m)	Revetment Slope	Est. Armour Rock size if considered issue	Actual Critical Analysis Rank for Priority Assessment
Northings	Eastings						
5175540	1581376	4.1	2.80	6.8	3.4	No issue	1
<b>Other issues identified:</b> Localised low spot.
