# **Arran Courts Housing Complex PRO 0823**

**Detailed Engineering Evaluation  
Quantitative Assessment Report**

**27 Arran Crescent, Linwood,  
Christchurch**

Date: September 2013  
Reference: 6-QC309.00  
Status: Final

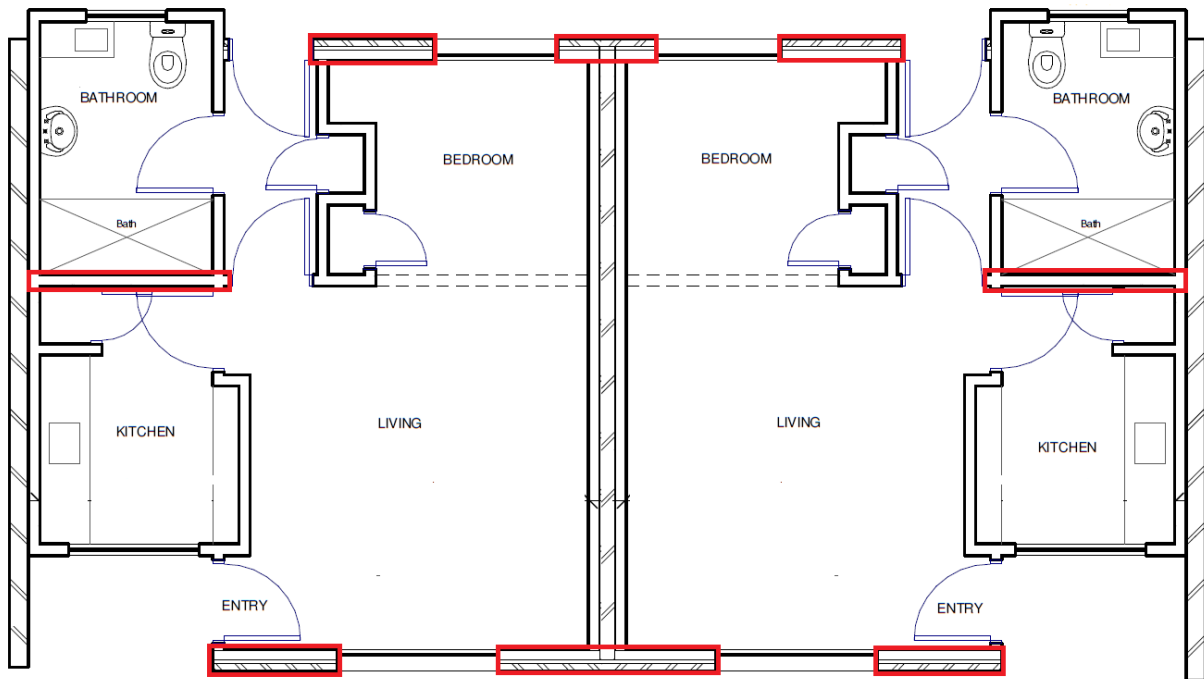
Figure 6: Walls used for bracing in the longitudinal direction.

Hand calculations were performed to determine seismic forces from the current building codes. These forces were applied globally to the structure and the capacities of the walls

were calculated and used to estimate the %NBS. The walls, highlighted in Figure 6 and Figure 7, were used for bracing in their respective directions.
