CHRISTCHURCH CITY COUNCIL
BU 0680-008 EQ2
Avebury Park Pool Plant Shed
9 Eveleyn Couzins Ave, Richmond

**QUALITATIVE ASSESSMENT REPORT
FINAL**

- Rev B
- 25 March 2013

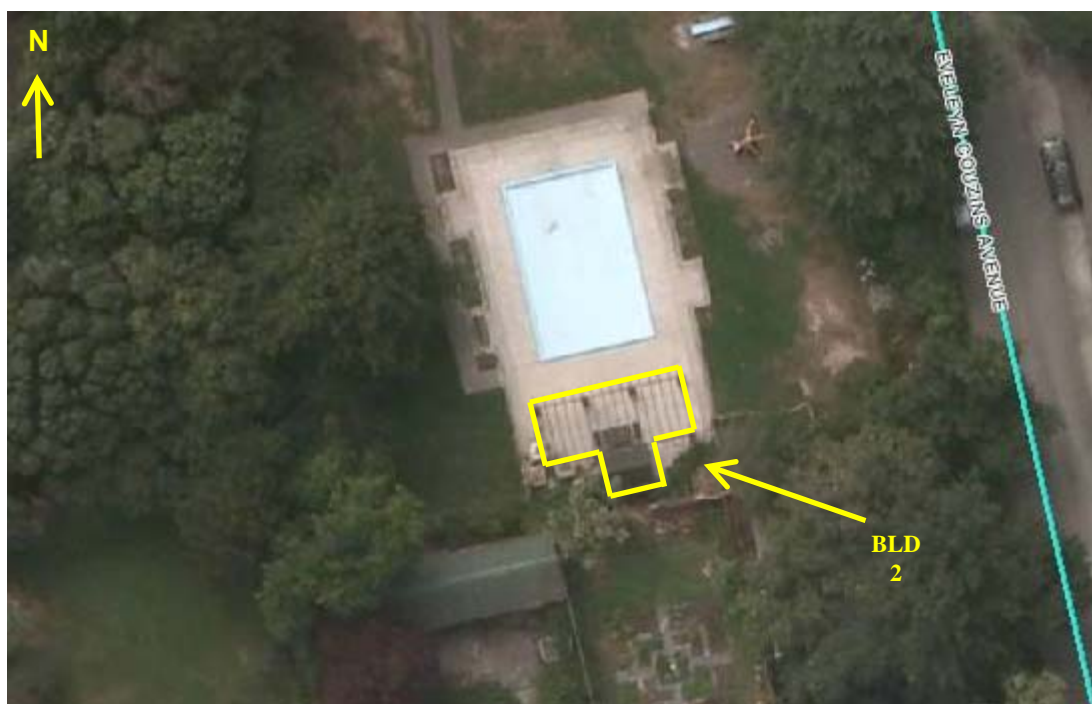
■ **Figure 1 Aerial Photograph of the plant shed in Avebury Park at 9 Eveleyn Couzins Ave**

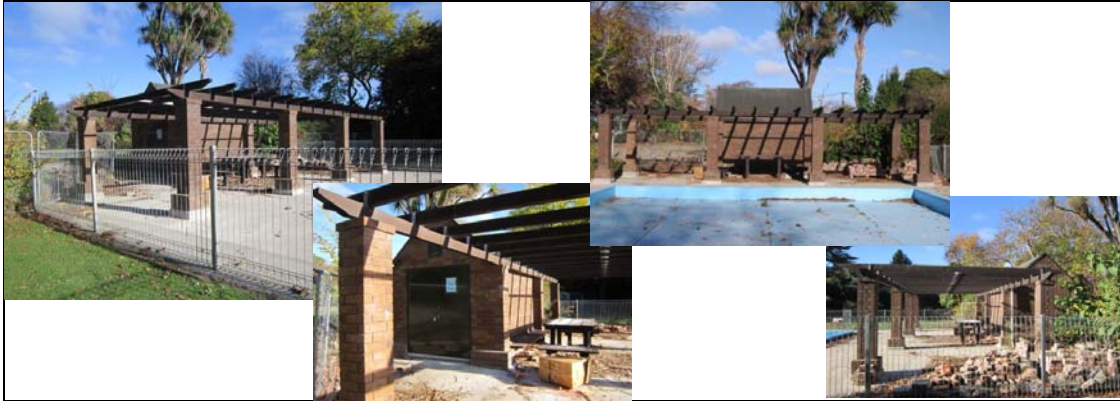
1.1 Photos (attach sufficient to describe building)

The building in Avebury Park at 9 Eveleyn Cousins Ave is one storey and is currently in use as a plant room for the nearby paddling pool. The building consists of timber framed walls with a brick veneer and a lightweight roof. There are six brick columns connected to the building by timber beams that are secondary structural elements. The columns are believed to have a minor effect on the building, therefore the main lateral load-resisting system will be the timber framing in the walls. Internal inspection was not able to be carried out as the building was inaccessible at the time of the inspection. The walls appear to be founded on a concrete slab footing. The building was believed to be designed and constructed after 1992, as the architectural drawings are dated 1999.

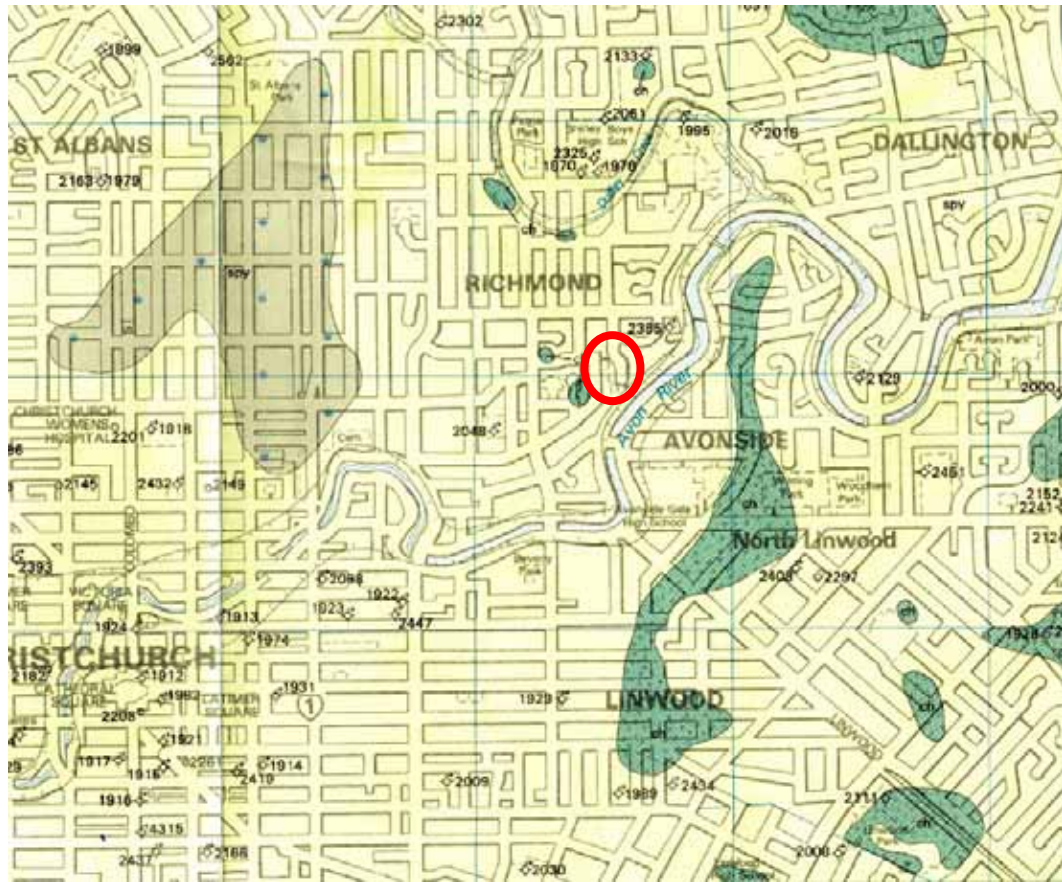
■ **Figure 3 – Local geological map (Brown et al, 1992). Site marked in red.**

The site is shown to be underlain by Holocene deposits comprising predominantly alluvial sand and silt overbank deposits of the Springston Formation.

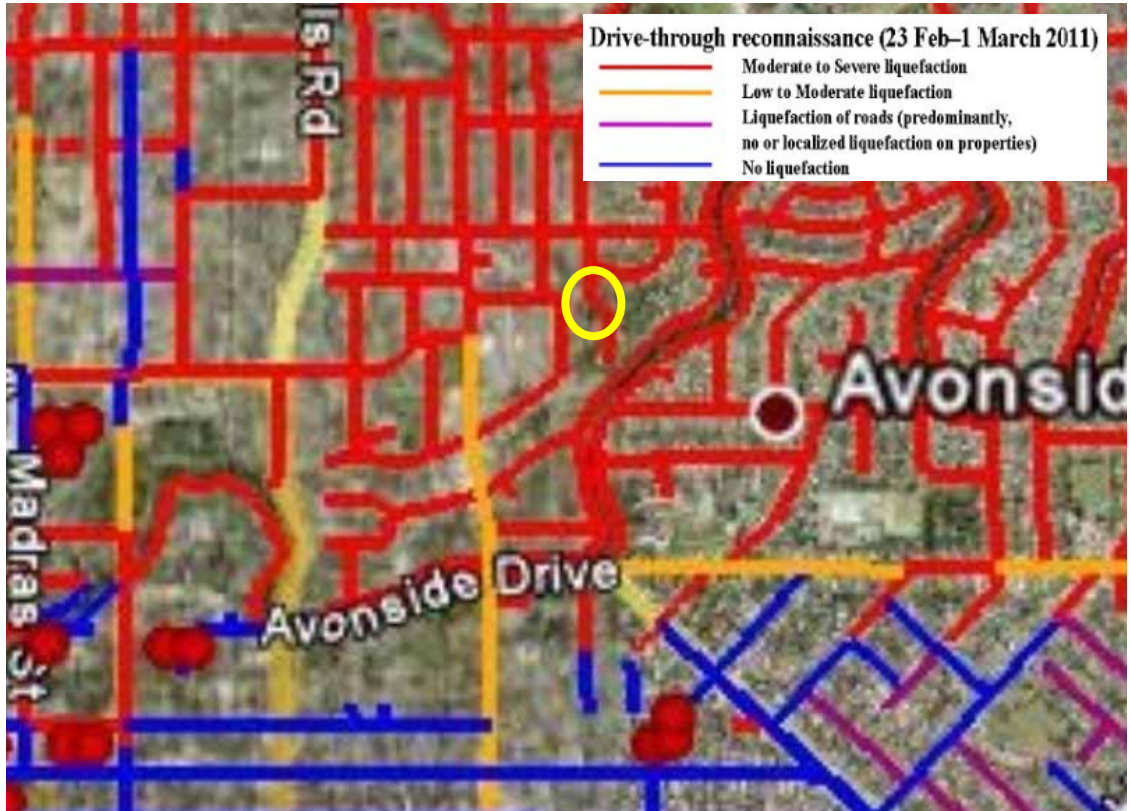
■ **Figure 4 – Liquefaction map (Cubrinovski & Taylor, 2011). Site marked in yellow.**

Following the 22 February 2011 event drive through reconnaissance was undertaken from 23 February until 1 March by M Cubrinovski and M Taylor of Canterbury University. Their findings show moderate to severe liquefaction on all streets surrounding the site.

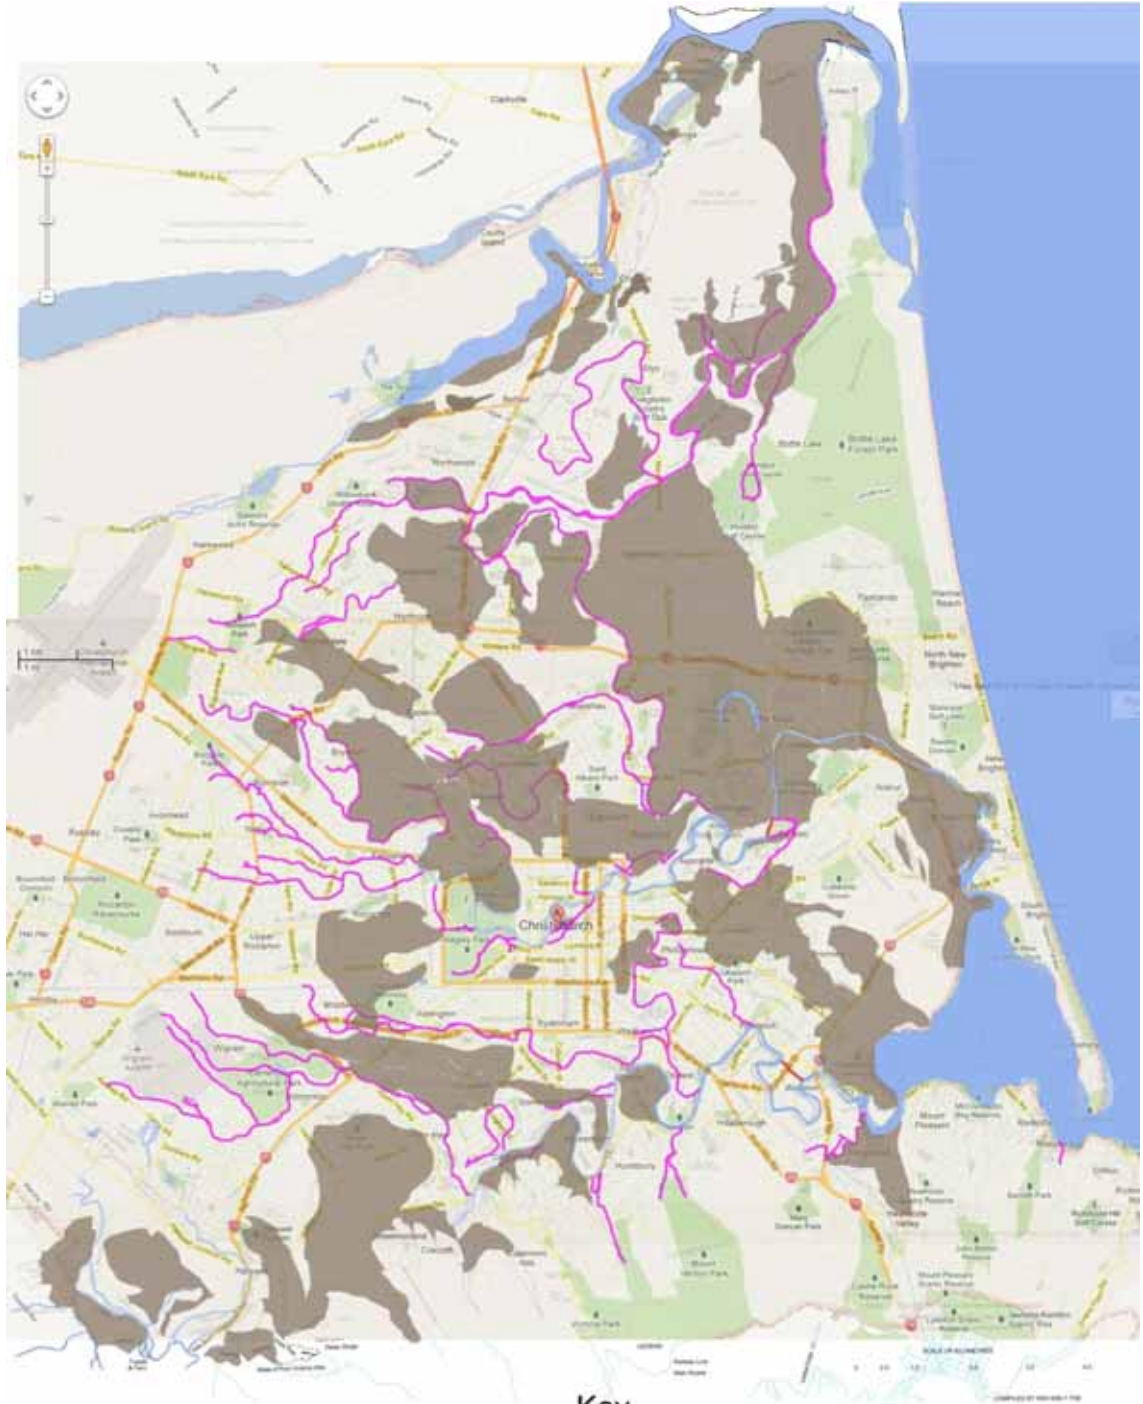
Reference to historical documents (e.g. Appendix A) shows that the site lies adjacent to, or on the boundary of, land that was recorded as marshland or swamp in 1856. The historical records also identify a river traversing the site. It is therefore possible that soft or liquefiable ground would be present near the site. Given the relatively low accuracy of these historical documents, it should be considered possible that old swamp deposits are present on the site.

The swamps and previous creeks/riders from 1856 have been overlaid onto a map of Christchurch in 2012
