Bromley Community Centre
BU 0897-001 EQ2
Detailed Engineering Evaluation
Quantitative Report
Christchurch City Council

Detailed Engineering Evaluation Quantitative Report

Date: October 2012
Reference: 6-QUCCC.89
Status: Final

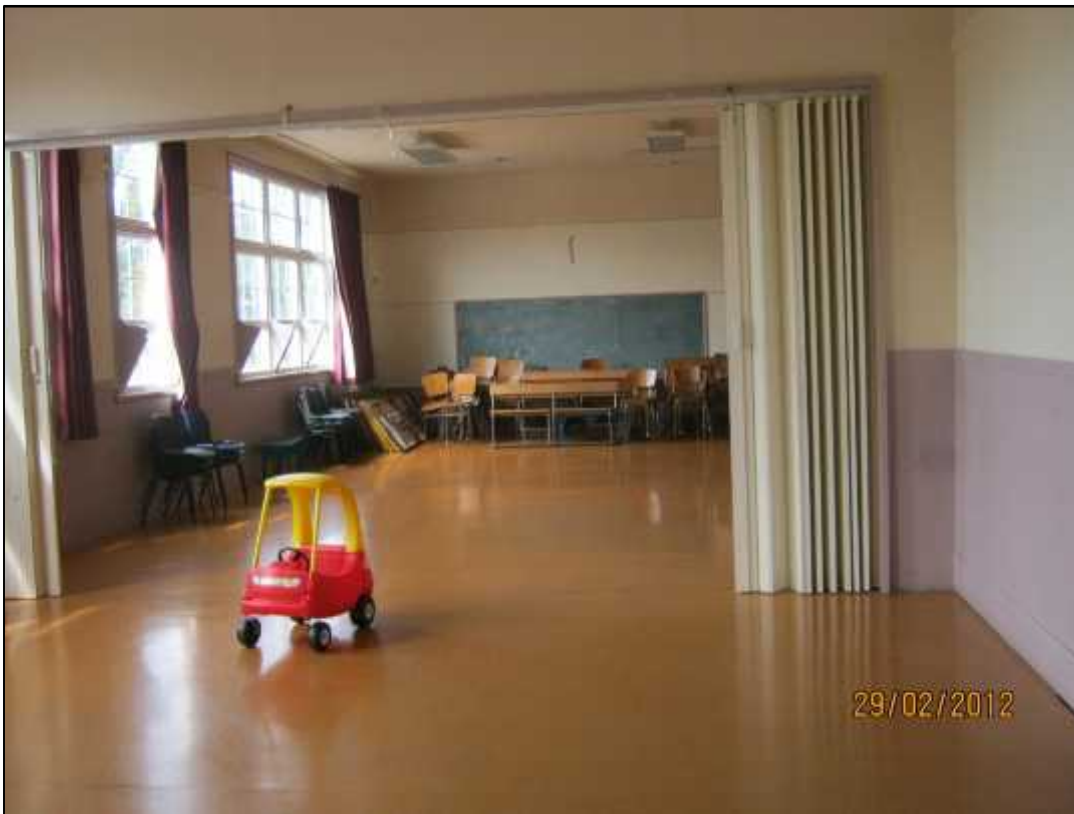
Photograph 3: View inside the hall

There are cracks present in the timber rafter near its support in the hall area (Appendix 1: Photograph 6).
