**Brougham Village Blocks A to E  
Detailed Engineering Evaluation  
Quantitative Report**

Christchurch City Council

Date: 3 October 2012  
Reference: 6-QUCCC.92

Detailed Engineering Evaluation  
Quantitative Report - SUMMARY  
Version 4 - Final

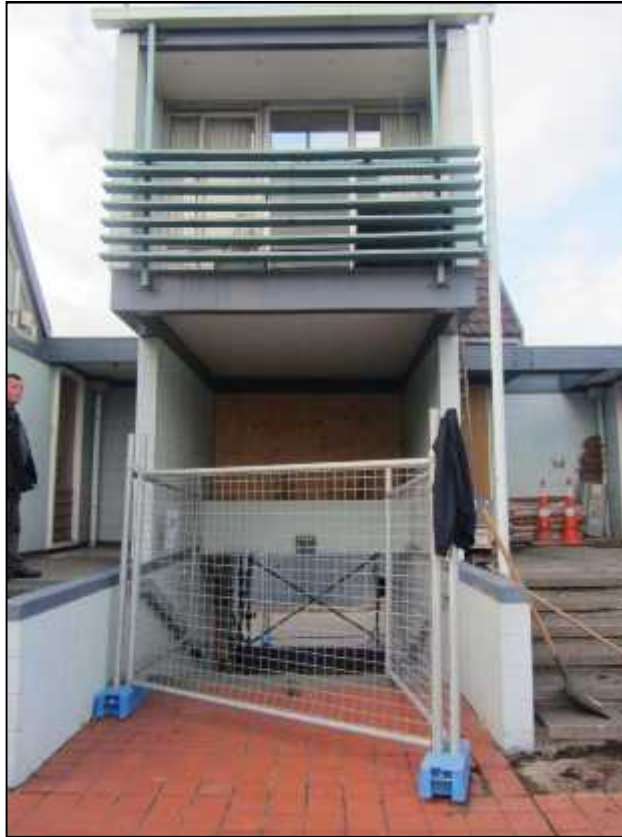
The 3-storey units pose a potential collapse hazard. Currently, the lateral restraint to the upper two levels of the units is provided by the out-of-plane capacity of the upper storey and a single in-plane wall on the first floor. Failure of the lateral resisting system will result in a high risk of collapse of the upper storeys onto the surrounding properties. The potential hazard zone includes the residential units on either side of the 3-storey unit

*Photo 3: View of a typical 3 storey section of building*

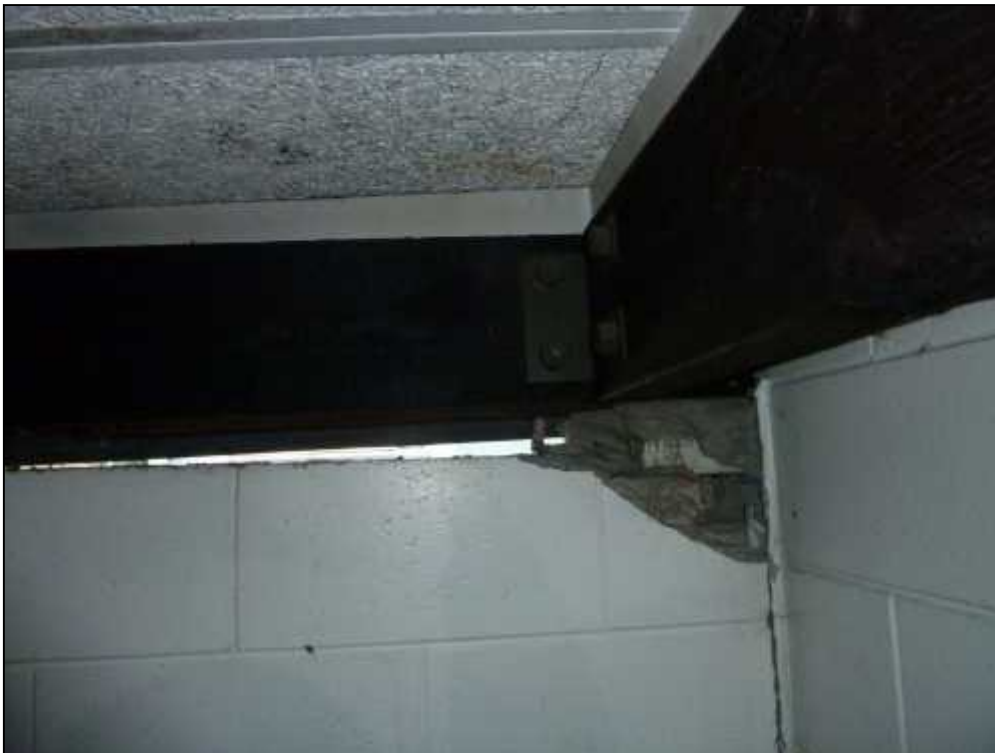
- Differential settlement of the slab foundations (Photo 5).
- Separation of the slab foundations at the interface with adjacent units (Photo 5).
- Settlement of walls and separation of walls at the interface with adjacent units (Photos 4 and 5).
- Cracking and displacement of concrete beams and suspended slab floors in the 2 to 3 storey sections (Photo 6).
- Separation of bond beams from top of reinforced masonry walls (Photo 4).
- Failure of wall due to excessive loading (Photo 10).
- Rotation of reinforced masonry piers to front of garage due to soil movement (Photos 8 and 9).

*Photo 4: 50mm settlement of a masonry wall 4 at the interface with adjacent unit*

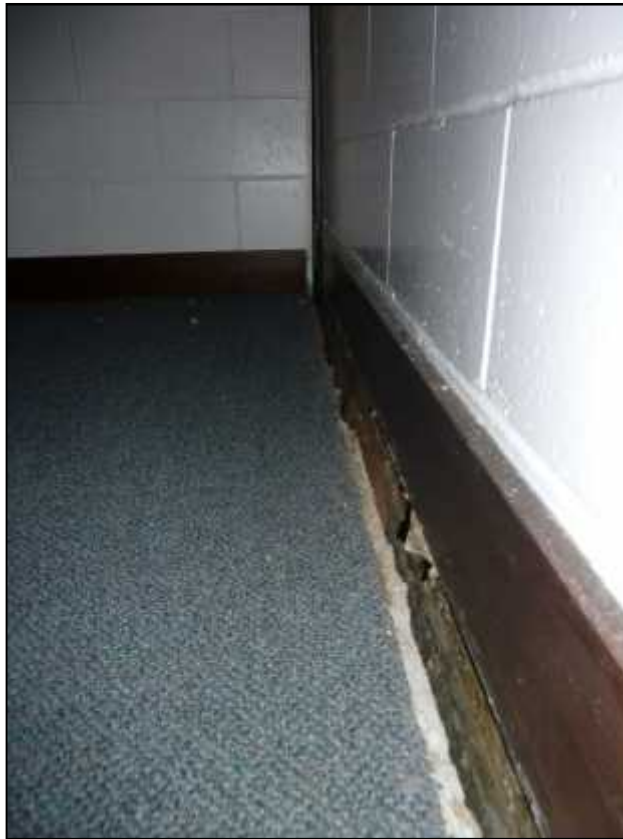
*Photo 5: 60mm settlement with 40mm lateral displacement of slab and wall at the interface with adjacent unit*

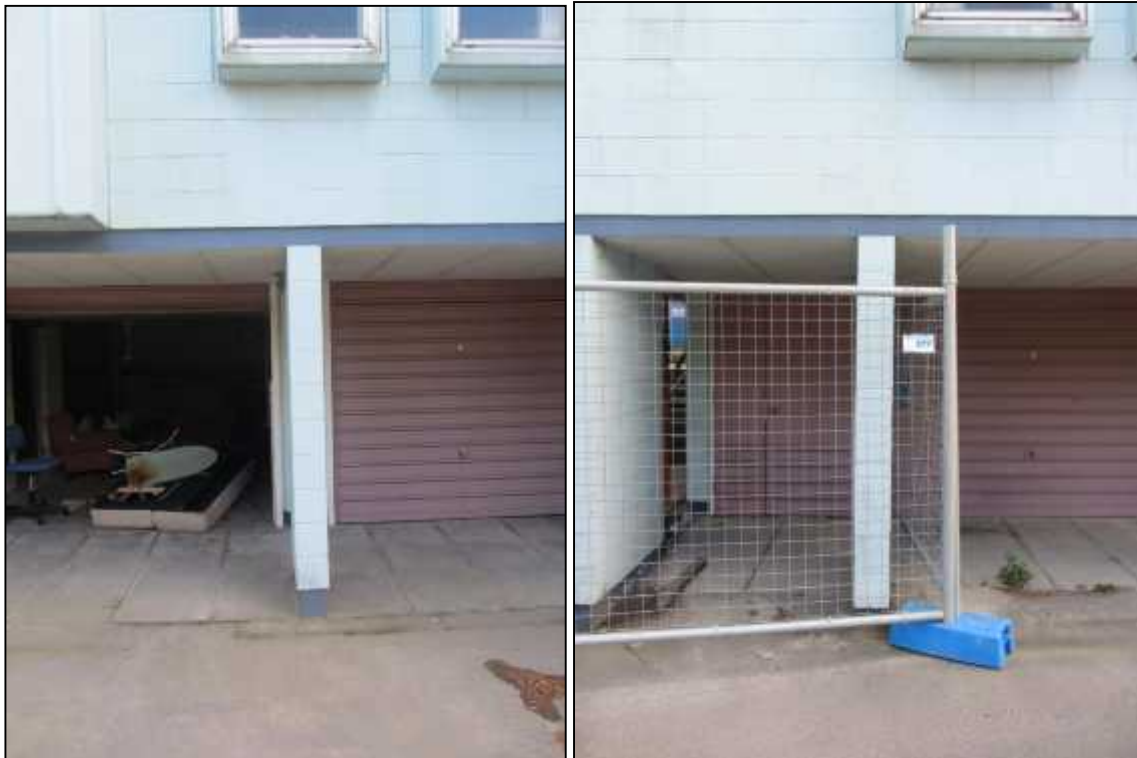
Photo 8 and 9: Masonry piers out of plumb due to differential settlement and lateral spread

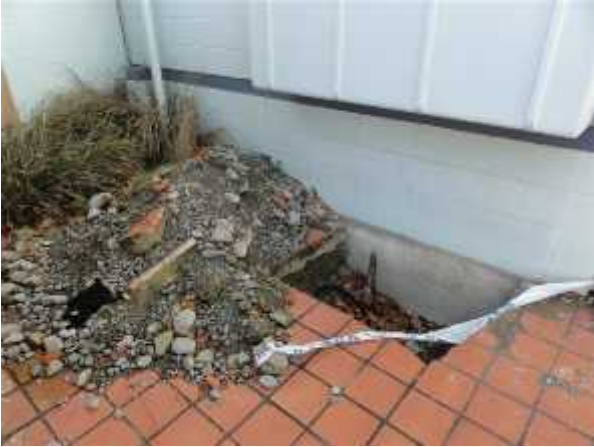
Open excavation showing rounded pit run.

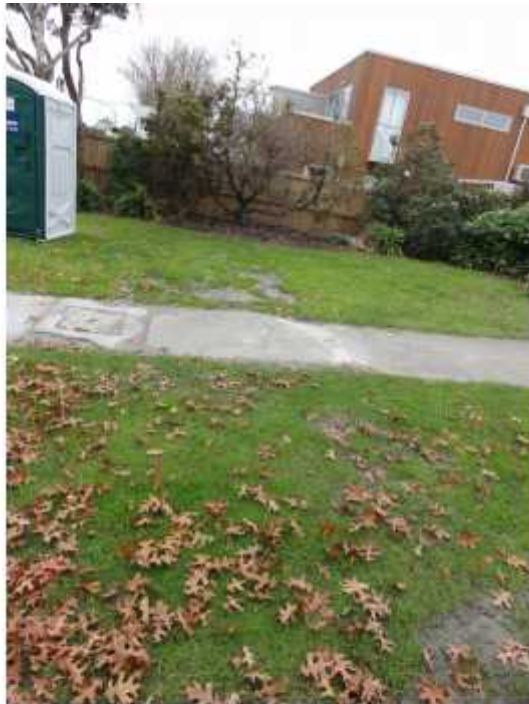
Ground Heave above service trench
