Christchurch City Council

Cecil Courts

BE 1047 EQ2

Detailed Engineering Evaluation
Quantitative Assessment Report

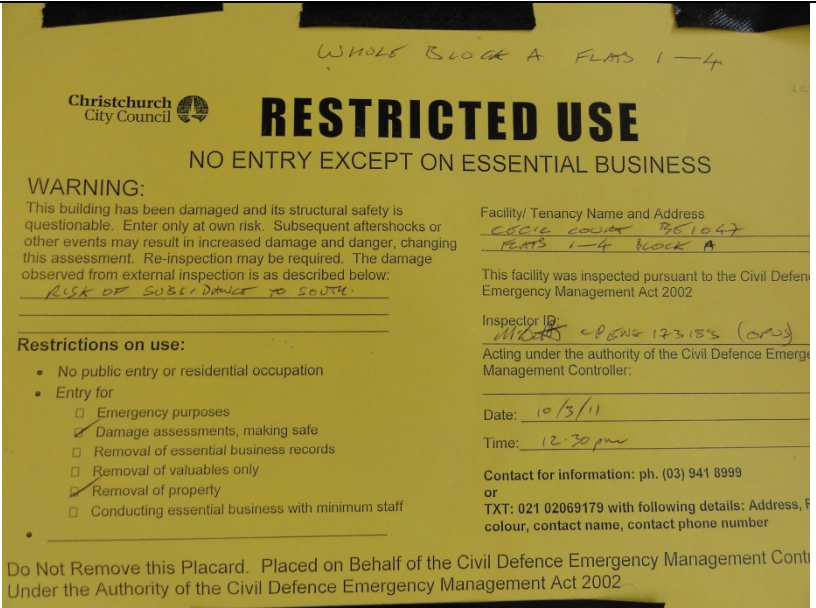
<p>7.</p>	<p>Yellow placard for Units 1-4 at 16 Cecil Place</p>

<p>WHOLE BLOCK A FLATS 1-4</p> <p>Christchurch City Council</p> <h2 align="center">RESTRICTED USE</h2> <p align="center">NO ENTRY EXCEPT ON ESSENTIAL BUSINESS</p> <p>WARNING: This building has been damaged and its structural safety is questionable. Enter only at own risk. Subsequent aftershocks or other events may result in increased damage and danger, changing this assessment. Re-inspection may be required. The damage observed from external inspection is as described below: <u>RISK OF SUBSIDENCE TO SOUTH</u></p> <p>Facility/ Tenancy Name and Address <u>CECIL COURT 1651047</u> <u>FLATS 1-4 BLOCK A</u></p> <p>This facility was inspected pursuant to the Civil Defence Emergency Management Act 2002</p> <p>Inspector ID <u>110005</u> <u>CPENG 123185 (CPD)</u> Acting under the authority of the Civil Defence Emergency Management Controller:</p> <p>Date: <u>10/3/11</u> Time: <u>12:30 pm</u></p> <p>Contact for information: ph. (03) 941 8999 or TXT: 021 02069179 with following details: Address, Facility name, colour, contact name, contact phone number</p> <p>Do Not Remove this Placard. Placed on Behalf of the Civil Defence Emergency Management Controller Under the Authority of the Civil Defence Emergency Management Act 2002</p>

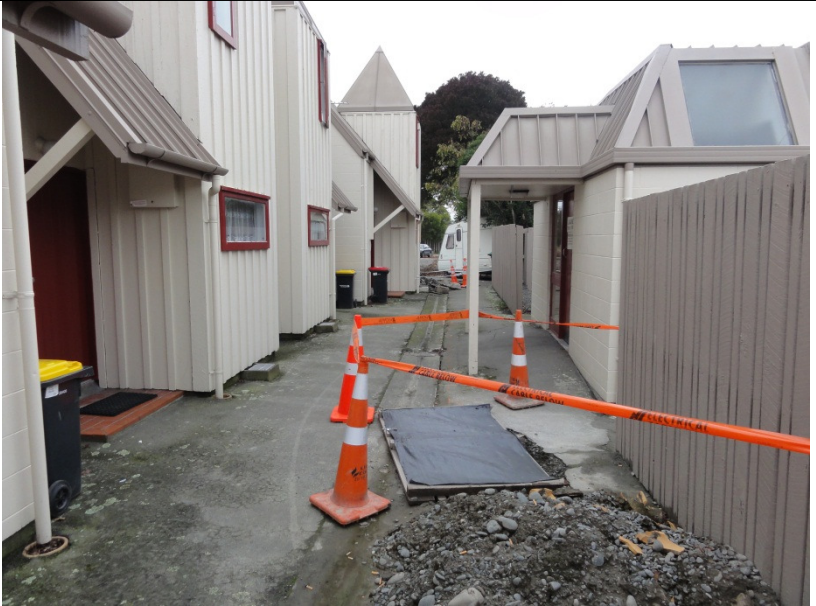
- A 4m long section of ground adjacent to the perimeter footing of Unit 9 at 16 Cecil Place (within Block C) collapsed. A void is located in the southeast corner of the foundation as evident by damaged services (see Appendix 1, photo 16).

<p>15.</p>	<p>Outside Unit 9 at 16 Cecil Place</p>

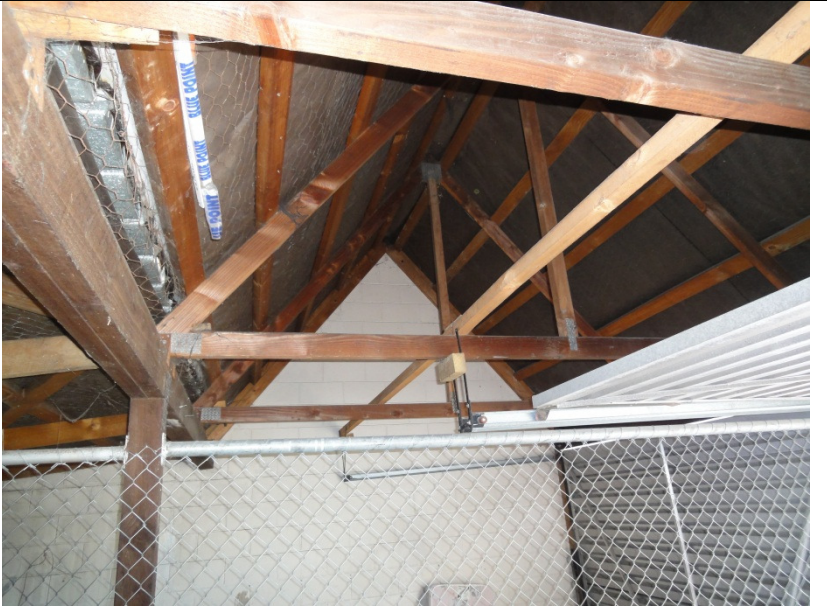
33.	Garage roof consists of skipped boards spanning between timber trusses

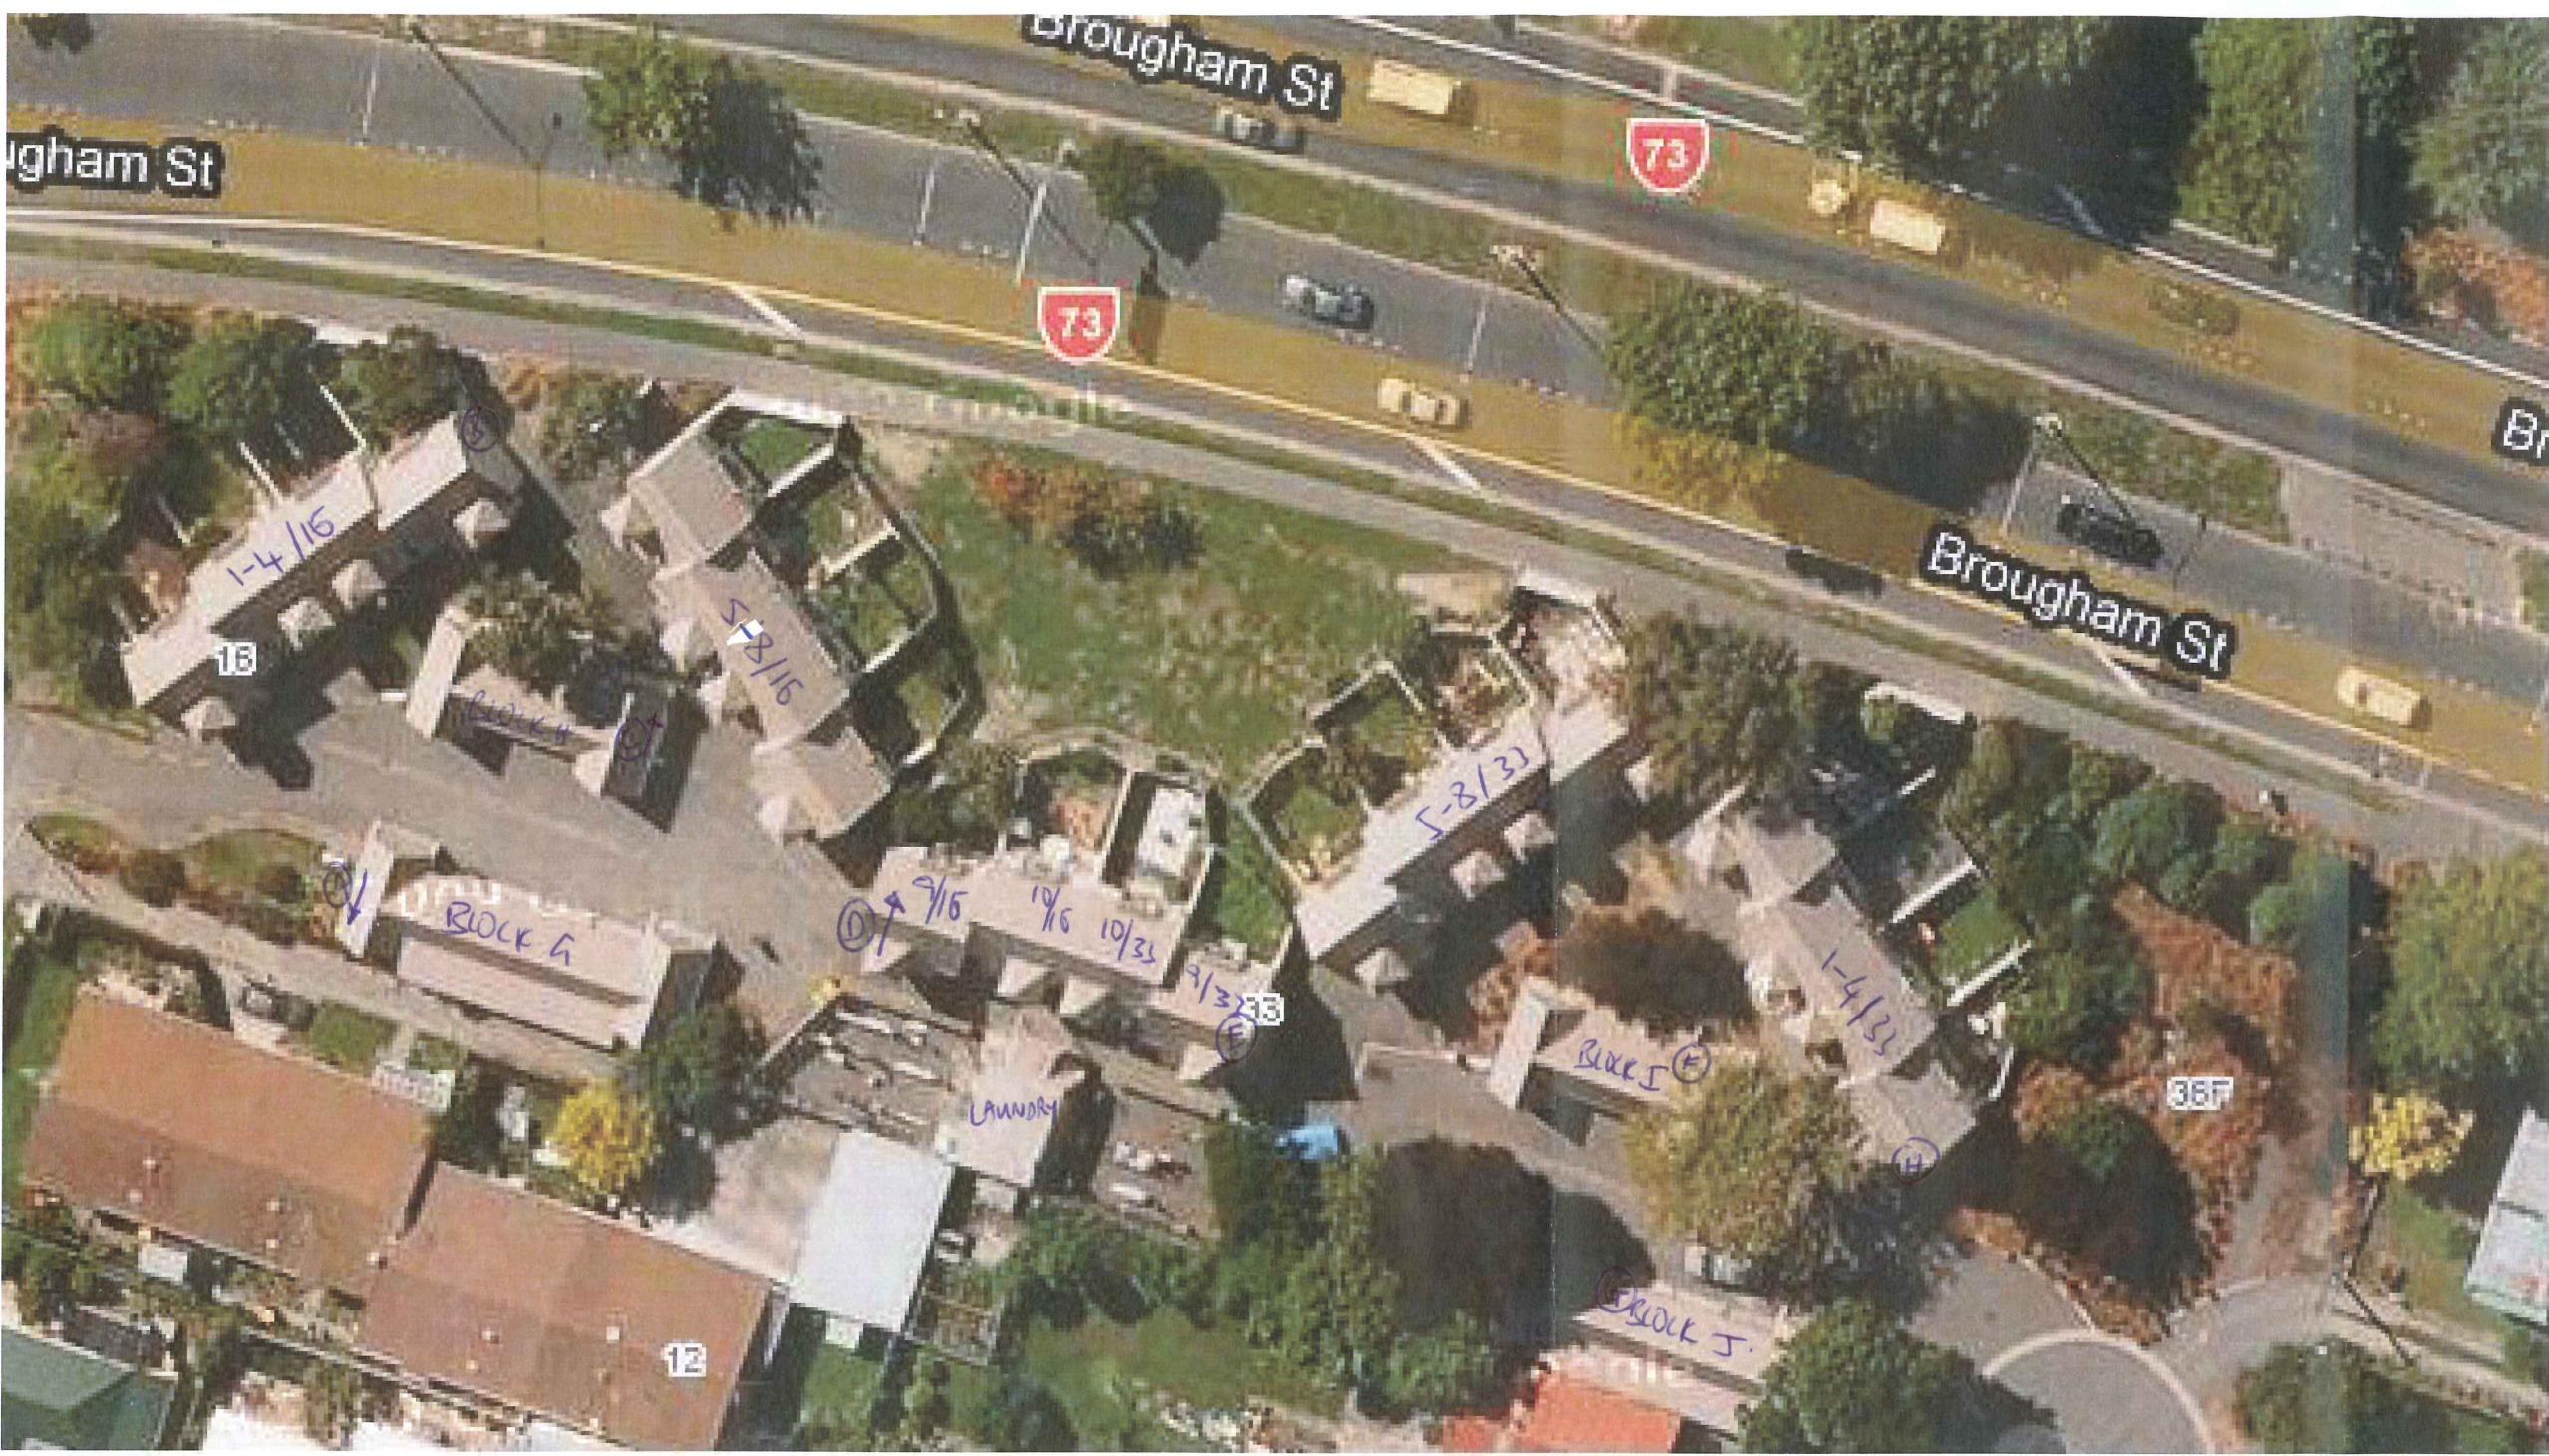
- Ⓐ Block G Tilting 150mm south, liquefaction
- Ⓑ big beam of foundation exposed unit 4/16 Cecil Court.
- Ⓒ Block H possible tilt north.
- Ⓓ unit 9/16 Cecil Court, leaning north.
- Ⓔ ground collapse along eastern elevation
- Ⓕ Block I tilting north
- Ⓖ Block J subsidence in front of garage 5.

Ⓖ Here in asphalt.
