**Division Street
Housing Complex
PRO 0547**

**Detailed Engineering Evaluation
Quantitative Assessment Report**

**38 Division Street, Riccarton,
Christchurch 8041**

Date: February 2014
Reference: 6-QC336.00
Status: Final

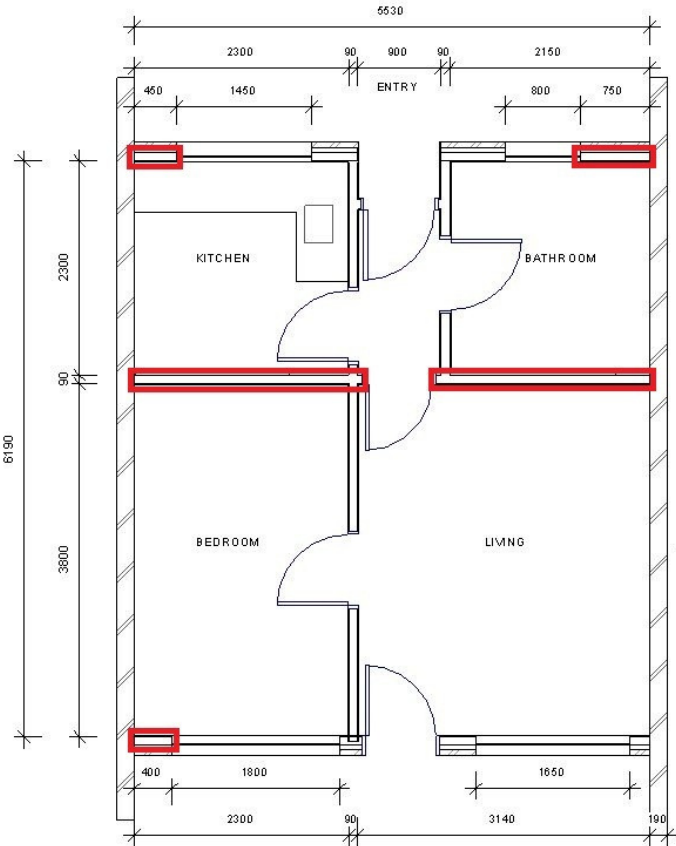
Figure 7: Walls used for bracing in the longitudinal direction single unit.

Hand calculations were performed to determine seismic forces from the current building codes. These forces were applied globally to the structure and the capacities of the walls were calculated and used to estimate the %NBS. The walls, highlighted in Figure 7 to Figure 11, were used for bracing in their respective directions.

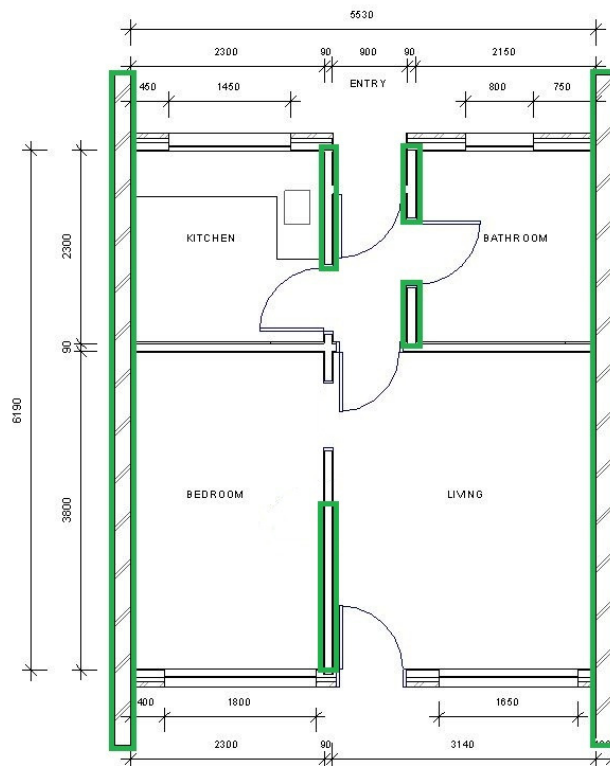
Figure 11: Walls used for bracing in the transverse direction for a unit with a sliding door in the bathroom.

Figure 4 and 5 show typical floor plans for a single residential unit and a double residential unit respectively. These plans were produced from site measurements by Opus. Figure 6 shows the cross section used in calculations. It was noted onsite that Blocks D, E and F had cavity sliding doors in the bedroom/lounge wall. This prevents this wall being used as bracing in calculations but does not affect the %NBS.
