CHRISTCHURCH CITY COUNCIL

PRK_3616_BLDG_004 EQ2

Duvauchelle Reserve and Campground – Office
Seafield Rd, Duvauchelle

QUALITATIVE ASSESSMENT REPORT

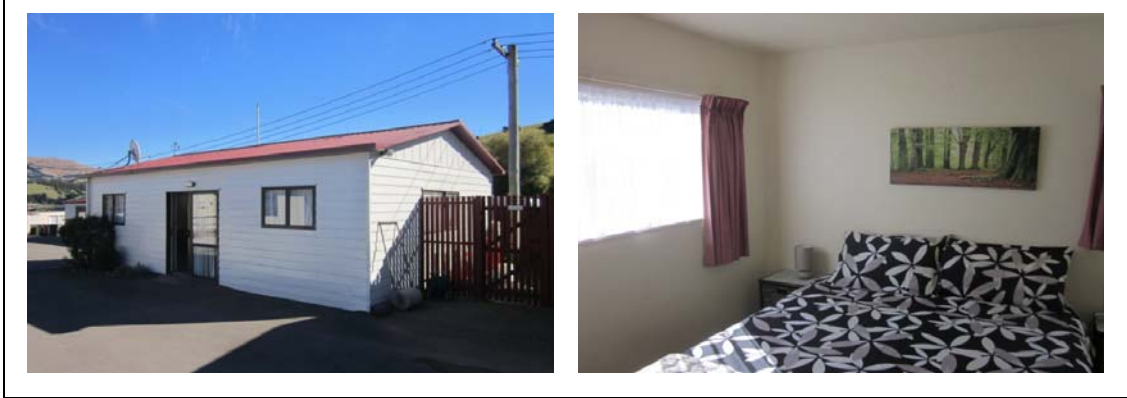
1.1 Photos (attach sufficient to describe building)

Building 4 is one of a number of buildings on the campsite grounds. The building is a former office, now used as accommodation. It is a single storey timber framed structure with folded steel wall cladding and corrugated roof sheeting. The building has a concrete slab foundation.

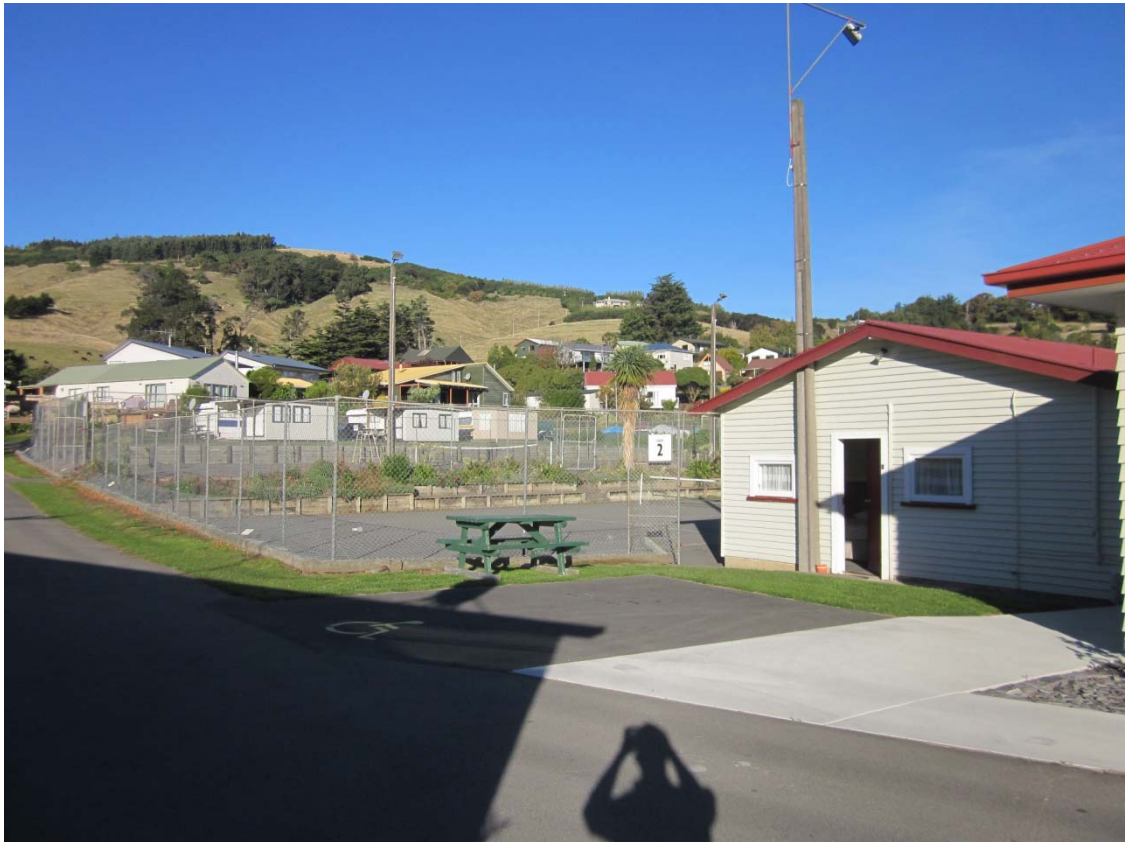
■ **Figure 5 Overview of the Community Hall**
