CHRISTCHURCH CITY COUNCIL
PRK_3616_BLDG_007 EQ2
Duvauchelle Reserve – BLDG 007
Seafield Rd, Duvauchelle

QUALITATIVE ASSESSMENT REPORT

FINAL

- Rev B
- 21 November 2012

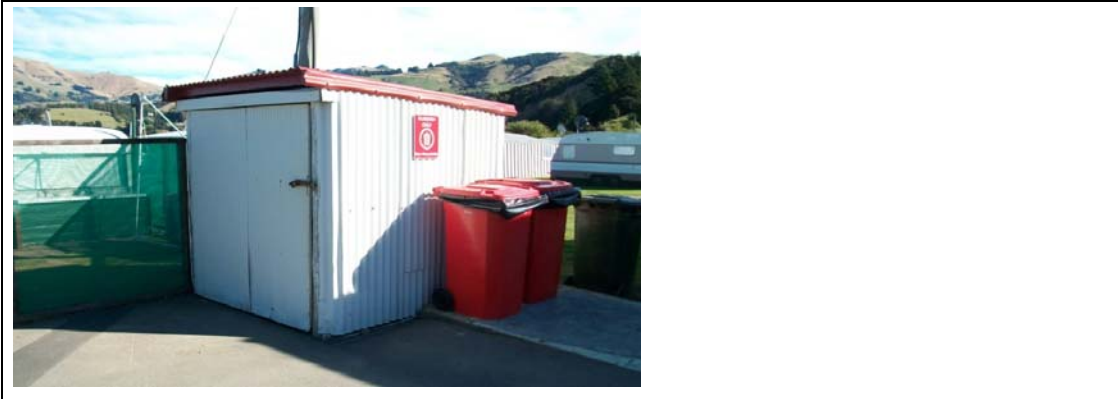
1.1 Photos (attach sufficient to describe building)

Building 7 is one of a number of buildings on the campsite grounds. The building is a small timber framed shed used to store a mower. The building is made up of timber poles, timber beams and timber purlins. The building has corrugated steel cladding to the walls and roof. No footing or flab slab was present. A steel framed door is located on the south side of the structure.

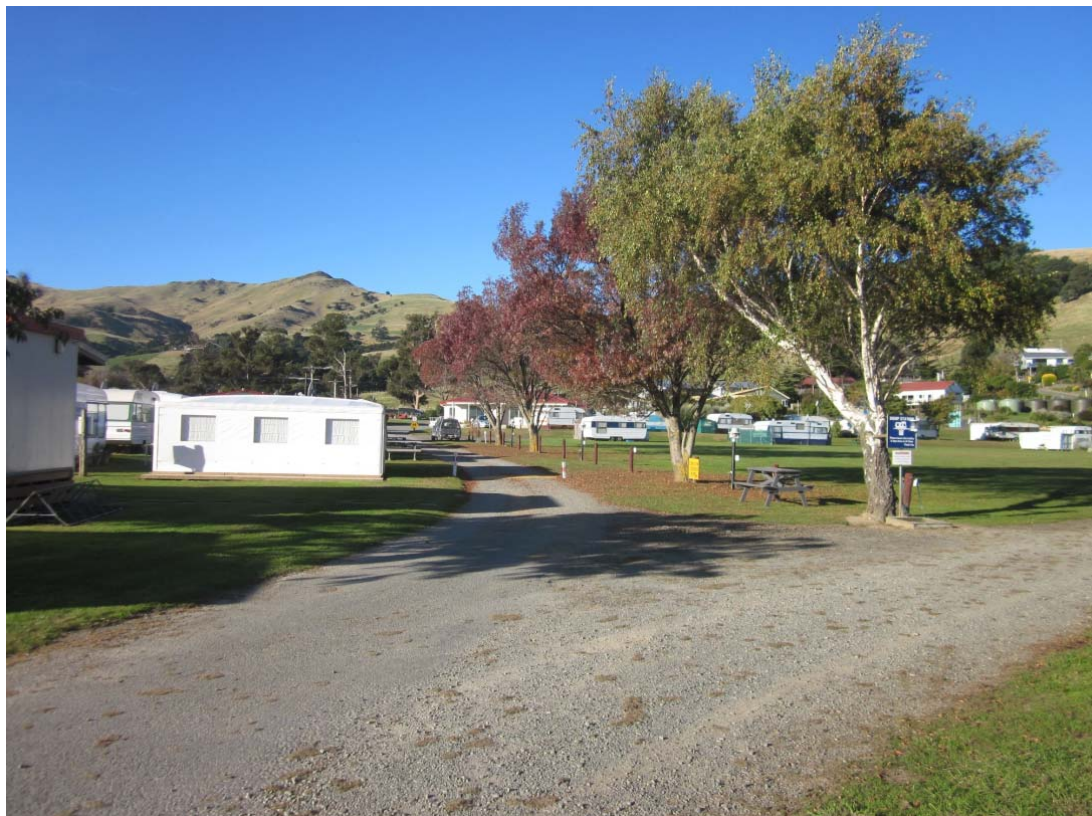
The only evidence of earthquake damage to the onsite structures was shear cracking to the masonry clad toilet. There is no evidence of any land damage.

■ **Figure 4 Overview of the site looking north east.**
