CHRISTCHURCH CITY COUNCIL
PRK_3616_BLDG_001 EQ2
Duvauchelle Reserve – Toilet Block 2 &
Kitchen
Seafield Rd, Duvauchelle

QUALITATIVE ASSESSMENT REPORT

- Rev C
- 23 May 2013

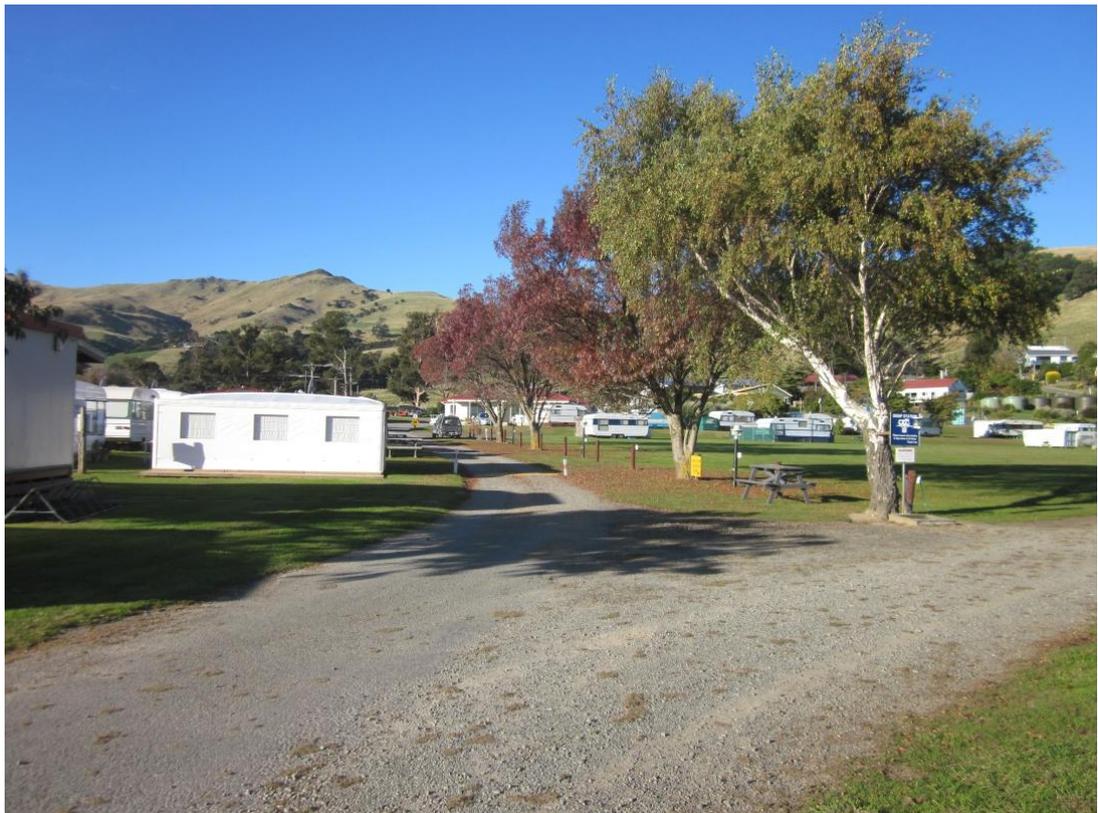
The only evidence of earthquake damage to the onsite structures was shear cracking to the masonry clad toilet. There is no evidence of any land damage.

■ **Figure 4 Overview of the site looking north east.**

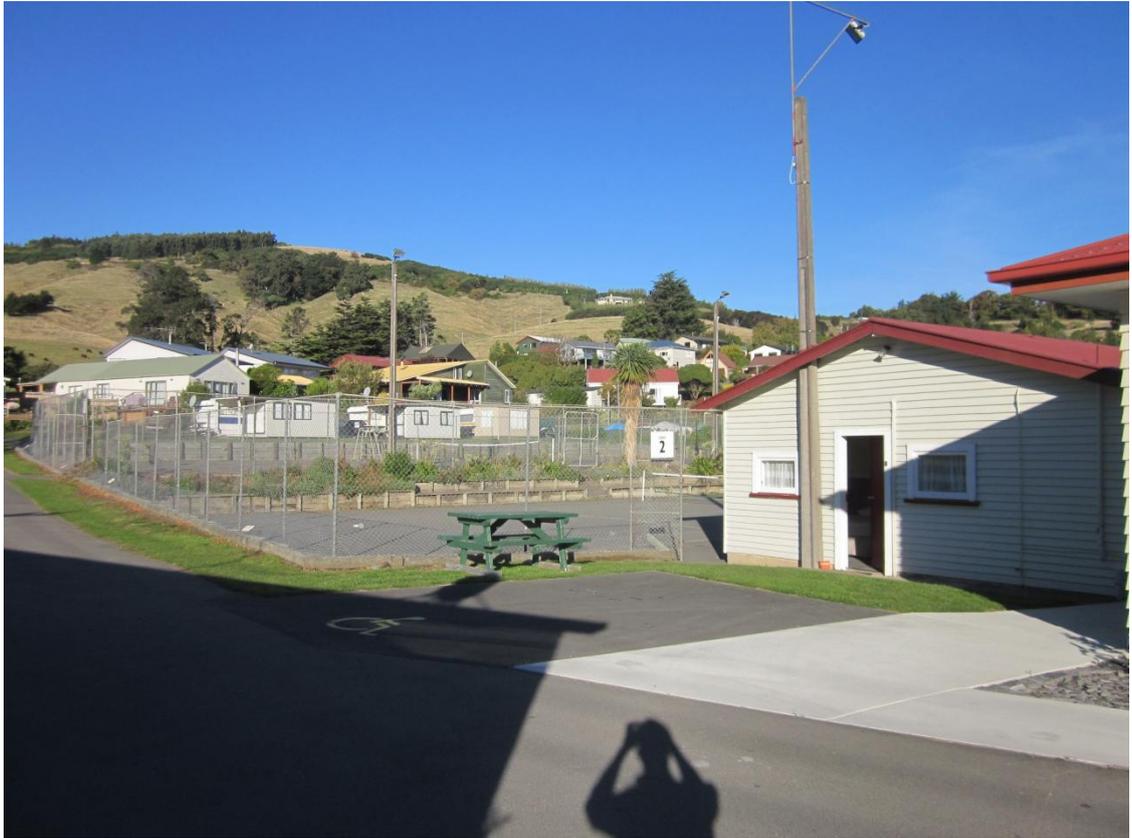
■ **Figure 5 Overview of the Community Hall**
