Duvauchelle Works Yard Shelter
PRO 3612-001
Detailed Engineering Evaluation
Qualitative Report
Version Final

Pawsons Valley Road, Duvauchelle

Christchurch City Council

Detailed Engineering Evaluation

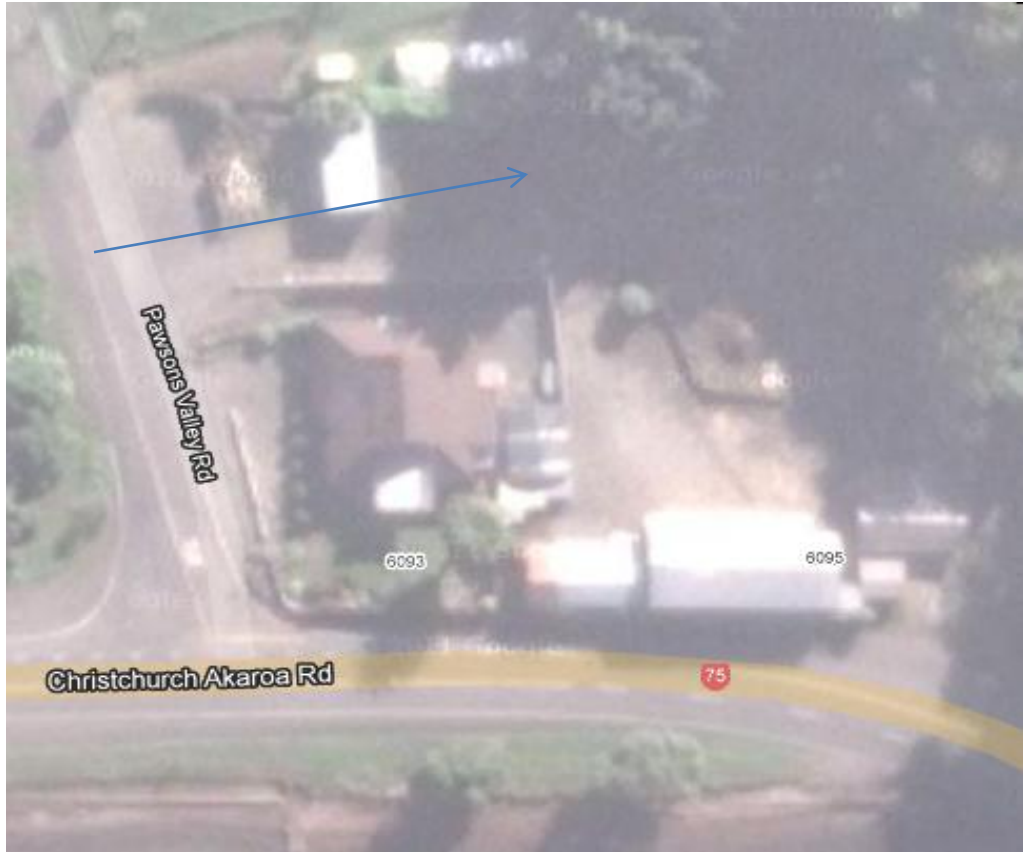
Photograph 7: Aerial Plan with Arrow pointing to Shelter Structure

The fire depot shelter is located in the Duvauchelle works yard, Pawsons Valley Road, Akaroa. The original construction date of the shelter is unknown but from site observation is estimated to be in the 1940's. The structure can be observed aerially in Photograph 7 in Appendix A.

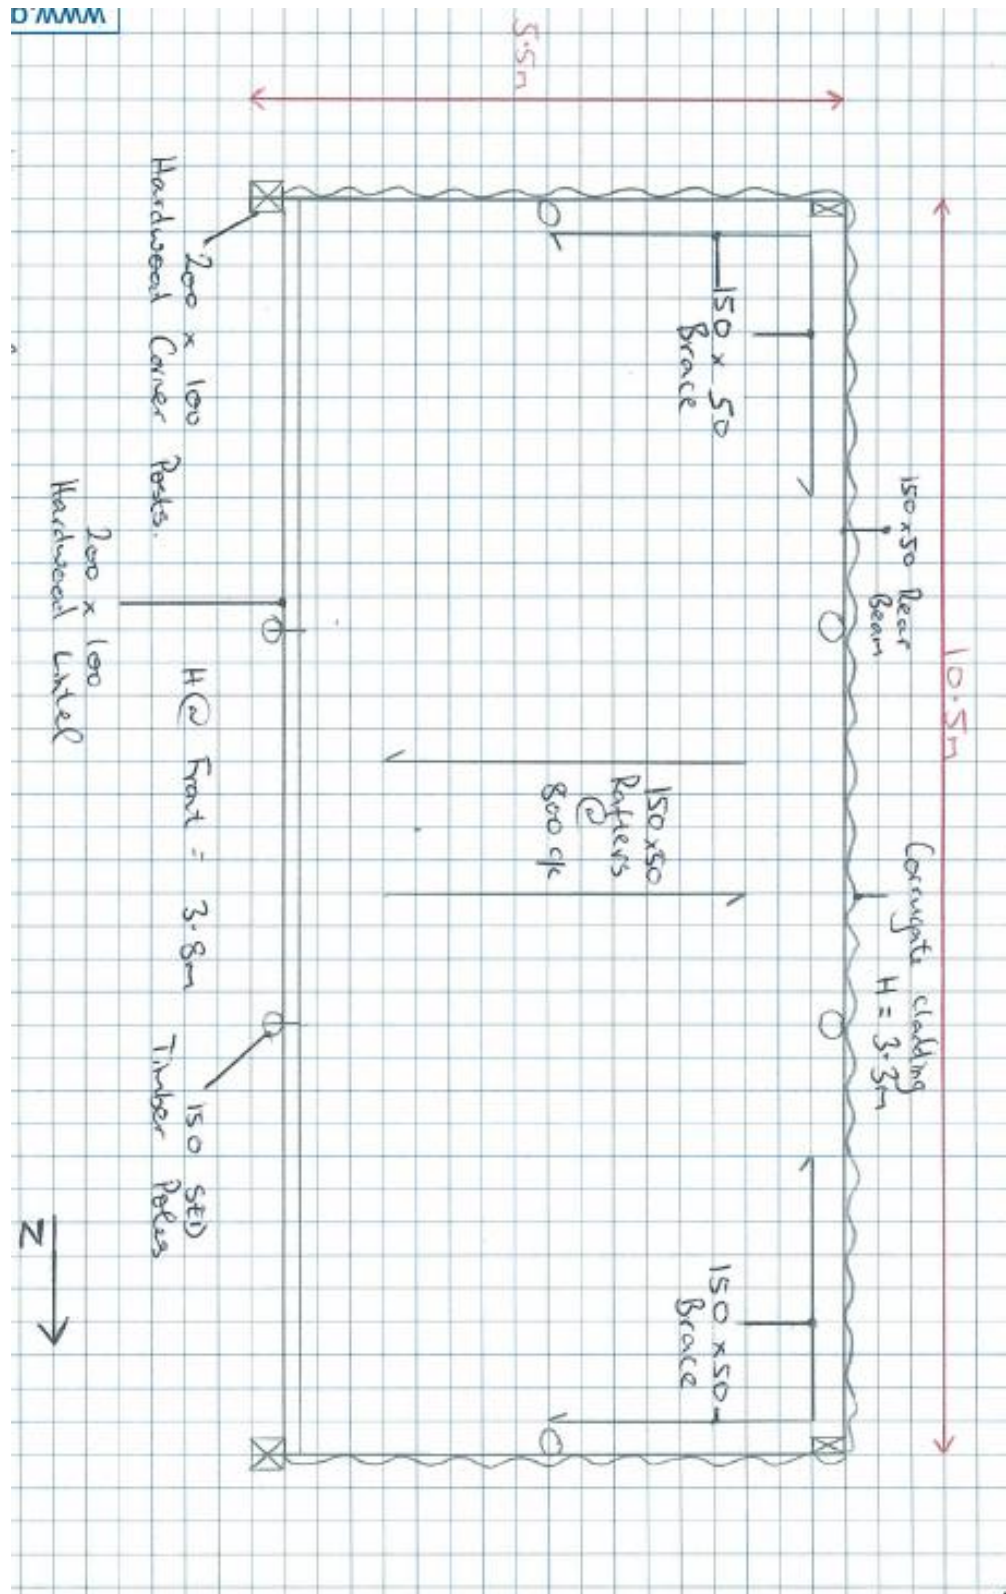
No drawings have been made available for this building. Shown below is a sketch of the building showing key structural elements.
