**GF Allan Courts
Housing Complex
PRO 1453**

**Detailed Engineering Evaluation
Quantitative Assessment Report**

GF Allan Courts Housing Complex Quantitative Assessment Report

30 Wiggins Street, Sumner,

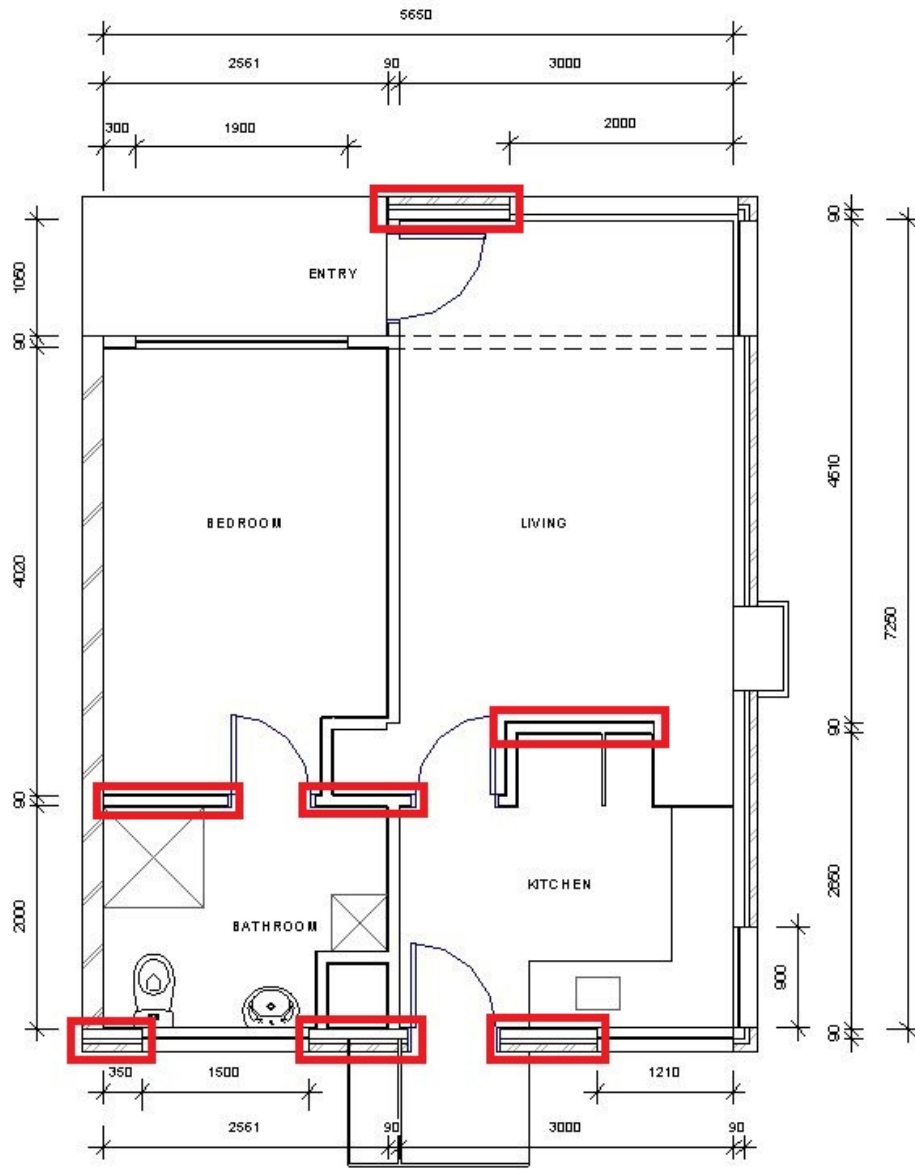
Figure 6: Walls used for bracing in the longitudinal direction.

Hand calculations were performed to determine seismic forces from the current building codes. These forces were applied globally to the structure and the capacities of the walls were calculated and used to estimate the %NBS. The walls, highlighted in Figure 6 and Figure 7, were used for bracing in their respective directions.
