**Gloucester Courts Blocks B & C**  
**BU 2373-002 EQ2, BU 2373-003 EQ2**  
Detailed Engineering Evaluation  
Quantitative Report  
Version FINAL

254 Gloucester Street, Christchurch

Christchurch City Council

**Date**  
14/11/2012

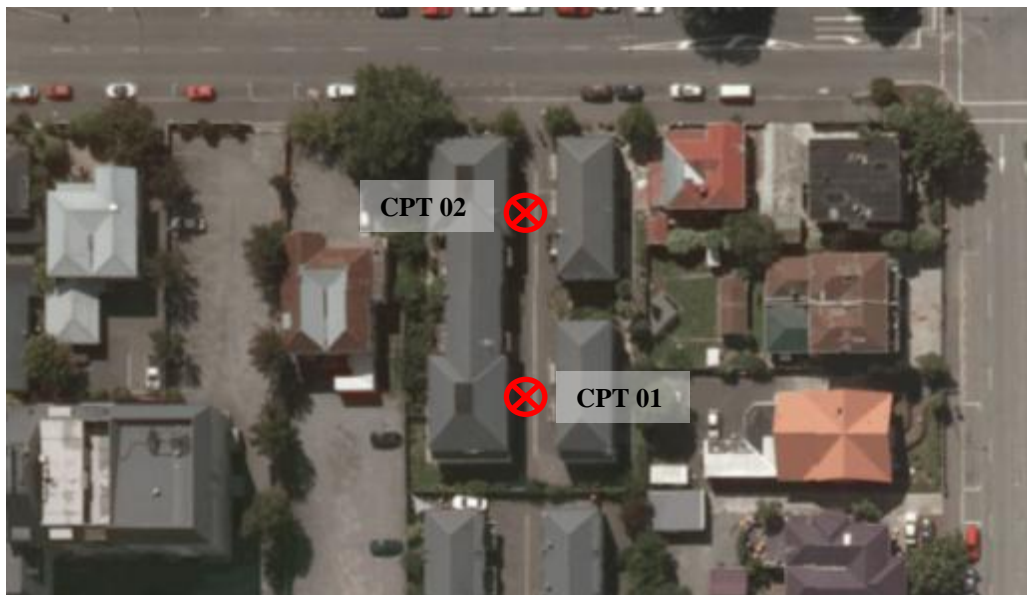
Figure 9: Intrusive Investigation Location

The CPT investigations were undertaken by McMillans Drilling Ltd, typically to a target depth of 20 m below ground level. However, refusal was reached at depths of 15.3 m and 16.3 m due to the presence of dense sands.

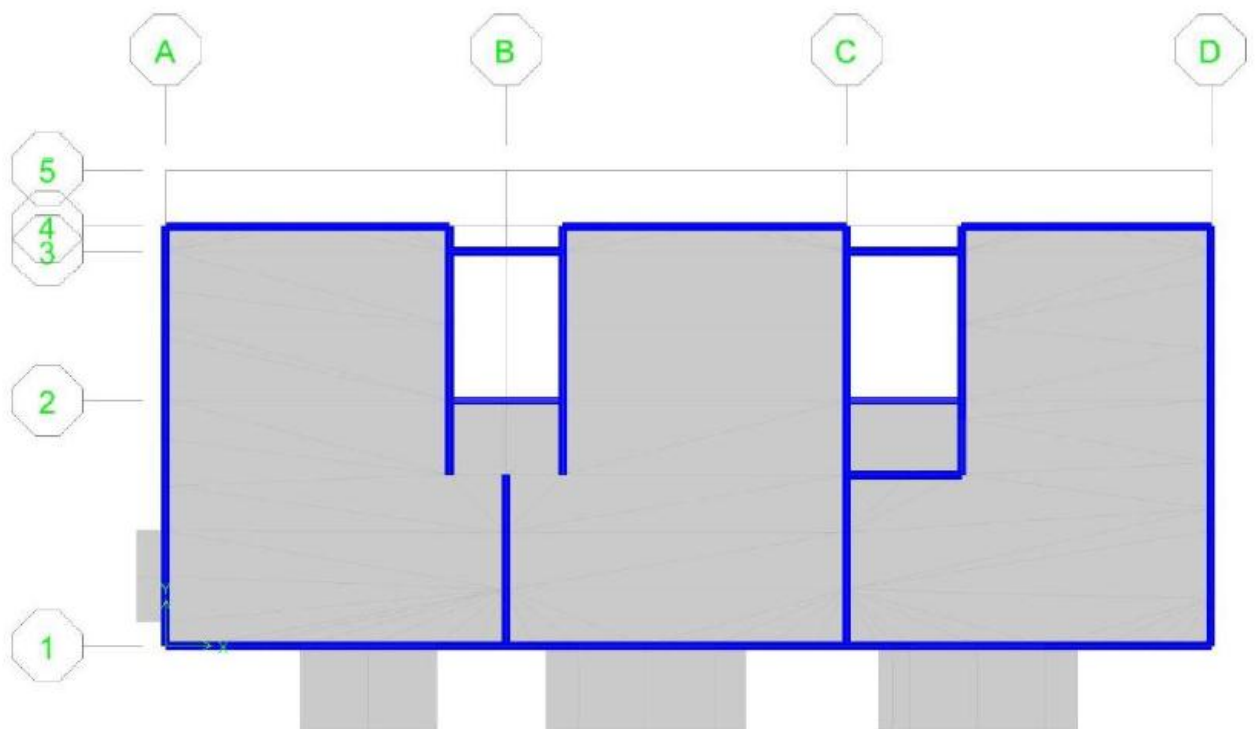
Figure 10: Plan Showing Gridlines (North Building)

The outcome of the three-dimensional model analysis and demand/capacity assessment is summarised below in Table 7. Note that the values given represent the critical elements in the building, as these effectively define the building's capacity. Other elements within the building will have significantly greater capacity when compared with the governing elements.

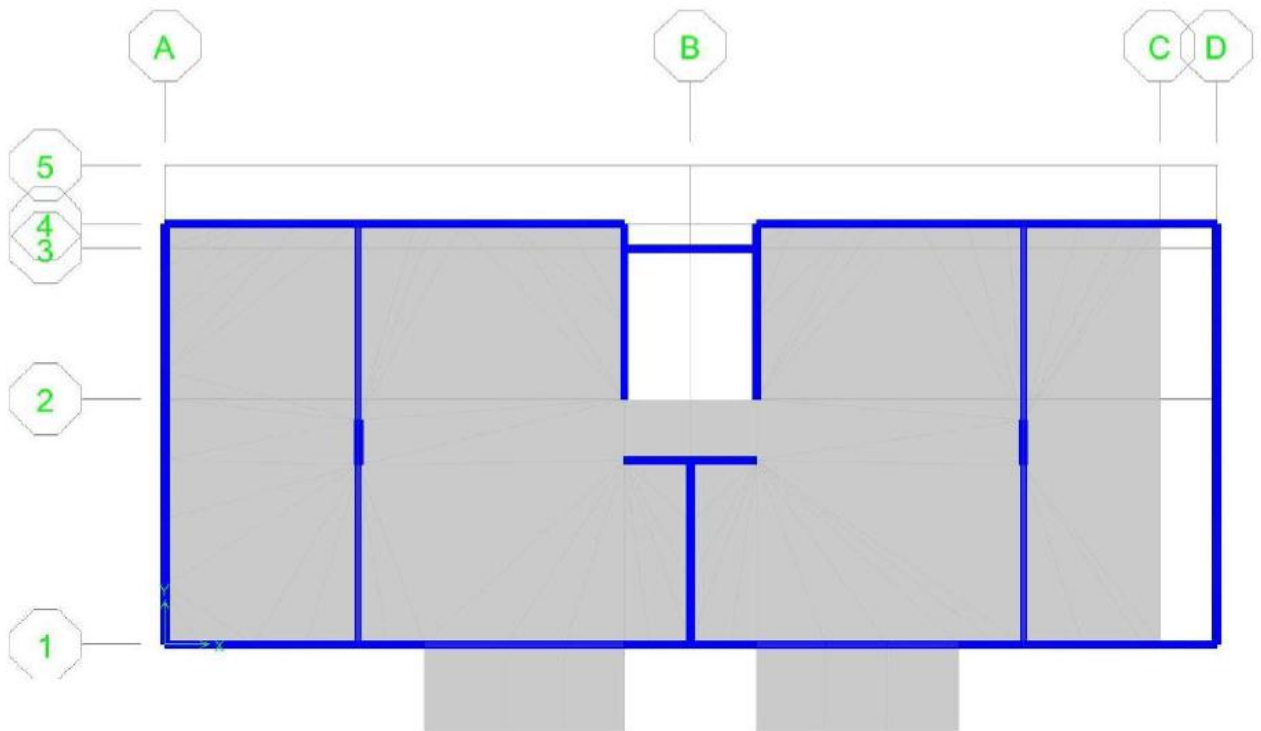
Figure 11: Plan Showing Gridlines (South Building)

The outcome of the three-dimensional model analysis and demand/capacity assessment is summarised below in Table 9. Note that the values given represent the critical elements in the building, as these effectively define the building's capacity. Other elements within the building will have significantly greater capacity when compared with the governing elements.

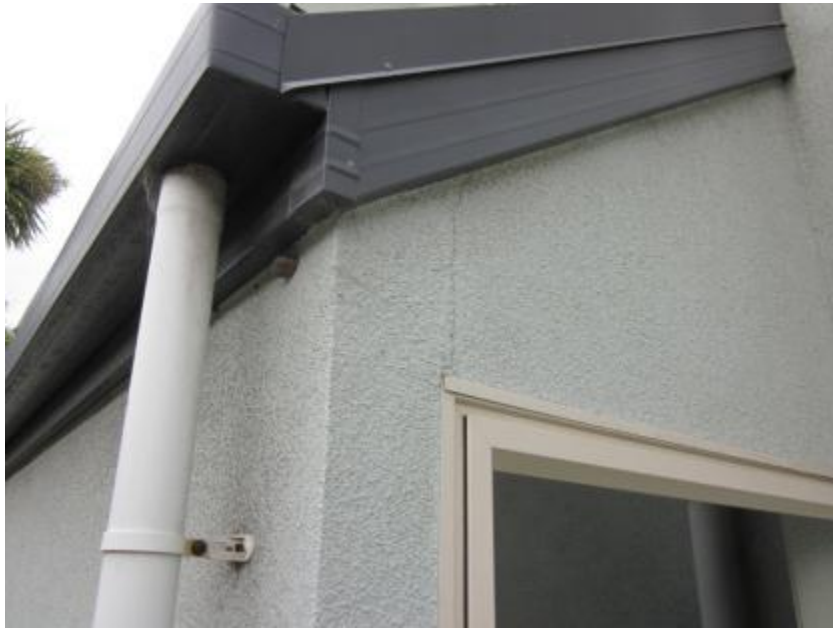
- ▶ Minor cracks were observed in walls above the exterior doors.
- ▶ Minor cracks were observed in the first floor slab near the staircase.

It is believed that the cracks mentioned above are due to localised stresses in the floors and walls during earthquake shaking.

Photograph 9 Minor cracks to the wall above the exterior door
