**Gowerton Place  
Housing Complex  
PRO 0678**

**Detailed Engineering Evaluation  
Quantitative Assessment Report**

## **Quantitative Assessment Report**

**Gowerton Place, Richmond,  
Christchurch 8013**

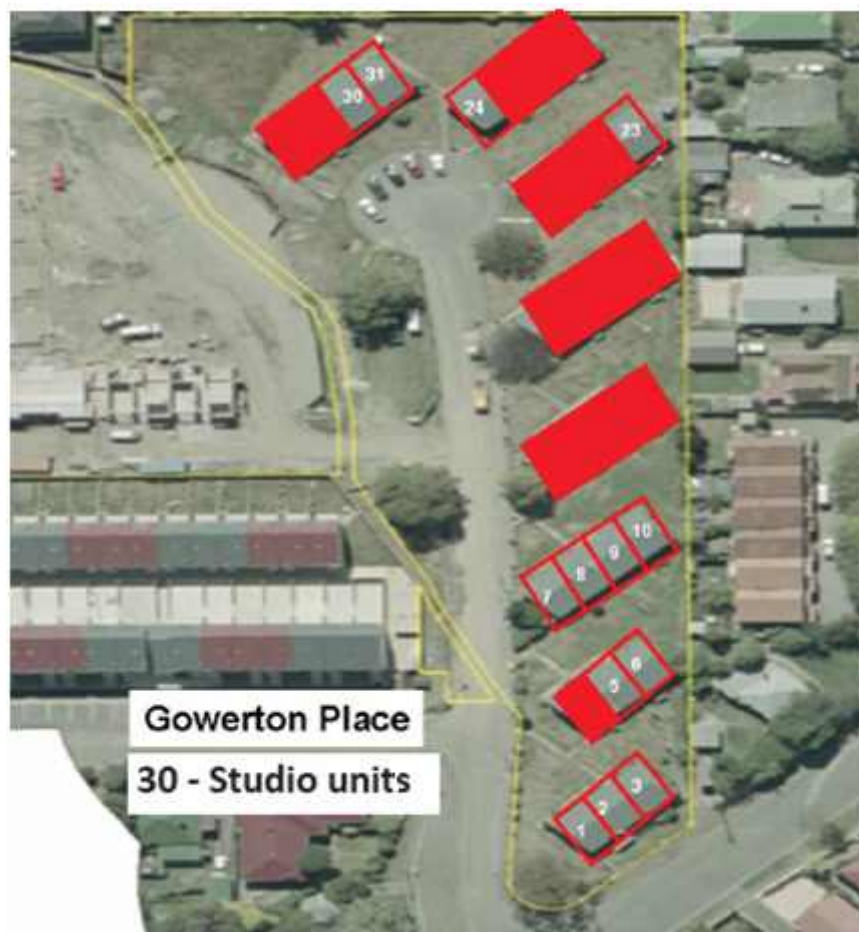
Figure 6: Units which have floor slopes exceeding 5mm/m (coloured red).

The results of the level survey indicate the possibility of ground settlement due to the earthquakes. This is particularly evident in units 4, 11-15, 16-19, 20-22, and 25-27 and 28-29, coloured red in Figure 6, where the floor slopes were measured to be beyond the 5mm/m limitation imposed by MBIE guidelines.

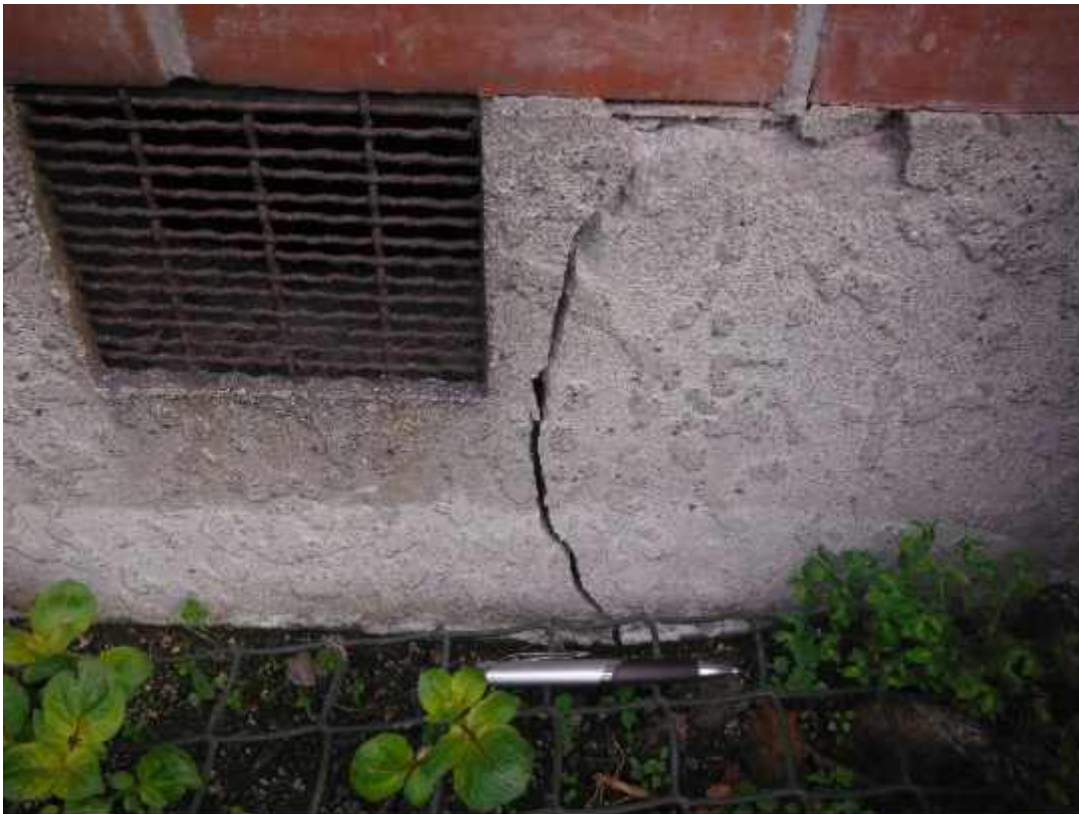
- Cracking (typically up to 4 mm wide and 250 mm long) observed in the footings of several units (Photograph 3, Appendix A). The location of the footing cracks are marked 'x' in the Walkover Inspection Plan in Appendix C. Large cracking (up to 25 mm wide and 300 long) observed in footings of Units 21, 22, 25 and 27 (Photograph 4, Appendix A).

**Photograph 3:** Observed crack (approximately 4 mm wide) in footing, south-eastern side of Unit 18.

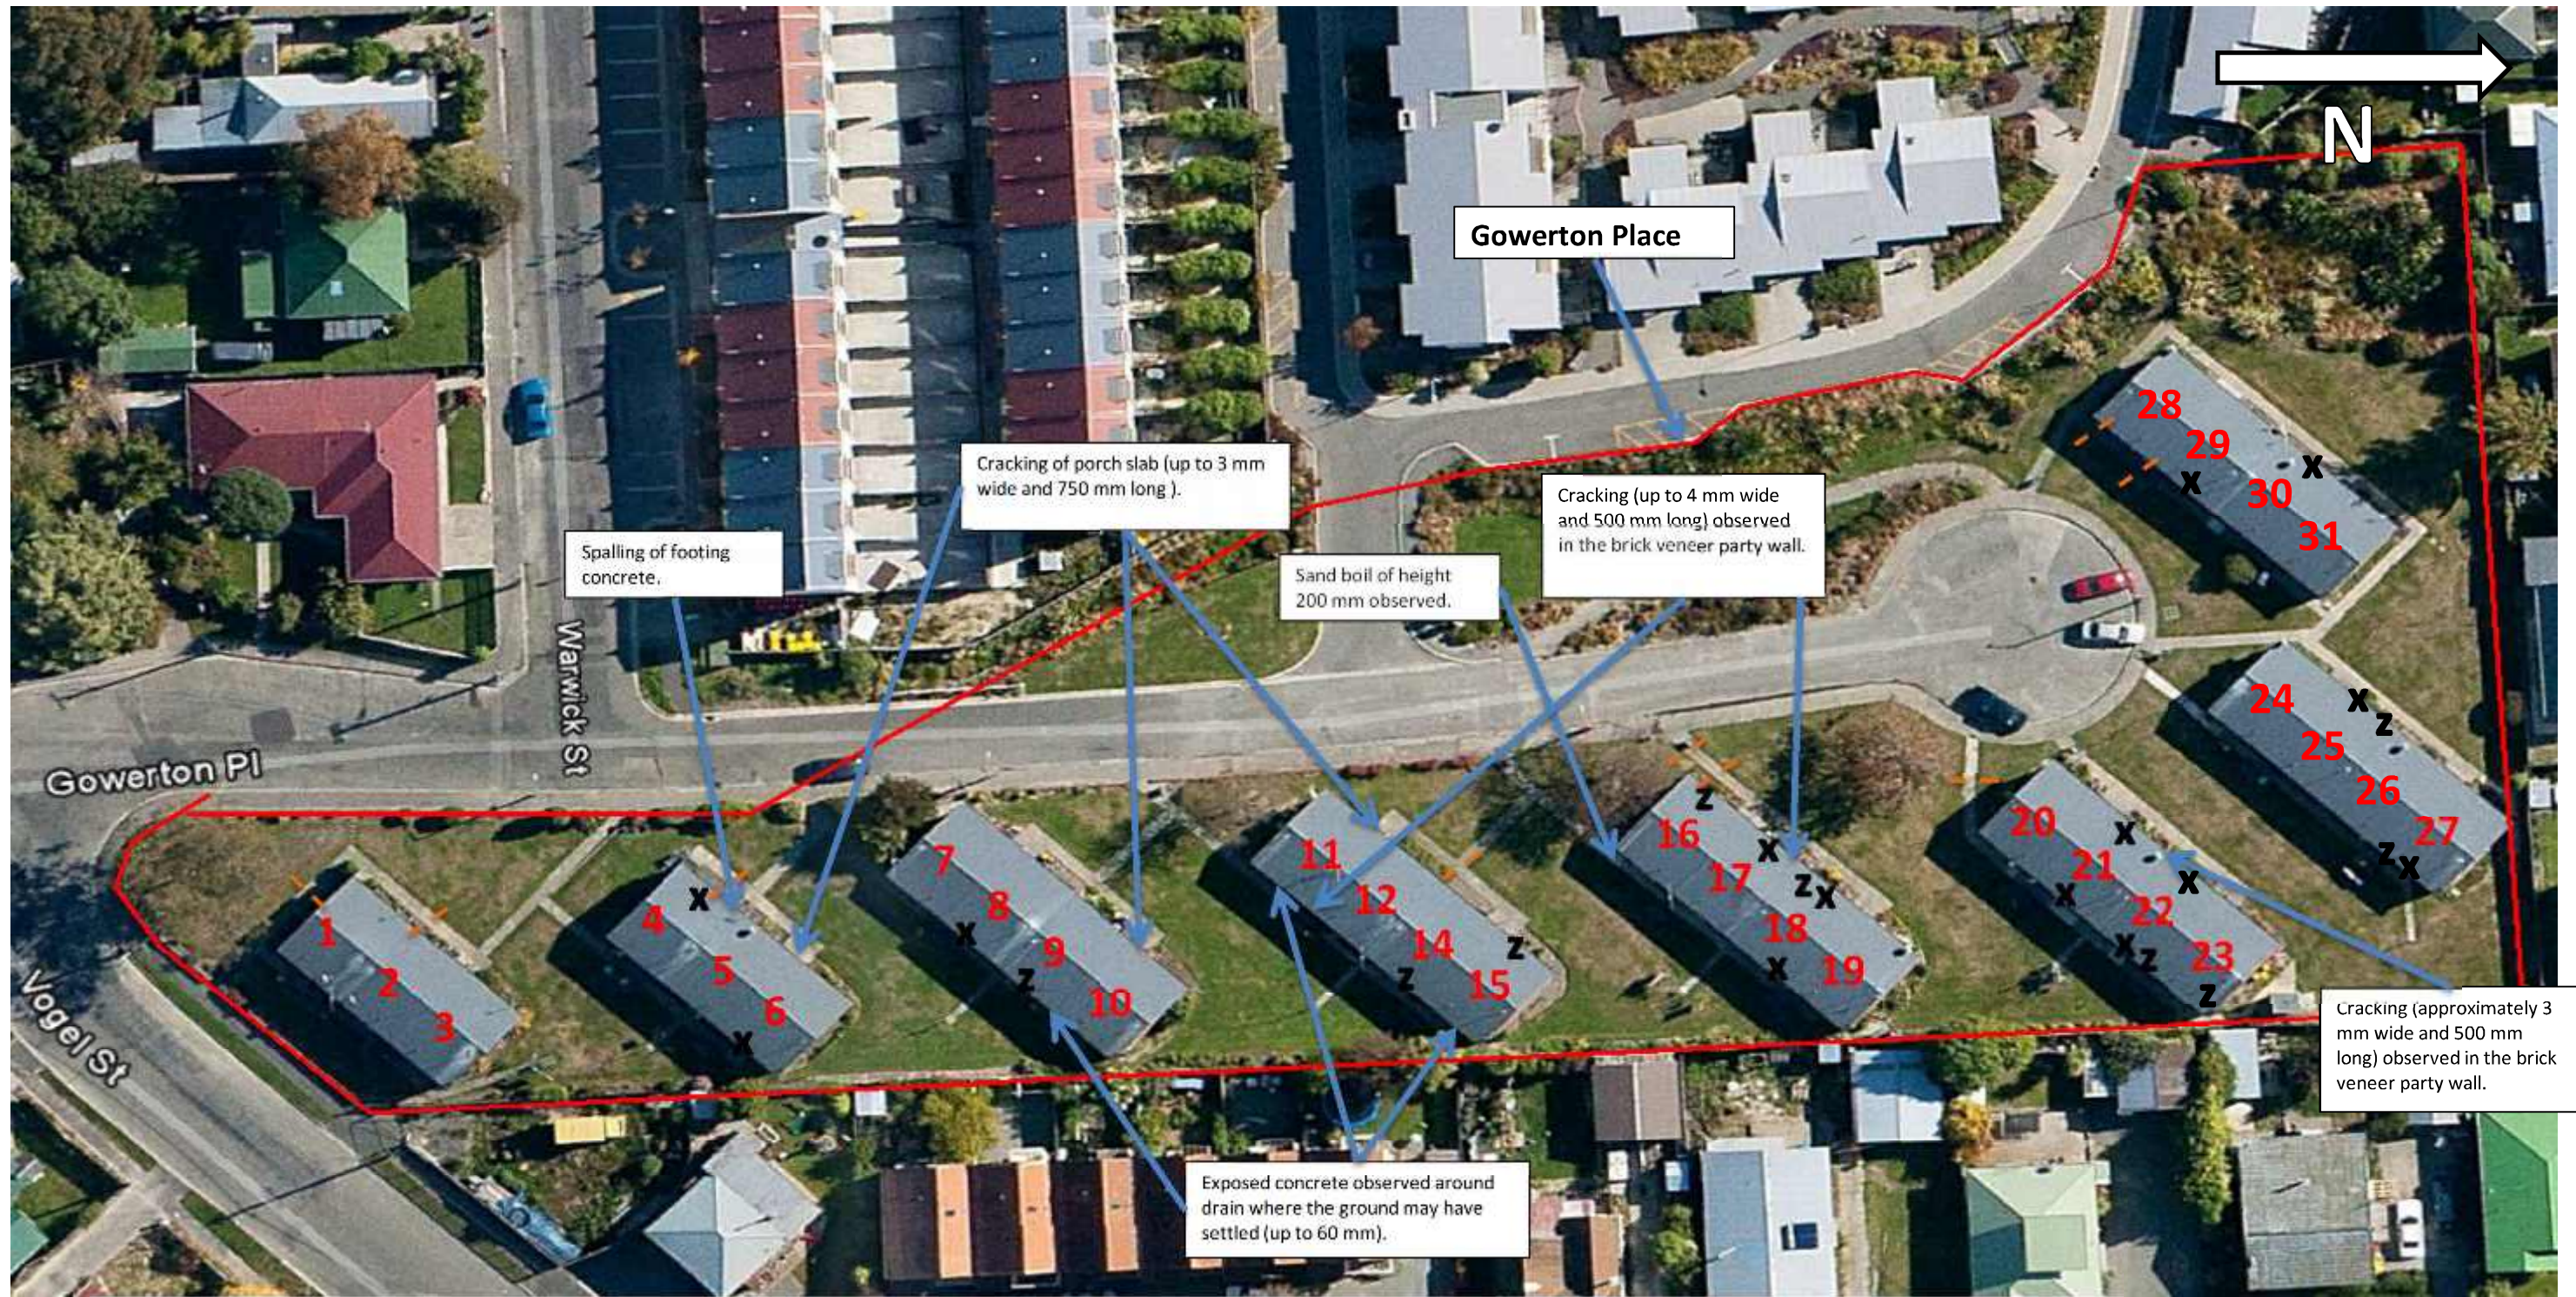
- Stepped cracking observed in brickwork of Unit 22 (approximately 40 mm wide and 1.5 m long) and Unit 18 (approximately 10 mm wide and 1.5 m long), which indicates settlement of footings (Photograph 5, Appendix A). Similar but less severe cracking observed in Units 9, 14, 15, 16, 23, 25 and 27. The location of the cracking is marked 'z' in the Walkover Inspection Plan in Appendix C.

x: Large cracks up to 25 mm wide and 300 mm long in the perimeter footings.

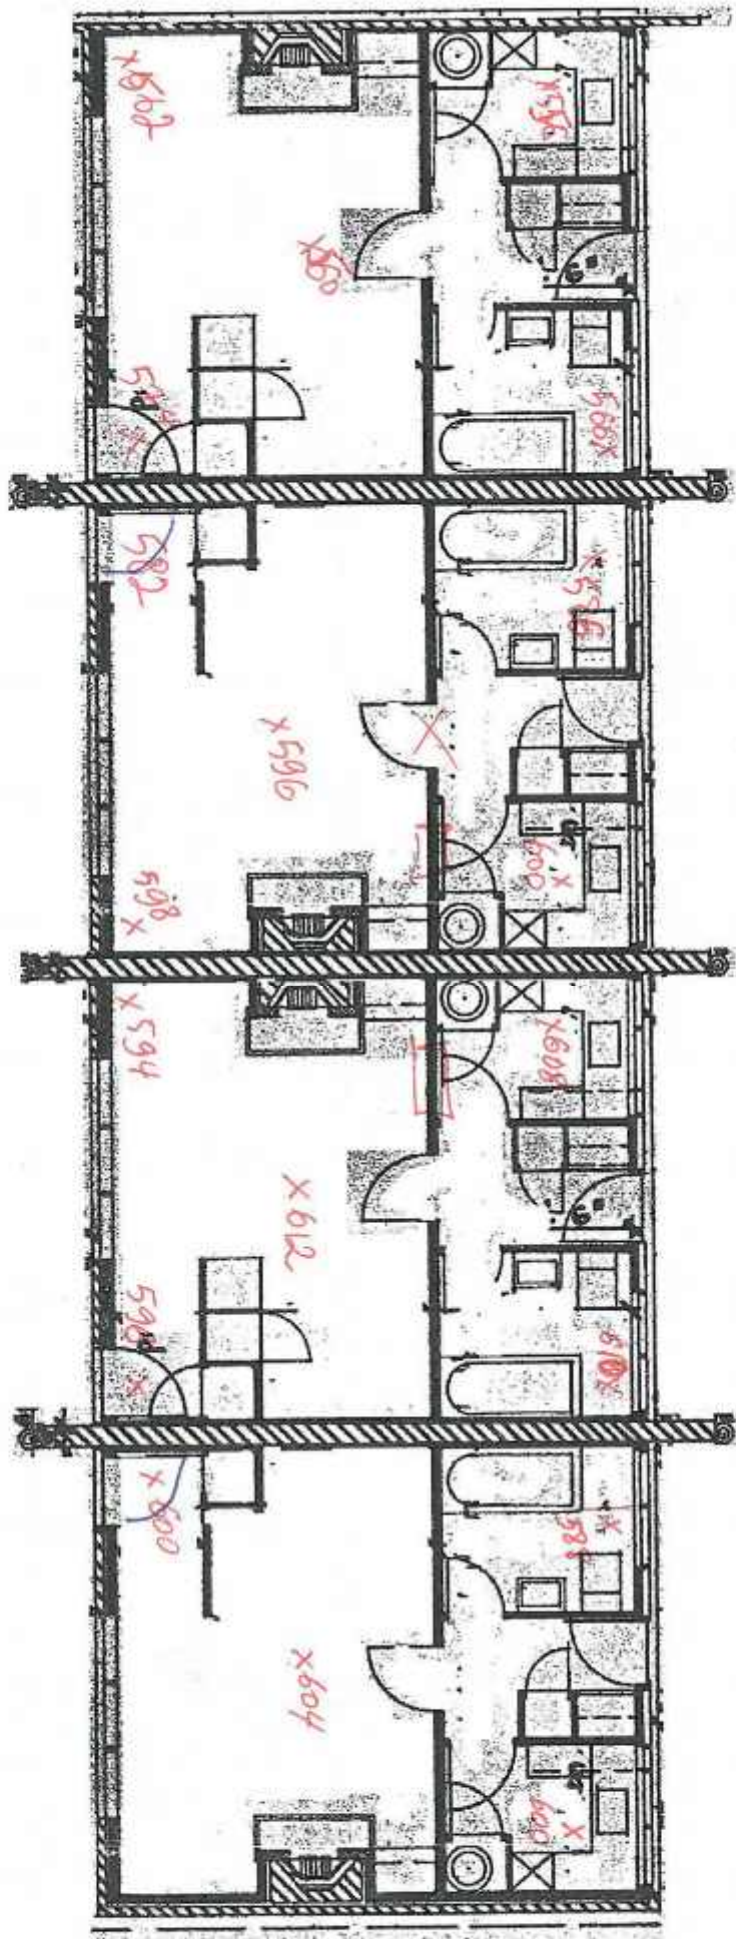
Roof damaged @ fire walls

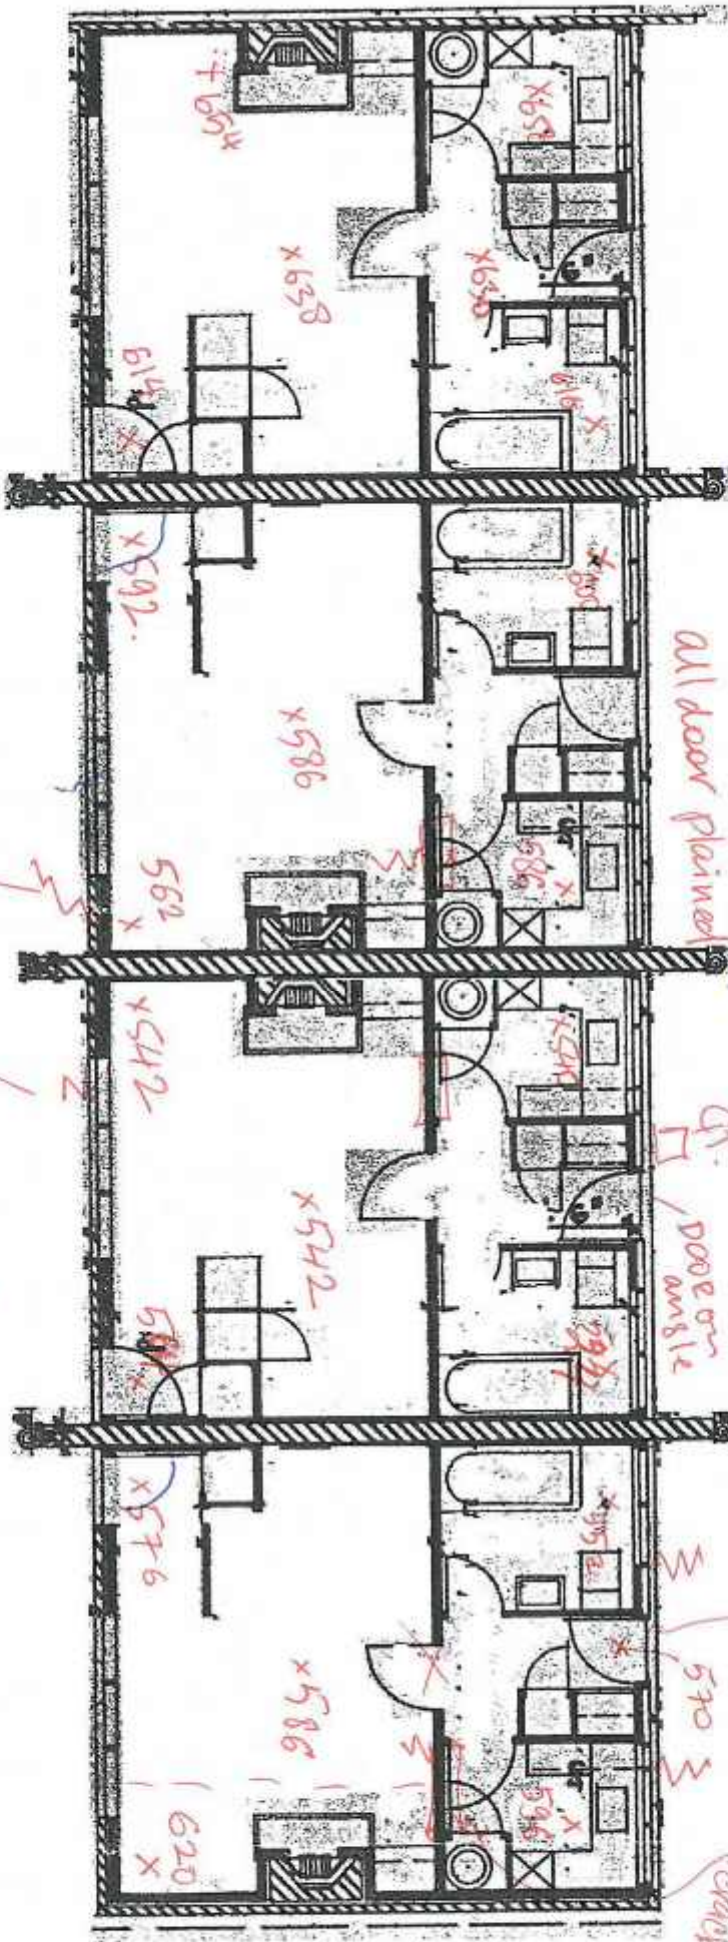
Drivings broken  
DOOR on angle

poorly lumbered  
large crack
