CHRISTCHURCH CITY COUNCIL
PRK_0348_BLDG_009 EQ2
The Groynes – Kiosk
182 Johns Road

QUALITATIVE ASSESSMENT REPORT
FINAL

- Rev B
- 05 December 2012

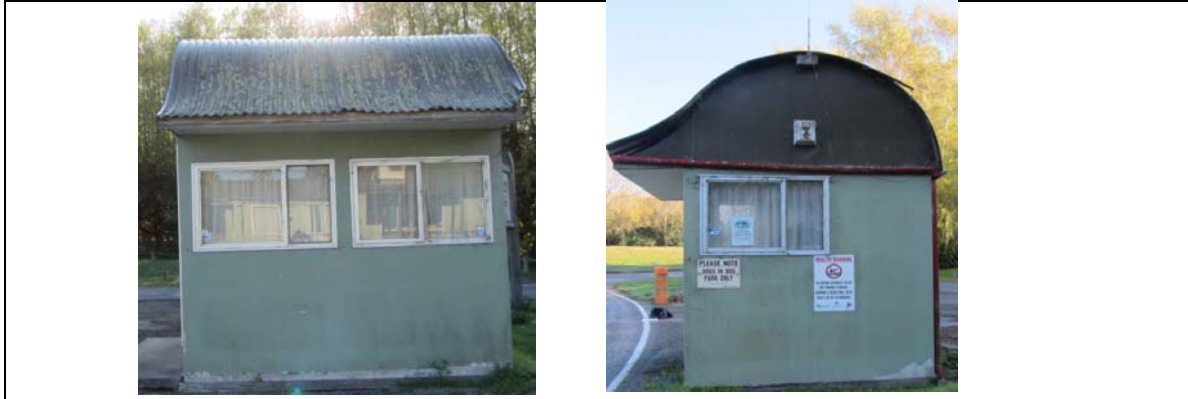
1.1 Photos (attach sufficient to describe building)

Building CCC-PRK-0348-009 is a small single storey building that is no longer used by The Groynes staff. The roof structure consists of timber framing and light weight corrugated steel cladding that is supported on the timber framed walls. These timber framed walls are clad with 6mm Flexboard and construction plywood. The building is founded a timber floor that is supported 150mm diameter timber piles that are located around the perimeter of the building. The area of the building is 2.8m x 2.4m and is approximately 3.5m high. The original structural drawings are dated September 1988 and as a result we have taken a design period of 1979-1992 for our assessment. Lateral loads acting across and along the building will be resisted the construction plywood that has been installed to all the walls. The loads will then be transferred down into the foundations where they will be resisted by the timber piles.

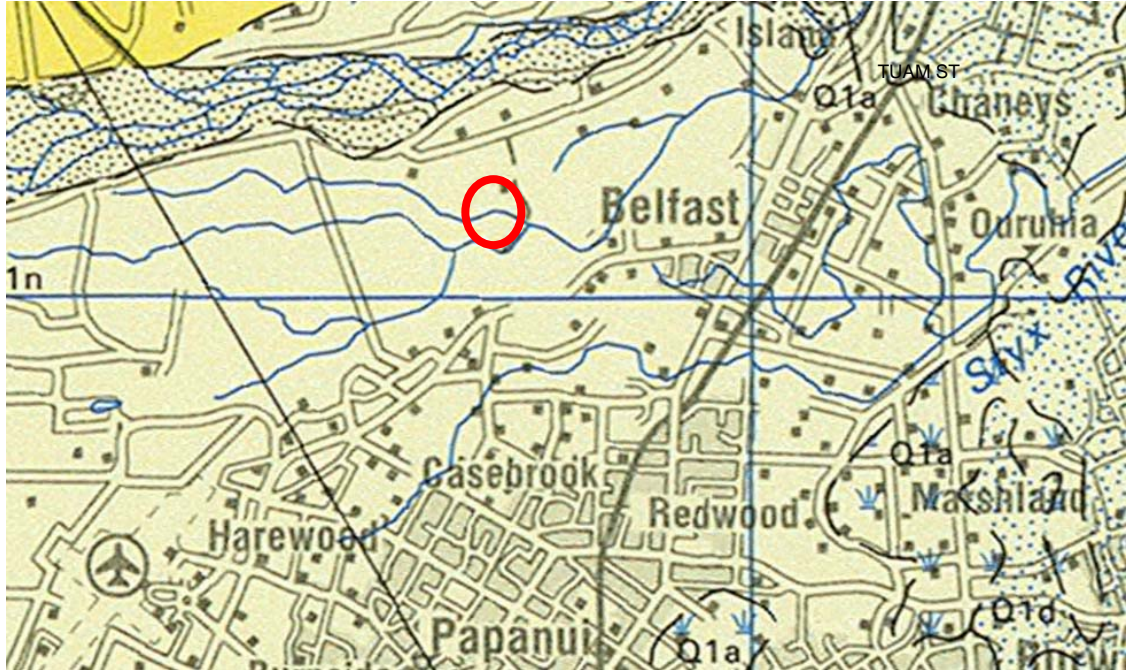
- **Figure 2 – Regional geological map (Forsyth et al, 2008). Site marked in red.**

The local geological map of the Christchurch area does not extend to the location of the site.

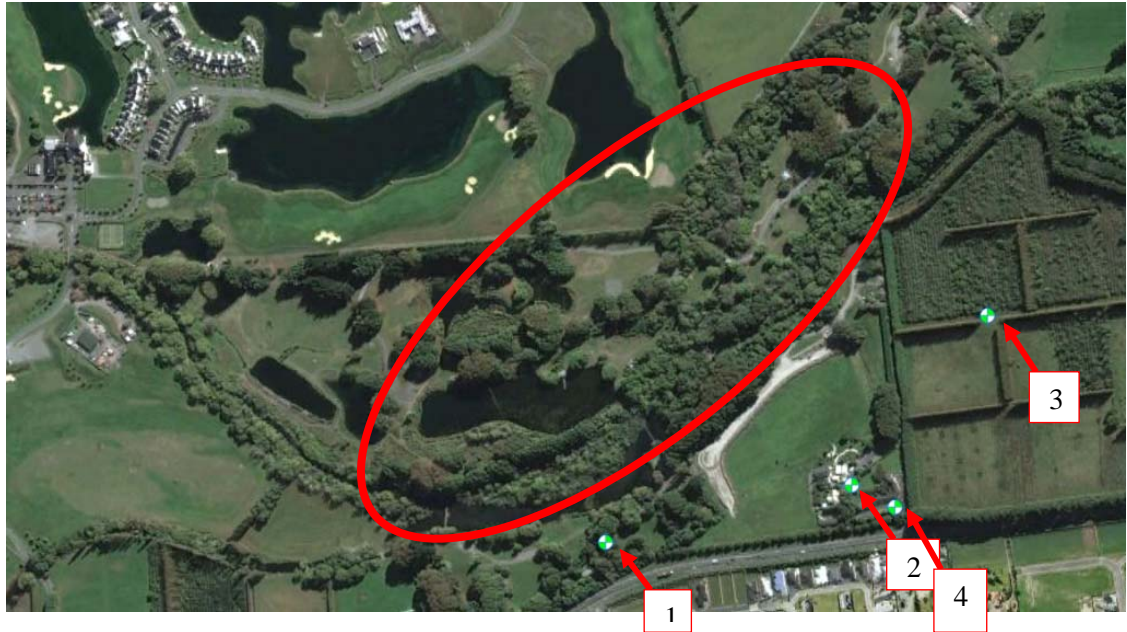
- **Figure 5 – Local boreholes from Project Orbit and SKM files (<https://canterburyrecovery.projectorbit.com/>)**

Where available logs from these investigation locations are attached to this report (Appendix B), and the results are summarised in Appendix C.
