Christchurch City Council
PRK_0348_BLDG_013 EQ2
Main Shop and Mobile Shop
The Groynes, 182 Johns Road

QUALITATIVE ASSESSMENT REPORT

- Rev B
- 23 May 2013

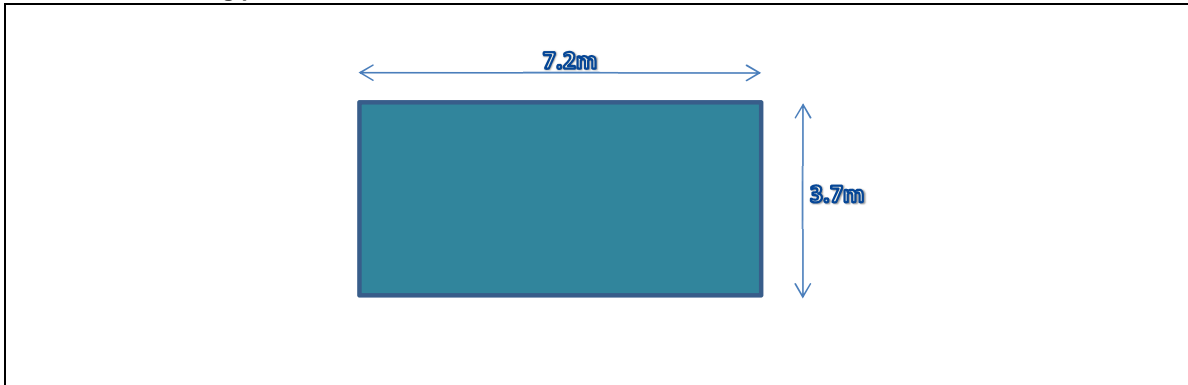
1.2 Sketch of building plan

Main Shop: Building PRK_0348_BLDG_013 is a single storey Portacom building located at Ruru Lawn Cemetery. The building is constructed from polystyrene sandwich panel which also forms the cladding. No drawings were available to indicate the date of construction of this structure. Based on the apparent ageing of this building we estimate that it was constructed sometime in the 1980's, so have assumed a post-1976 construction date for the purposes of our assessment.
