PRK_0348_BLDG_008 EQ2

Toilets No 3 Ground

The Groynes, 182 Johns Road

QUALITATIVE ASSESSMENT REPORT FINAL

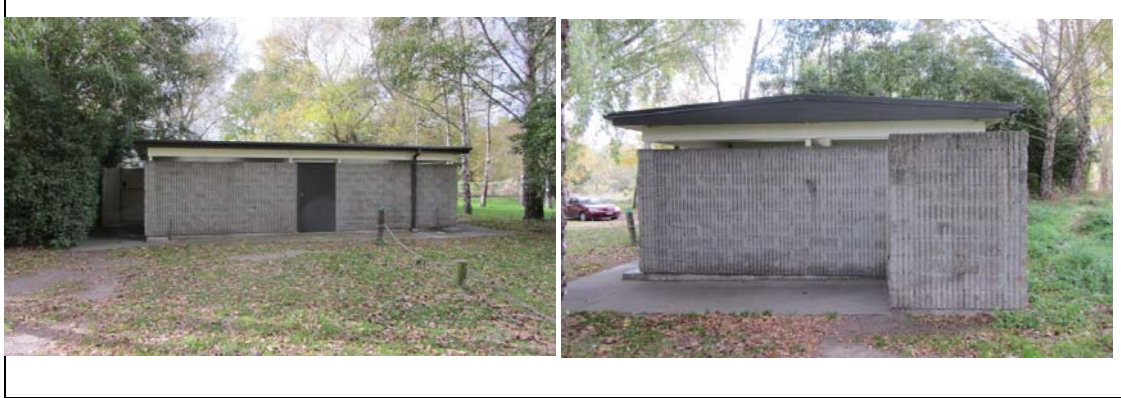
1.1 Photos (attach sufficient to describe building)

This building is a single storey toilet block. It is constructed from reinforced filled masonry walls with a timber framed corrugated iron roof, which is connected with steel tubes and brackets cantilevering vertically from the walls. This building shares the same drawings with PRK_0348_BLDG_002 Toilets No.1 Ground East the drawings indicate the building was designed in April 1987.
