CHRISTCHURCH CITY COUNCIL
PRK_0348_BLDG_016 EQ2
Storage Shed
The Groynes, 182 Johns Road

QUALITATIVE ASSESSMENT REPORT
FINAL

- Rev B
- 07 December 2012

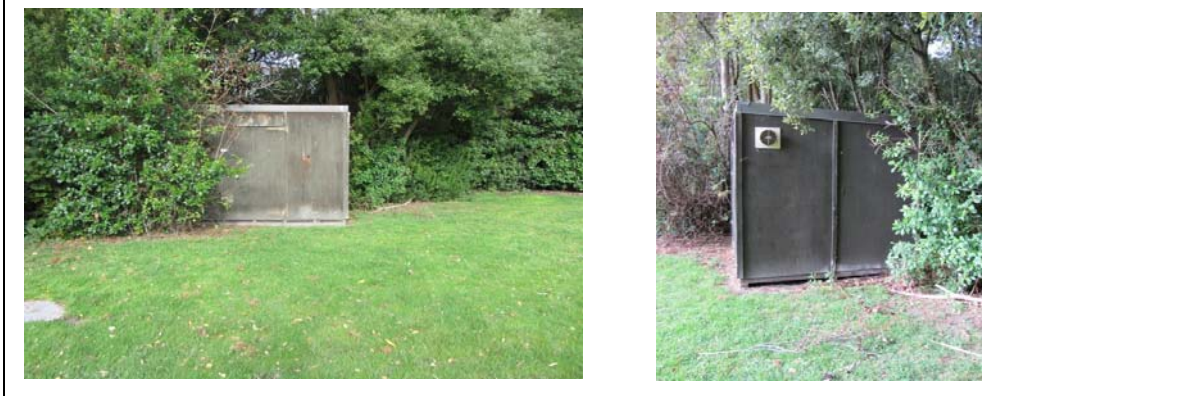
1.1 Photos (attach sufficient to describe building)

Building PRK_0348_BLDG_016 is a single storey timber framed timber shed. Based on the apparent ageing of this building we estimate that it was constructed sometime in the 1980's, so have assumed a post-1976 construction date for the purposes of our assessment.
