**CHRISTCHURCH CITY COUNCIL**  
PRK\_0348\_BLDG\_011 EQ2  
The Groynes – Workshop & Garage  
182 Johns Road

QUALITATIVE ASSESSMENT REPORT  
FINAL

- Rev B
- 08 November 2012

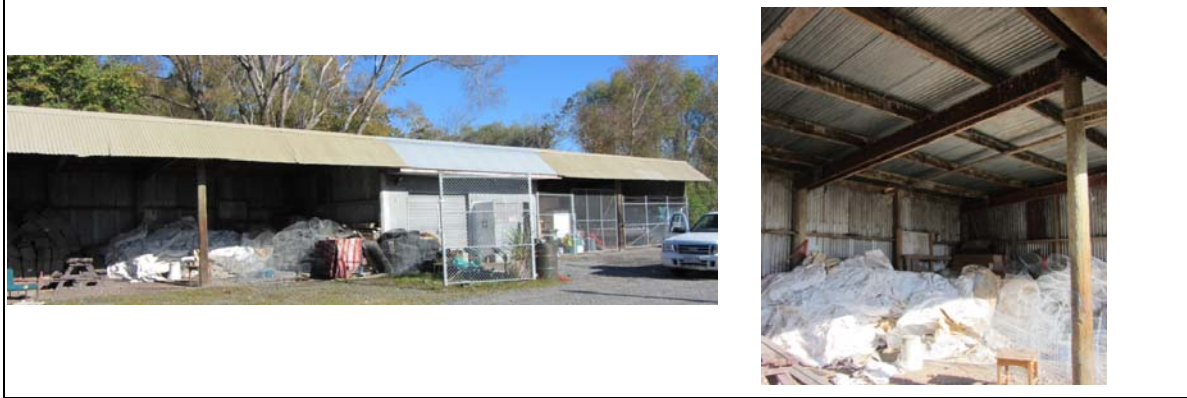
**1.1 Photos (attach sufficient to describe building)**

Building CCC-PRK-0348-011 is a small single storey building that is used as storage and workshop by The Groynes staff. The roof is constructed from timber rafters that support timber purlins and a light weight corrugated steel cladding. The roof is supported on round timber columns that are set into the ground. The footprint of this structure is approximately 30.0m x 5.6m and is approximately 4.0m high. Due to a lack of structural drawings a post 1992 construction date has been assumed based on the architecture and the condition of the structure. Lateral loads acting across and along the building will be resisted the round timber columns. These columns are set into the ground and will act as cantilevering piles.
