CHRISTCHURCH CITY COUNCIL
BU 0812-002 EQ2
Guthrey Courts – Block B
72a Olliviers Road, Phillipstown

QUANTITATIVE ASSESSMENT REPORT

- Rev E
- 03 May 2013

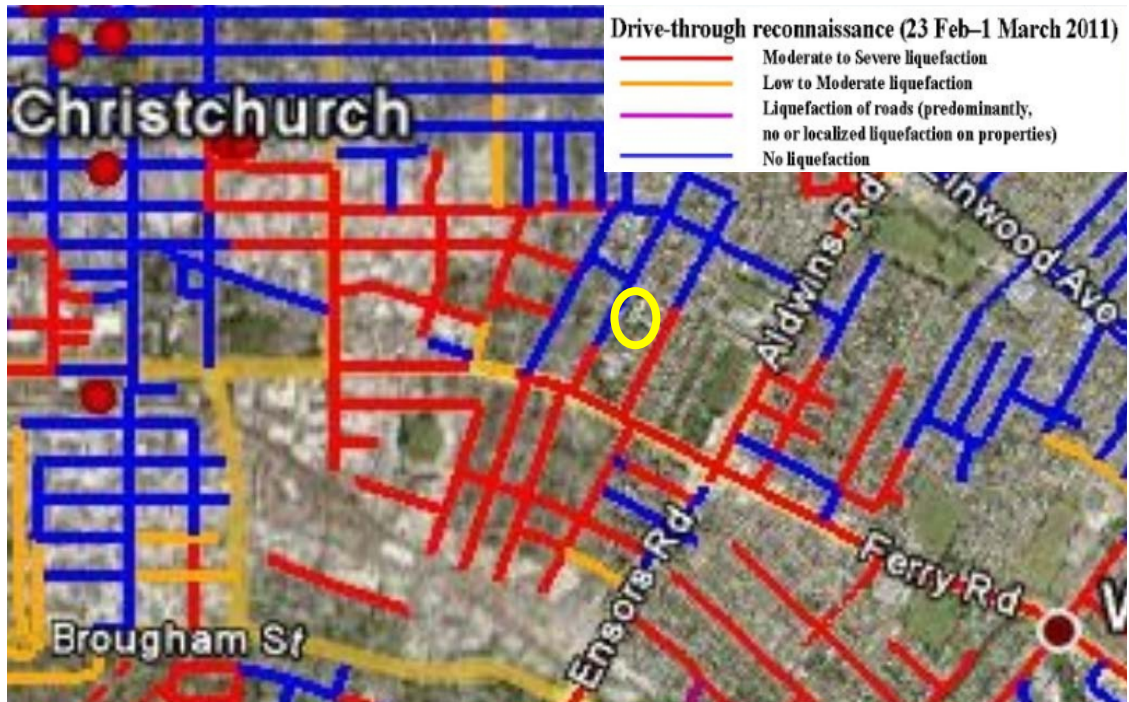
- **Figure 4 – Liquefaction map (Cubrinovski & Taylor, 2011). Site marked in yellow.**

There finding shows no liquefaction near Olliviers Road side of the site. However, it should be noted that moderate to severe liquefaction was observed on sections of Olliviers Road and Bordesley Street that are located near Ferry Road.

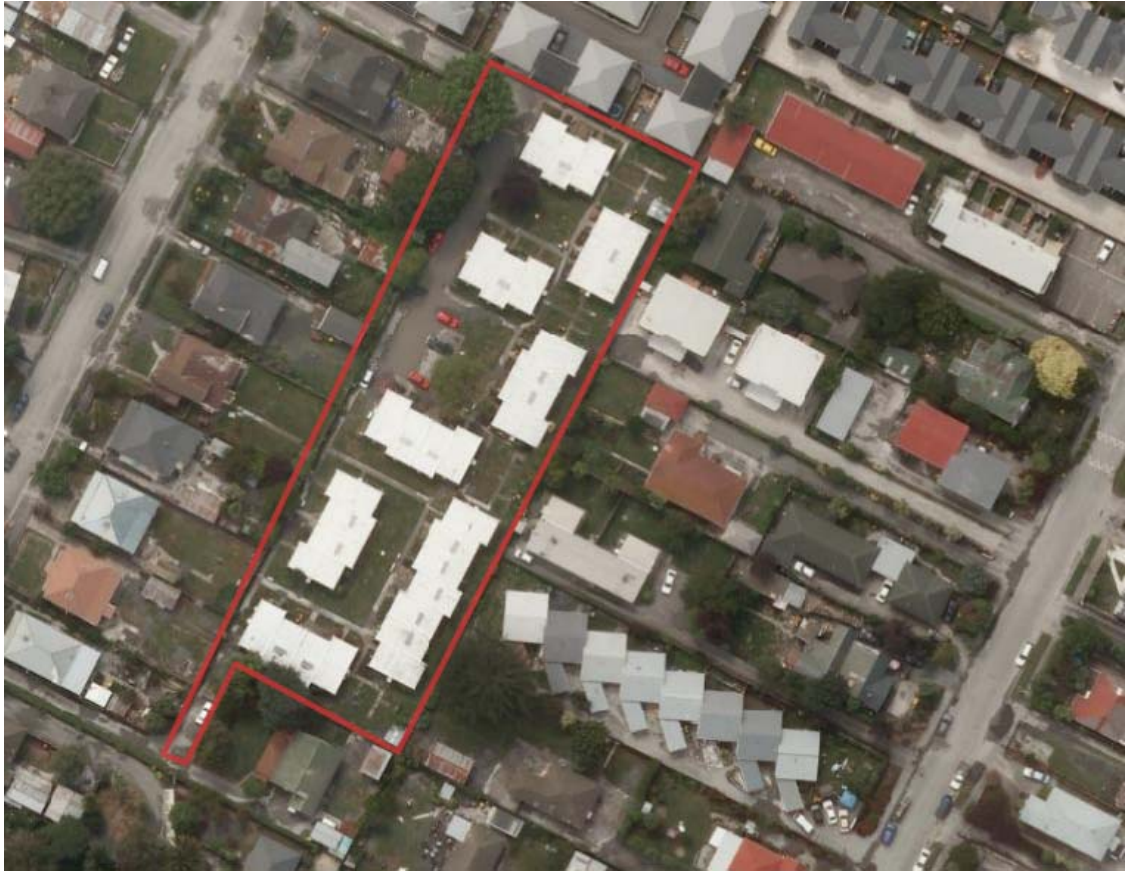
■ **Figure 5 – Aerial photography from 24 Feb 2011 (<http://viewers.geospatial.govt.nz/>)**

A significant amount of liquefied on Olliviers Road and Bordesley Street could be seen from the aerial photograph. Additionally, liquefaction around the property and on the driveways of residential properties could also be seen. The findings from the aerial photograph seem to contradict the conclusions from the reconnaissance undertaken between 23 February and 1 March 2011.

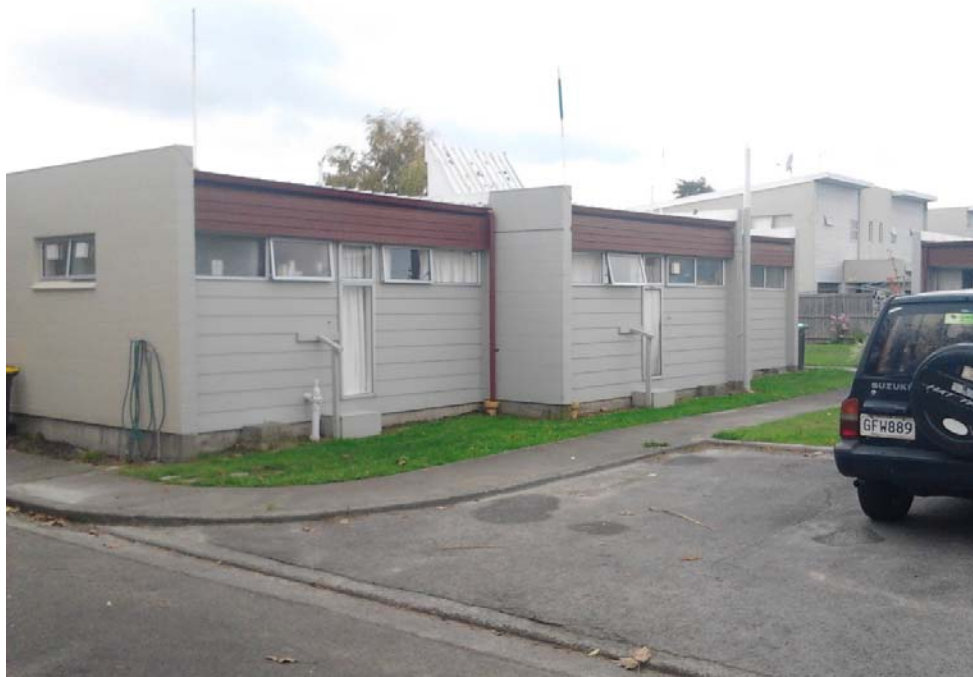
Significant land damage was observed during the external site walkover. The site had significant liquefaction during the Feb 2011 earthquake, as there was evidence of this over a year later. There were remaining sand ejecta on the site, significant ground undulations including domes in the driveway where sand boils were ejected beneath the asphalt. There was undulating grass land and settlement of footpaths. It is expected that some settlement of the structure would have occurred as a result of significant liquefaction of underlying ground.

■ **Figure 7 Overview of the block units on site**
