CHRISTCHURCH CITY COUNCIL
BU 0812-008 EQ2
Guthrey Courts – Block H
72a Olliviers Road, Phillipstown

QUANTITATIVE ASSESSMENT REPORT

- Rev E
- 03 May 2013

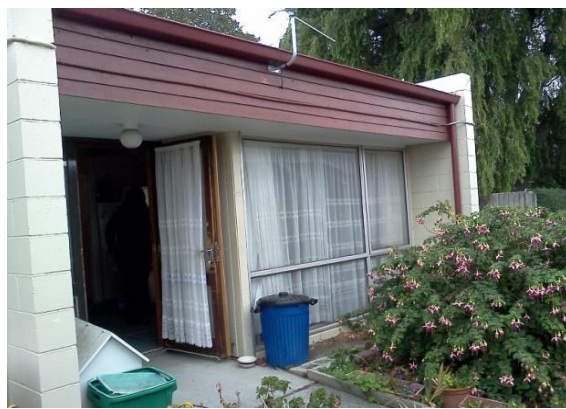
Photo 5: North elevation of Unit 30 (typical).

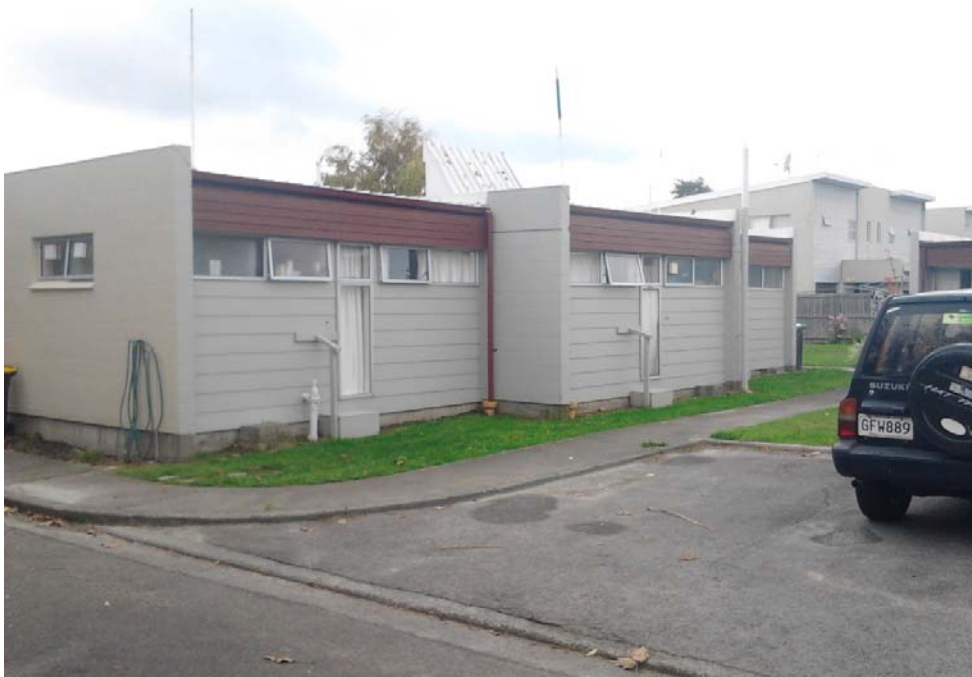
Significant land damage was observed during the external site walkover. The site had significant liquefaction during the Feb 2011 earthquake, as there was evidence of this over a year later. There were remaining sand ejecta on the site, significant ground undulations including domes in the driveway where sand boils were ejected beneath the asphalt. There was undulating grass land and settlement of footpaths. It is expected that some settlement of the structure would have occurred as a result of significant liquefaction of underlying ground.

■ **Figure 7 Overview of the block units on site**
