Haast Courts Block G
BU 0792-007 EQ2
Detailed Engineering Evaluation
Quantitative Report
Version FINAL

151 Stanmore Road, Linwood

Christchurch City Council

Date
31/10/12

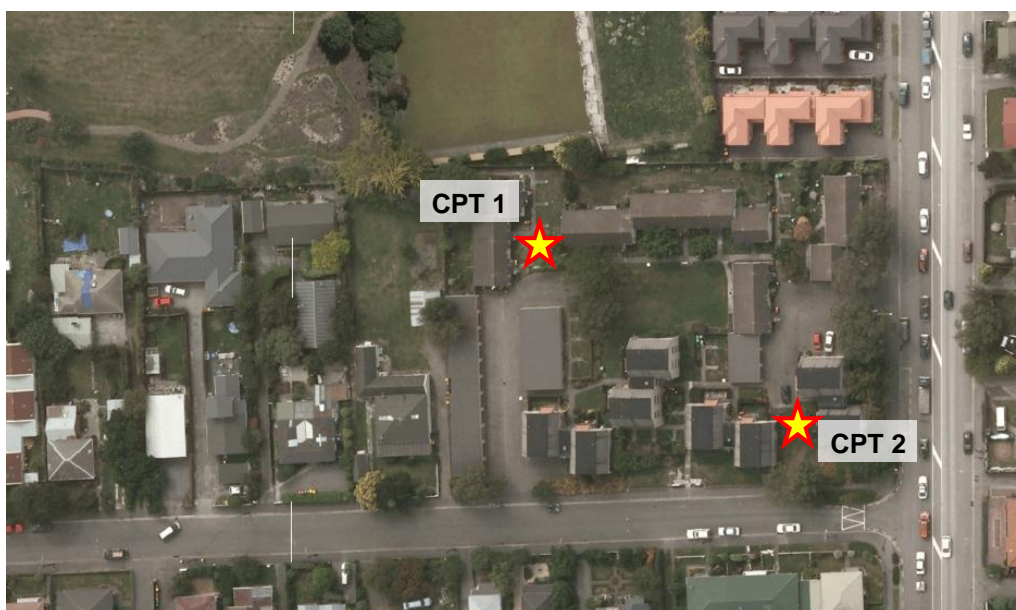
Figure 7.1 Aerial Photograph depicting CPT Investigation Locations³

In order to further understand the ground conditions at the site, intrusive testing comprising two piezocone CPT investigations were conducted at the site on 28 June 2012. The locations of the tests are indicated on Figure 7.2 below.
