**Halswell Courts
Housing Complex
PRO 1630**

**Detailed Engineering Evaluation
Quantitative Assessment Report**

Halswell, Christchurch

Date: November 2013
Reference: 6-QC355.00
Status: Final

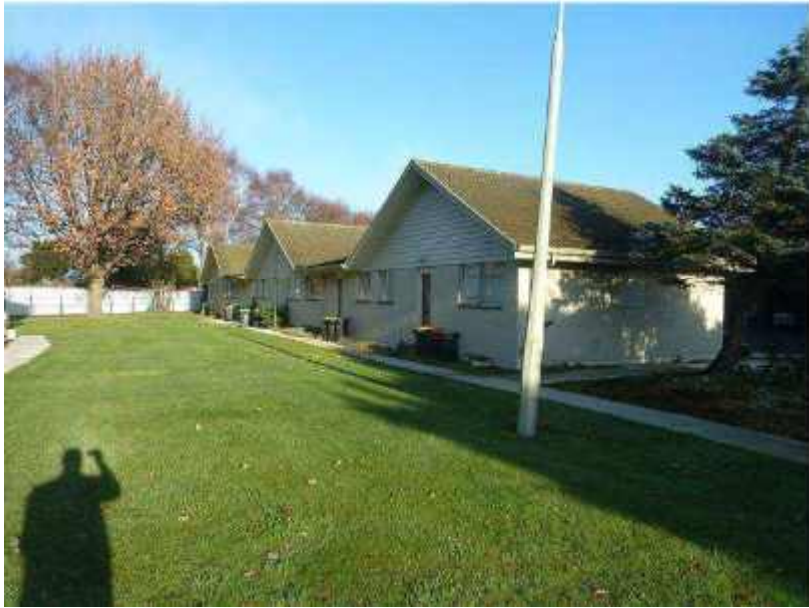
Photo 7: View Behind Flats 6-14, Looking South

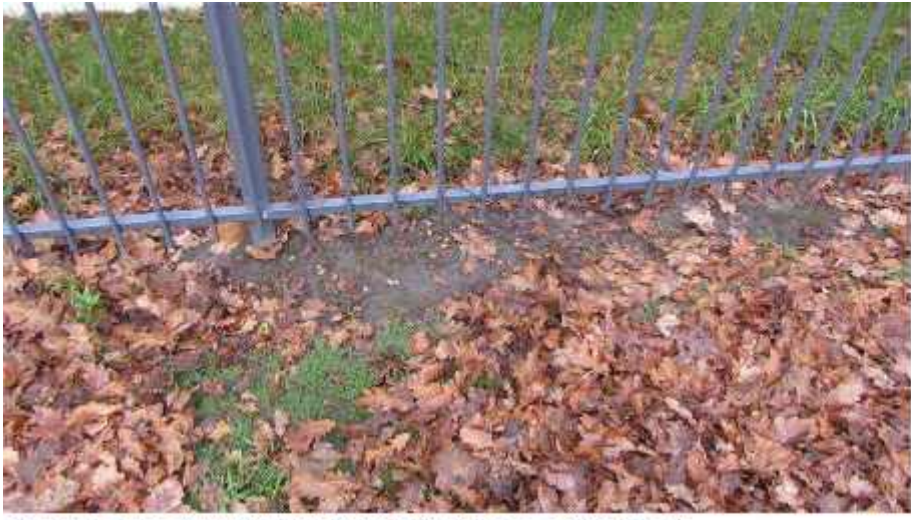
- Grey SILT/SAND ejecta behind Flats 6 and 15 (typified by Photos 13, 16 and 17 in Appendix B)
- Ground settlement in behind Flats 6 and 15 (typified by Photos 14 and 15 in Appendix B)

Photo 13: Ejecta along Southern Fence Behind Flat 15, Looking South

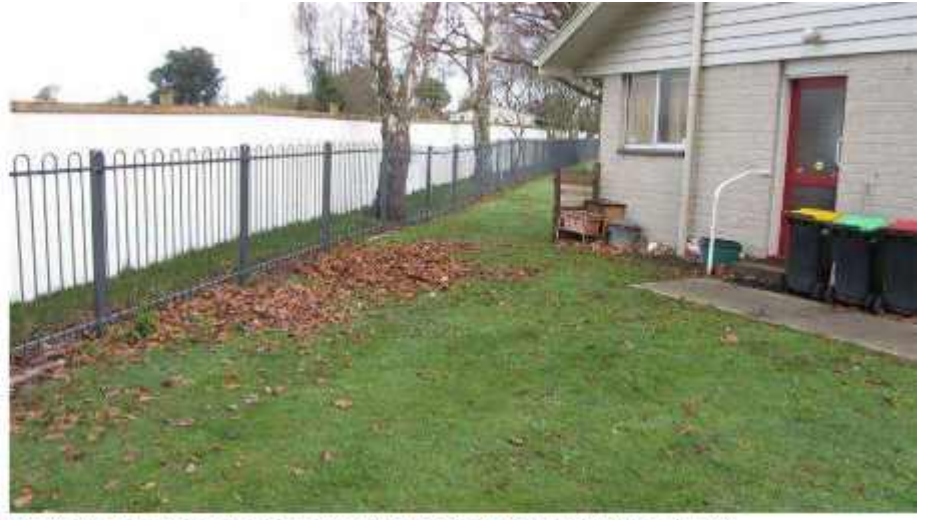
Photo 14: View of Ground Settlement behind Flat 15, Looking Southwest

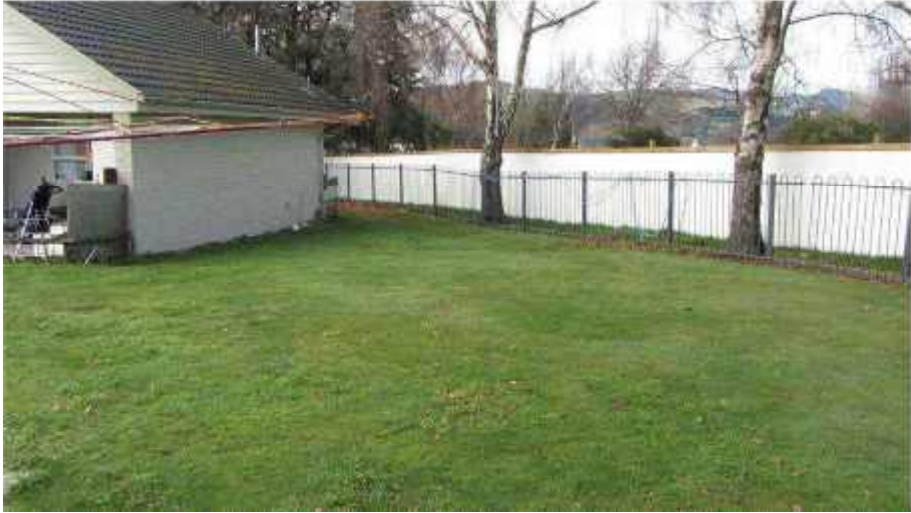
Photo 15: View of Ground Settlement behind Flat 15, Looking Southeast

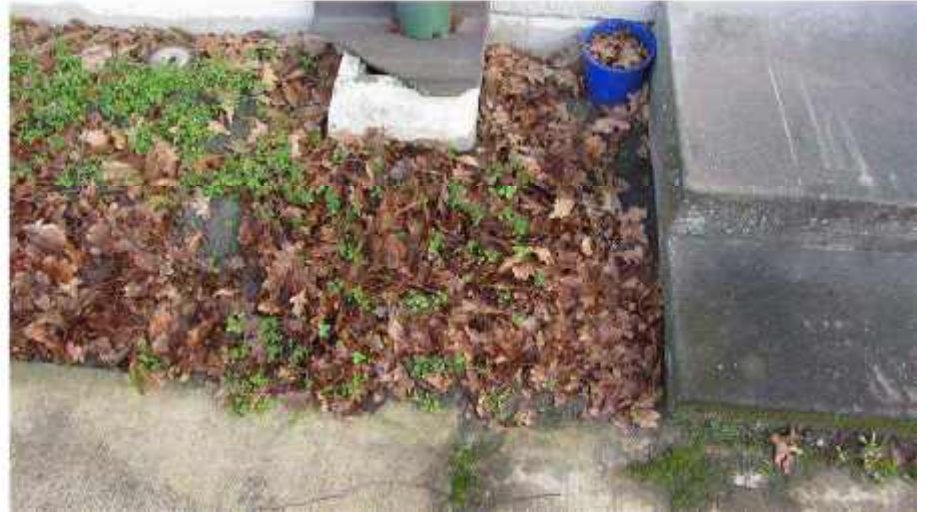
Photo 16: Ejecta behind Flat 6, Looking Northwest

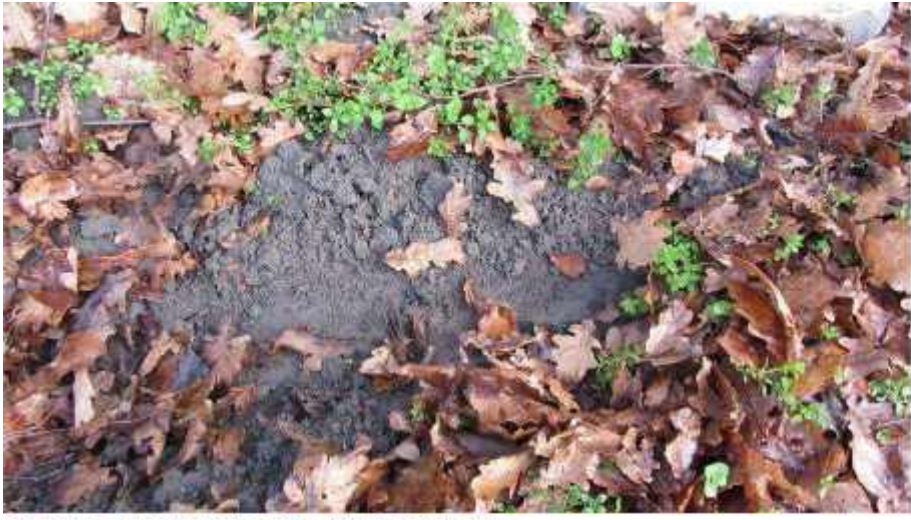
Photo 17: Ejecta behind Flat 6, Looking Northwest

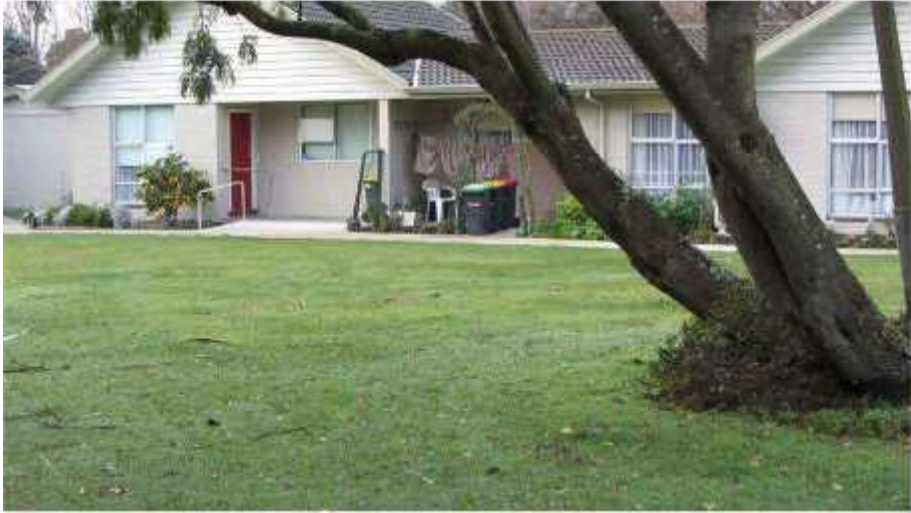
- Shallow ground depression in front of Flats 1-3 (refer to Photos 18 and 19 in Appendix B)

Photo 19: Shallow Depression in Front of Flats 1-3, Looking Northeast

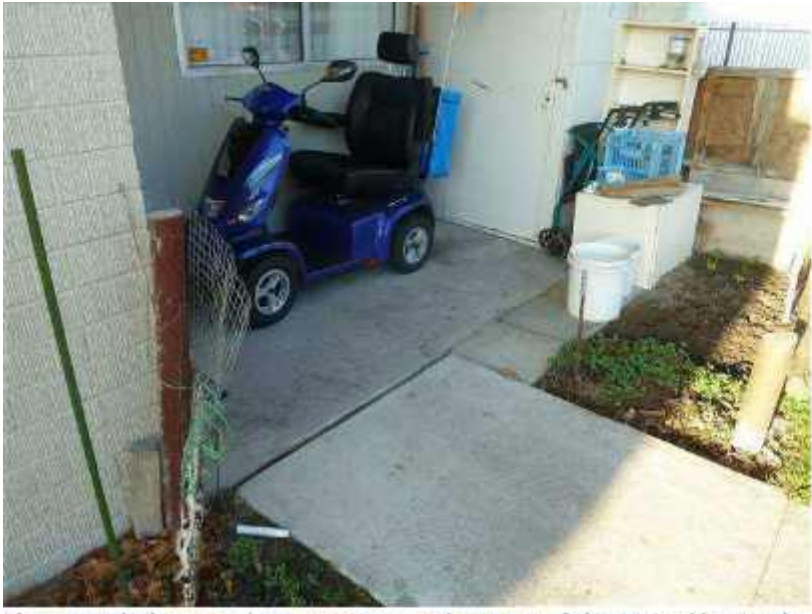
- Cracking of concrete footpath between Flats 1 and 8 and at front of Flat 15 (typified by Photos 29 through 31 in Appendix B)
- Differential movement of concrete footpaths behind Flats 6-8 and in front of Flat 8 (typified by Photos 25 and 32 in Appendix B)

Photo 25: Displacement in Concrete Footpath at Front of Flat 15, Looking South
