Hennessy Place Housing Complex PRO 1093

**Detailed Engineering Evaluation
Quantitative Assessment Report**

**2 Hennessy Place, Spreydon,
Christchurch 8024**

Date: August 2013
Reference: 6-QC358.00
Status: Final

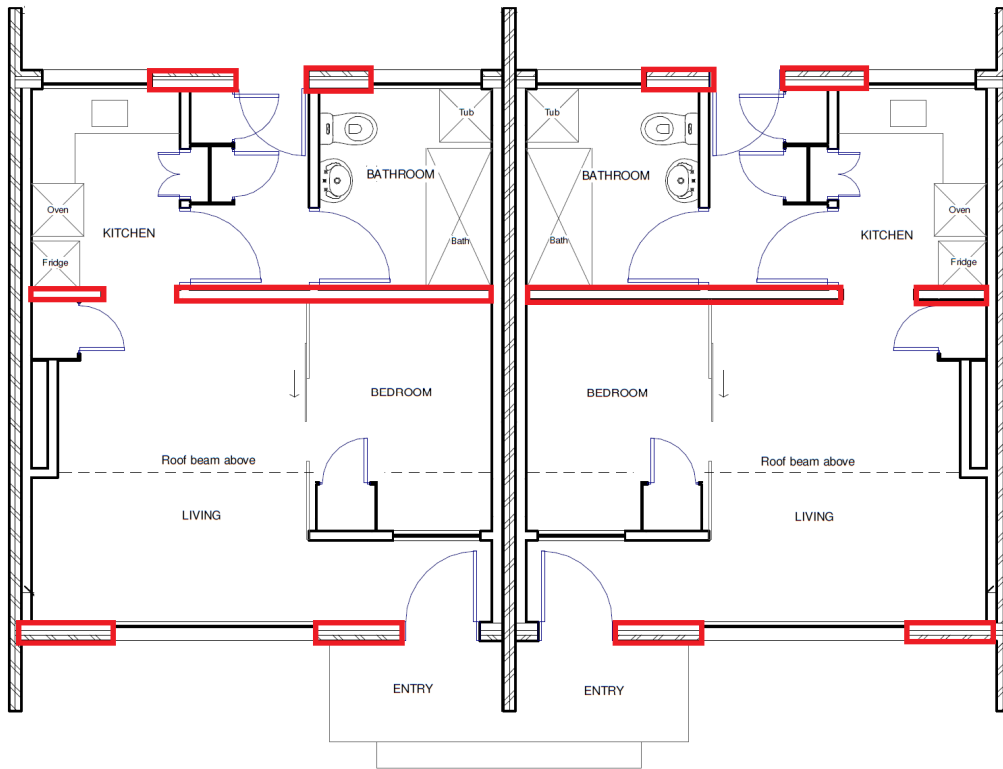
Figure 7: Walls used for bracing in the longitudinal direction.

Hand calculations were performed to determine seismic forces from the current building codes. These forces were applied globally to the structure and the capacities of the walls were calculated and used to estimate the %NBS. The walls, highlighted in Figure 7 and Figure 8, were used for bracing in their respective directions.

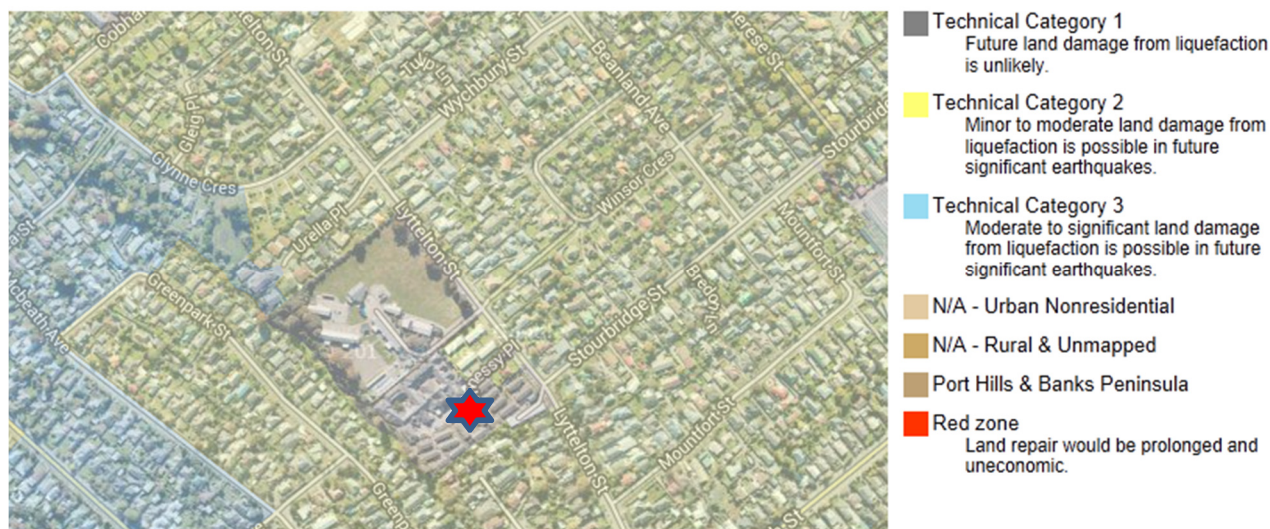
Figure 9: CERA Technical Categories map (loc. starred)

CERA indicates that Hennessy Place Housing Complex is located in a TC2 zone (as shown in Figure 9). This classification suggests future significant earthquakes will cause minor to moderate land damage due to liquefaction and settlement.
