CHRISTCHURCH CITY COUNCIL

PRK_0722_BLDG_001_EQ2

Horseshoe Lake Reserve - Toilet

QUALITATIVE ASSESSMENT REPORT

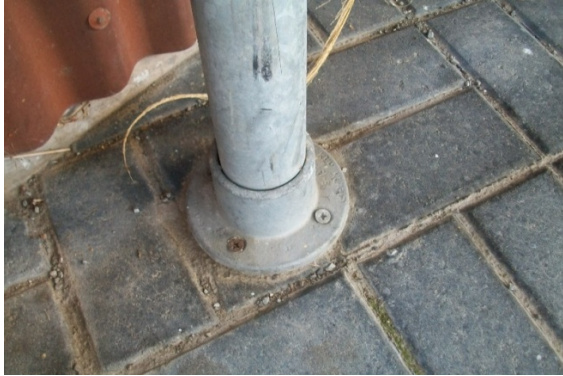
<p>Photo 17: Ground connection detail of steel grid frame extended down East wall.</p>	<p>Photo 18: Toilet and basin layout inside the building looking from the North side.</p>

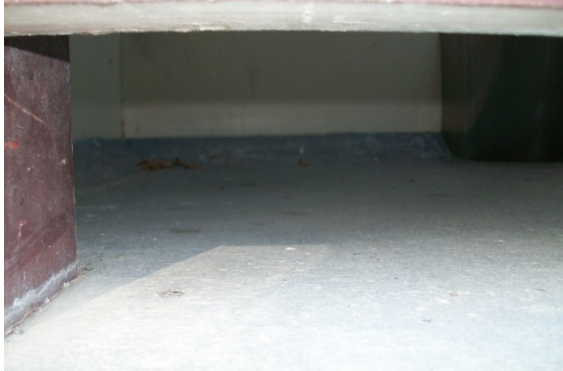
<p>Photo 19: Interior floor of the building looking from the North side.</p>	<p>Photo 20: Top of interior South wall and ceiling.</p>

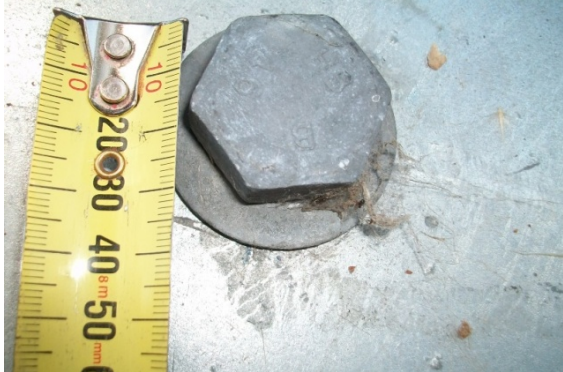
<p>Photo 21: Bolt at beam-column connection of timber portal frame.</p>	<p>Photo 22: Rivet in corrugated metal exterior wall cladding (typical).</p>
