**Kaumatua Place
Housing Complex
PRO 0417**

**Detailed Engineering Evaluation
Quantitative Assessment Report**

Date: February 2014
Reference: 6-QC367.00
Status: Final

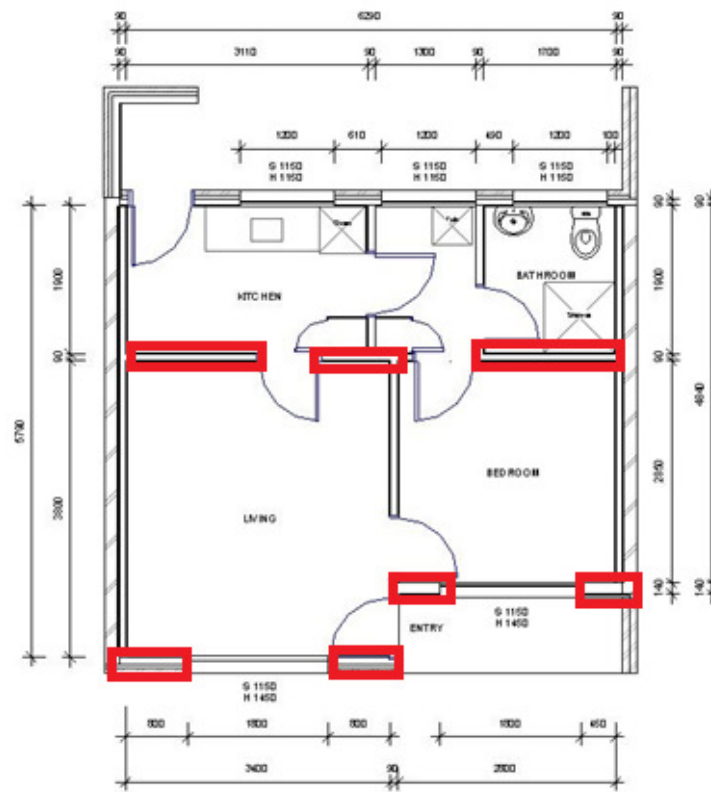
Figure 7: Walls used for bracing in the longitudinal direction.

Hand calculations were performed to determine seismic forces from the current building codes. These forces were applied globally to the structure and the capacities of the walls were calculated and used to estimate the %NBS. The walls, highlighted in Figure 7 and Figure 8, were used for bracing in their respective directions.

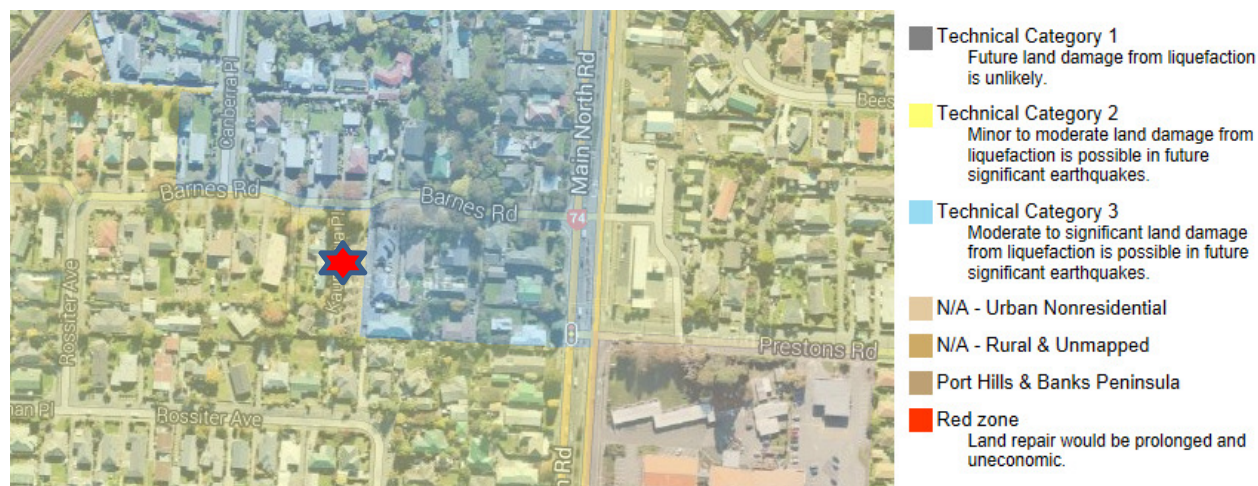
CERA indicates that Kaumatua Place is located in a TC2 zone (as shown in Figure 9). This classification suggests future significant earthquakes will cause minor to moderate land damage due to liquefaction and settlement.

Figure 9: CERA Technical Categories map (loc. starred).

There is no evidence to suggest that further geotechnical investigation is warranted for this site.
