CHRISTCHURCH CITY COUNCIL
PRK_0227_BLDG_007 EQ2
Linwood Nursery – Glasshouses (×5)
320 Linwood Ave, Linwood

QUALITATIVE ASSESSMENT REPORT

- Rev C
- 23 May 2013

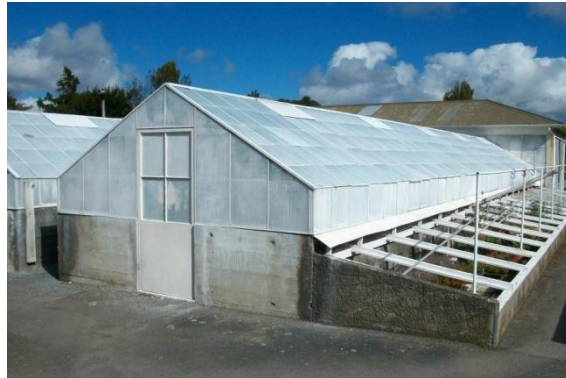
Linwood Nursery – Glasshouses (x5) is made up of five glasshouses orientated in a north-south direction. Each glasshouse has 125mm thick, 850mm high concrete walls and an aluminium framed structure fixed to the top of the walls. The structures are clad with glass panes which clip in to place, allowing for some movement. The longitudinal concrete walls of each structure are tied in to the northern wall of the Linwood Nursery – Potting Shed (PRK_0227_BLDG_004). Five vents, approximately 560mmx280mm in size, are located near the base of each longitudinal wall. (see Photo 1, Photo 2 and Photo 3)

Photo 1: Exterior of a glasshouse structure

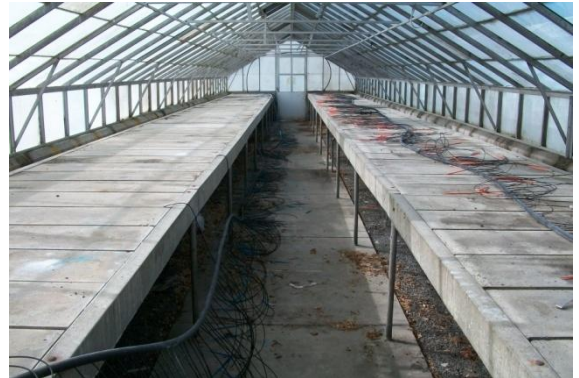
Internal concrete decking runs the length of the glasshouses, adjacent to the east and west walls of each structure. The decking is supported off concrete beams and steel posts and is tied in to the adjacent glasshouse wall. The deck is used for the storage of plants. (see Photo 2 and Photo 4)

Photo 2: Interior of a glasshouse structure

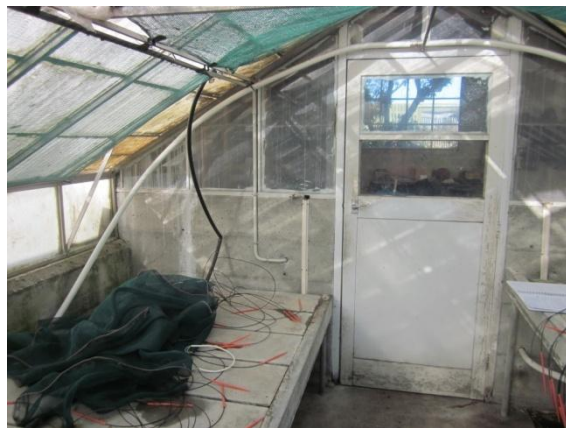
Photo 3: The south end of a glasshouse structure showing the connection to the wall of the Potting Shed (Building 4)

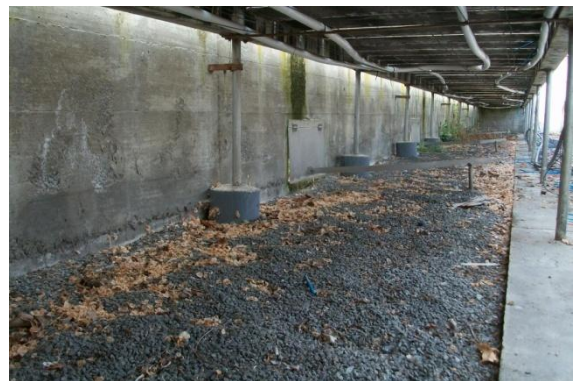
Photo 4: The underside of the concrete decking showing the supporting steel posts and ties to the adjacent walls
