Little Akaloa Toilets
Quantitative Engineering
Evaluation

Reference: 237794

Prepared for:
Christchurch City Council

Date: 23 September 2013

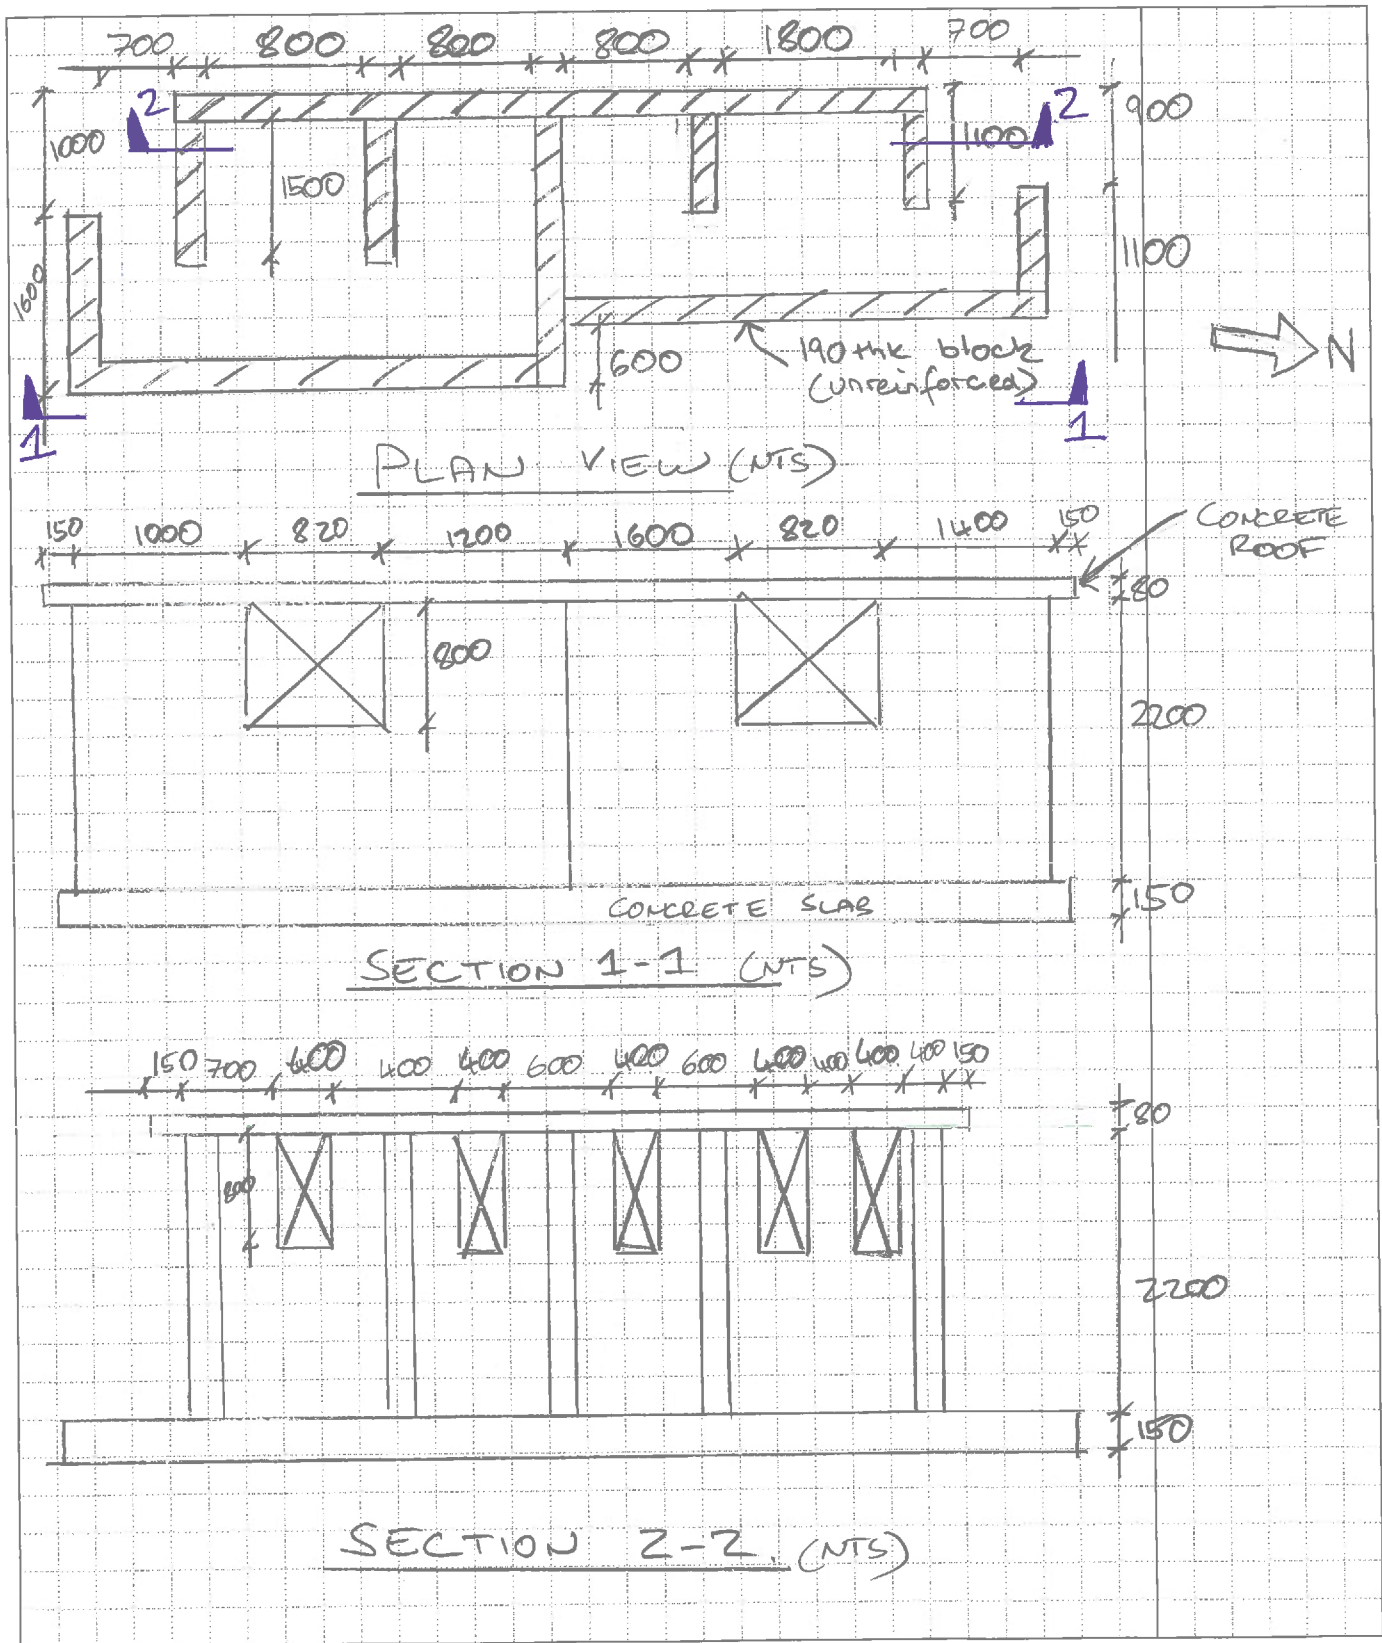
Client: CCC	Date: 27/08/13
Project/Job: LITTLE AKALOA TOILETS	Job No: 237794
Subject: FLOOR PLAN AND ELEVATIONS.	Sheet No: SK01 By: CTL

No structural or architectural drawings were available for the Little Akaloa Toilets. Inspection priorities related to a review of potential damage to concrete roof, masonry walls and foundations. A measure up of the building was carried out on site and a sketched plan and elevations can be seen in Appendix B.
